# Letter of Notification for Amlin-Dublin 138 kV Transmission Line Project

PUCO Case No. 20-0946-EL-BLN

Submitted by:  
AEP Ohio Transmission Company, Inc.

May 26, 2020

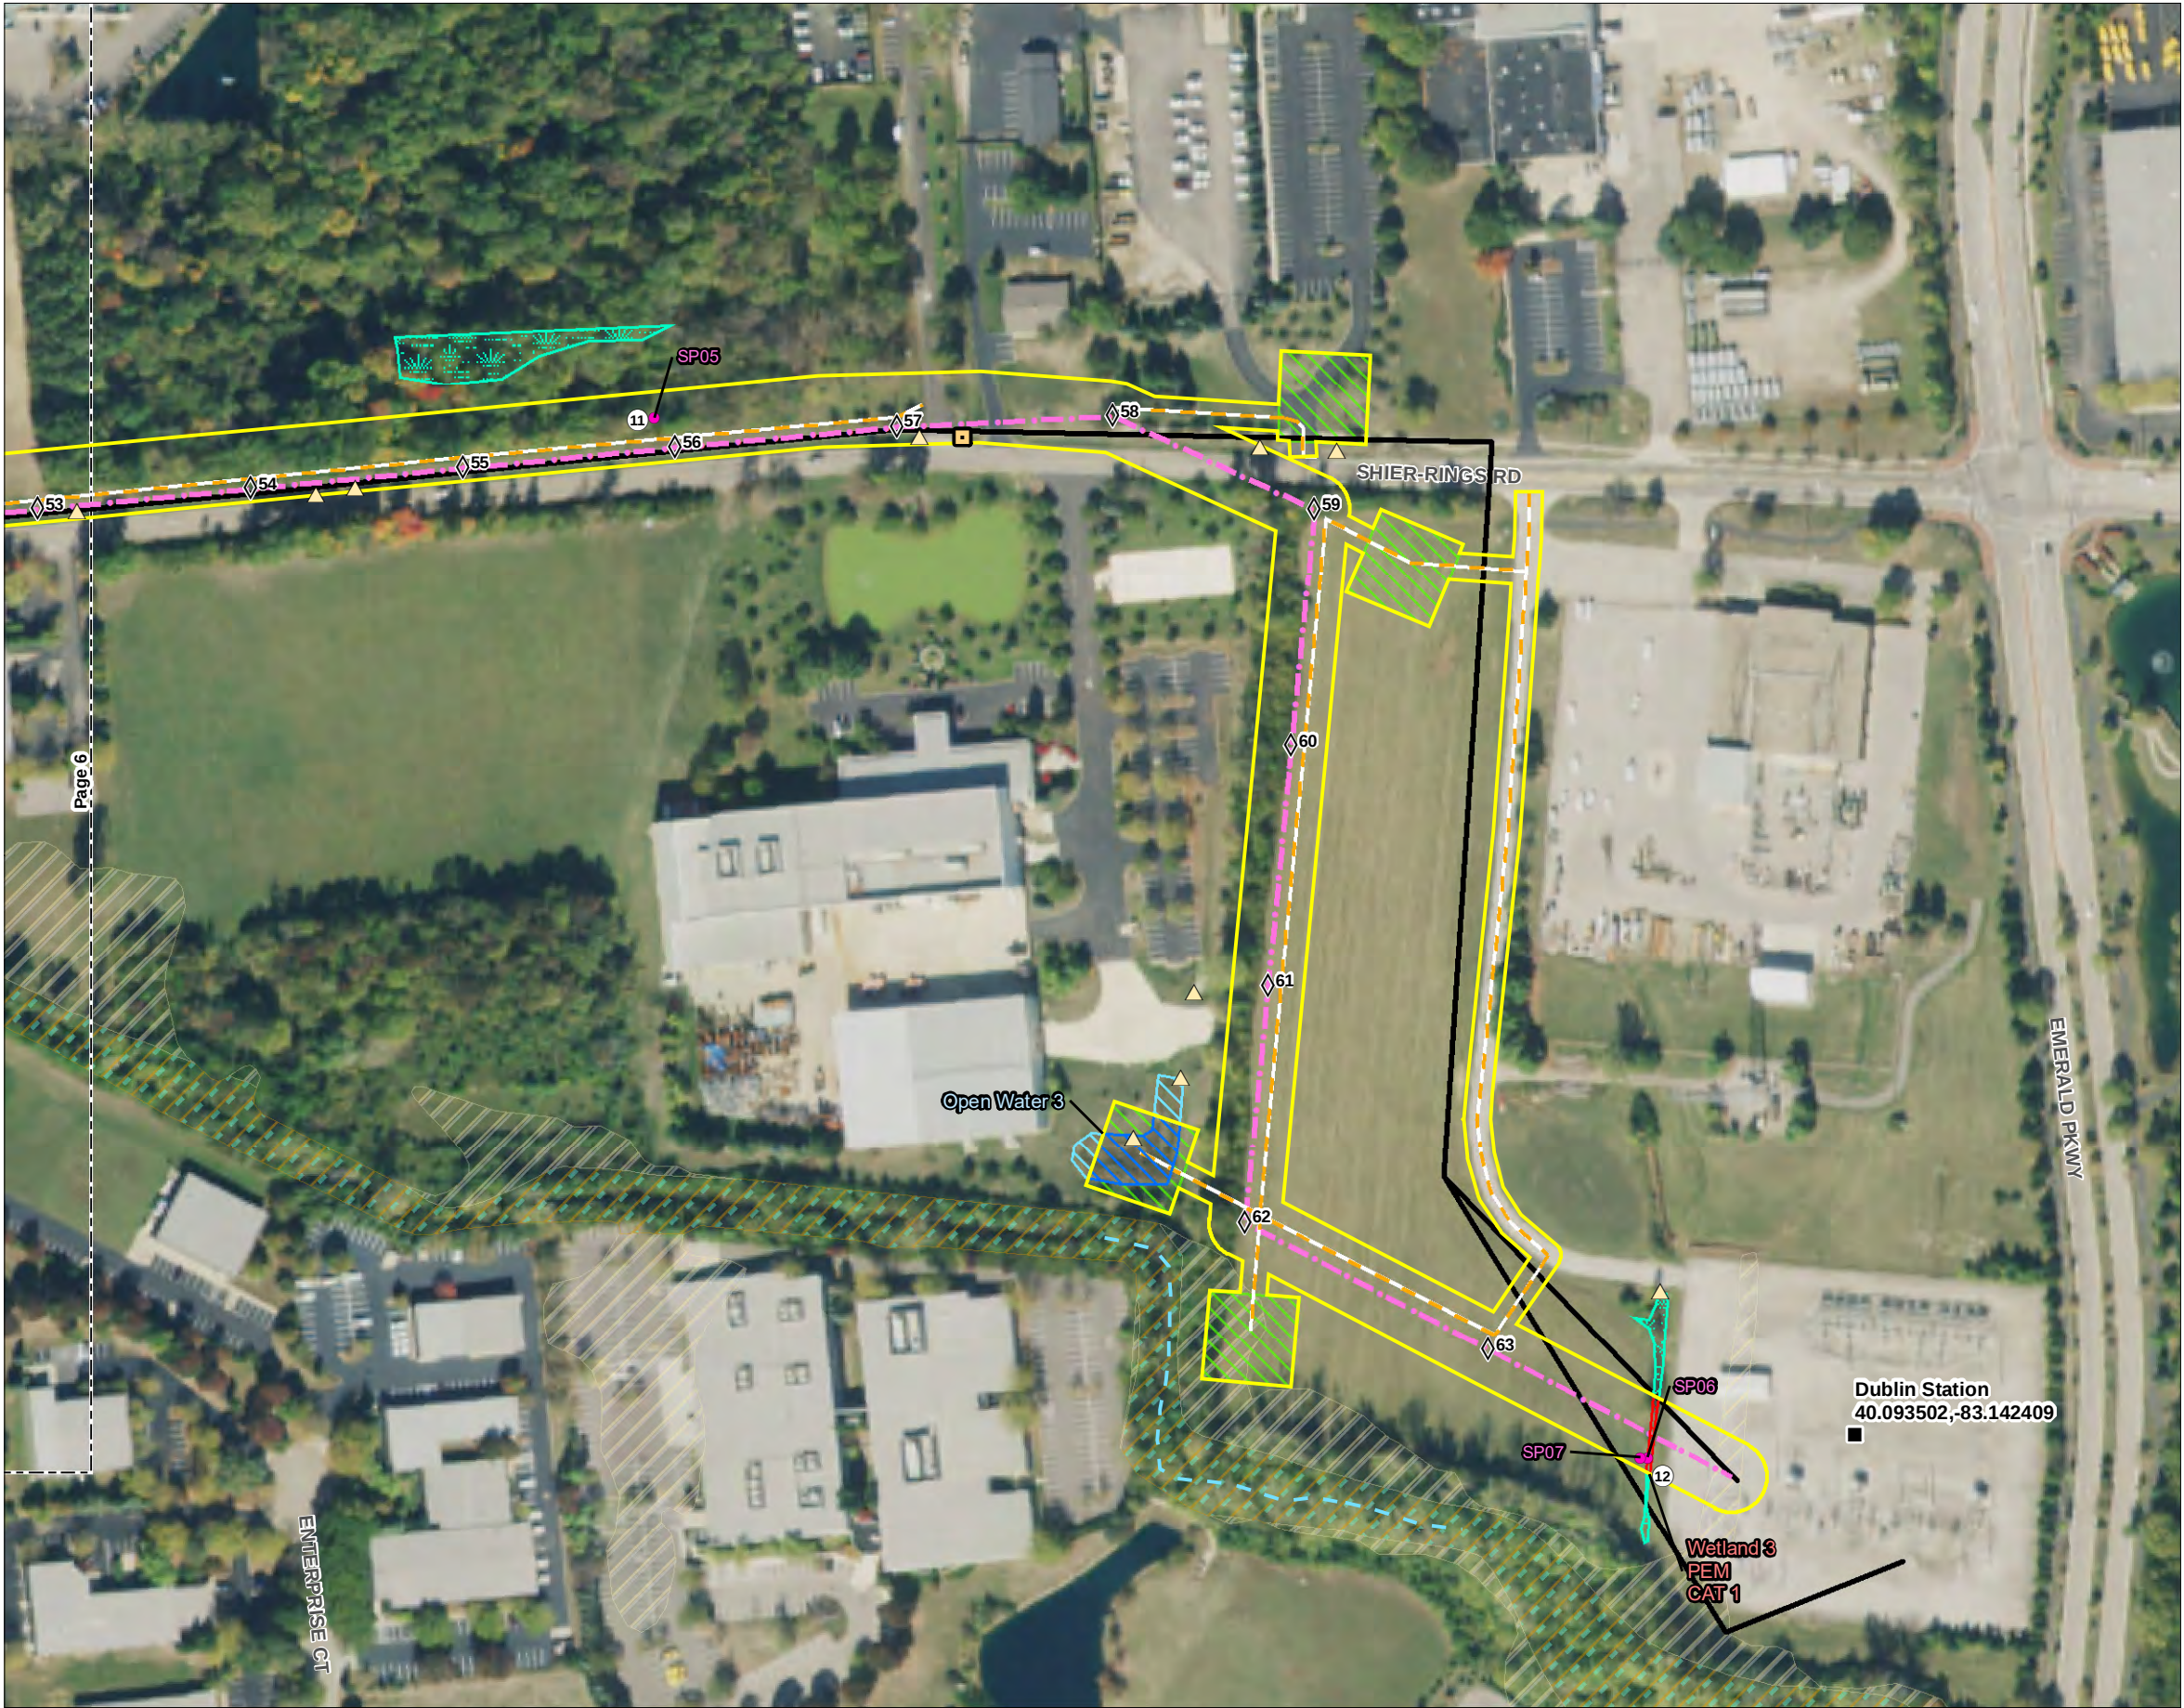
Figure No.  
**2**  
Title  
**Wetland and Waterbody  
Delineation Map**

- Legend
- AEP Substation
  - ◇ Proposed Structure
  - Existing 138 kV Transmission Line to be Rebuilt
  - Proposed 138 kV Transmission Line
  - Proposed Access Road
  - Project Area
  - Pulling/Tensioning Pad
  - Photo Location
  - Culvert
  - Storm Drain
  - Wetland Determination Sample Point
  - Upland Drainage Feature
  - Approximate Upland Drainage Feature
  - Field Delineated Waterway
  - Approximate Waterway
  - Field Delineated Waterway Area
  - Field Delineated Open Water
  - Approximate Open Water
  - Field Delineated Emergent Wetland
  - Approximate Wetland
  - FEMA Flood Hazard Area
  - 100-year Flood Zone
  - 100-year Floodway

Notes  
1. Coordinate System: NAD 1983 StatePlane Ohio South FIPS 3402 Feet  
2. Data Sources: Stantec, AEP, USGS, FEMA, NADS, OGRIP  
3. Orthophotography: 2019 NAIP

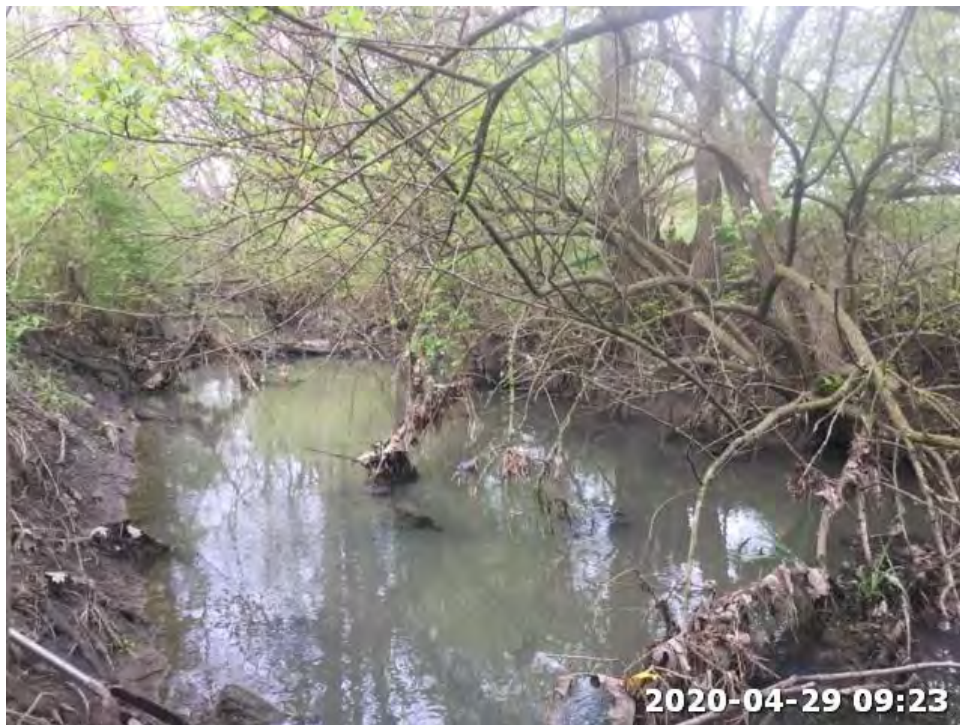
Photo Location 4. View of Stream 1, South Fork Indian Run. Photograph taken facing upstream, southwest.

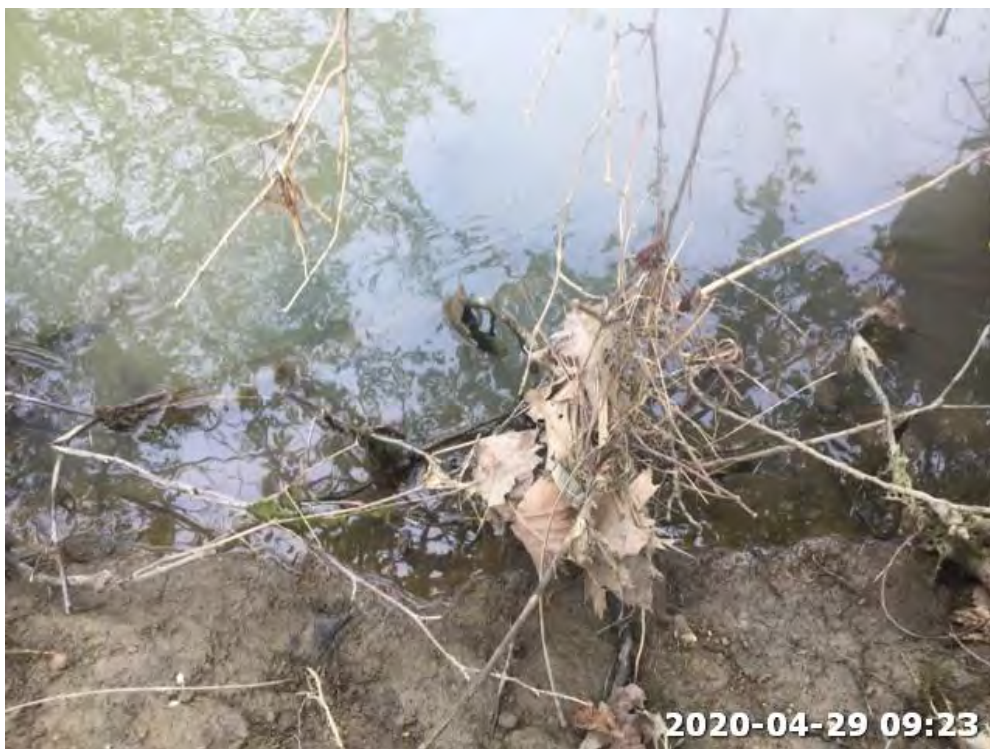
Photo Location 4. View of Stream 1, South Fork Indian Run, typical substrates.
