Re: Case No. 20-1321-EL-BGA - In the Matter of the Application of Hardin Solar II LLC for a Boundary Amendment to its Certificate Issued in Case No. 18-1360-EL-BGN.

Supplement to Application – Road Condition Report and Updated Sound Analysis

Road Condition Report

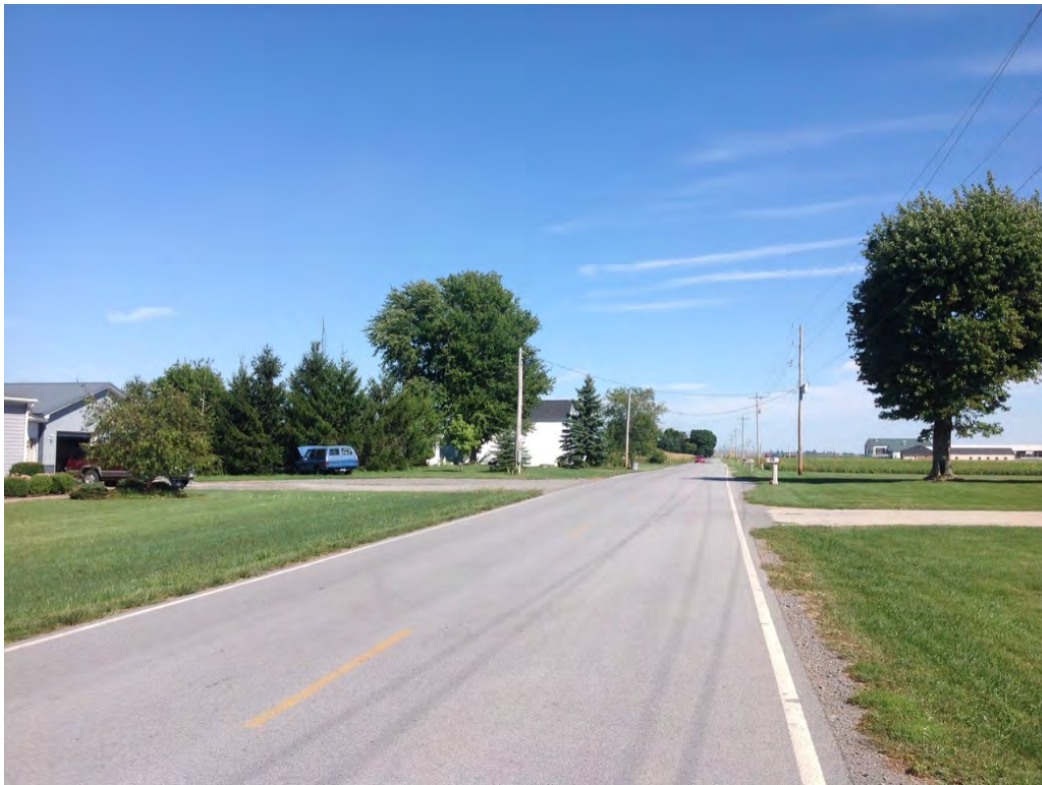
Figure 4-1 CR-110 Section 1

Section 1 from OH-235 to approximately 2 miles east of OH-235 was generally in good condition. Minimal distresses such as shoulder drop-off, sags and bumps were observed, specifically on the bridge at the intersection with CR-35 and at the irrigation ditch crossings by the Van Deurzen Dairy site. Heavy traffic from harvesting activities was observed coming in and out of the Van Deurzen Dairy site and travelling east on CR-110 to the adjacent fields. During the site visit no significant distresses were observed in this section of road product of the heavy traffic. Two sample units were selected within the section.

SAMPLE UNIT	PCI	RATING
1	97	GOOD
2	97	GOOD

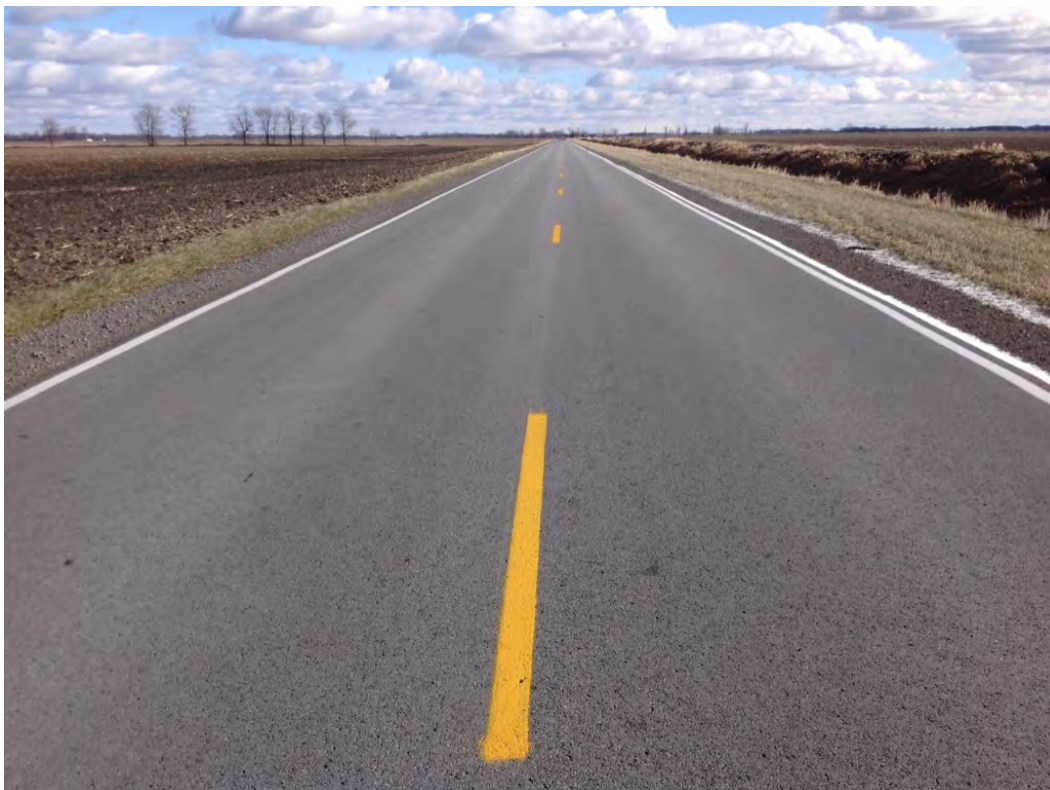
Figure 4-2 CR-110 Section 2

Table 4-3 CR-110 Section 2 – PCI Summary

SAMPLE UNIT	PCI	RATING
1	88	GOOD
2	77	SATISFACTORY

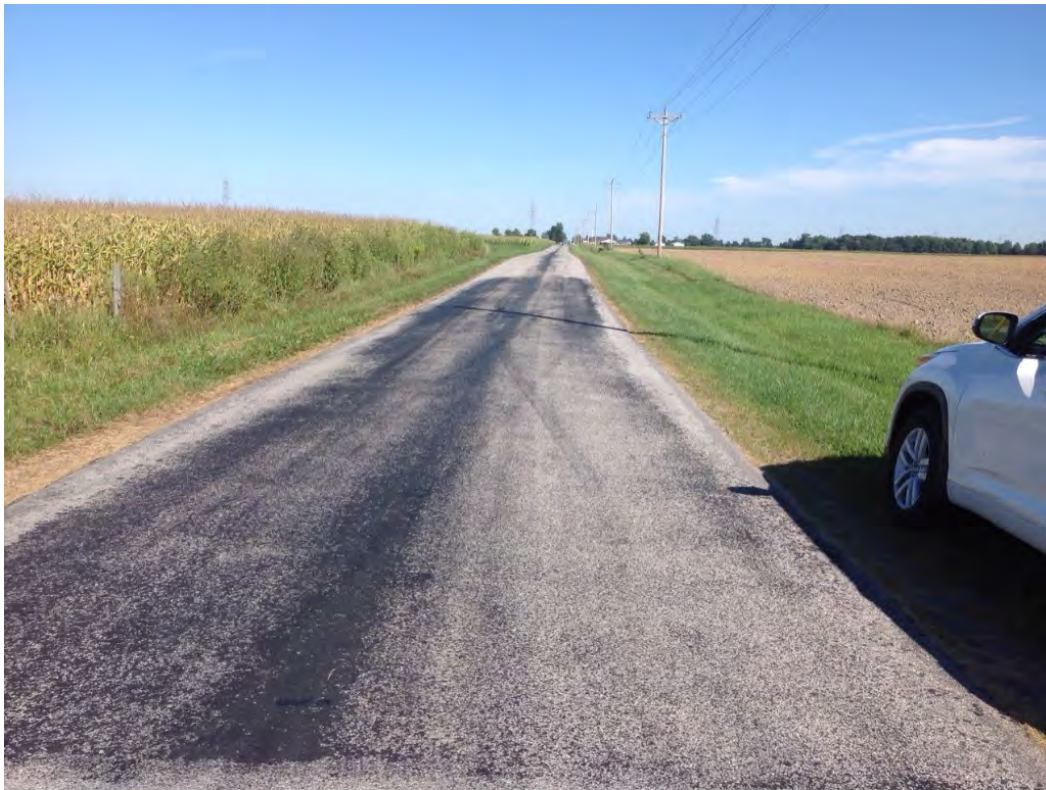
Figure 4-3 TR-120 Section 1

Section 1 from OH-235 to CR-35 was observed generally in good condition. The pavement has minimal distresses such as bleeding. Two sample units were selected within the section.

SAMPLE UNIT	PCI	RATING
1	97	GOOD
2	97	GOOD

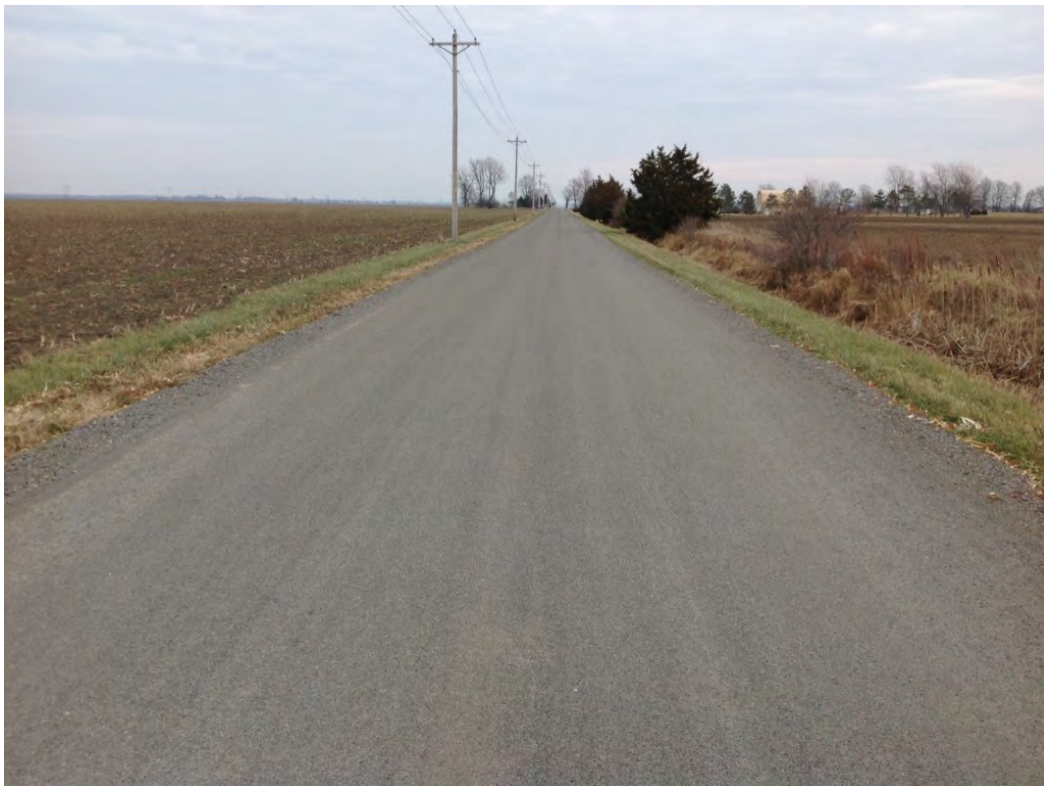
Figure 4-4 TR-120 Section 2 – Sample 1

Section 2 from CR-35 to OH-195 was observed generally in good condition, with a localized area, approximately 1 mile west of the east end (intersection with Scioto River) that was rated as fair (See Figure 4-5).

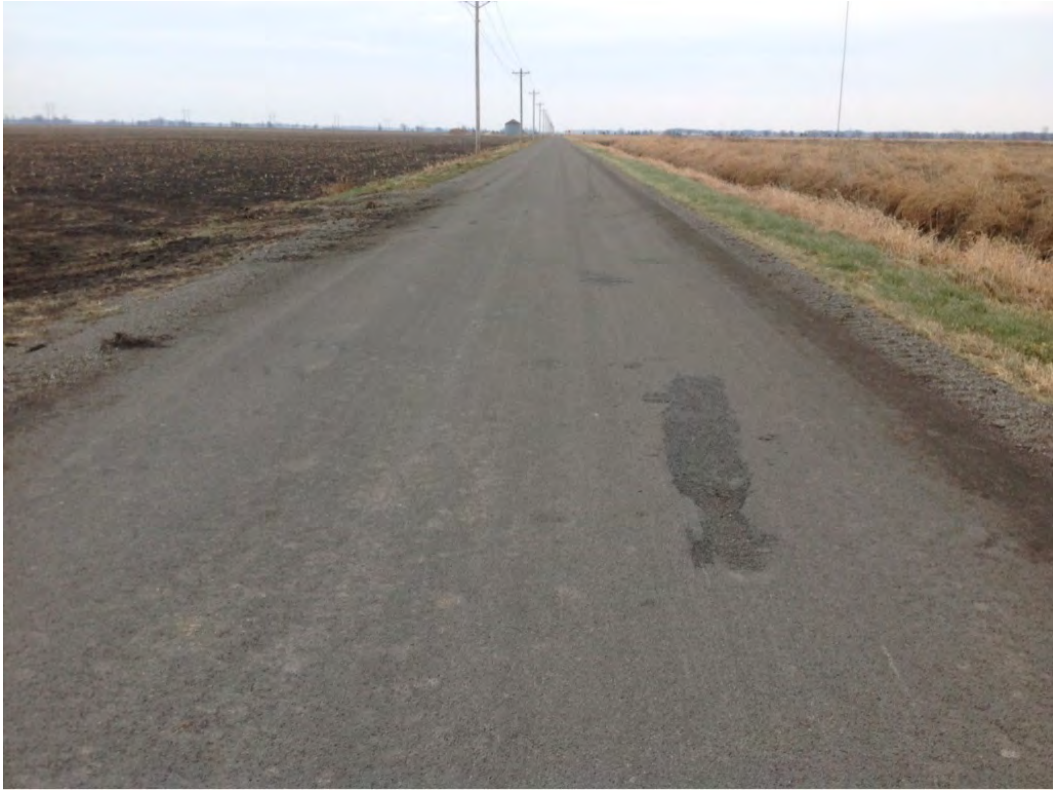
Figure 4-5 TR-120 Section 2 – Sample 2

Table 4-5 CR-150 Section 2 – PCI Summary

SAMPLE UNIT	PCI	RATING
1	90	GOOD
2	68	FAIR

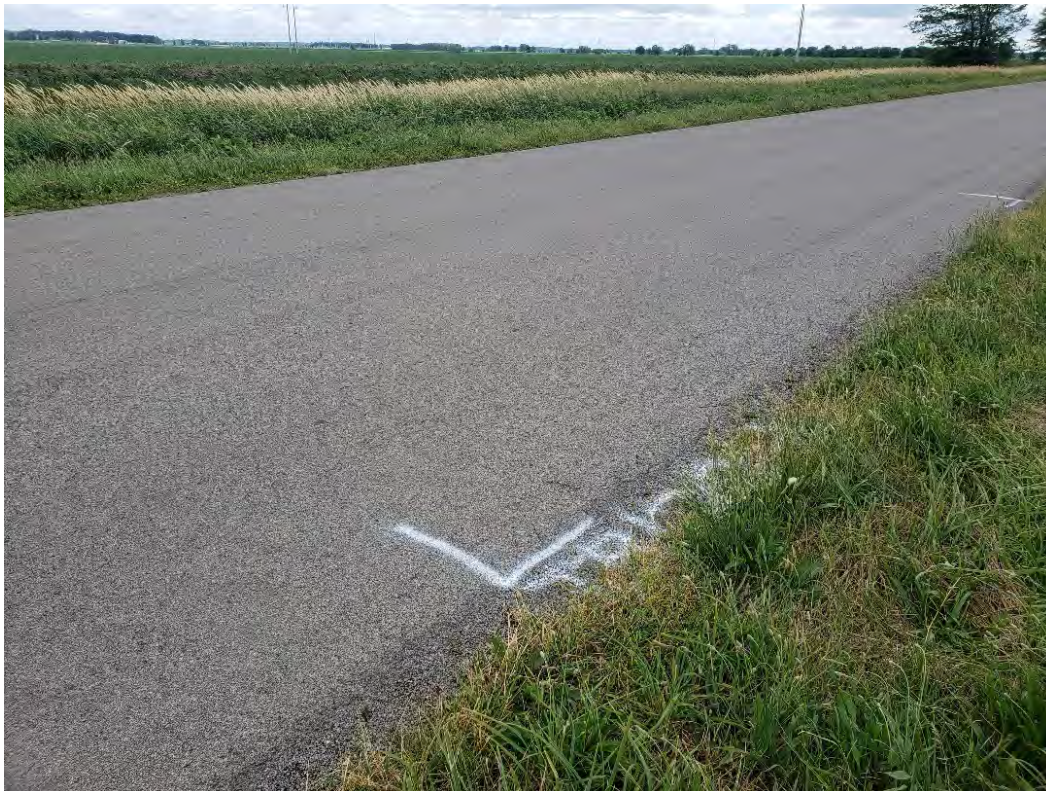
Figure 4-6 OH-195 Section 1

Section 1 from TR-120 to CR-65 was observed generally in good condition. The pavement has minimal distresses such as longitudinal and transverse cracking, shoulder drop off, and edge cracking. Two sample units were selected within this section.

SAMPLE UNIT	PCI	RATING
1	78	SATISFACTORY
2	85	GOOD

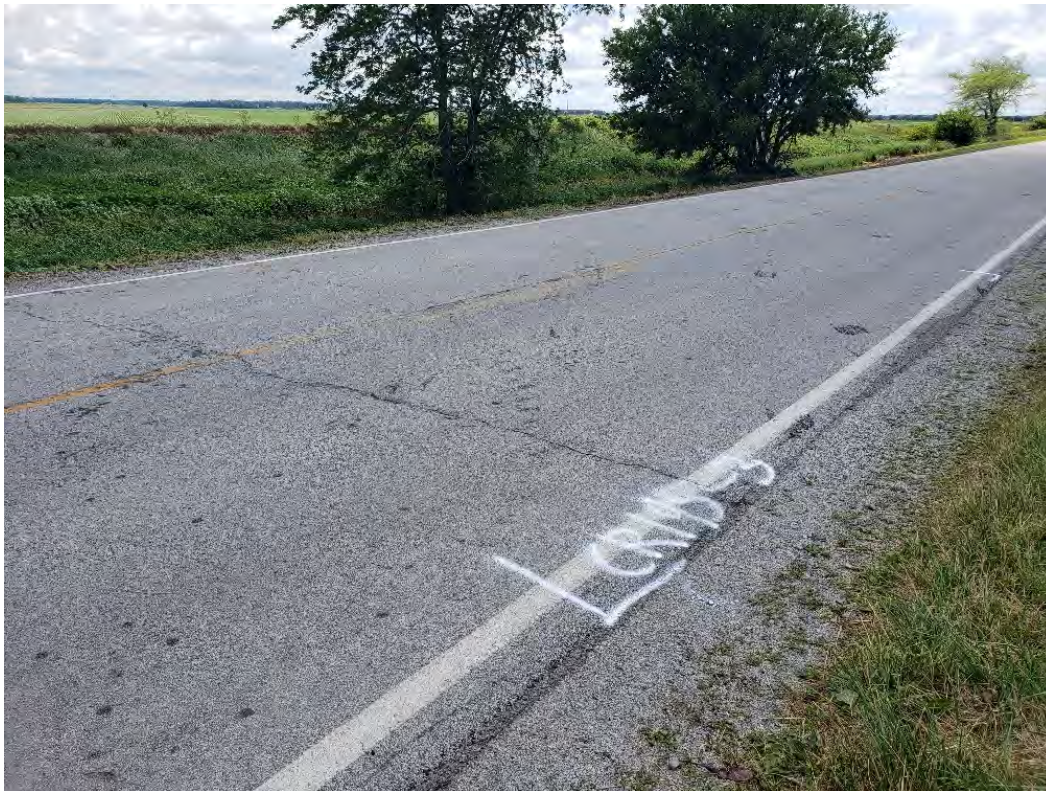
Figure 4-7 OH-195 Section 2

Section 2 from CR-65 to CR-110 was observed generally in good condition. The pavement has minimal distresses such as longitudinal and transverse cracking, shoulder drop off, and edge cracking. Four sample units were selected within this section.

Table 4-7 OH-195 Section 2 – PCI Summary

SAMPLE UNIT	PCI	RATING
1	78	SATISFACTORY
2	86	GOOD
3	91	GOOD
4	78	SATISFACTORY

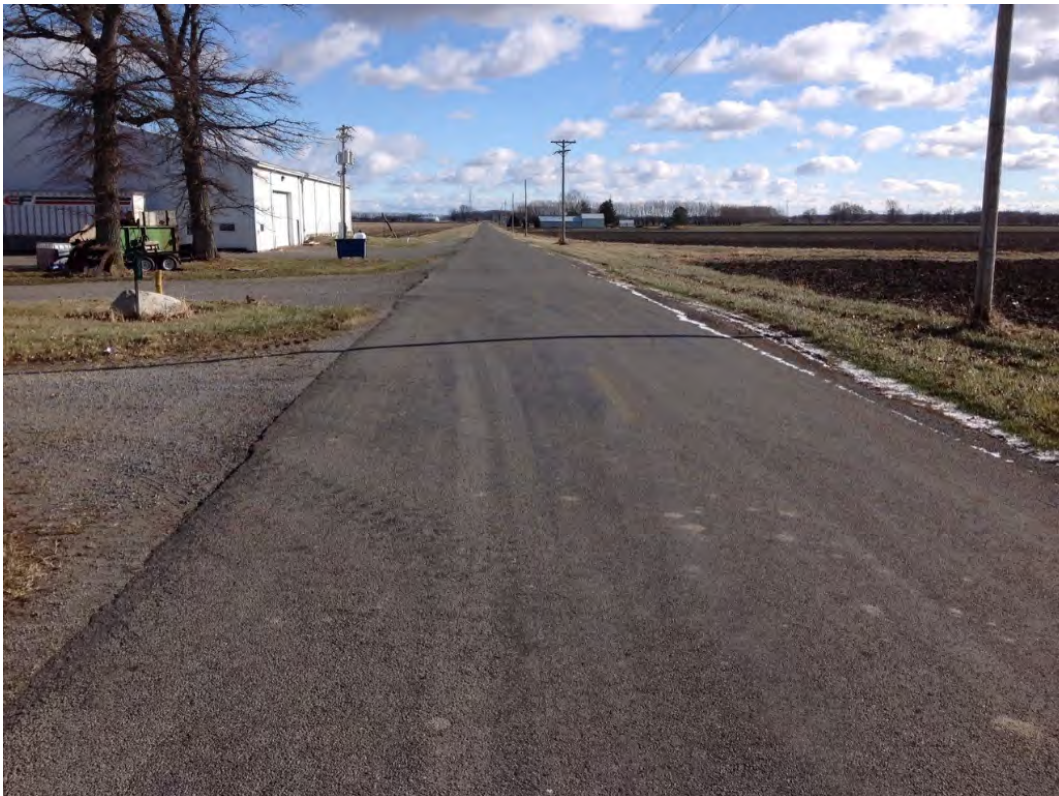
Figure 4-9 CR-130 Section 1

Section 1 from OH-235 to TR-55 conditions were generally good with one fair section due to potholes. Such distresses were mainly classified as low.

SAMPLE UNIT	PCI	RATING
1	86	GOOD
2	64	FAIR
3	88	GOOD
4	93	GOOD

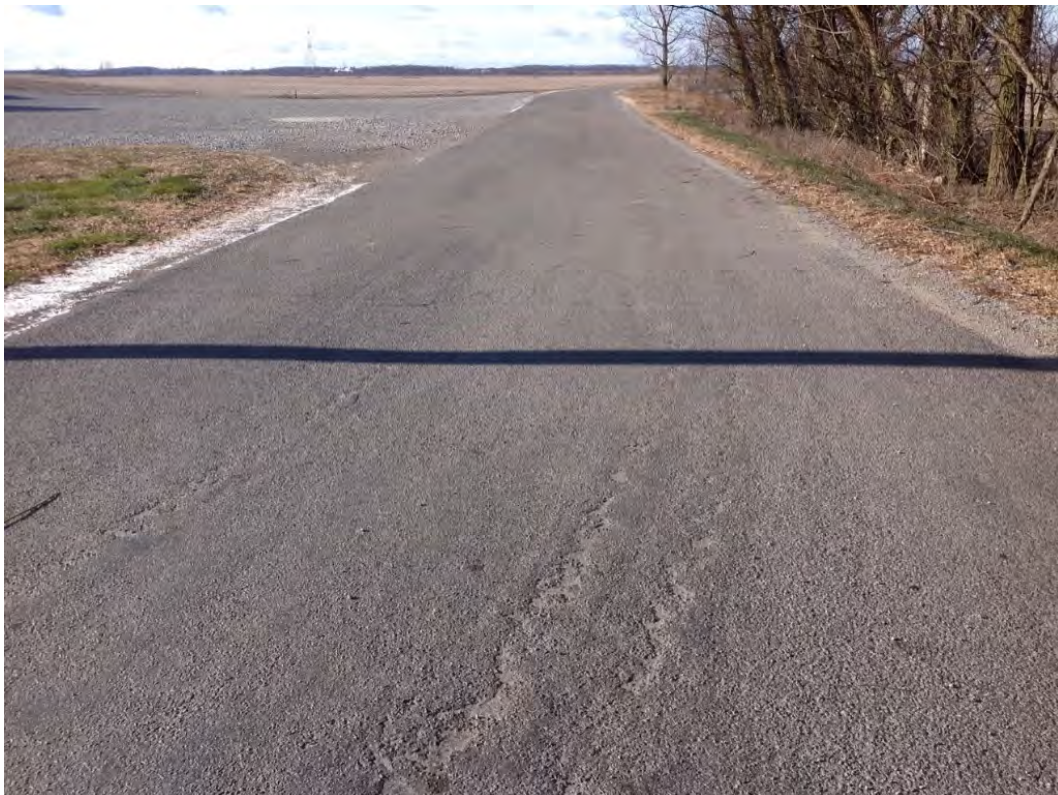
Figure 4-10 CR-130 Section 2

Section 2 from TR-55 to CR-65 conditions varied along its length from fair to good with the majority of the distresses at the intersections with other roads, bridges or at farm entrances. Such distresses were mainly classified as low, with few areas where the severity was deemed as medium.

SAMPLE UNIT	PCI	RATING
1	76	SATISFACTORY
2	89	GOOD
3	87	GOOD
4	72	SATISFACTORY
5	67	FAIR
6	70	SATISFACTORY
7	64	FAIR
8	68	FAIR

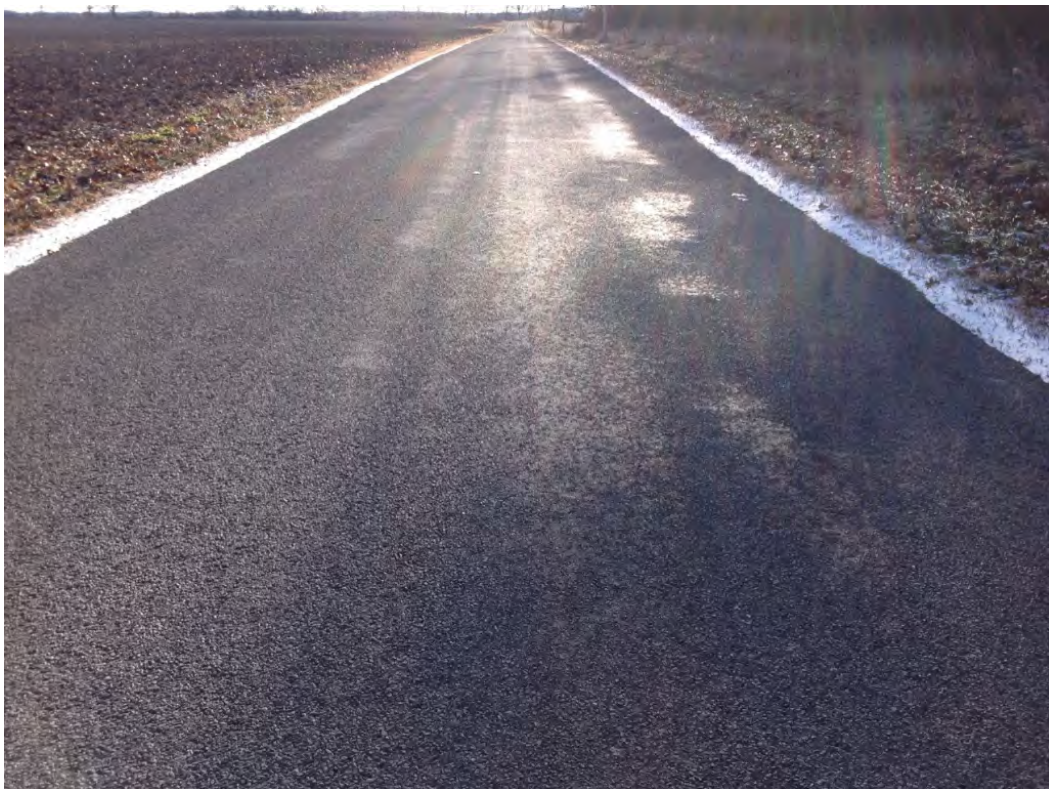
Figure 4-11 CR-130 Section 3

Section 3 from CR-65 to TR-65 was observed generally in good condition. The pavement has minimal distresses such as bleeding. The road differs from previous sections with a width of 17 feet compared to 20 feet. Two sample units were selected within the section.

SAMPLE UNIT	PCI	RATING
1	90	GOOD
2	93	GOOD

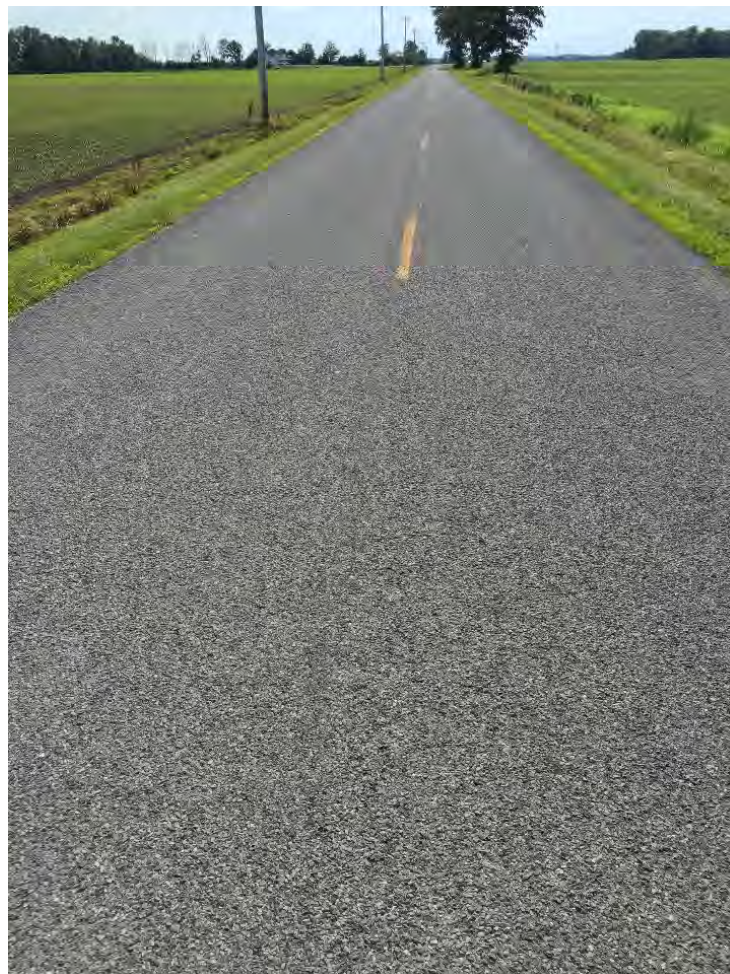
Figure 4-12 CR-130 Section 4

Section 4 from TR-65 to CR-75 was observed generally in good condition. The pavement has minimal distresses such as edge cracking. Three sample units were selected within the section.

Table 4-12 CR-130 Section 4– PCI Summary

SAMPLE UNIT	PCI	RATING
1	79	SATISFACTORY
2	92	GOOD
3	92	GOOD

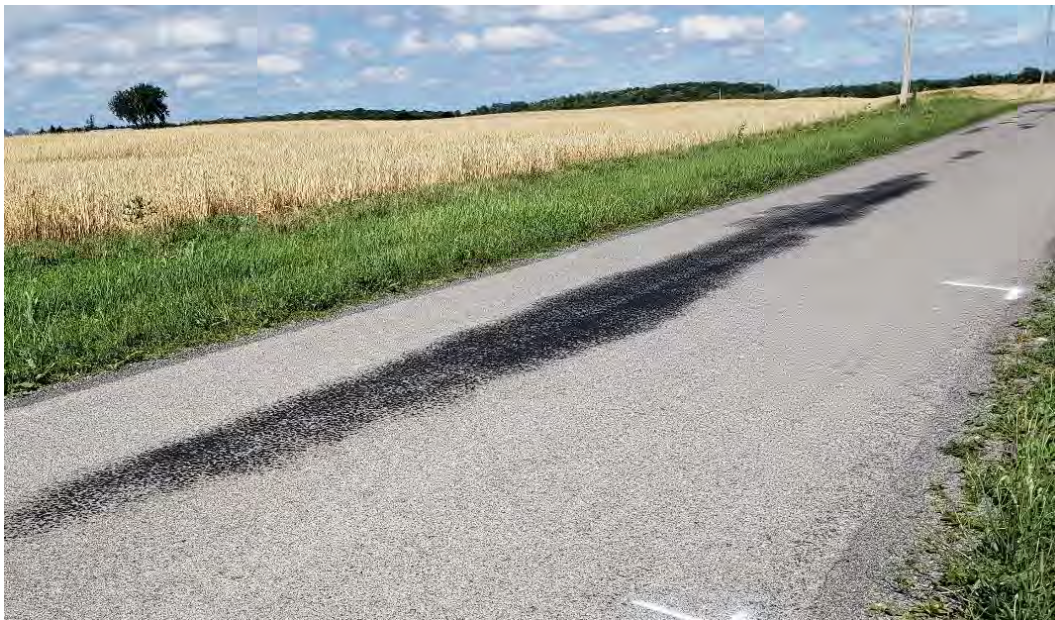
Figure 4-13 TR-130

TR-130 was inspected from OH-235 to approximately 2500' west. TR-130 was observed generally in good condition. The pavement has minimal distresses such as bleeding, shoulder drop off, edge cracking, and weathering. Two sample units were selected along TR-130.

Table 4-13 TR-130 – PCI Summary

SAMPLE UNIT	PCI	RATING
1	89	GOOD
2	82	SATISFACTORY

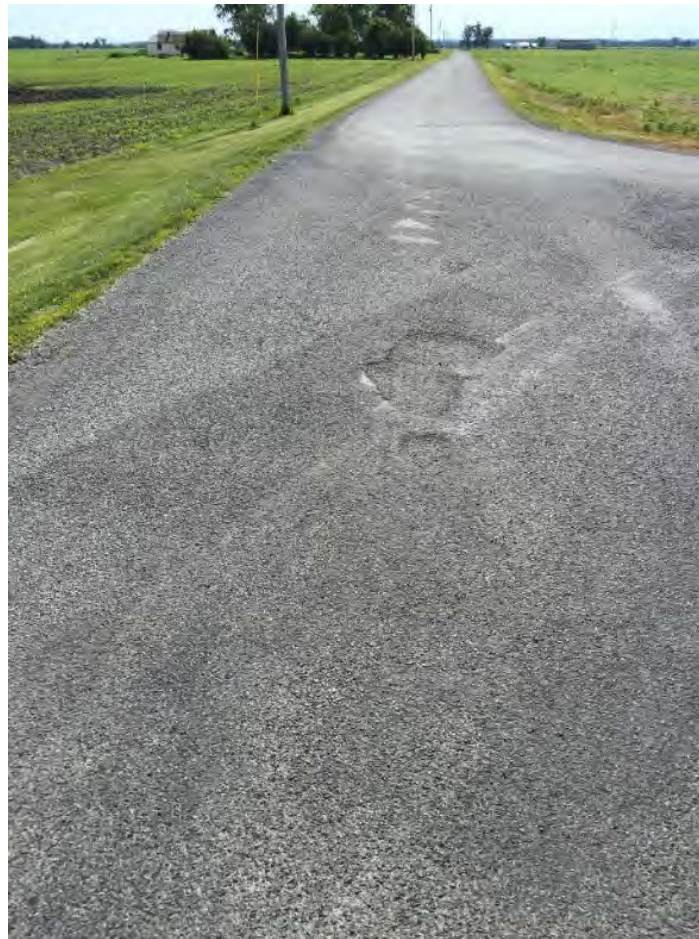
Figure 4-14 TR-65 Section 1

Section 1 from CR-130 to the road's 90° bend was observed generally in satisfactory condition. The pavement has minimal distresses such as bleeding and edge cracking. Some areas had small potholes and corrugation resulting in lower rating. Five sample units were selected within the section.

SAMPLE UNIT	PCI	RATING
1	69	FAIR
2	69	FAIR
3	84	SATISFACTORY
4	92	GOOD
5	92	GOOD

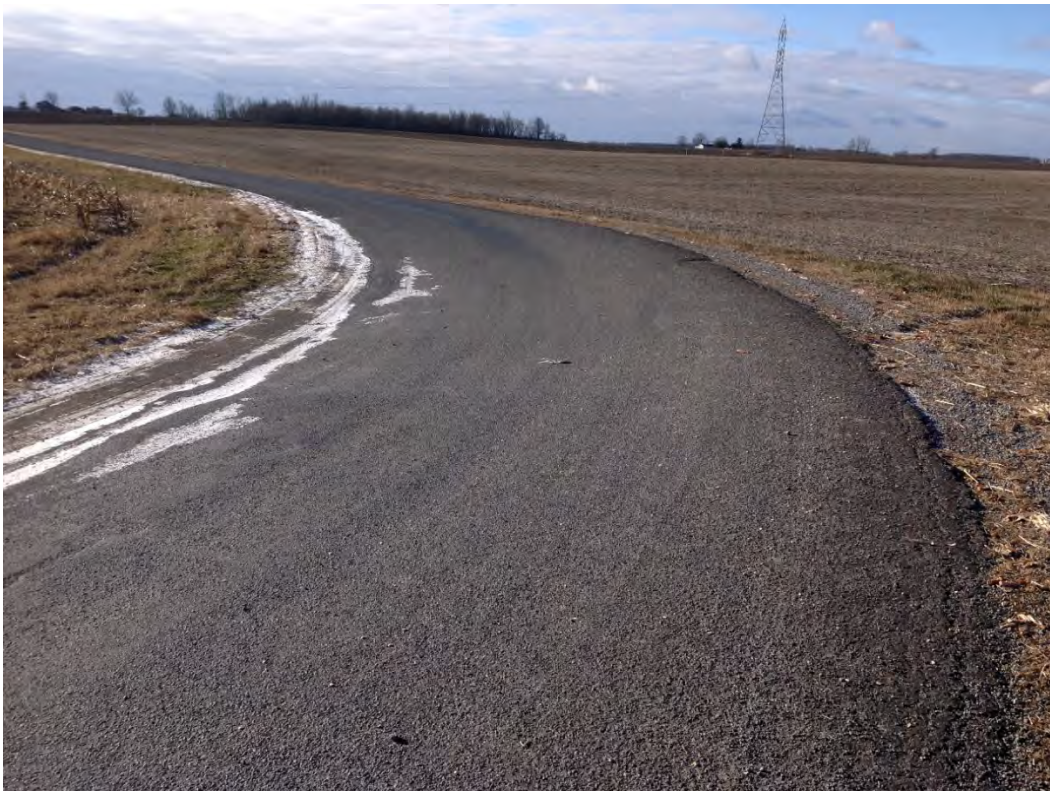
Figure 4-15 TR-65 Section 2

Section 2 from the bend to the intersection with access road to the substation was observed generally in satisfactory condition, except for the curve section, where fair conditions were observed due to a depression at the internal lane, and therefore the ride quality was noticeably affected. The rest of the inspected section had low distresses such as bleeding and edge cracking. Three sample units were selected within the section.

SAMPLE UNIT	PCI	RATING
1	59	FAIR
2	84	SATISFACTORY
3	82	SATISFACTORY

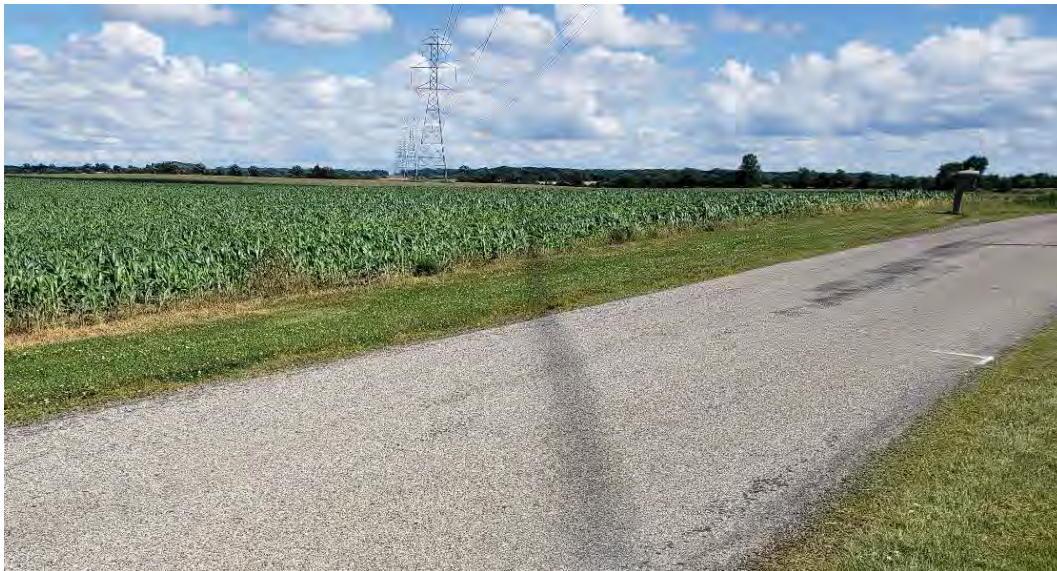
Figure 4-16 TR-65 Section 3

Section 3 from the intersection with the access road to the substation to approximately 4500' to the south of the road's 90° bend was observed generally in fair condition. The pavement has minimal to moderate distresses such as bleeding, edge cracking, shoulder drop off, alligator cracking, and rutting. Three sample units were selected within the section.

Table 4-16 TR-65 Section 3 – PCI Summary

SAMPLE UNIT	PCI	RATING
1	68	FAIR
2	59	FAIR
3	72	SATISFACTORY

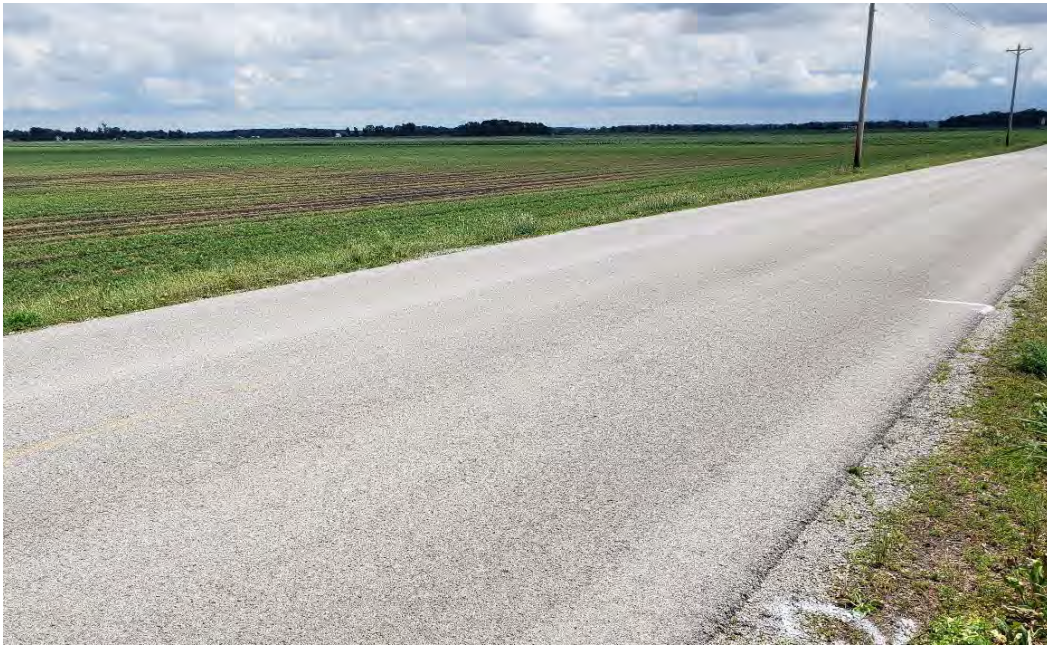
Figure 4-17 CR-65 Section 1

Section 1 from OH-195 to approximately 4500' south of OH-195 was observed generally in good condition. The pavement has minimal distresses such as shoulder drop off. Three sample units were selected in this section.

SAMPLE UNIT	PCI	RATING
1	86	GOOD
2	86	GOOD
3	86	GOOD

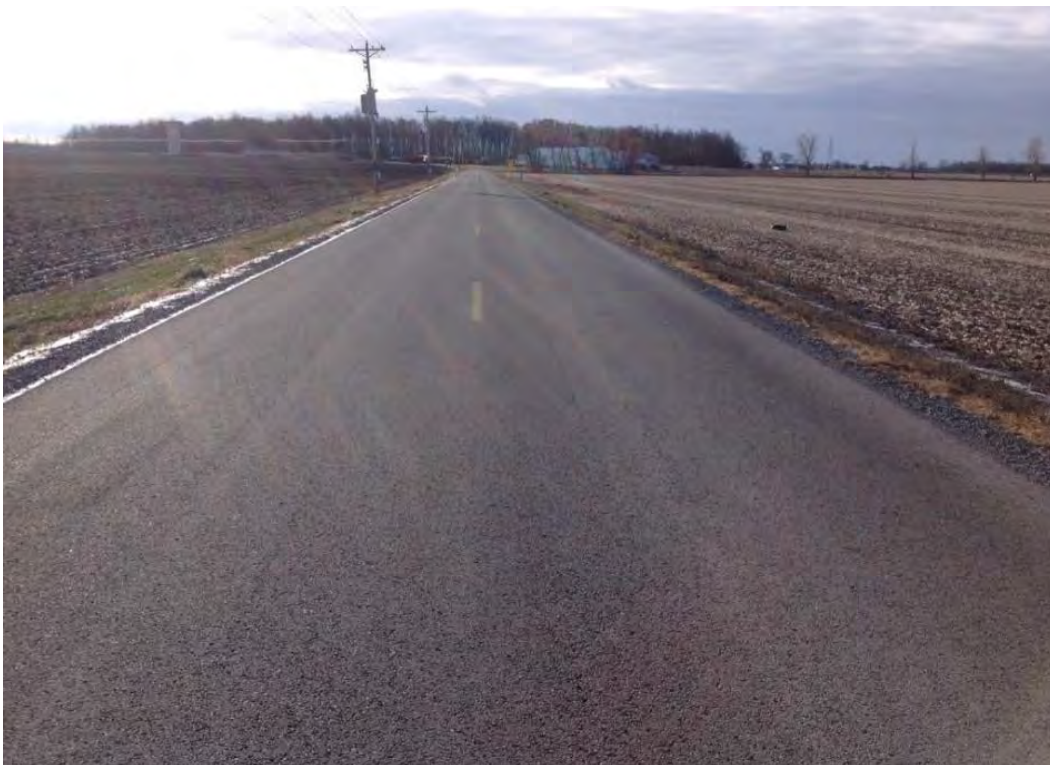
Figure 4-18 CR-65 Section 2

Section 2 from approximately 4500' south of OH-195 to CR-130 was observed generally in good condition. Low severity distresses such as shoulder drop-off and patching were observed, especially near the intersection with CR-130. Three sample units were selected in this section.

Table 4-18 CR-65 Section 2 – PCI Summary

SAMPLE UNIT	PCI	RATING
1	87	GOOD
2	87	GOOD
3	86	GOOD

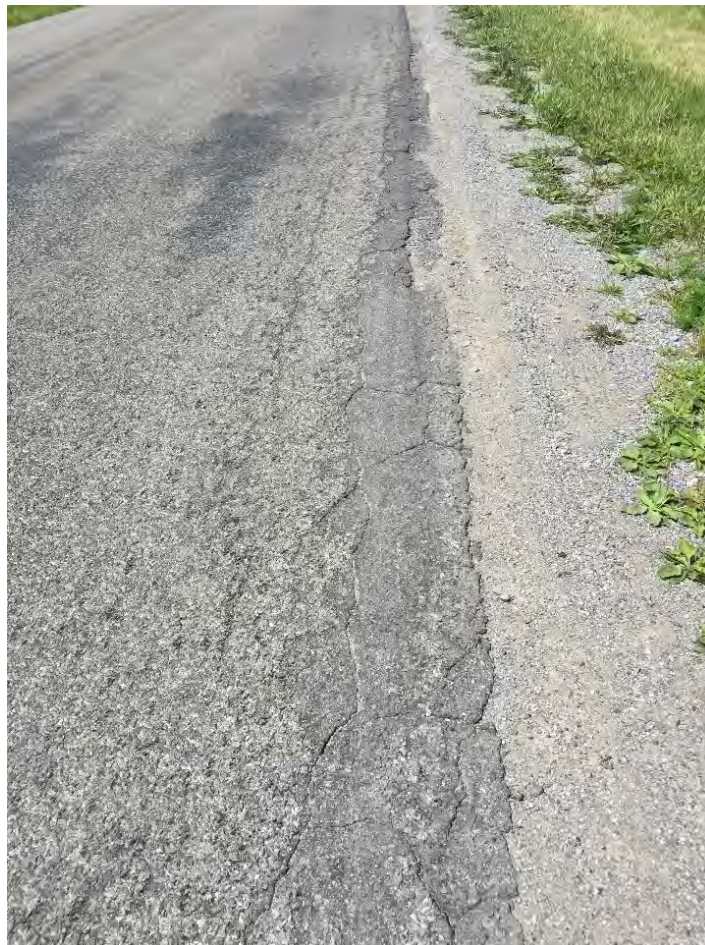
Figure 4-19 CR-75 Section 1

Section 1 from OH-67 to approximately 3350 feet to the north was observed generally in satisfactory condition. The pavement has minimal distresses such as edge cracking. Six sample units were selected within the section.

SAMPLE UNIT	PCI	RATING
1	78	SATISFACTORY
2	86	GOOD
3	91	GOOD
4	78	SATISFACTORY
5	78	SATISFACTORY
6	80	SATISFACTORY

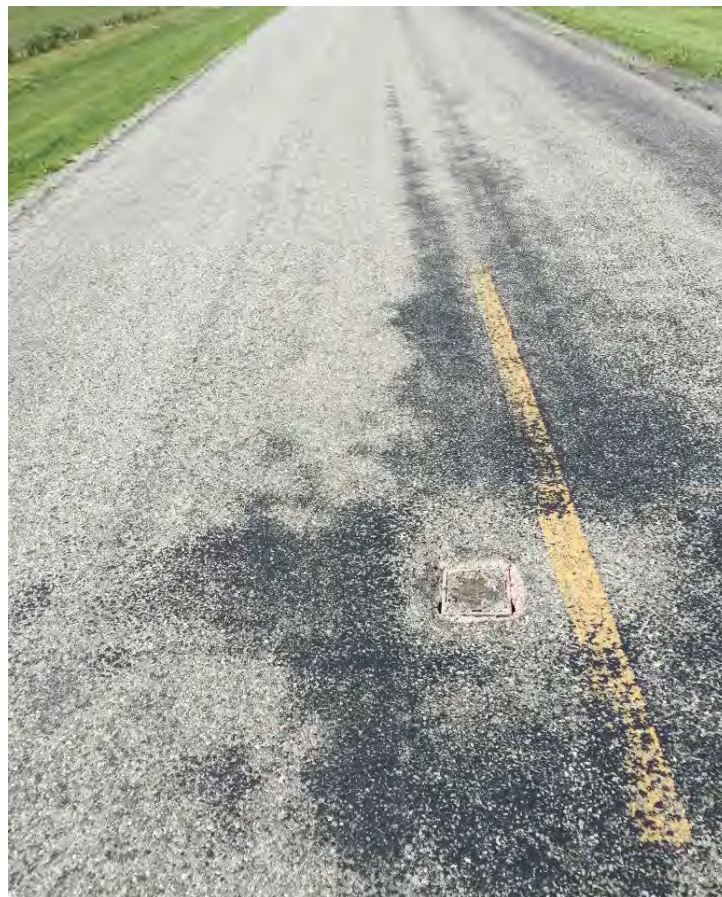
Figure 4-20 CR-75 Section 2

Section 2 from approximately 3350 feet to the north of OH-67 to TR-154 was observed generally in satisfactory condition. The pavement has minimal distresses such as edge cracking. There are small areas with longitudinal and transverse cracking as well as patching. Four sample units were selected within the section.

SAMPLE UNIT	PCI	RATING
1	79	SATISFACTORY
2	80	SATISFACTORY
3	78	SATISFACTORY
4	88	GOOD

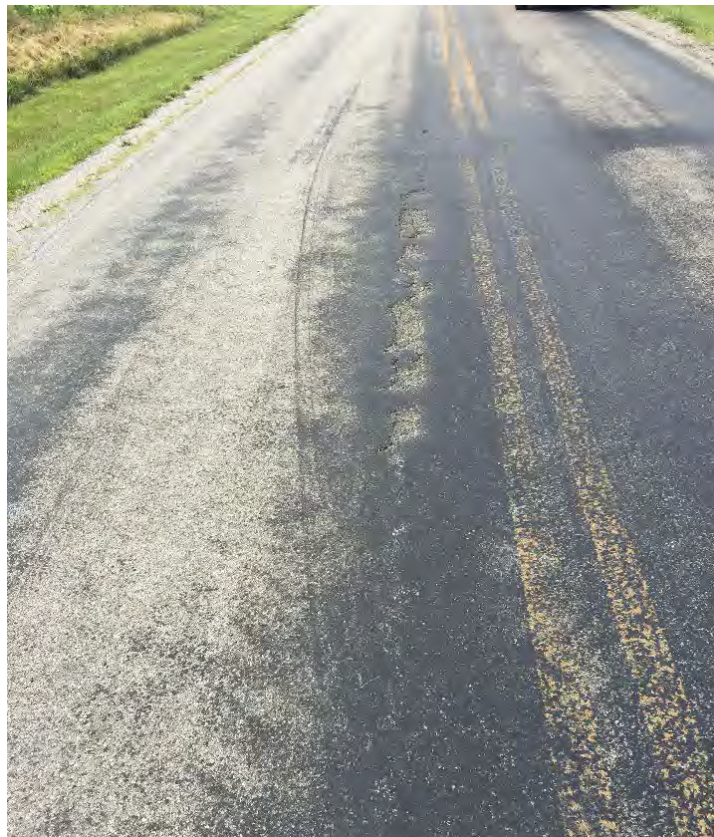
Figure 4-21 CR-75 Section 3

Section 3 from TR-154 to the north intersection with CR-150 was observed generally in satisfactory condition. The pavement has minimal distresses such as bleeding and edge cracking. One sample unit had potholes, bleeding and edge cracking and seemed only in "fair" condition. Six sample units were selected within the section.

SAMPLE UNIT	PCI	RATING
1	60	FAIR
2	80	SATISFACTORY
3	88	GOOD
4	86	GOOD
5	78	SATISFACTORY
6	77	SATISFACTORY

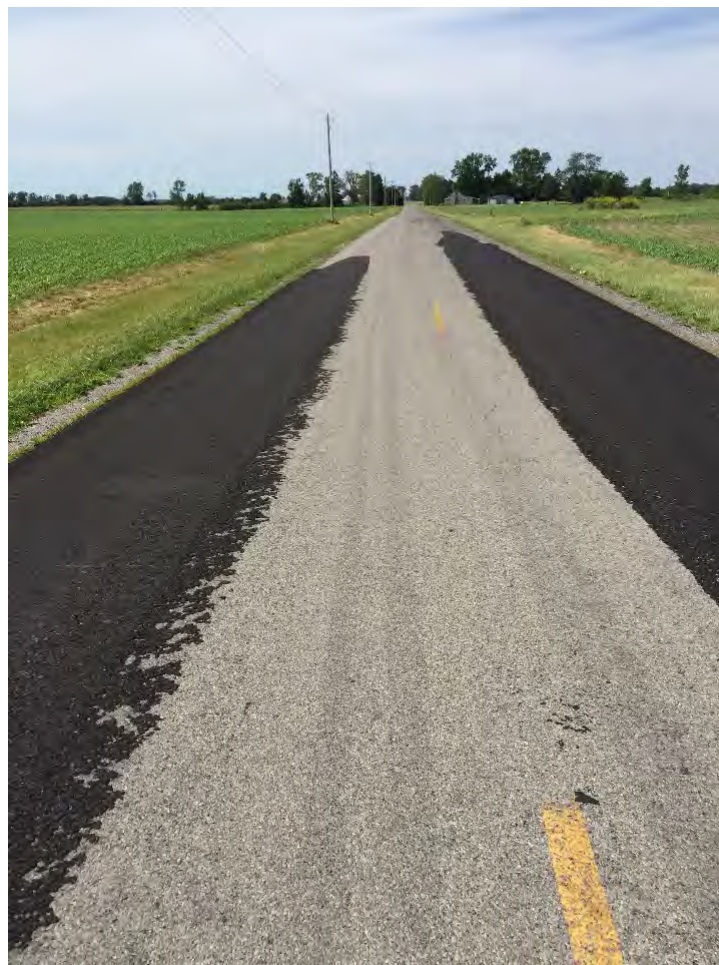
Figure 4-22 CR-75 Section 4

Section 4 from the north intersection with CR-150 to CR-130 was observed generally in satisfactory condition. The pavement has minimal distresses such as longitudinal cracking, transverse cracking and edge cracking. There were a couple of areas with patching that resulted in a "fair" rating for one sample unit. Six sample units were selected within the section.

SAMPLE UNIT	PCI	RATING
1	70	SATISFACTORY
2	67	FAIR
3	75	SATISFACTORY
4	88	GOOD
5	84	SATISFACTORY
6	93	GOOD

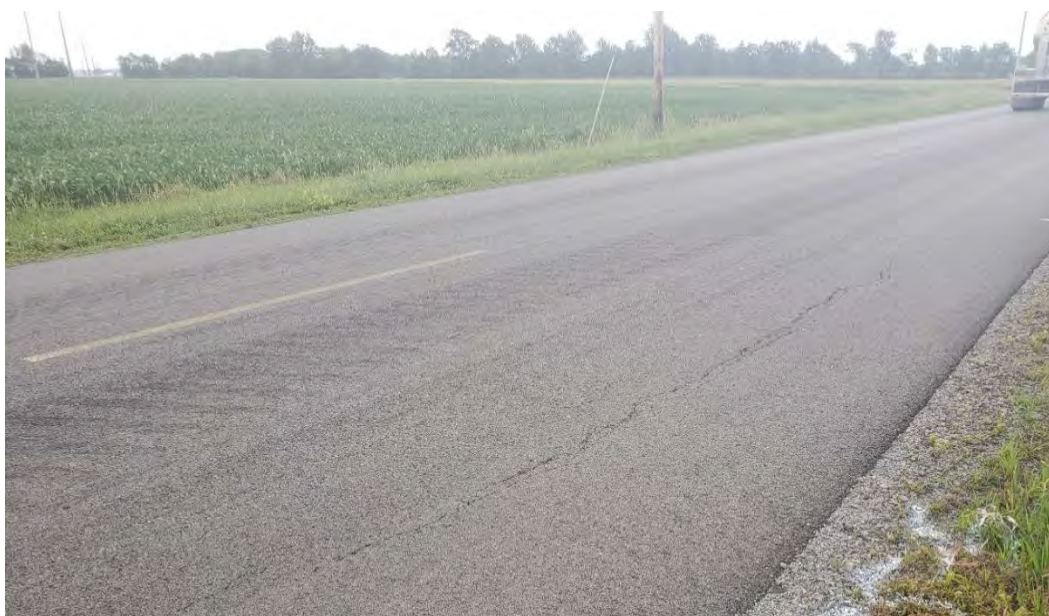
Figure 4-23 CR-75 Section 5 – Sample 1

Section 5 from CR-130 to TR-120 was observed generally in satisfactory condition. The pavement has minimal distresses such as longitudinal cracking, bleeding, shoulder drop off and edge cracking. Some moderate edge cracking and shoulder drop off was also observed. Four sample units were selected within the section.

Table 4-23 CR-75 Section 5 – PCI Summary

SAMPLE UNIT	PCI	RATING
1	72	SATISFACTORY
2	69	FAIR
3	71	SATISFACTORY
4	71	SATISFACTORY

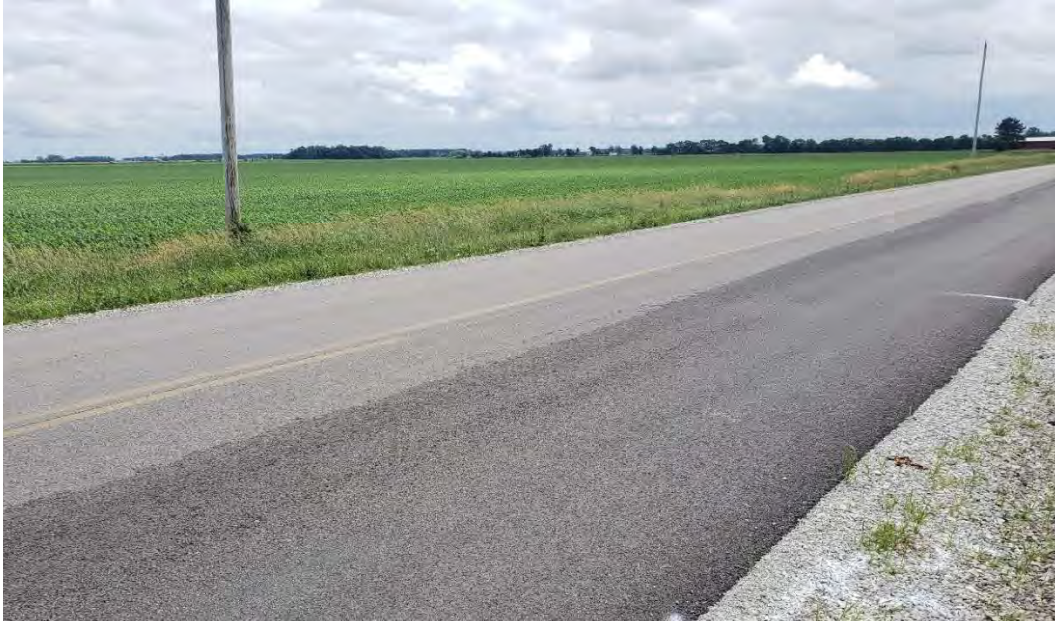
Figure 4-25 CR-75 Section 6 – Sample 1

Section 6 from TR-120 to CR-110 was observed generally in satisfactory condition. The pavement has minimal distresses such as bleeding, shoulder drop off and edge cracking. Some moderate edge cracking and was also observed. Patching was observed in the southbound lane between CR-110 and approximately 500' south, giving Sample Unit 1 a fair rating. Four sample units were selected within the section.

Table 4-24 CR-75 Section 6 – PCI Summary

SAMPLE UNIT	PCI	RATING
1	59	FAIR
2	78	SATISFACTORY
3	85	GOOD
4	80	SATISFACTORY

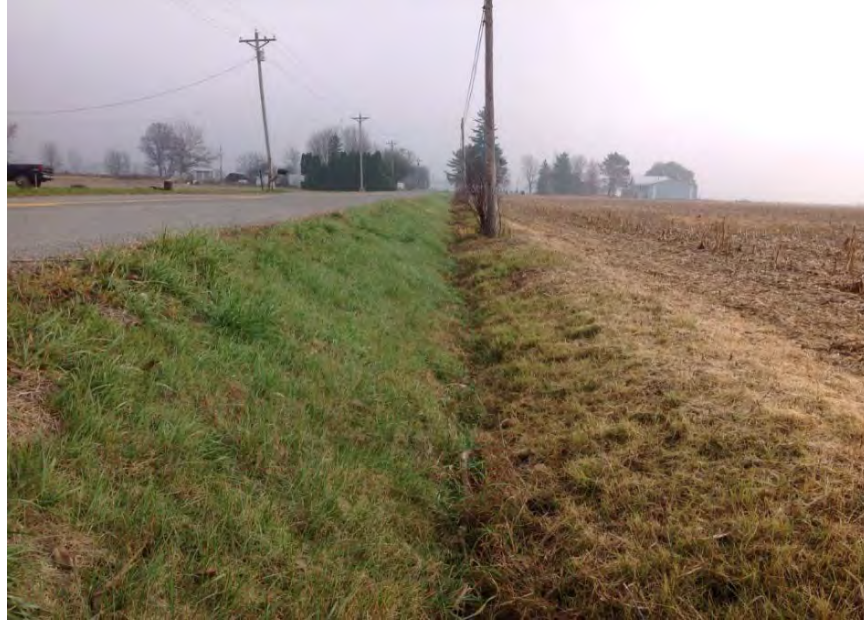
Figure 7-2 CR-110 – South Ditch

Irrigation ditch D-5 continues along the north side of the road up and transitions to the south and continued to the east along the road. Well-maintained ditches were observed on the south side of the road, at Van Deurzen Dairy. Water is directed to the east until discharged into drainage ditch D-5.

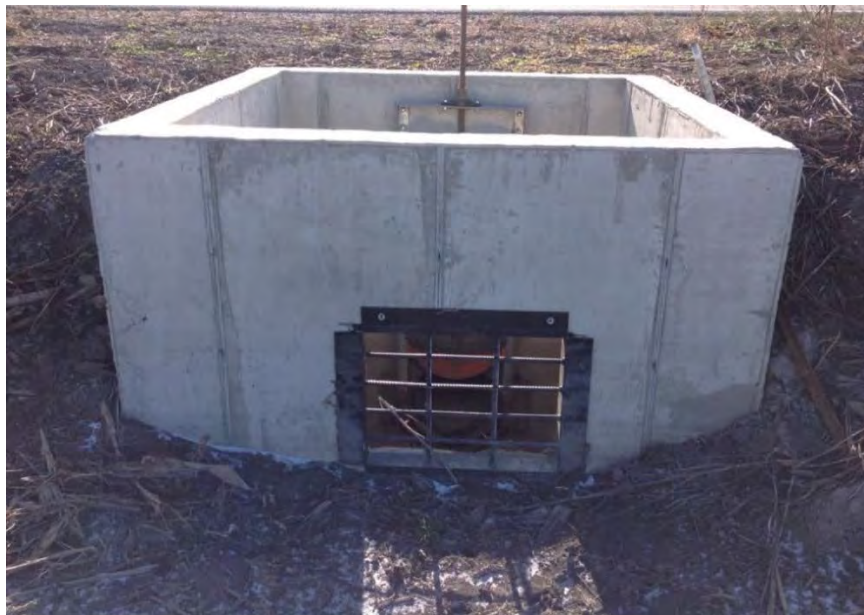
Figure 7-3 CR-110 – Catch Basin

Approximately 1,600 feet west of the intersection with TR-55 (Planned Road), a concrete catch basin was observed that collects water from the north side of the road and directs it to the south drainage ditch. At the intersection with OH-195, a pump station also transfers water from the north to D-5. D-5 discharges into the Scioto River, approximately ½ mile east.

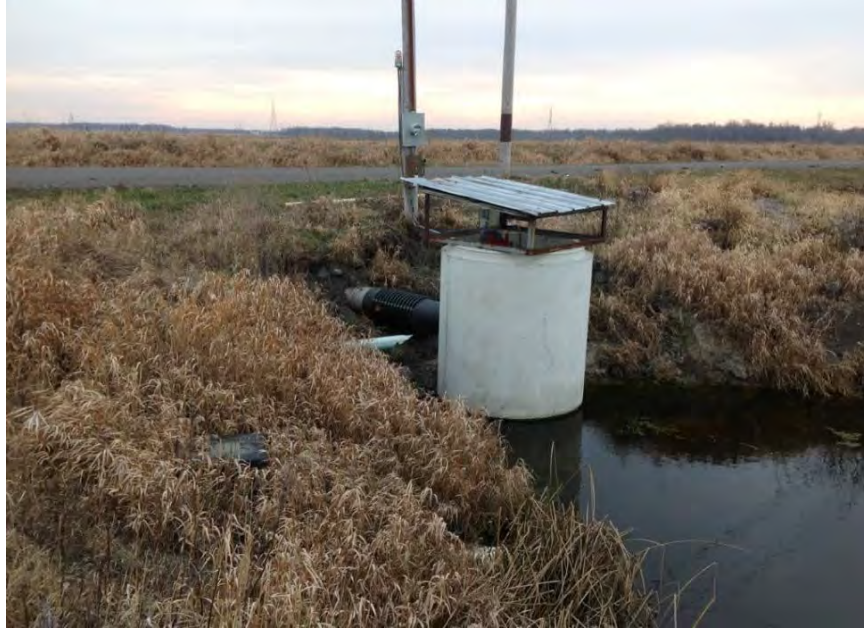
Figure 7-5 TR-120 – West Pump Station

The ditch on the south side of the road becomes gradually deeper, approximately $\frac{3}{4}$ mile east of the intersection with OH-235, until it reaches a depth of 4-5 feet. Approximately 1 mile west of the east end of the inspected road, a concrete manhole collects water from the north side of the road and directs it through a pump to the south side, where D-12 is located along the south side of the road, and that discharges at the Scioto River. A second structure with similar setup was observed about $\frac{1}{2}$ mile west of the east end of the road.

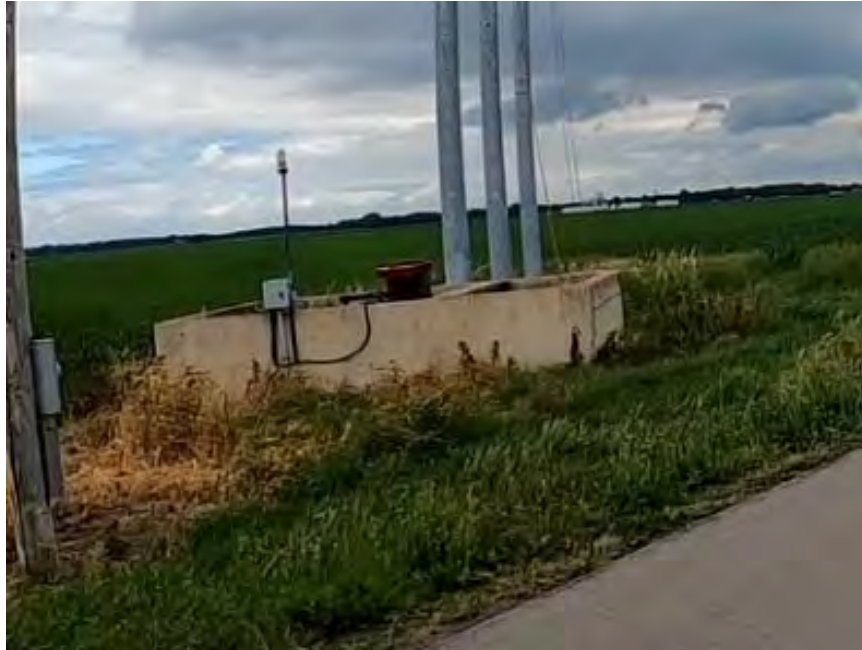
Figure 7-7 OH-195 – Pump Station

OH-195 was observed higher than the surrounding areas. Fields to the west of OH-195 were approximately 3-4' lower than the road surface. The Scioto River border OH-195 on its east side until OH-195 turns north just south of CR-110. A concrete structure like that observed on CR-110 was observed on the west side of OH-195. It appears that drainage from the north and south is collected here and pumped east into the Scioto River. Ditches along the east side of OH-195 were less defined where OH-195 turns north as it appears that drainage flows east into the Scioto River.

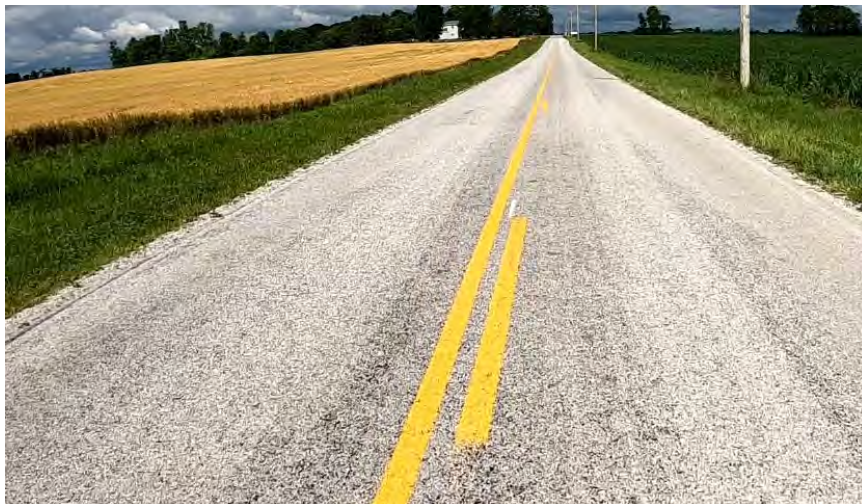
Figure 7-8 CR-126 Shallow Ditches

Shallow ditches are present along CR-126, though it appears that drainage generally flows away from the roadway. Drainage on the north side of the roadway flows out into the fields and to the northeast, while drainage to the south flows to the south and east. It appears that the latter makes its way to D-12.
