Re: Case No. 20-1321-EL-BGA - In the Matter of the Application of Hardin Solar II LLC for a Boundary Amendment to its Certificate Issued in Case No. 18-1360-EL-BGN.

Supplement to Application – Road Condition Report and Updated Sound Analysis

Road Condition Report

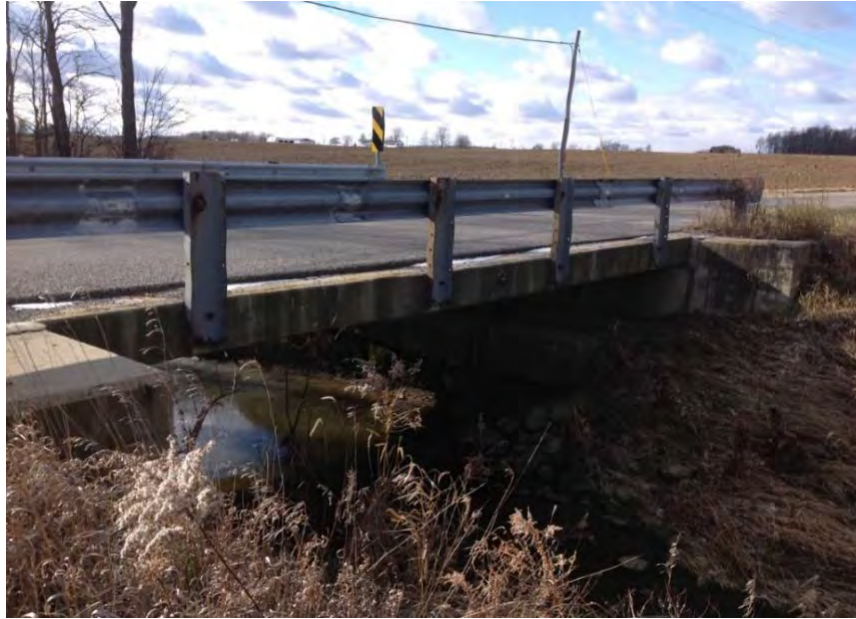
Figure 7-9 CR-130 – Elder Creek Bridge

The north fields' direct water towards Elder Creek or to Dunlap Creek, both discharge into the Scioto River. The south fields drain similarly to the north, with the only interference being the road itself. Culverts were observed on low points along the road, in addition to this, it is known that most agricultural fields in this area have drain tile systems interconnected with the drainage ditches.

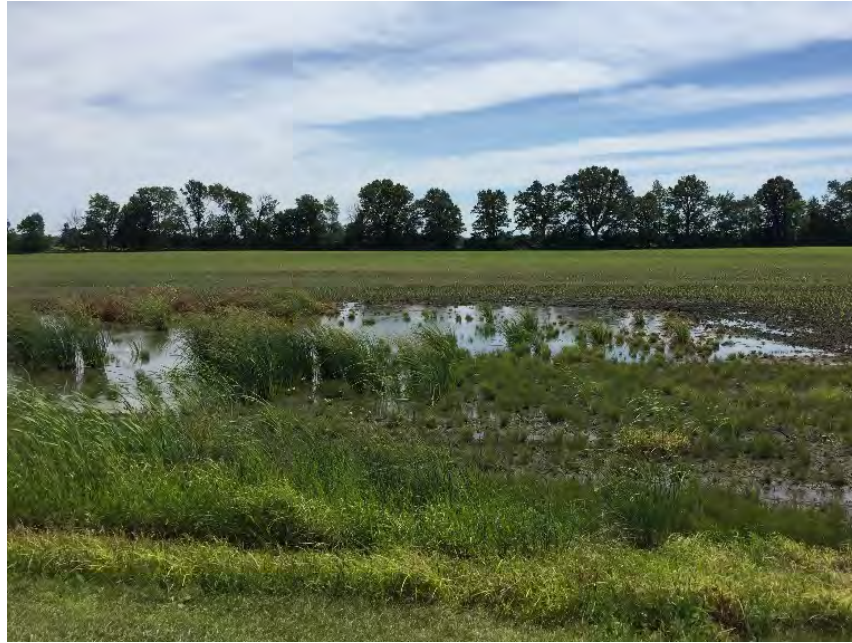
Figure 7-11 CR-130 – Standing Water

Ditches on both sides of the road were observed for the area between TR-65 and CR-75. The ditches are approximately 2-3 feet deep and have side-slopes of approximately 3:1 with the flow line of the ditches approximately 6 feet from the edge of the roadway. The ditches are relatively flat directing flow to the west. There is a low spot 700 feet east of TR-65 in the south side of the road with standing water.

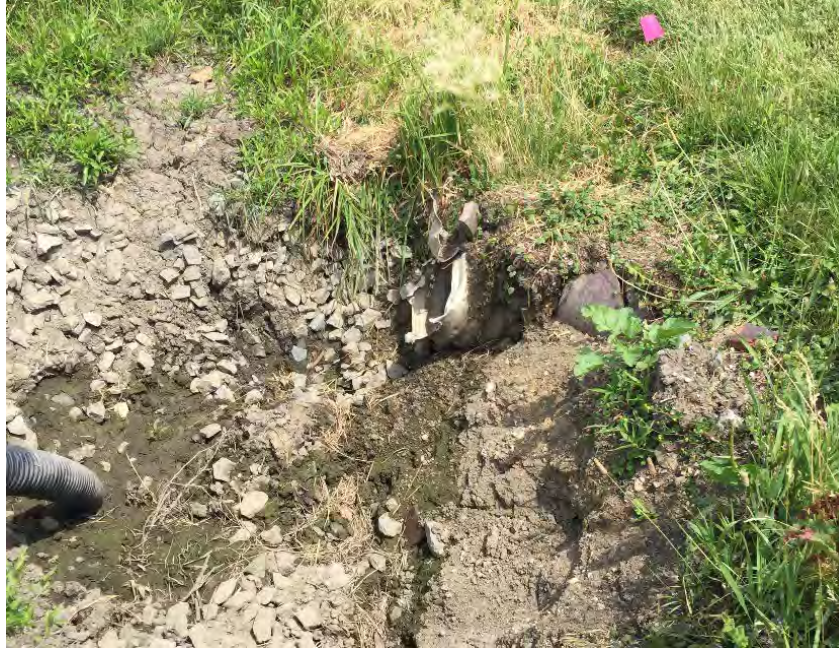
Figure 7-12 CR-130 – Culvert

On the north side of the road there is a culvert that appears to go beneath the road and discharges water south of CR-130.

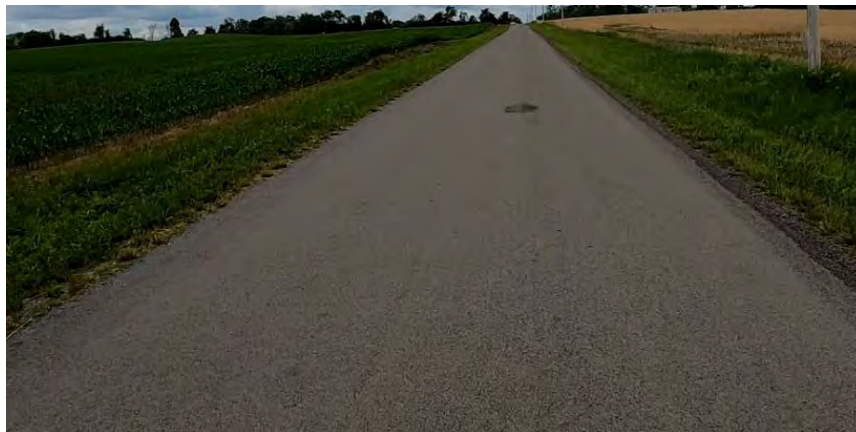
Figure 7-13 TR-130 – Ditches

A shallow ditch was observed along the north side of TR-130, but no defined ditch was observed on the south side. Drainage flows generally to the east. Culverts were observed on the north and south sides of the road at OH-235, allowing flow from west to east underneath the highway.

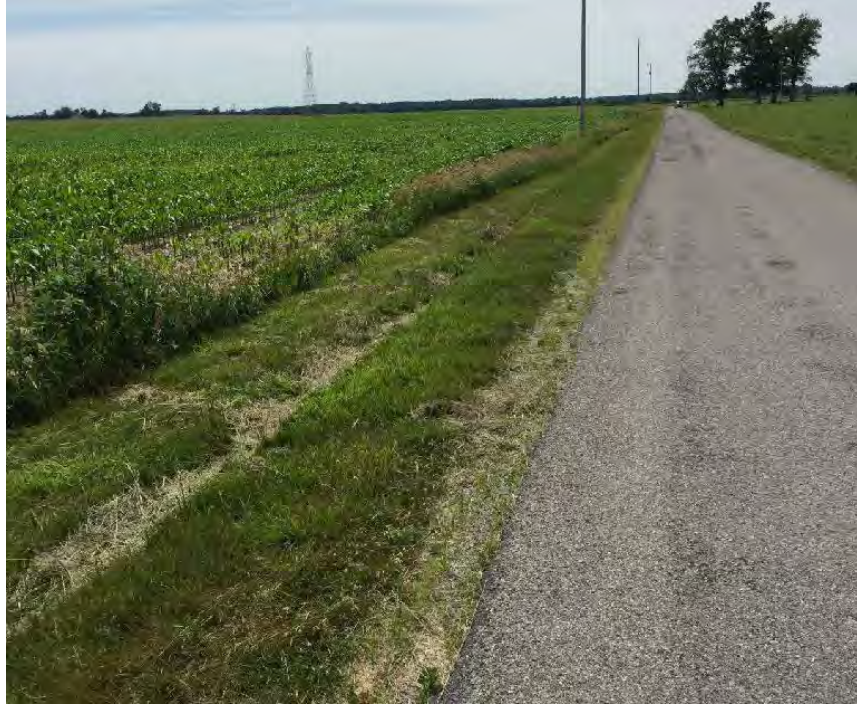
Figure 7-14 TR-65 – Ditch

TR-65 between CR-130 and the 90° bend has ditches present on both sides of the road directing flow generally towards the west. The first 1,200 feet closest to CR-130 has relatively flat slope but the slope of the ditches increases as they get closer to the 90° bend. A culvert near the bend allows water to cross from the south side to the north where it flows towards the Scioto River.

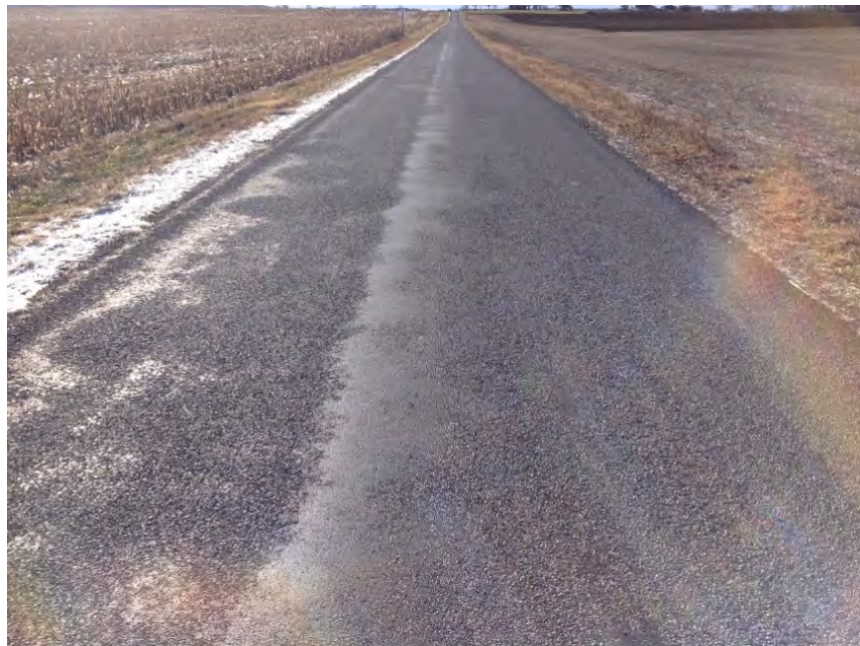
Figure 7-15 TR-65 – Road

South of the 90° bend the road is elevated and drainage is directed away from the road. The adjacent fields to the observed area drain in their majority to the north, on the east side, and to the north-west, on the west side of the road. Culverts were not observed along this section of the road.

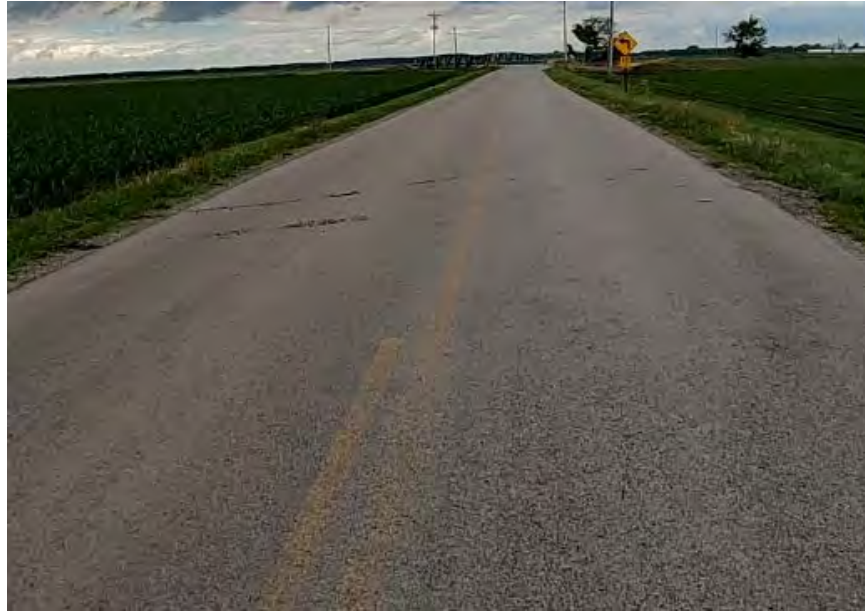
Figure 7-16 CR-65 – Elevated Road

CR-65 is an elevated road without defined ditches on its sides. Drainage of the adjacent fields is generally directed towards the Scioto River, on the west side of the road, and to the north on the east side of the road. A sump was observed south of the intersection with TR-67. This sump appears to collect runoff from the SE and direct water to the drain tile system that discharges into the Scioto River.

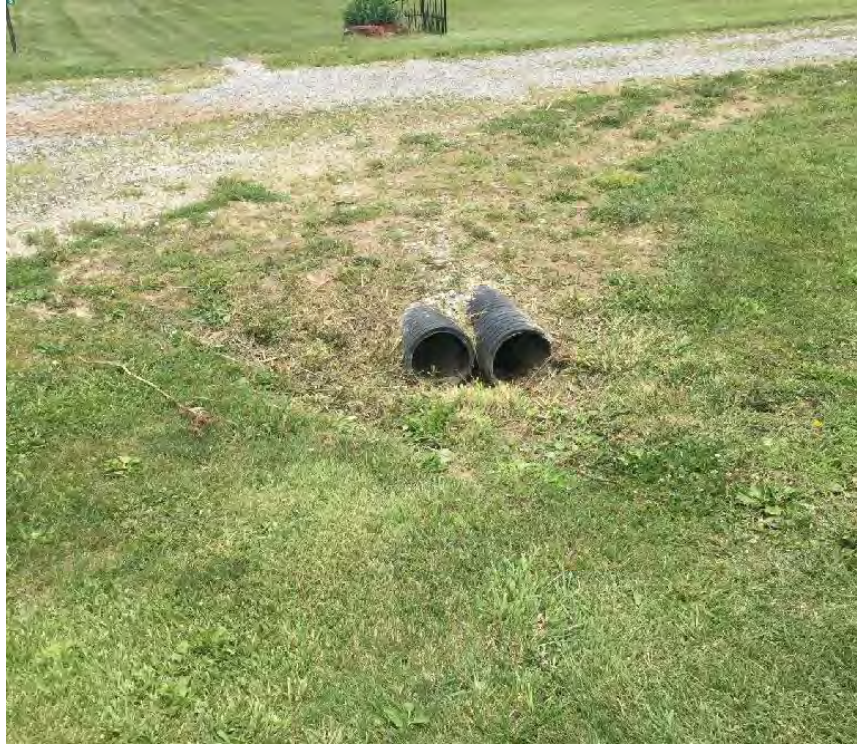
Figure 7-17 CR-75 – Culverts under driveway

Drainage on CR-75 was variable throughout its entire length. Several high points were observed that divided the site's drainage towards any of the multiple waterways. The road had ditches on both sides but in an intermittent fashion. These ditches varied on depth and side slopes but generally between 1 and 2 feet wide at the bottom and between 6 inches and 3 feet deep. The flow lines of the ditches varied from approximately 10-15 feet from the edge of the roadway. Several culverts were seen under driveways.

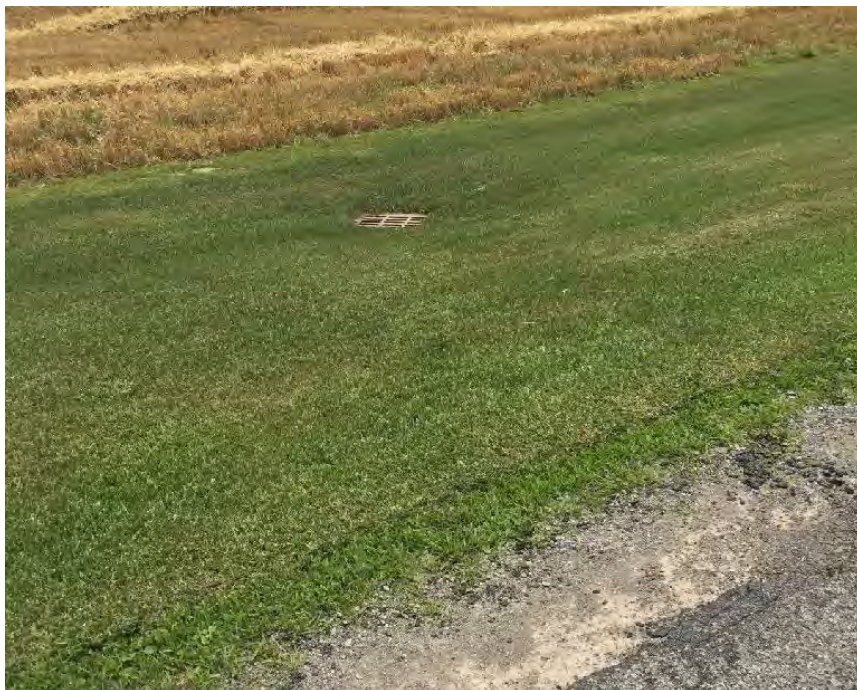
Figure 7-18 CR-75 – Catch Basin

Approximately 2,550 feet north of OH-67 there is a catch basin in the ditch on the east side of the road. It was not clear if there were more streams captured by the catch basin and where the catch basin outlet was.

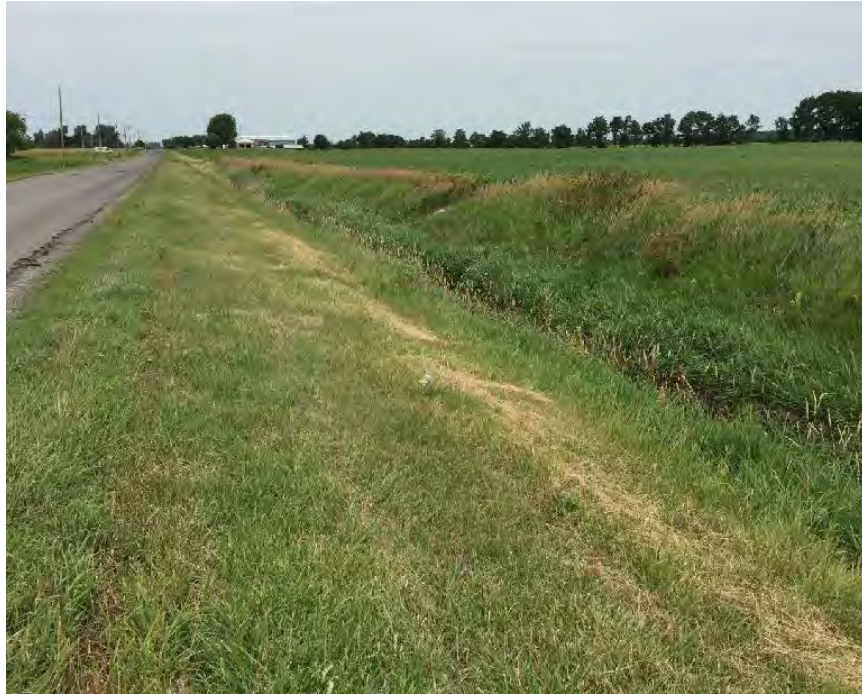
Figure 7-19 CR-75 – Stream

North of TR-154, there is a stream on the east side of the road with a crossing 570 feet south of the intersection with CR-150. The ditch featured a riprap inlet from a field to the east crossing a swale. Water was stagnant at the time of the survey but appeared to be flowing north upon review of the contours.

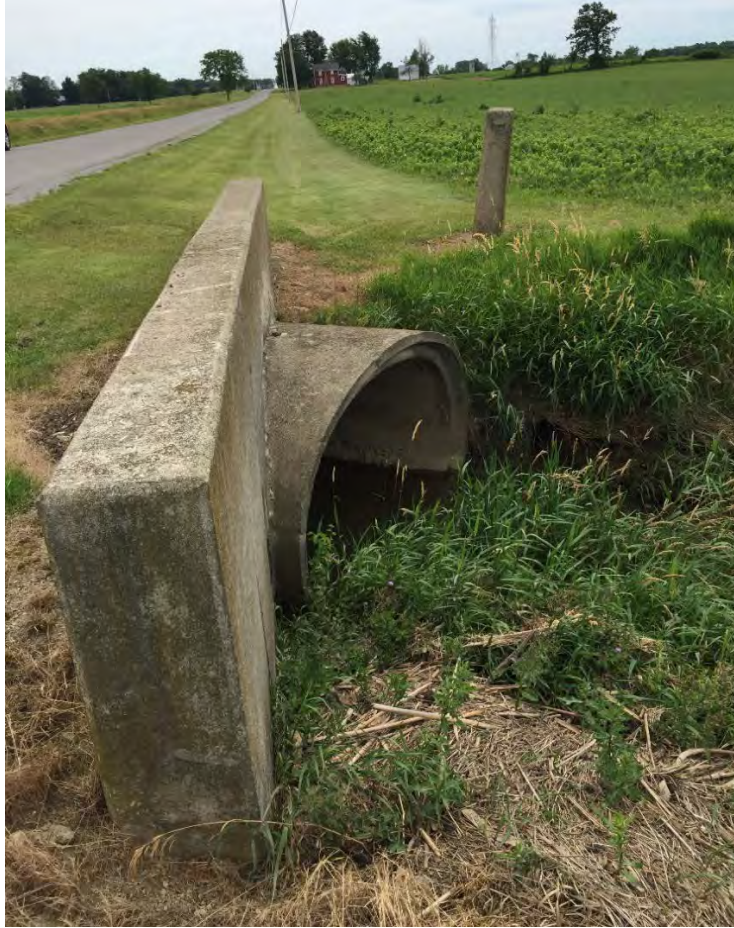
Figure 7-20 CR-75 – 60" RCP Culvert Crossing

The stream crossing featured a 60-inch culvert. The crossing was diagonal and also had 3 pipe outlets near it – two downstream and one upstream. One of the pipes had visible water flowing out of it. The pipes are likely to be outlets from field drain tiles or catch basins.

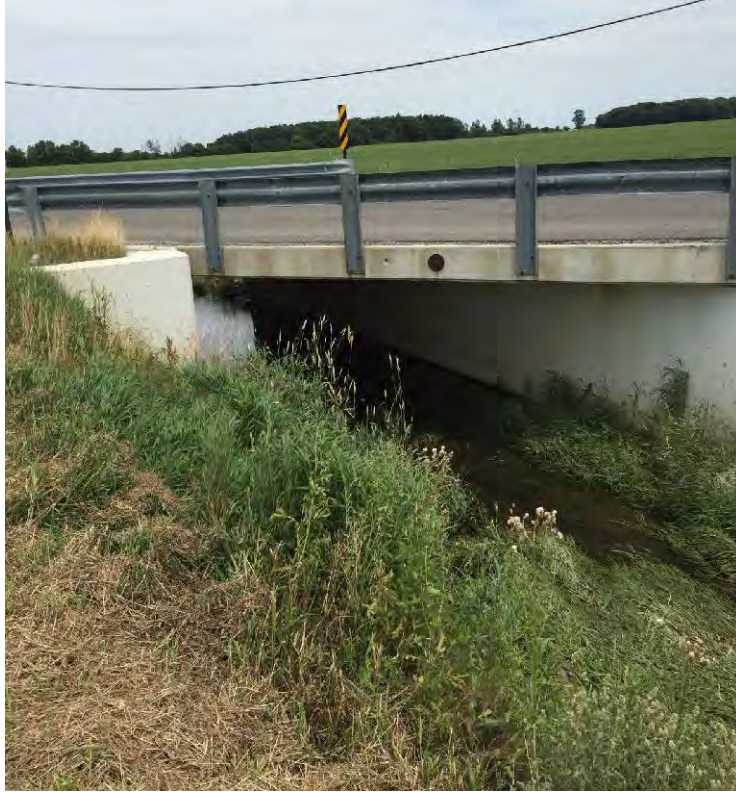
Figure 7-21 CR-75 – Box Culvert Crossing

Approximately 1,100 feet south of CR-130 there is bridge/box culvert crossing under CR-130 for the same stream as the 60" RCP crossing.

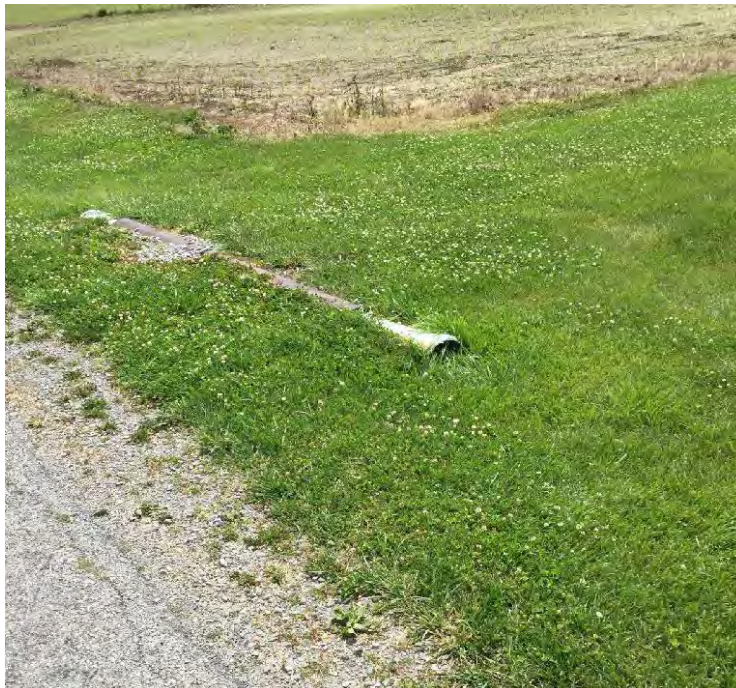
Figure 7-22 CR-75 – Exposed Culvert

After the box culvert, there are shallow ditches on both sides of the road. The ground is relatively flat but flows gradually south towards the stream. There is an exposed culvert in that stretch.

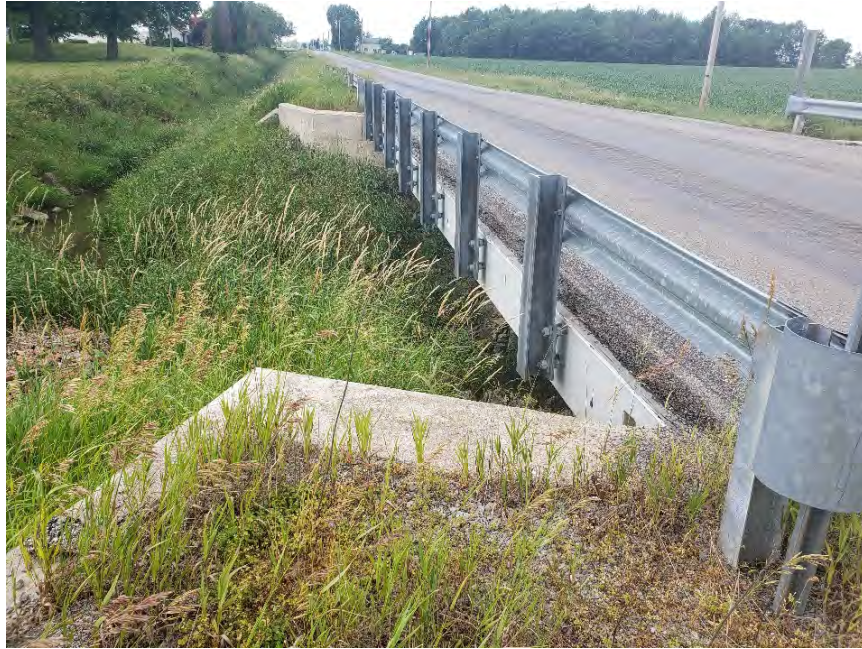
Figure 7-23 CR-75 – Bridge

North of CR-130, shallow ditches continue along both sides of the road. Approximately 3200' south of TR-120, a bridge crosses the same stream crossed by the box culvert and 60" RCP. From this point north, a stream borders CR-75 on the west side. It appears that drainage on the east side of CR-75 flows towards D-10. It is unknown if there are any culverts or structures allowing water to flow from the east side of the roadway into the adjacent stream on the west.

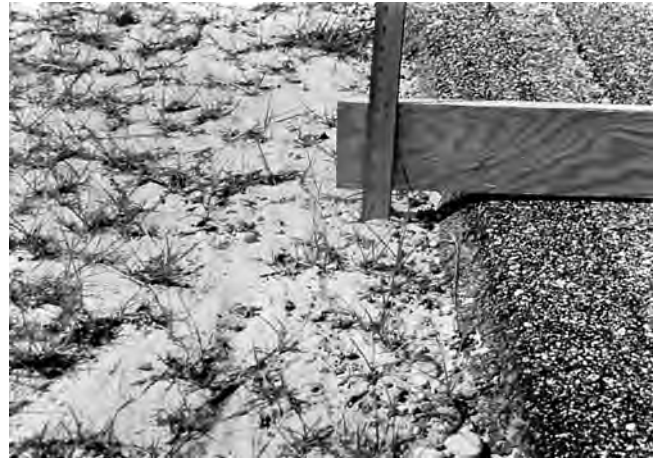
FIG. X1.25 Low-Severity Lane/Shoulder Drop-Off

X1.13.1.1 L—The difference in elevation between the pavement edge and shoulder is > 25 mm (1 in.) and < 50 mm (2 in.) (**Fig. X1.25**).

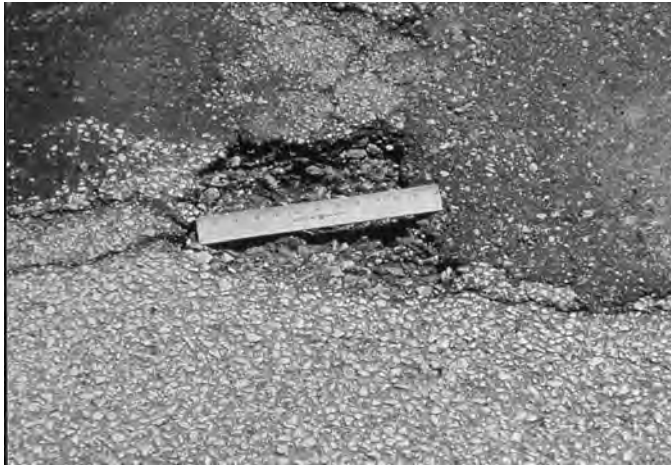
FIG. X1.35 Low-Severity Pothole

Maximum Depth of Pothole	Average Diameter (mm) (in.)		
	100 to 200 mm (4 to 8 in.)	200 to 450 mm (8 to 18 in.)	450 to 750 mm (18 to 30 in.)
13 to ≤25 mm (½ to 1 in.)	L	L	M
>25 and ≤50 mm (1 to 2 in.)	L	M	H
>50 mm (2 in.)	M	M	H

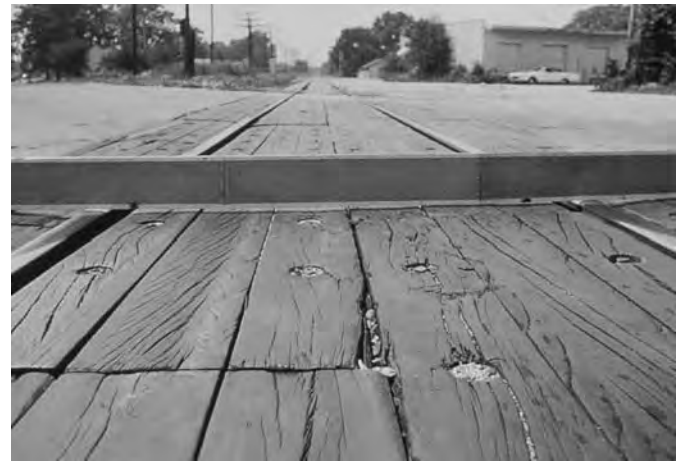
FIG. X1.38 Low-Severity Railroad Crossing

X1.18.1.1 **L**—Railroad crossing causes low-severity ride quality (Fig. X1.38).

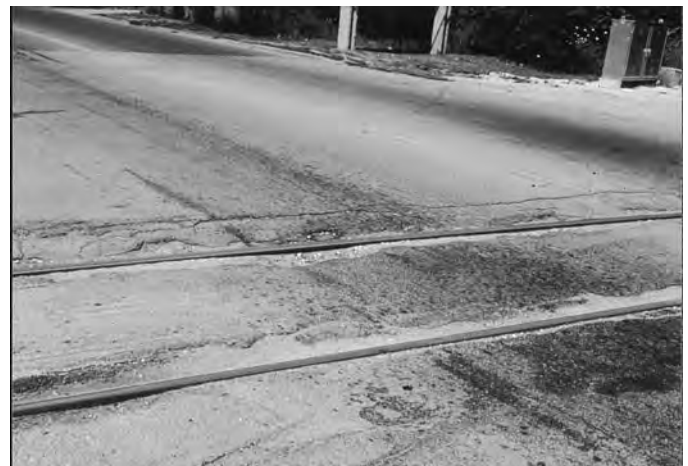
FIG. X1.39 Medium-Severity Railroad Crossing

X1.18.1.2 **M**—Railroad crossing causes medium-severity ride quality (Fig. X1.39).

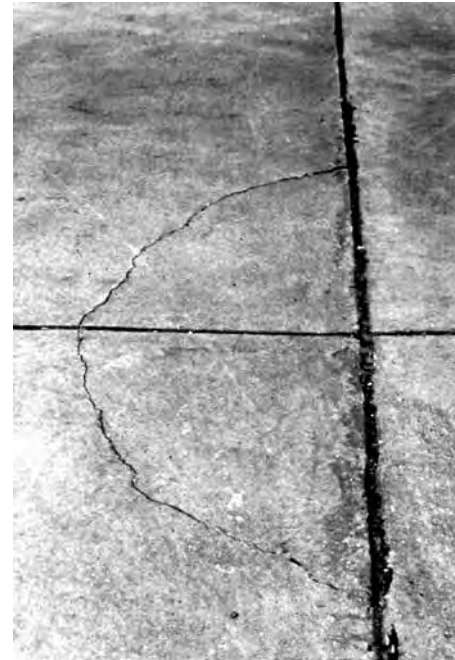
FIG. X2.4 Low-Severity Corner Break

X2.4.1.1 **L**—Break is defined by a low-severity⁴ crack. A low severity crack is < 13 mm ($\frac{1}{2}$ in.), cracks of any width with satisfactory filler; no faulting. The area between the break and the joints is not cracked or may be lightly cracked (Fig. X2.4).

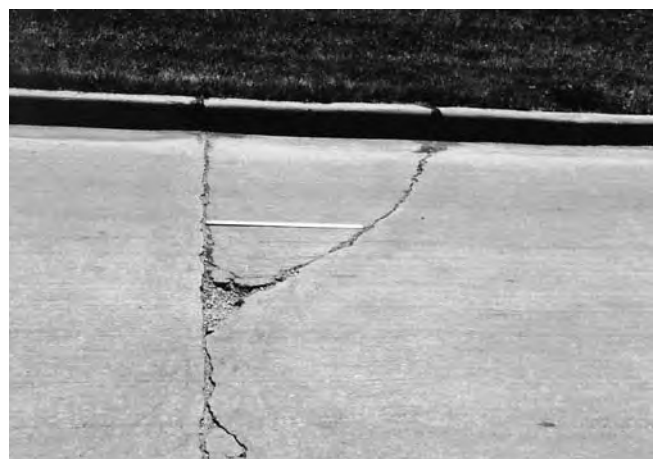
FIG. X2.5 Medium-Severity Corner Break

X2.4.1.2 **M**—Break is defined by a medium-severity⁴ crack, or the area between the break and the joints, or both, has a medium crack. A medium severity crack is a nonfilled crack > 13 mm and < 50 mm ($>\frac{1}{2}$ in. and < 2 in.), a nonfilled crack <

50 mm (2 in.) with faulting < 10 mm ($\frac{3}{8}$ in.), or a any filled crack with faulting < 10 mm ($\frac{3}{8}$ in.) (Fig. X2.5).

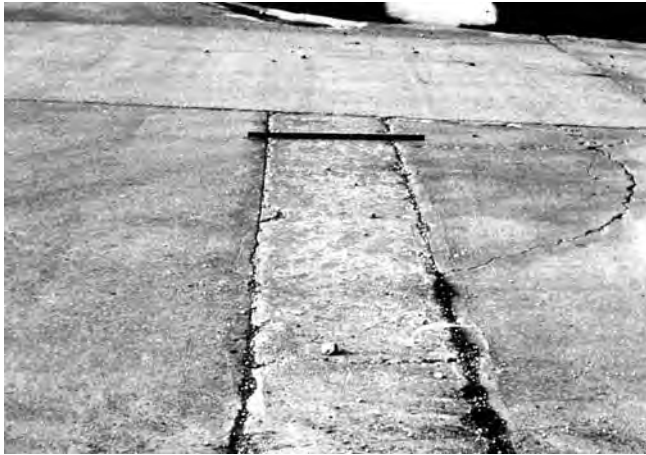
FIG. X2.26 Medium-Severity Patching, Large and Utility Cuts

X2.11.1.2 M—Patch is moderately deteriorated, or moderate spalling can be seen around the edges, or both. Patch material can be dislodged with considerable effort (Fig. X2.26).

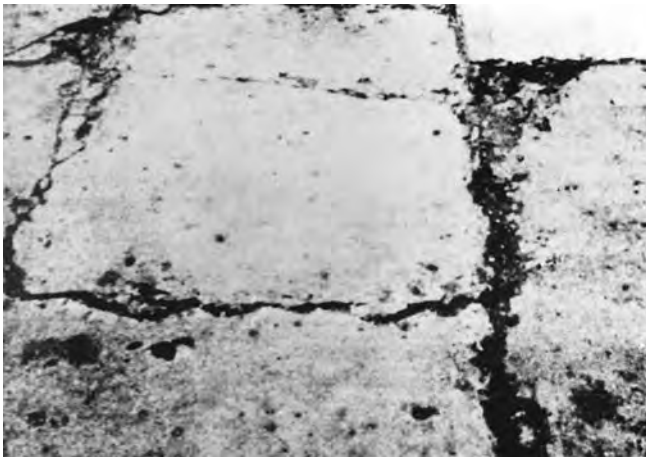
FIG. X2.27 High-Severity Patching, Large and Utility Cuts

X2.11.1.3 H—Patch is badly deteriorated. The extent of the deterioration warrants replacement (Fig. X2.27).

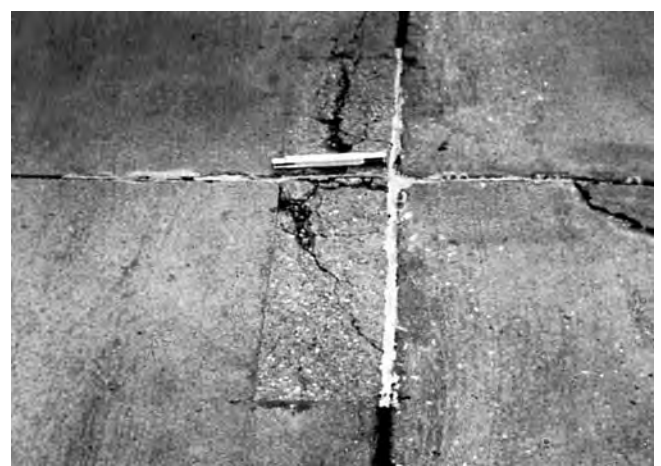
FIG. X2.30 High-Severity Patching, Small

X2.12.1.3 **H**—Patch is badly deteriorated. The extent of deterioration warrants replacement (Fig. X2.30).

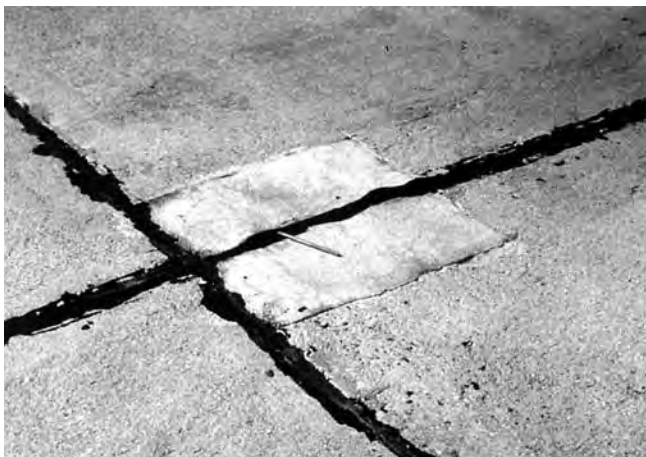
FIG. X2.28 Low-Severity Patching, Small

X2.12.1.1 L—Patch is functioning well with little or no deterioration (Fig. X2.28).

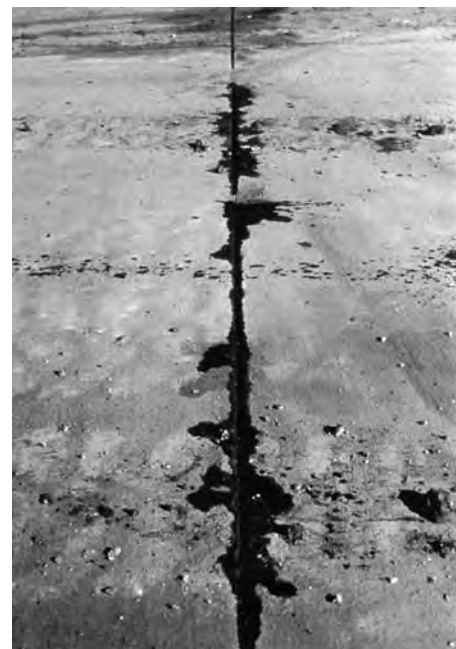
X2.15 *Description*—Pumping is the ejection of material from the slab foundation through joints or cracks. This is caused by deflection of the slab with passing loads. As a load moves across the joint between the slabs, water is first forced under the leading slab, and then forced back under the trailing slab. This action erodes and eventually removes soil particles resulting in progressive loss of pavement support. Pumping can be identified by surface stains and evidence of base or subgrade material on the pavement close to joints or cracks. Pumping near joints is caused by poor joint sealer and indicates loss of support; repeated loading eventually will produce cracks. Pumping also can occur along the slab edge causing loss of support.

X2.15.1 *Severity Levels*—No degrees of severity are defined. It is enough to indicate that pumping exists (Fig. X2.33 and Fig. X2.34).

FIG. X2.33 Pumping

FIG. X2.34 Pumping

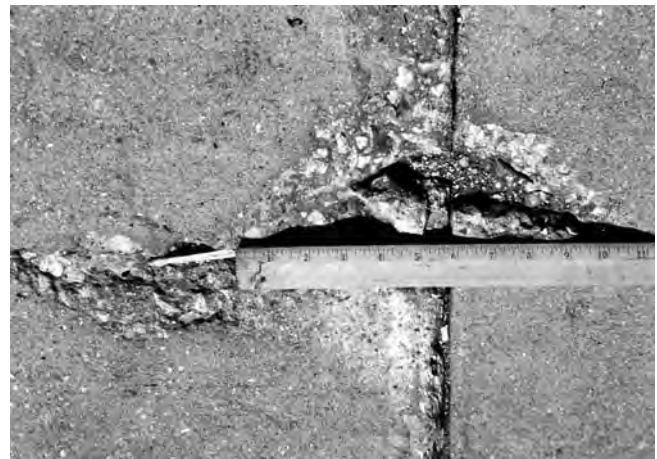
FIG. X2.46 Medium-Severity Spalling, Corner

X2.20.1 *Severity Levels*—Table X2.3 lists the levels of severity for corner spalling. Figs. X2.45-X2.47 show examples. Corner spalling with an area of less than 650 cm (10 in.²) from the crack to the corner on both sides should not be counted.
