Ecological Resource Analysis Report

New Market Solar II
Stringtown Road
Buford, Highland County, Ohio
August 27, 2020
Terracon Project No. N1207316

Re: Ecological Resources Analysis Report
New Market Solar II
Stringtown Road
Buford, Highland County, Ohio
Terracon Project No. N1207316

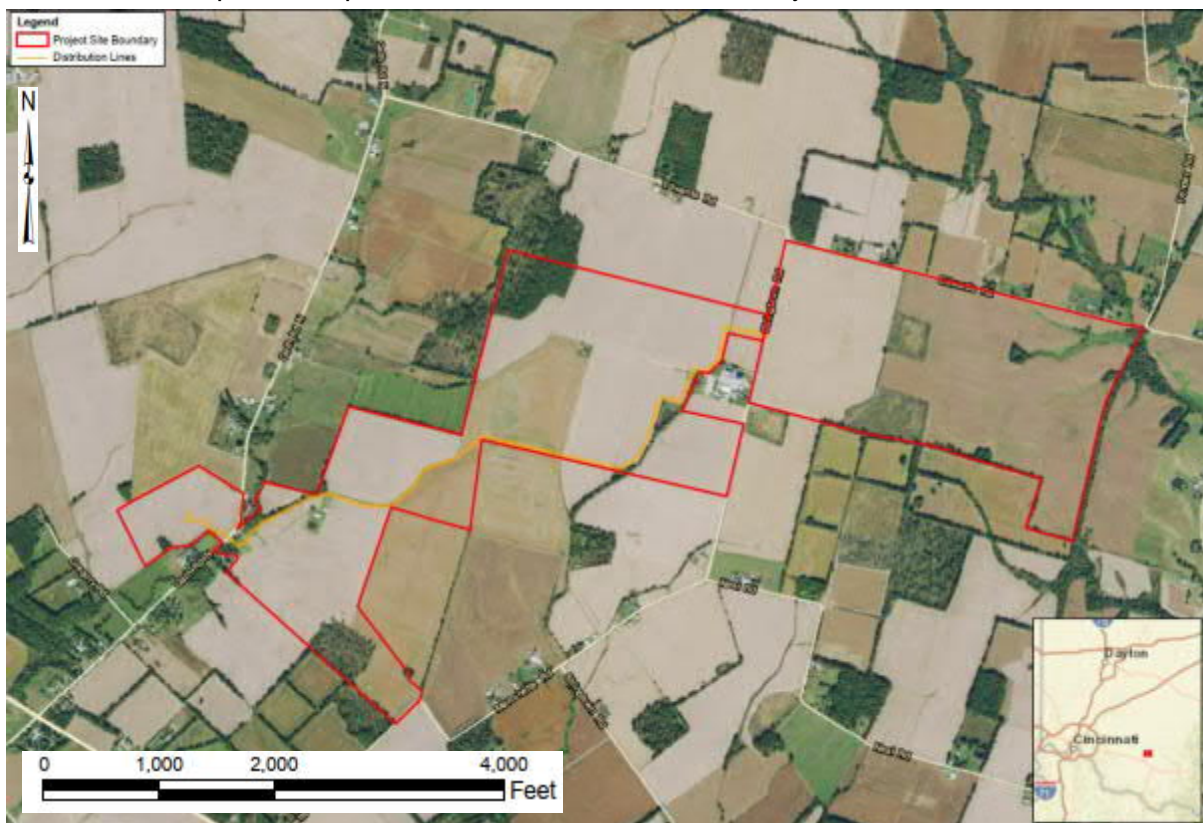
Figure 1. An aerial overview of the Project Site.

The Project Site comprises approximately 721-acres of land. The majority of the Project Site is comprised of agricultural land, the proposed photovoltaic (PV) panel area, and a substation and associated structures and equipment. These portions of the Project Site consist of agricultural land with few, small intermittent patches of forested areas. A transmission line also traverses agricultural land and briefly parallels Stringtown Road to connect the PV panel area to the substation. Numerous overhead power lines appear to cross the Project Site and are assumed to provide a point of interconnection for the Project.

The Project consists of a PV solar energy facility with a proposed generation capacity of 35 megawatts (MW). The Project includes the development of PV panels and supporting steel frames. Foundations for the solar array may consist of wide flange steel piles (W6x9 or similar) or other propriety sections. In addition, Terracon understands that invertors, transformers, and other appurtenant equipment may be supported on shallow spread or mat foundations or through a direct drilled pier foundation. We anticipate that the solar field will follow existing topographic grade with minimal grading required. Terracon understands plans also include the development of some access roads, transmission lines, and a small substation (Figure 1).

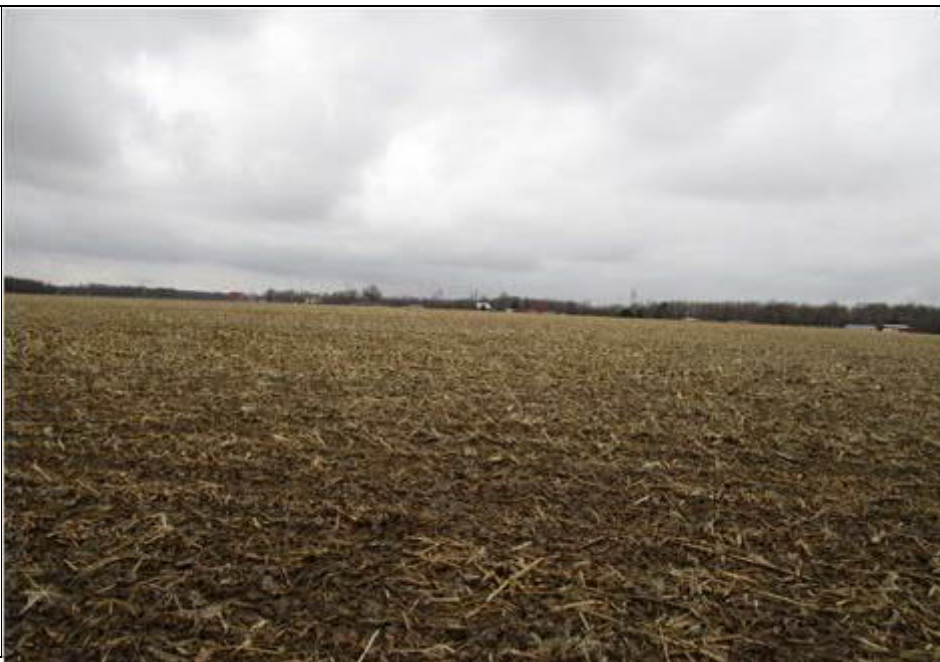
General view of agricultural land on site.

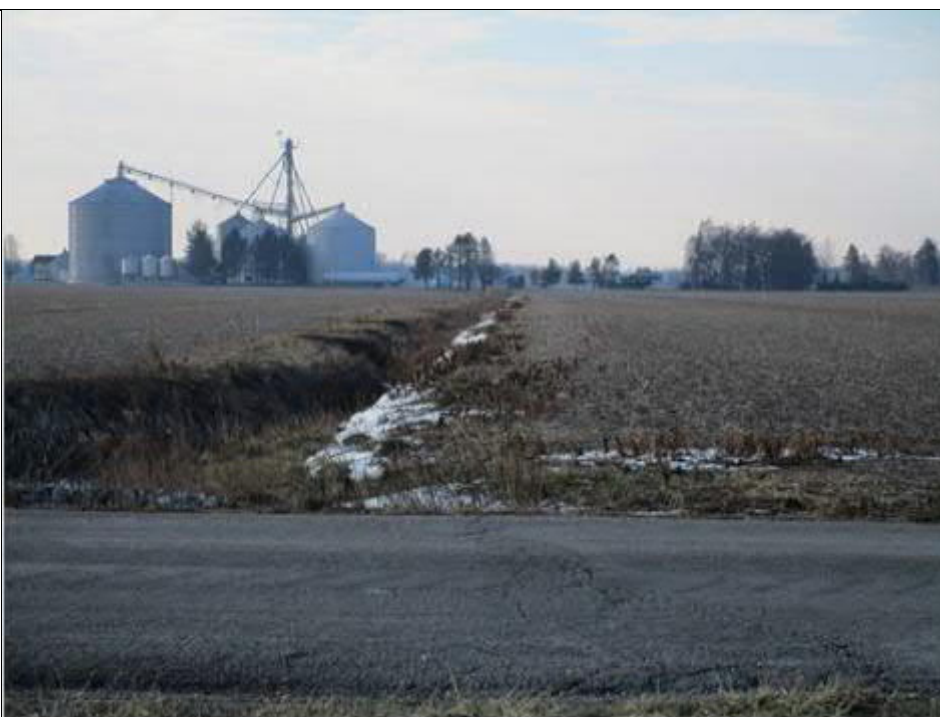
Photograph No. 2

Bell's Run

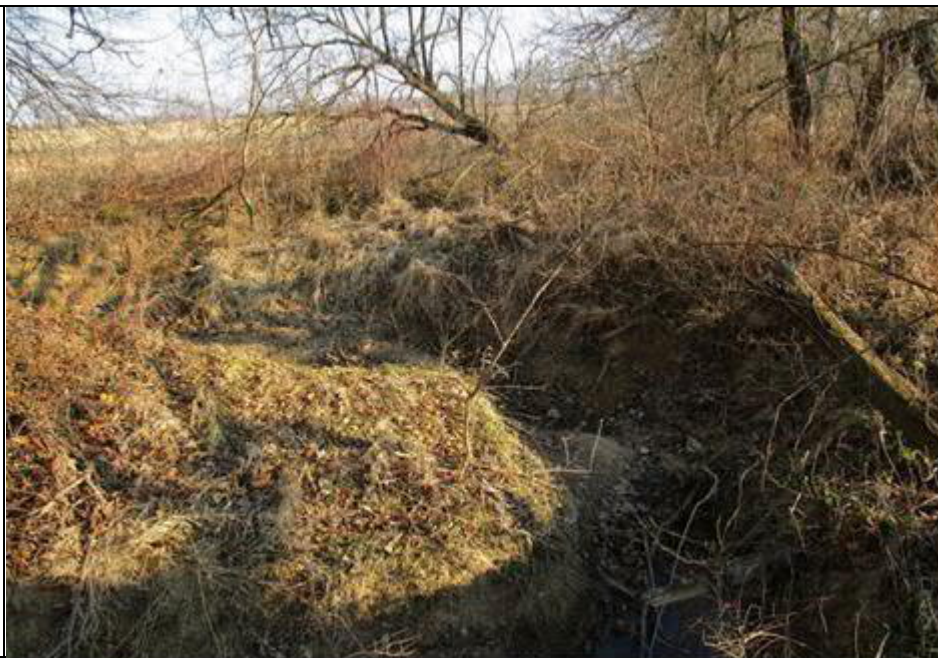
General view of a typical
ephemeral stream on site.

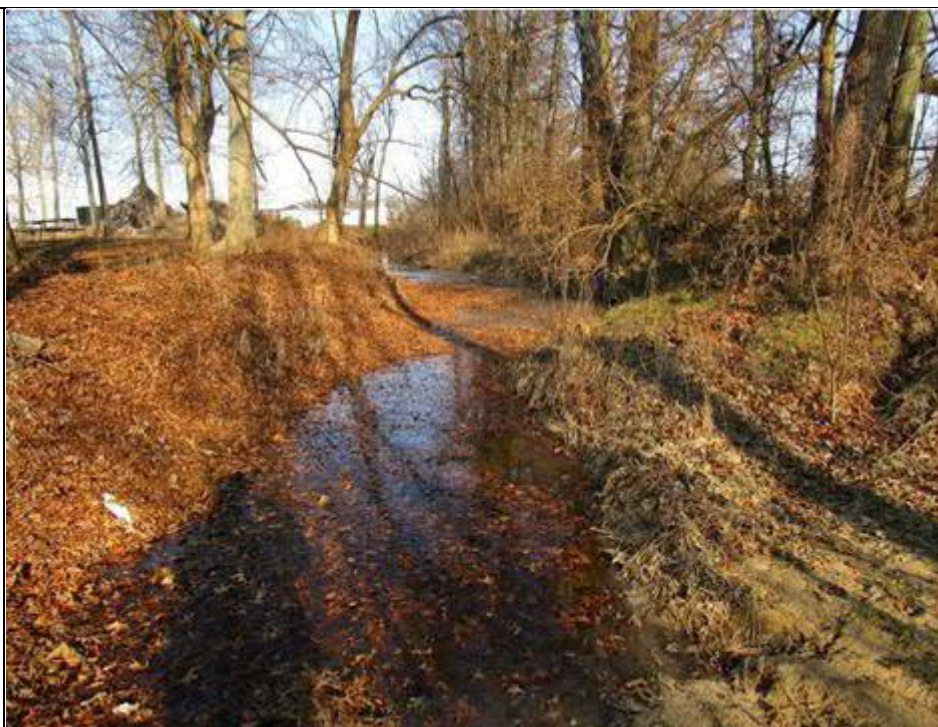
Photograph No. 4

Flat Run

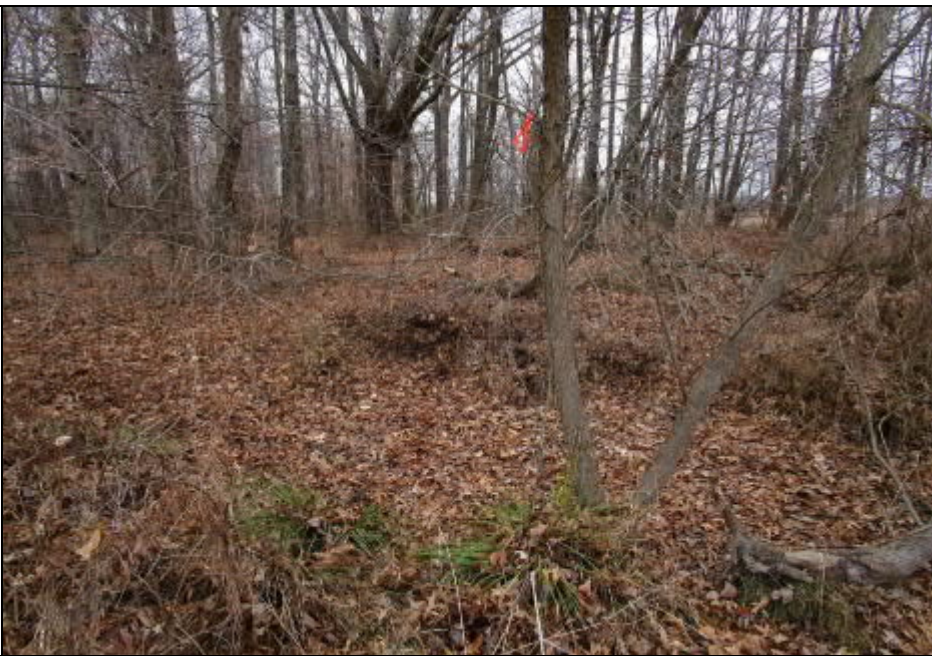
Description:
General view of a
forested wetland found
on site.

Various plant communities and types of land cover were observed at the Project Site including forested wetlands, emergent wetlands, and upland communities. Forested wetlands were dominated by red maple, sweetgum, and Virginia white grass. Emergent wetlands were dominated by touch-me-nots, yellow nutsedge and spicebush.

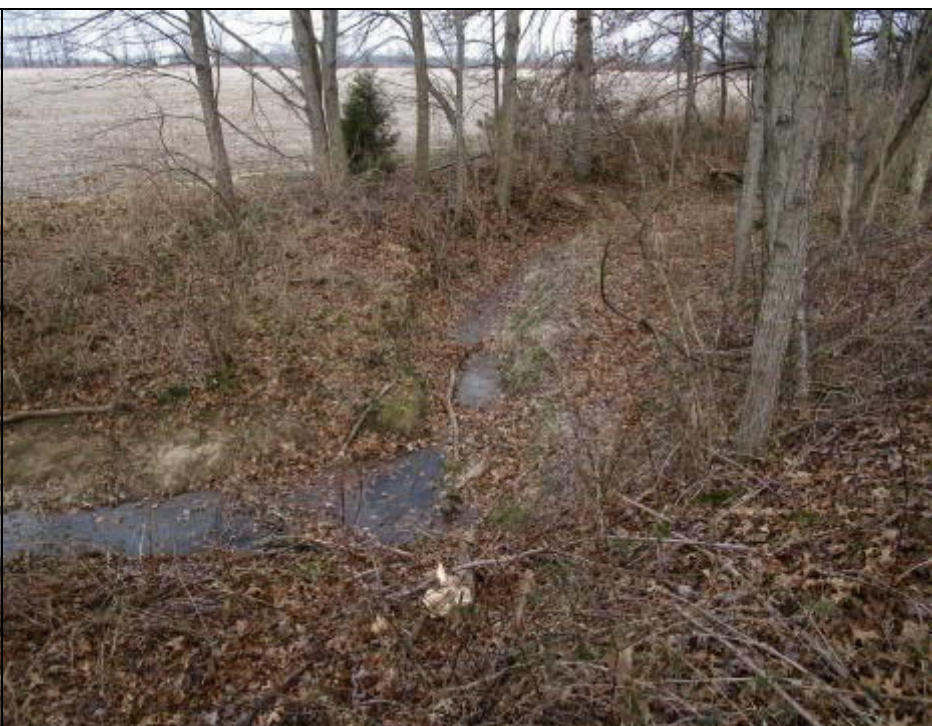
Photograph No. 6

Description:
Stream 1
