Ross County Solar

Ecological Assessment

Case No. 20-1380-EL-BGN

Ross County Solar, LLC

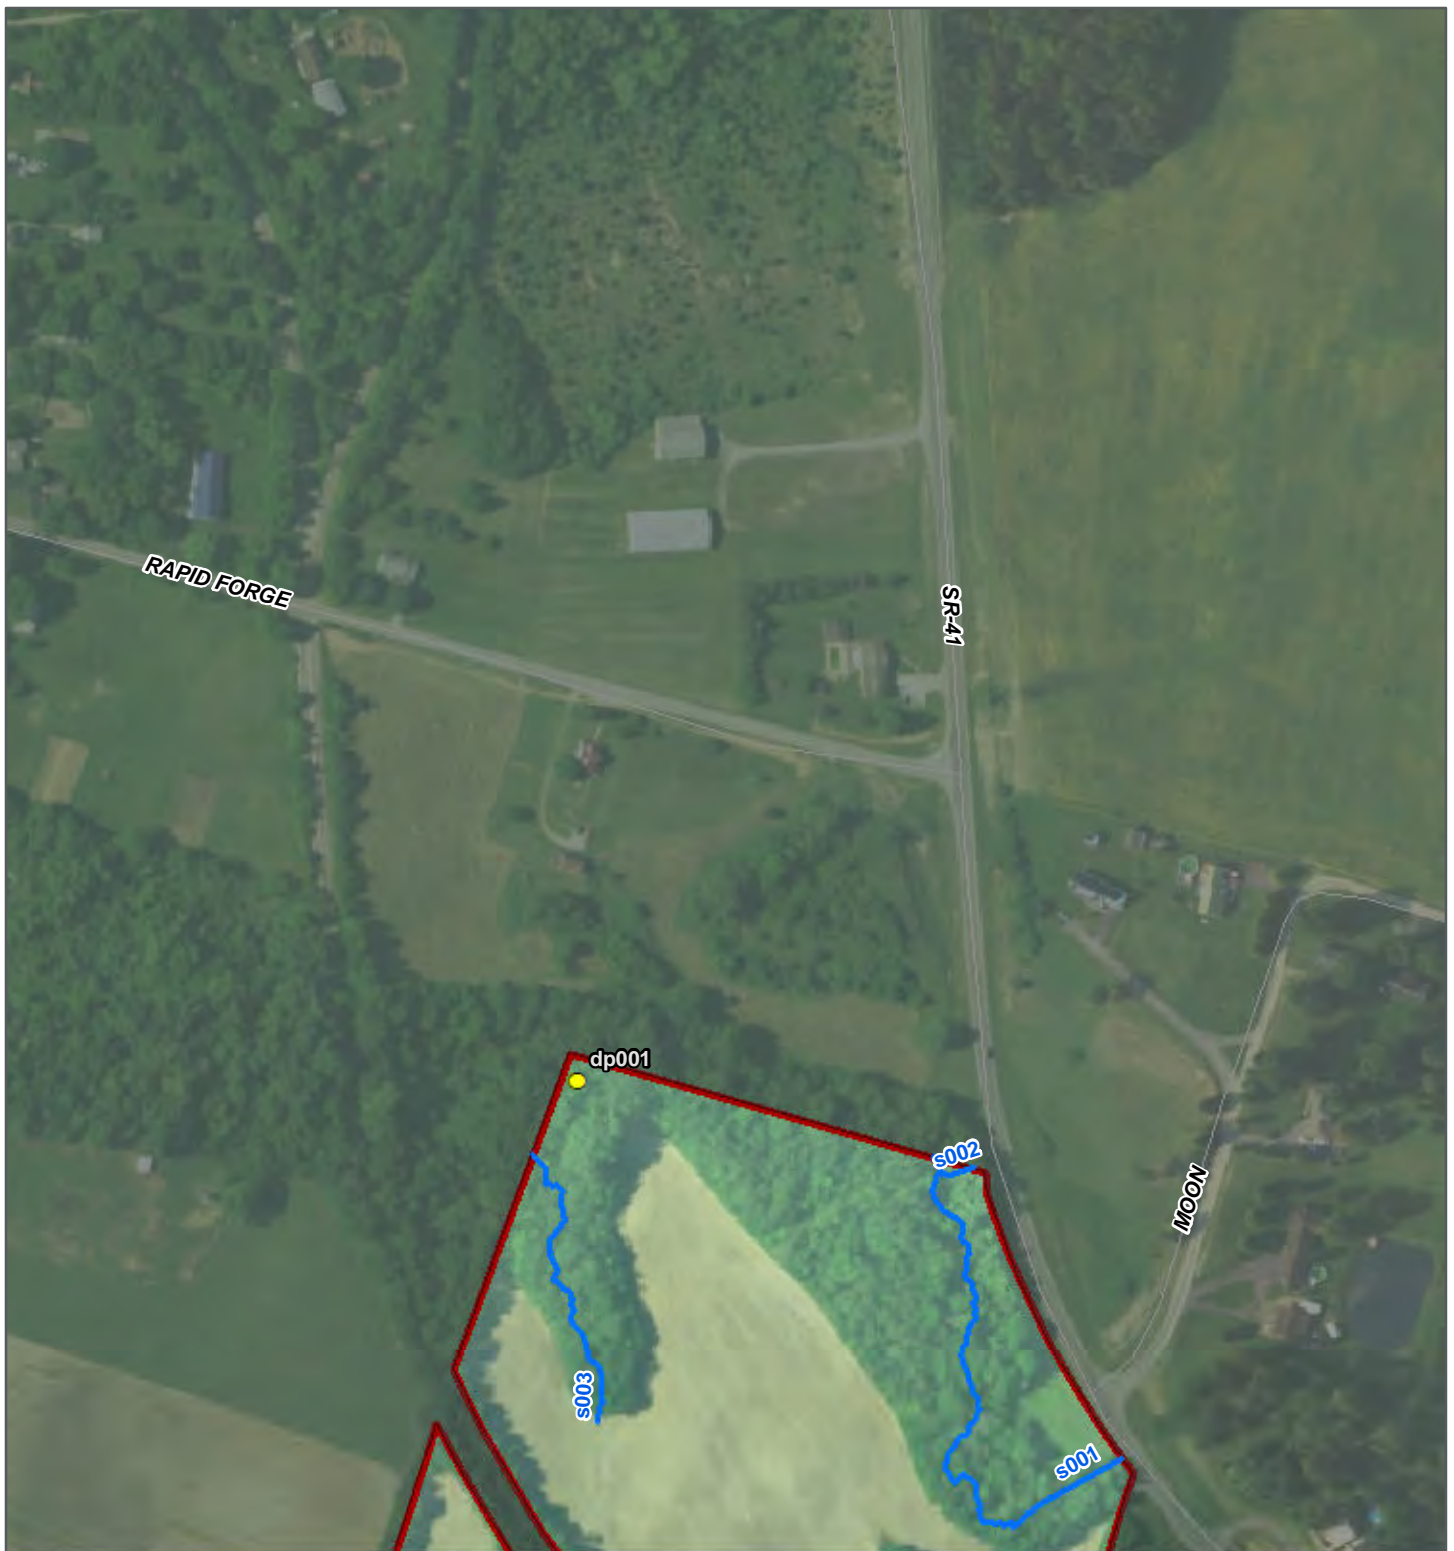
Figure 5.1: Delineation Set Ross County Solar Regulated Waters Delineation Report Ross County Solar LLC Ross County, Ohio

- Data Point
- Delineated Stream
- Project Location
- Delineated Pond
- Delineated Wetland

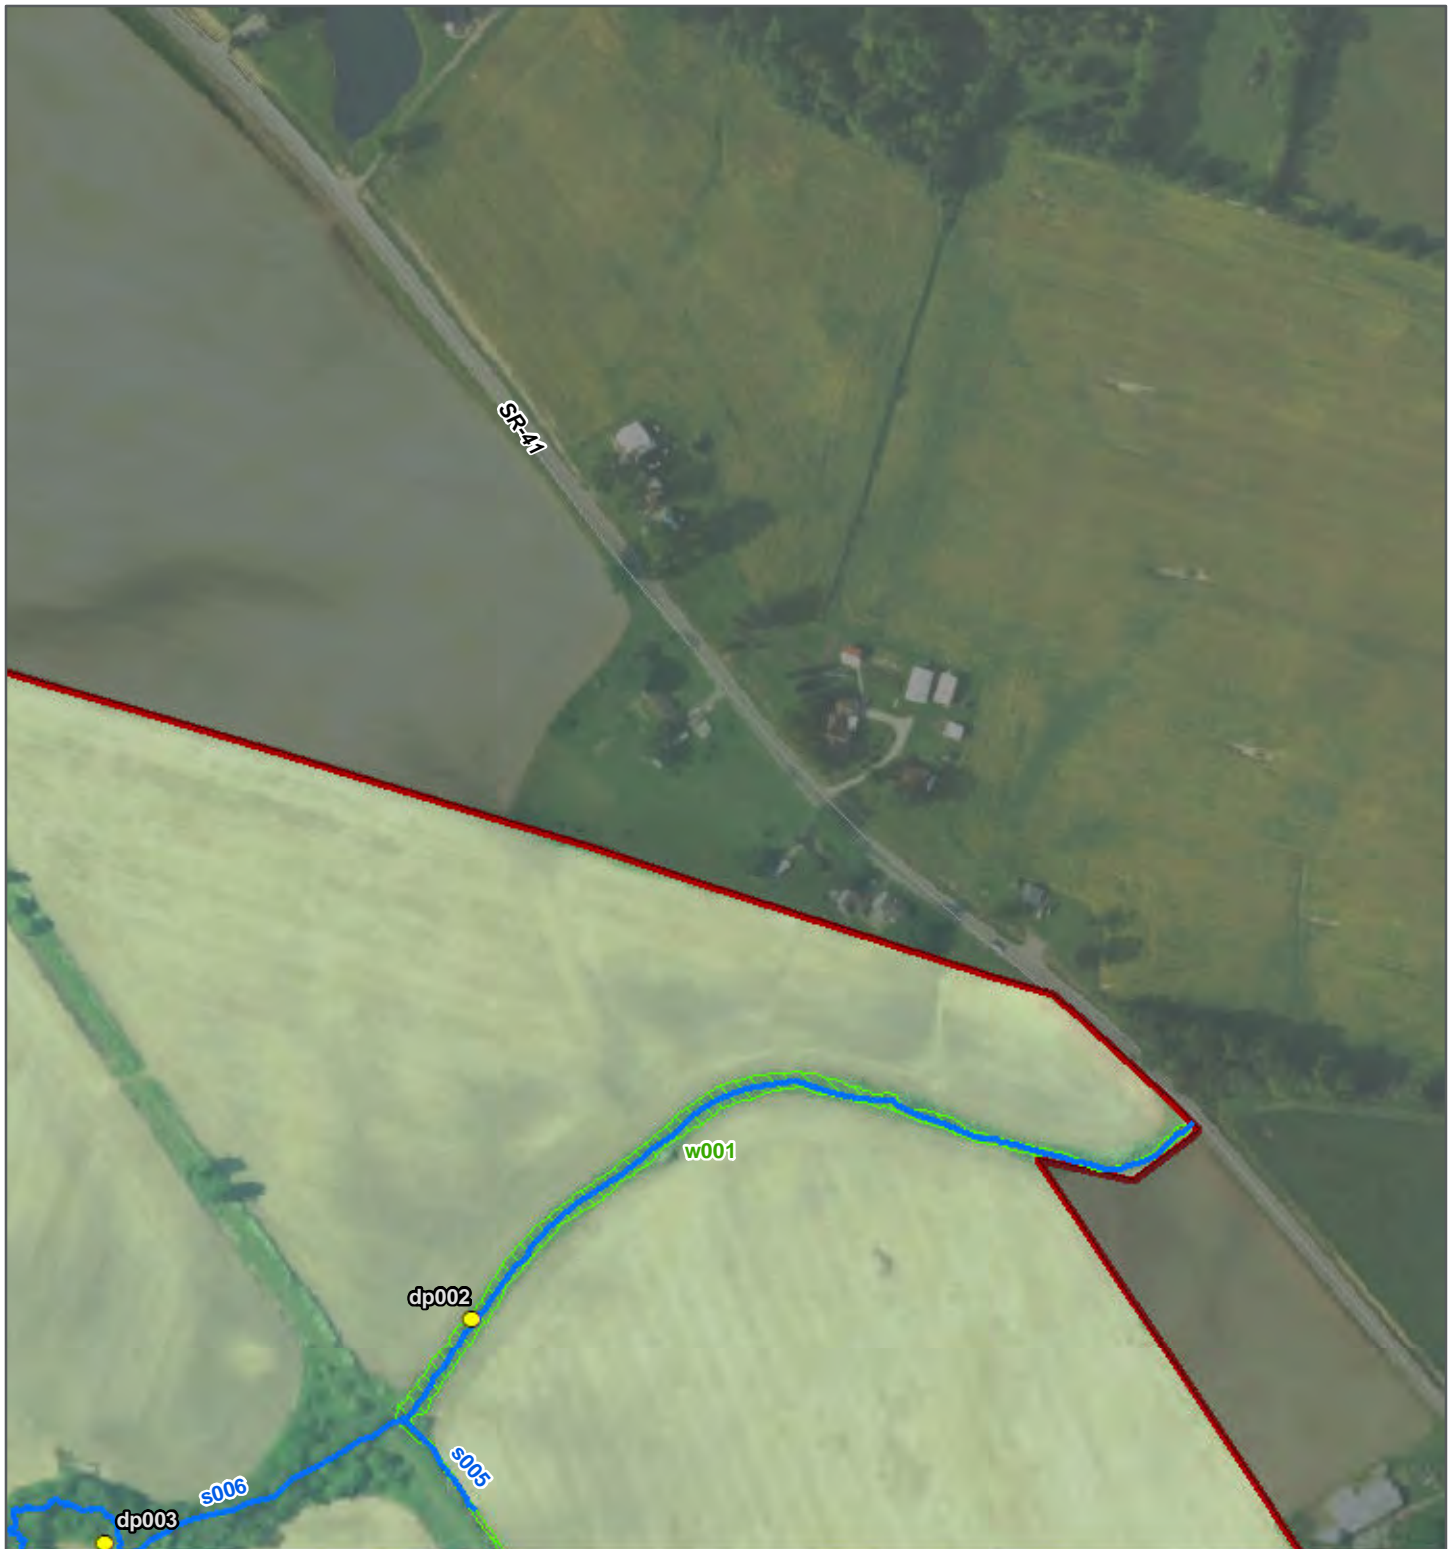
Figure 5.3: Delineation Set Ross County Solar Regulated Waters Delineation Report Ross County Solar LLC Ross County, Ohio

- Data Point
- Delineated Stream
- Delineated Pond
- Delineated Wetland
- Project Location

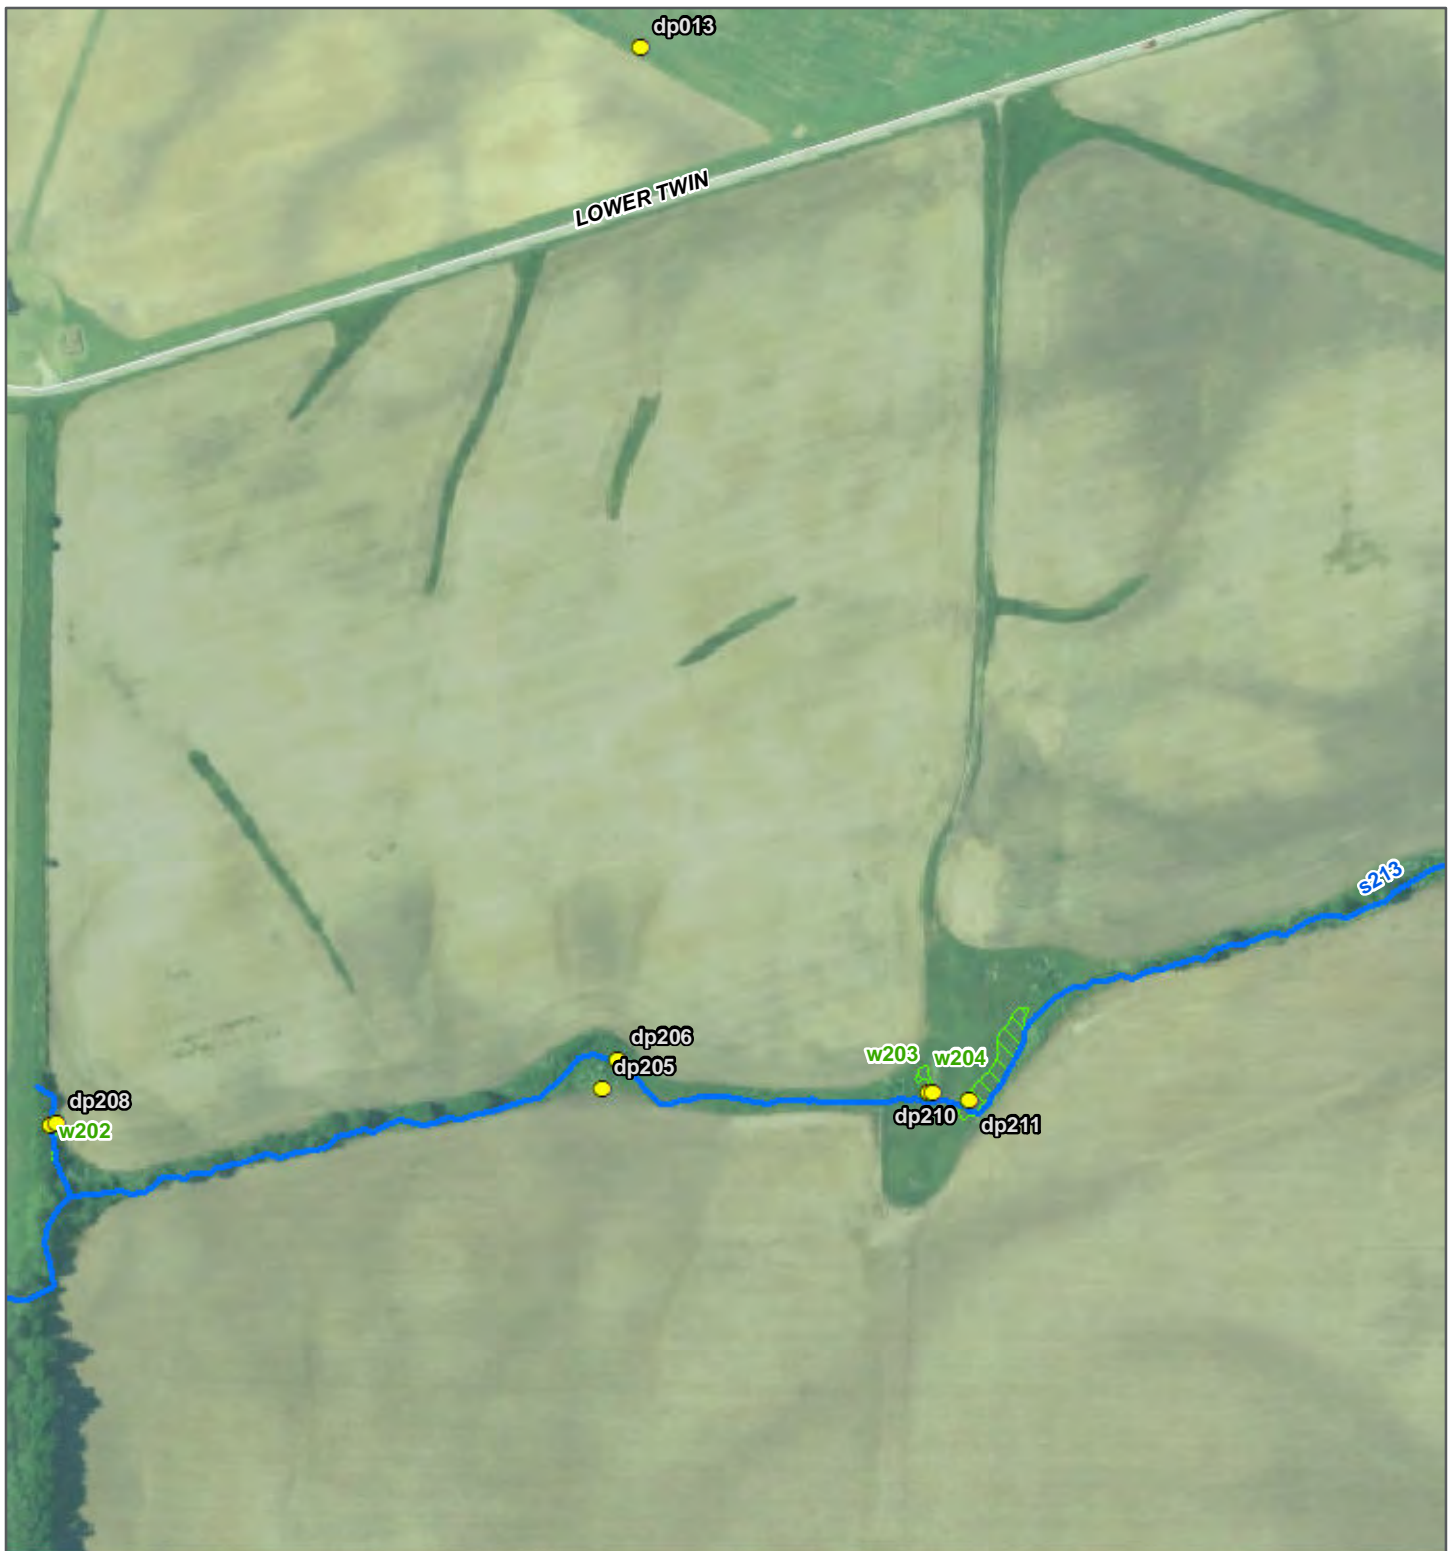
Figure 5.9: Delineation Set Ross County Solar Regulated Waters Delineation Report Ross County Solar LLC Ross County, Ohio

- Data Point
- Delineated Stream
- ▨ Delineated Wetland
- Project Location
- ▭ Delineated Pond

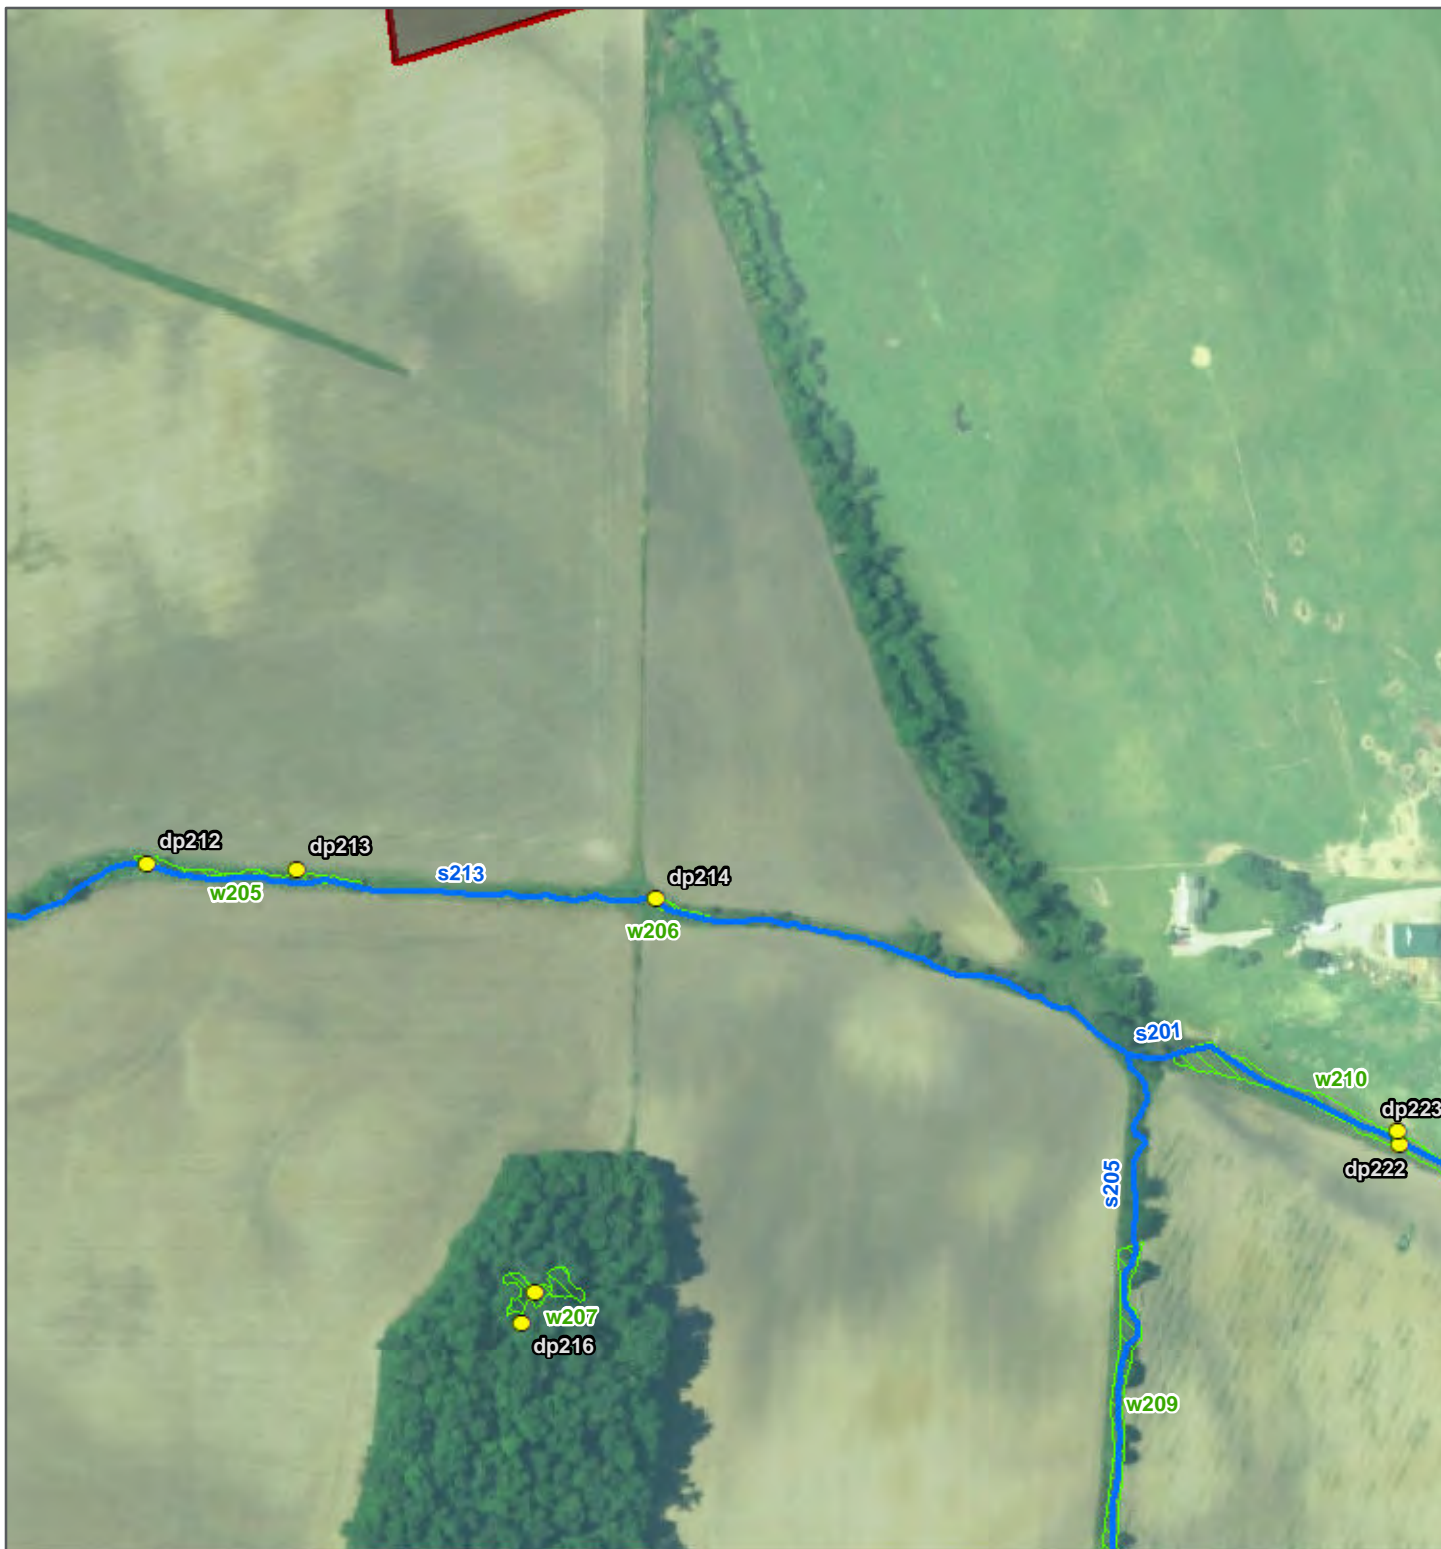
Figure 5.10: Delineation Set Ross County Solar Regulated Waters Delineation Report Ross County Solar LLC Ross County, Ohio

- Data Point
- Delineated Stream
- Delineated Pond
- ▨ Delineated Wetland
- Project Location

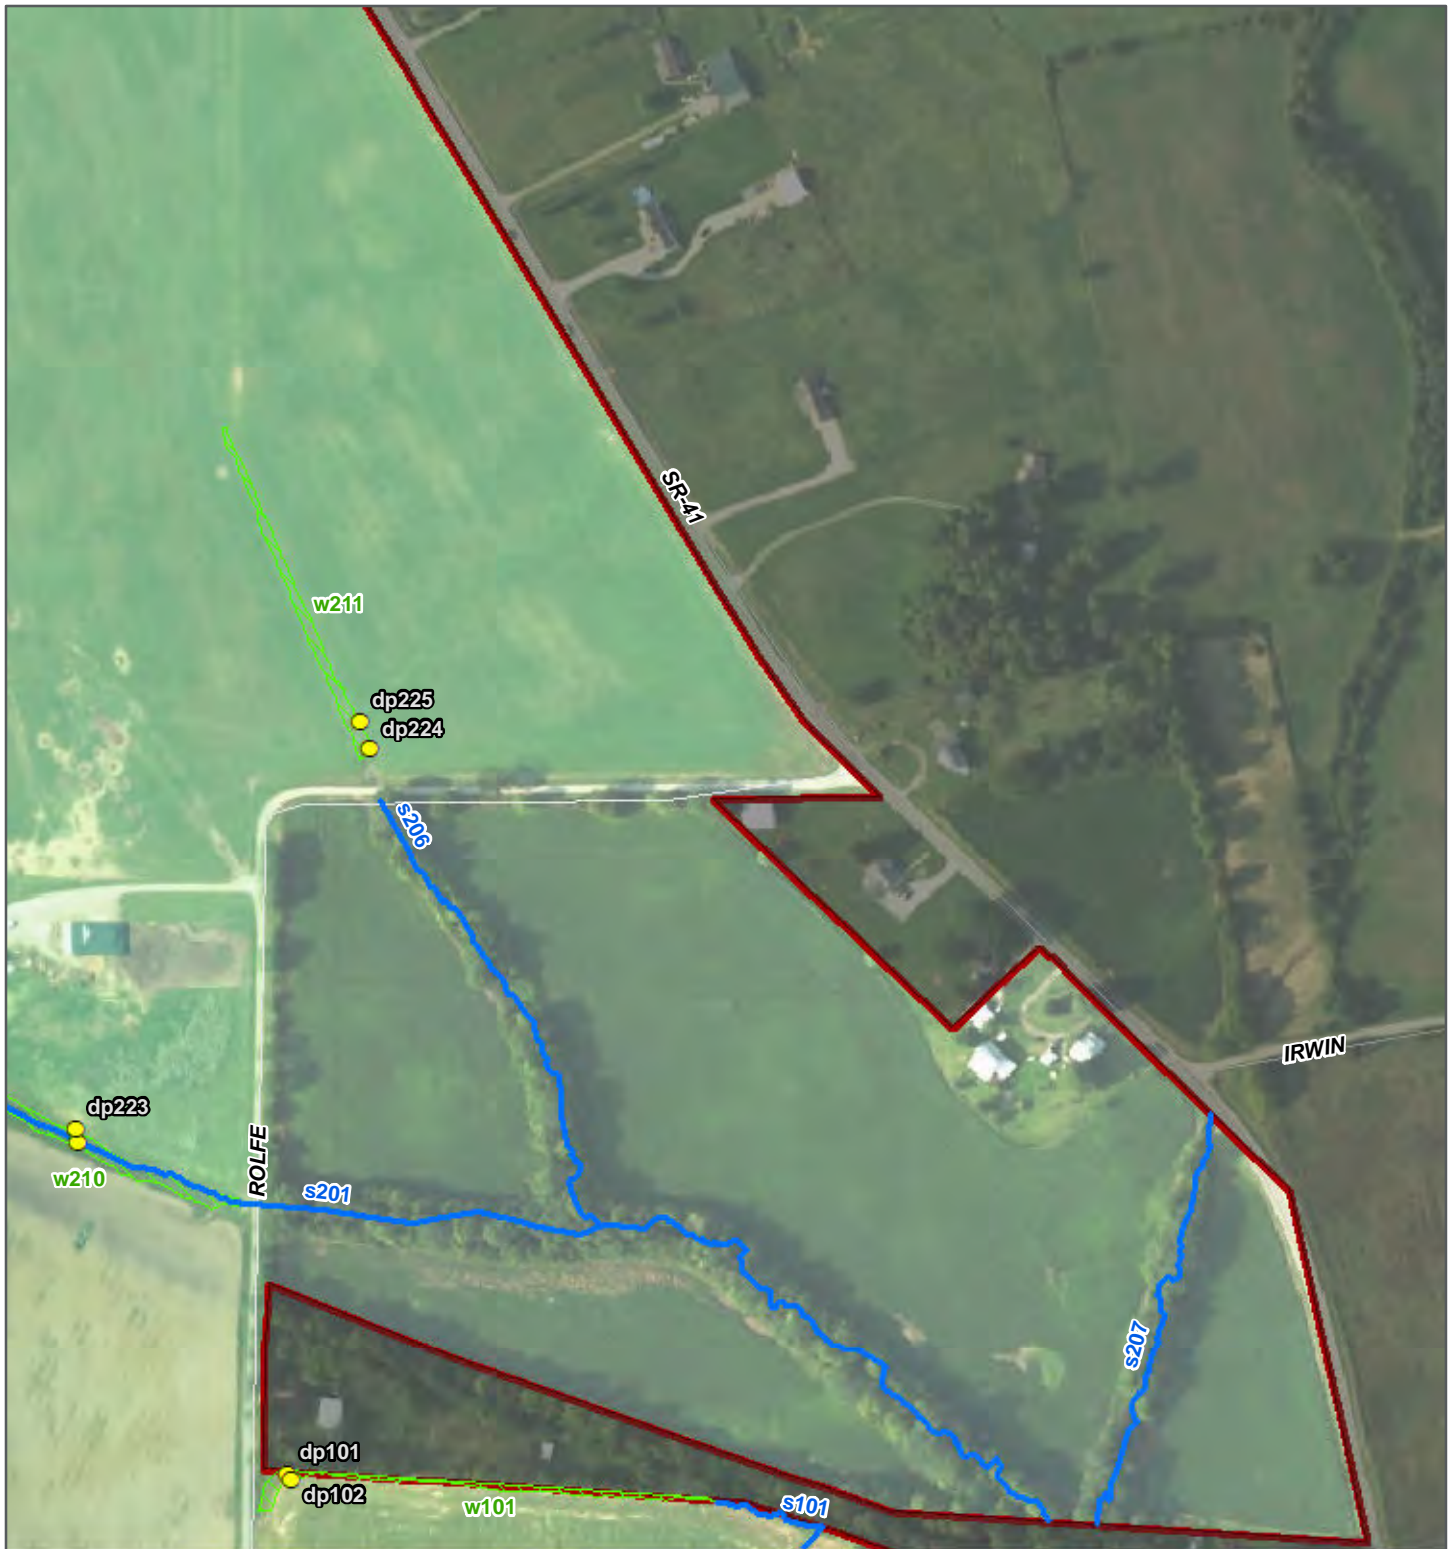
Figure 5.11: Delineation Set
Ross County Solar
Regulated Waters Delineation Report
Ross County Solar LLC
Ross County, Ohio

- Data Point
- Delineated Stream
- Project Location
- Delineated Pond
- ▨ Delineated Wetland
