Ross County Solar

Phase 1 History Architecture Reconnaissance Survey

Case No. 20-1380-EL-BGN

Phase I History Architecture Reconnaissance Survey

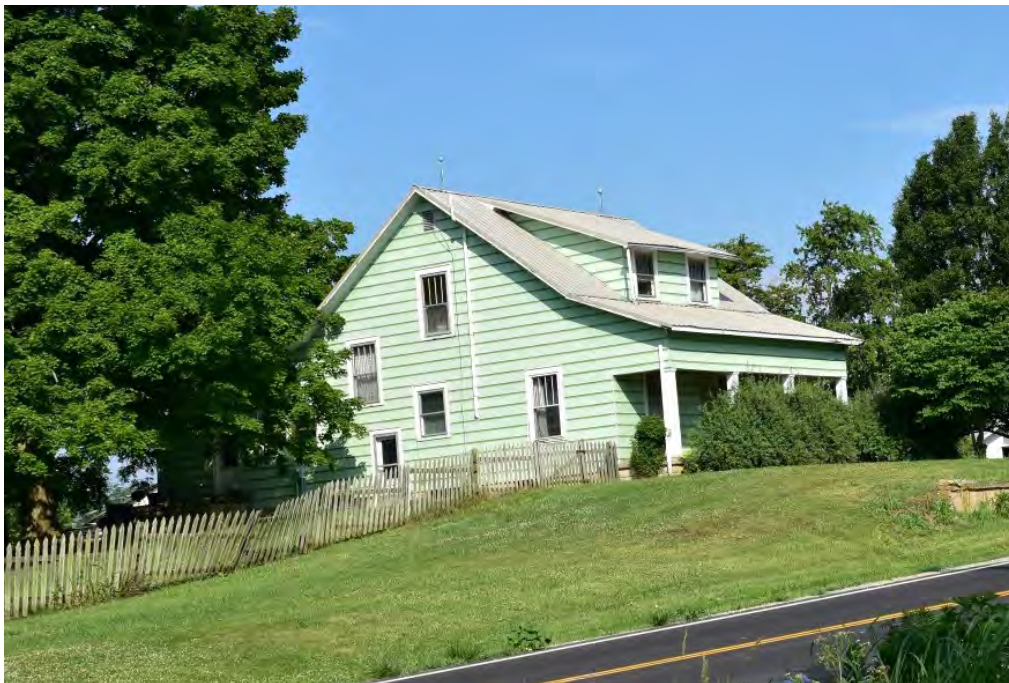
Figure 6. Resource 15, facing west-northwest.

There are six, one-and-one-half-story Bungalows within the APE built during the early twentieth century (Resources 1, 15, 23, 51, 55, and 61). Resource 15 is a side-gabled Bungalow with a front shed dormer and inset porch (Figure 6).

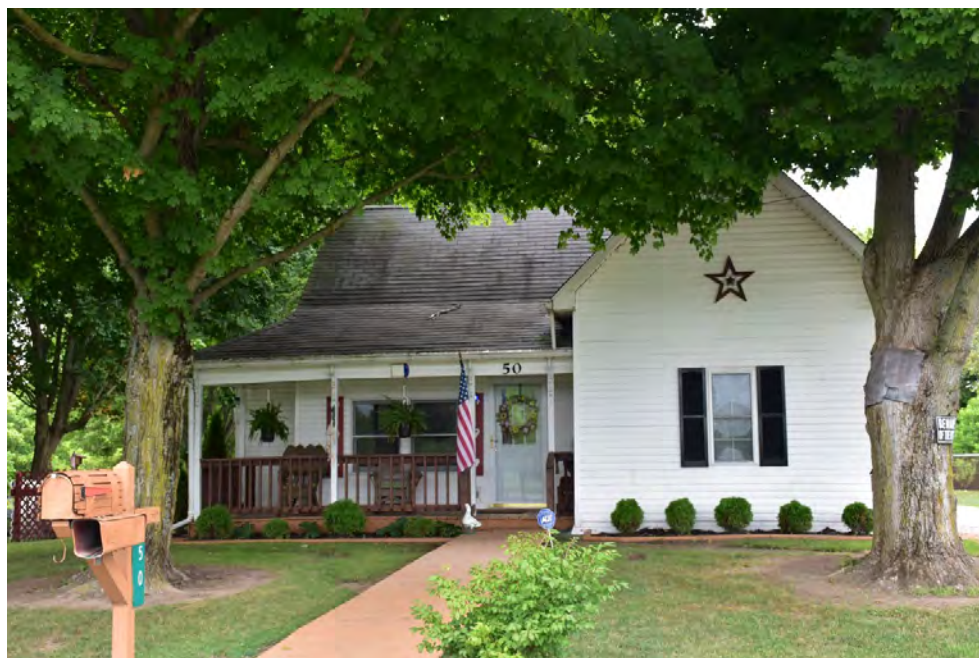
Figure 7. **Resource 25, facing east.**

to the mid-twentieth century. These structures represent traditional building forms such as the gabled ell, hall and parlor, New England one-and-a-half, saddlebag, and Minimal Traditional forms. Minimal stylistic influences include Folk Victorian and Colonial Revival style elements. Resource 25 is a one-story gabled ell style dwelling with an intersecting gable roof clad with composition shingles, vinyl siding, and replacement vinyl windows (Figure 7). Resource 66 appears to have originally featured a hall and parlor form but the entry was relocated and the building was surfaced with aluminum siding (Figure 8).

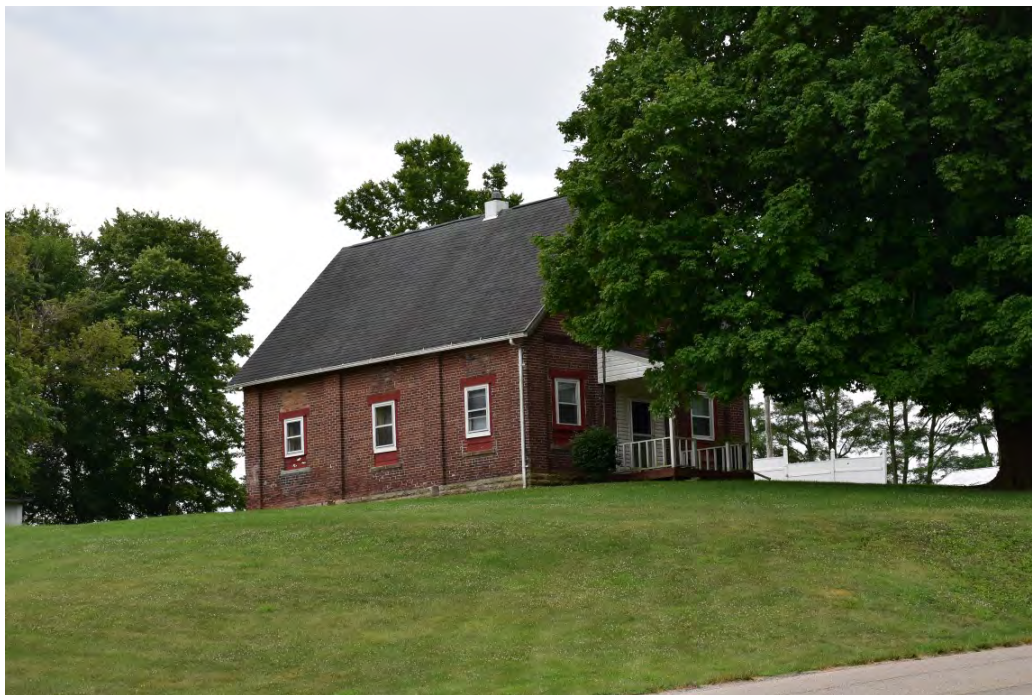
Figure 9. Resource 32, facing south-southeast

Three former schools are situated within the APE (Resources 22, 32, and 60). Resources 22 and 32 are of brick construction which have been converted to residences, while Resource 60 is a wood frame building which is vacant. Resource 60 appears individually eligible and is addressed in Section 4.2.4.5 of this report. Resource 32, the former Thrifton School, rests on a continuous stone foundation and has window openings which have been partially enclosed and partially filled with replacement windows (Figure 9). The front entrance has also been partially enclosed with vinyl siding and the entry porch has been rebuilt.

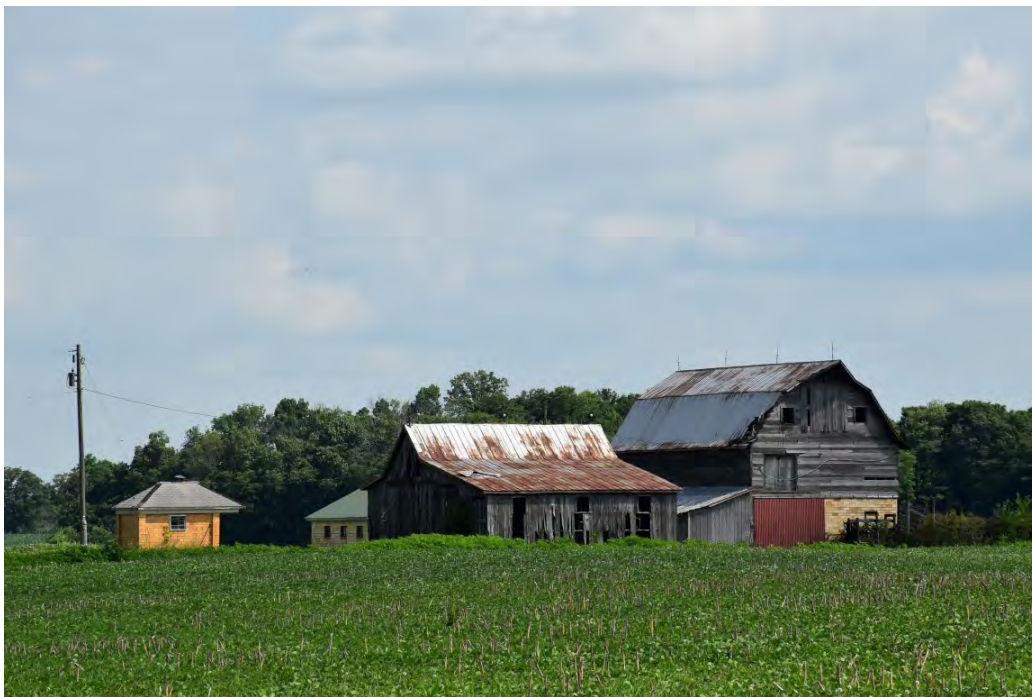
Figure 14. Resource 21, facing north

There are numerous farmsteads throughout the APE with historic outbuildings constructed during the late nineteenth century to the early twentieth century, including dairy barns, equipment sheds, and silos. Since many of these are working farms, there are various modern barn buildings within the APE as well. Wood-clad dairy barns with metal gambrel roofs from the early twentieth century are found at Resources 1, 9, and 15 (Figure 13). Two of the farmsteads have lost their historic house (Resources 3 and 21), leaving only outbuildings behind (Figure 14).

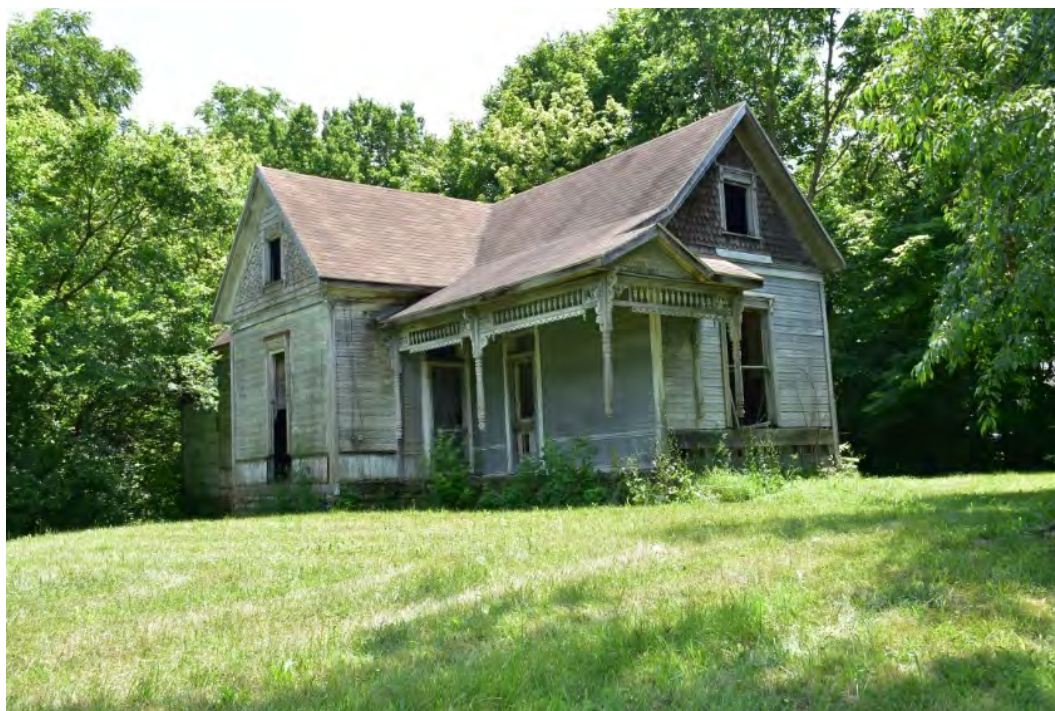
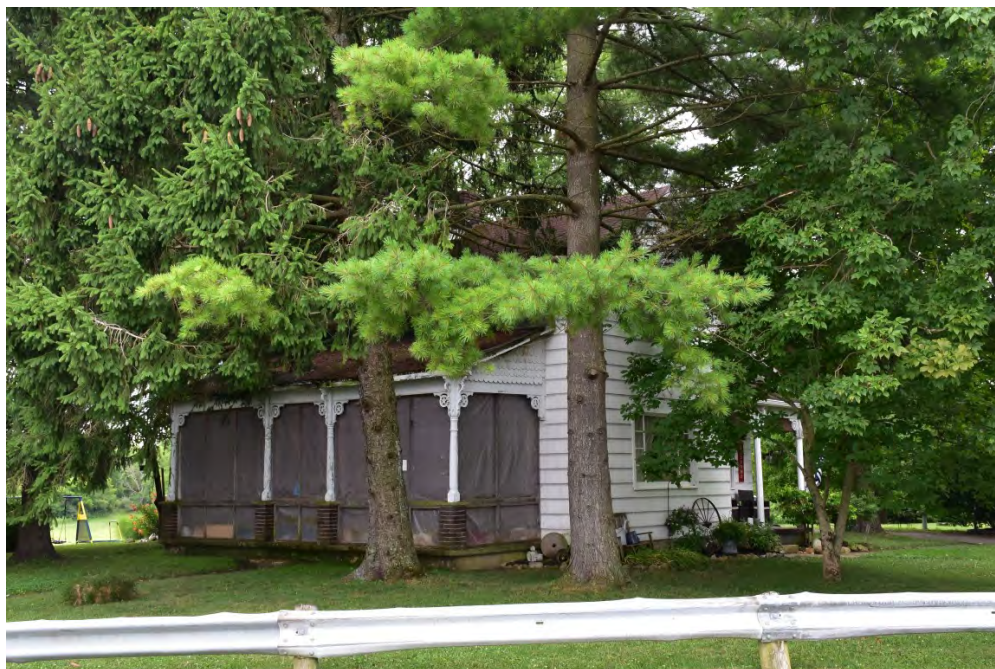
The historic properties in Thrifton largely consist of small, one-story wood frame buildings exhibiting traditional vernacular forms such as the gabled ell, saddlebag, and New England one-and-a-half. The lone exception is Resource 36, a New England One-and-a-Half constructed of stone, which appears individually eligible and is discussed in Section 4.2.4.3. Resources 7 and 30 were likely built during the early development of Thrifton in the late nineteenth century and retain good architectural integrity, but have no known historical significance (Figure 15 and Figure 16).

Figure 15. Resource 7, facing northeast.

Figure 16. Resource 30, facing south.

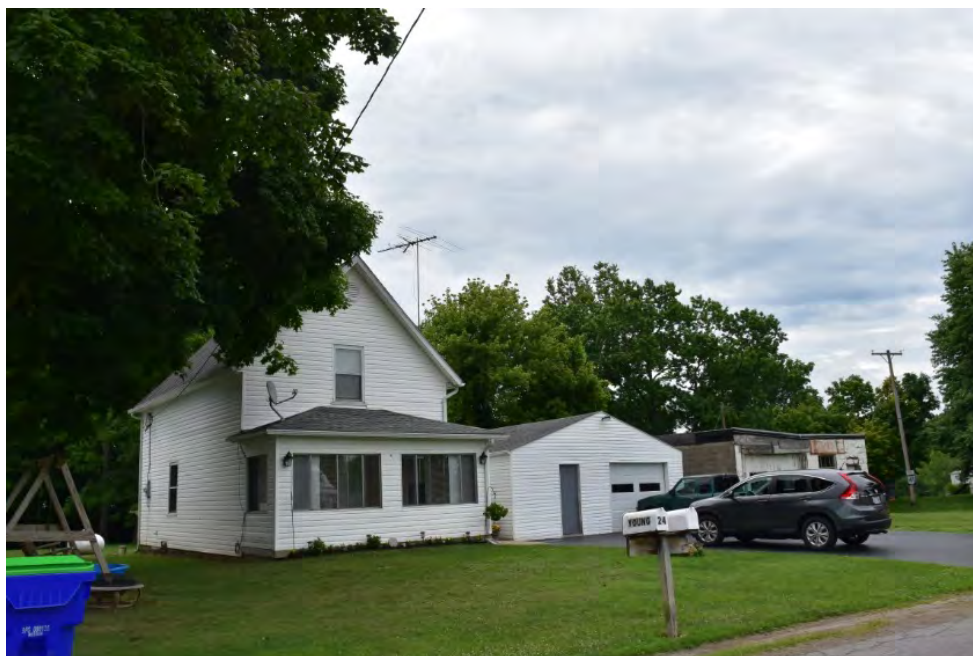
Figure 17. Resource 28, looking east.

The remaining residences were constructed in the early twentieth century. They are one- and one-and-a-half story dwellings with gable roofs and are clad in vinyl or asbestos siding. Resources 26, 28 and 37 are representative of the remaining structures in Thrifton which typically have replacement windows, enclosed porches, and additions. Resource 28 is a one-and-one-half-story with replacement windows, an enclosed front porch, enclosed openings, and vinyl siding (Figure 17).

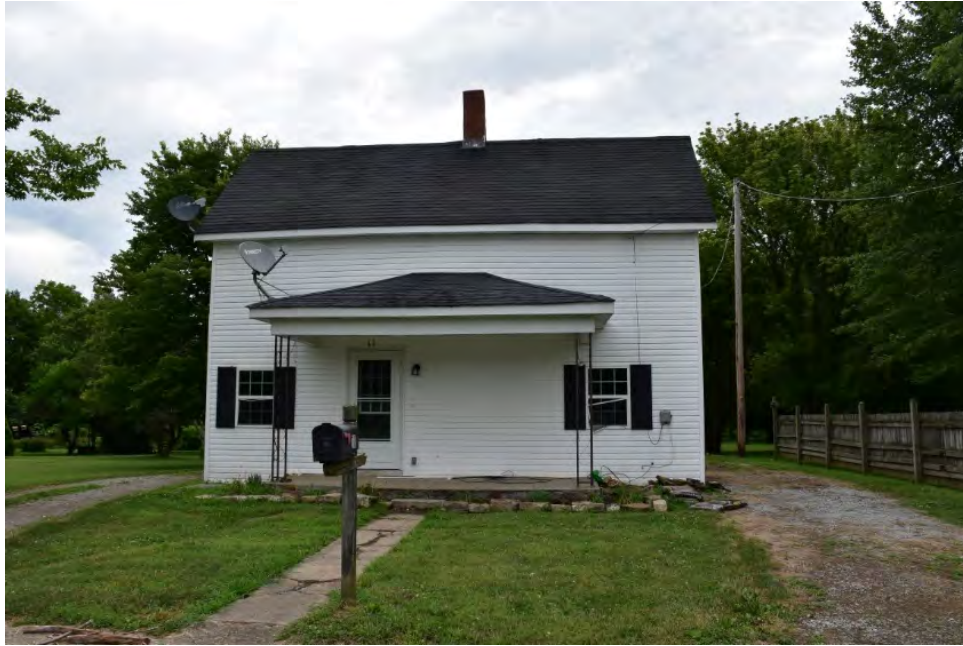
Figure 18. Resource 26, looking east.

Resource 26, a New England One-and-a-Half, has been extensively altered with vinyl siding, replacement windows, enclosed openings, an altered porch, and an addition to the rear (Figure 18). Resource 37 is a one-story vernacular house with wood siding, replacement metal windows, and several additions (Figure 19).

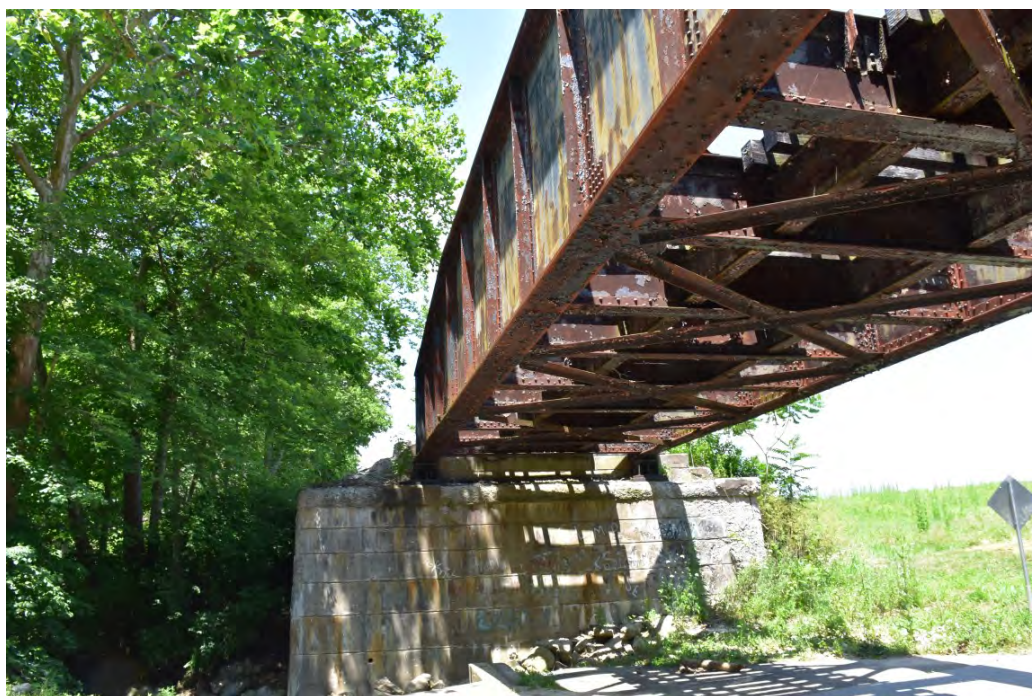
Figure 20. Railroad Bridge over Thrifton Road (7130244), facing north.

Bridge 7130244, the DT&I Railroad Bridge over Thrifton Road, is a through plate girder bridge situated 0.31 miles north of Rapid Forge Road (Figure 20; Baughn 2020; ODOT 2020). Constructed of steel, the bridge is 88.9 feet long and set on stone abutments. Intended for heavier loads, this bridge is designed so that the deck on which the rails are located is carried along the bottom chord with higher solid panels

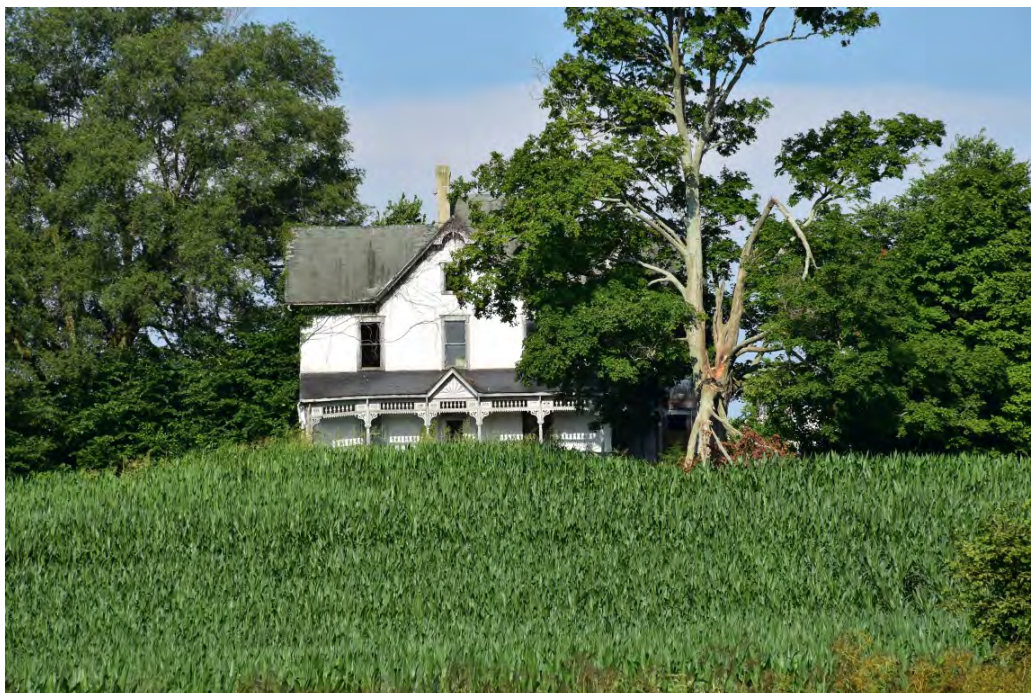
Figure 21. J.W. Baird Farm, facing west.

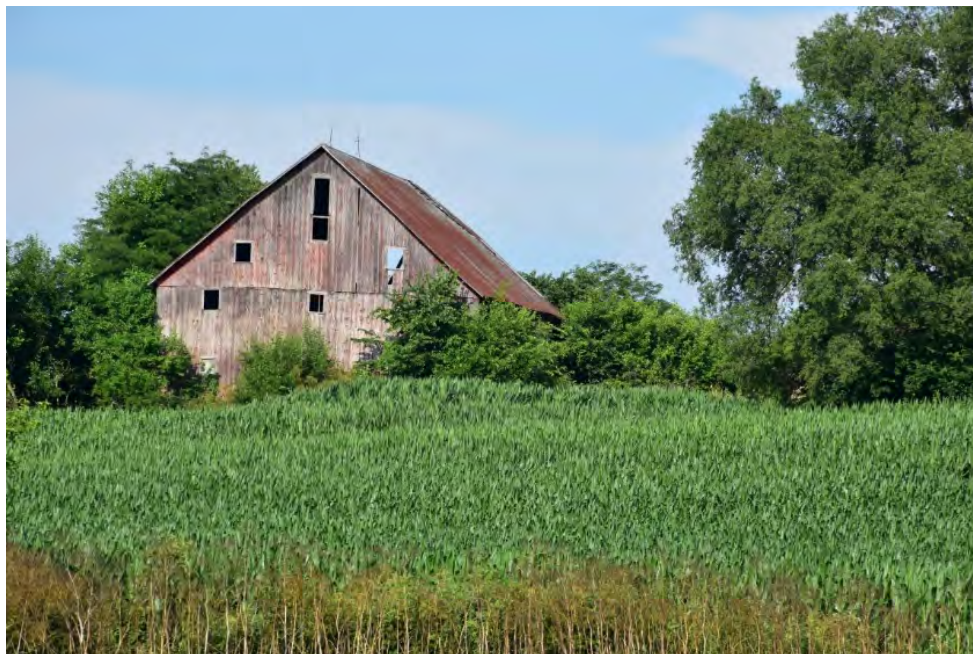
Figure 22. J.W. Baird Farm barn, facing west.

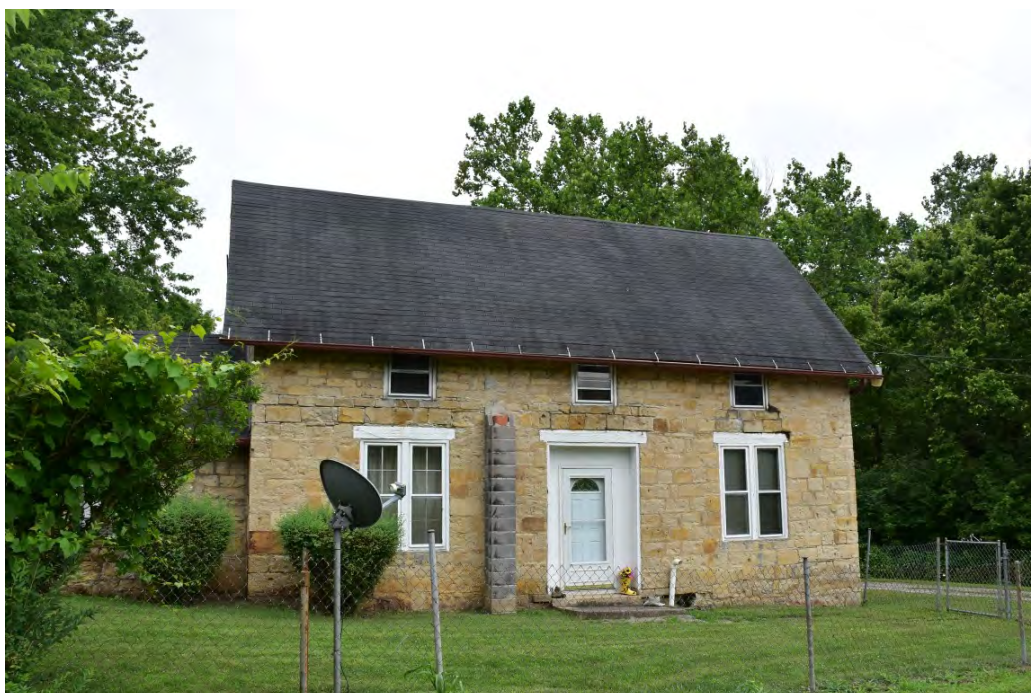
Figure 23. House at 8860 Rapid Forge Road, facing east.

This New England One-and-a-Half, located at 8860 Rapid Forge Road, represents a vernacular building tradition of construction with native stone (Figure 23). The main building is three bays wide, by one bay deep, but a one-story wing, also built of native stone, extending north and east provides additional space. The one-and-one-half-story single-family residence features a side-gabled roof with small, rectangular frieze windows set under the roofline. The walls and foundation are constructed of coursed stone. Paired one-over-one and four-over-four windows set under stone lintels are on the first floor, while replacement one-over-one windows are on the upper half story. The primary entrance has a replacement fiberglass door set behind a storm door with the entrance surrounds replaced ca. 1990. A concrete block and tile chimney was added to the façade, but is now partially demolished. A garage built between 1960 and 1994 is north of the house.

This residence remains a good example of vernacular building traditions exhibiting the New England One-and-a Half form using native stone. In spite of some alterations, it retains integrity of location, design, setting, materials, workmanship and feeling and appears NRHP eligible under Criterion C in the area of Architecture.

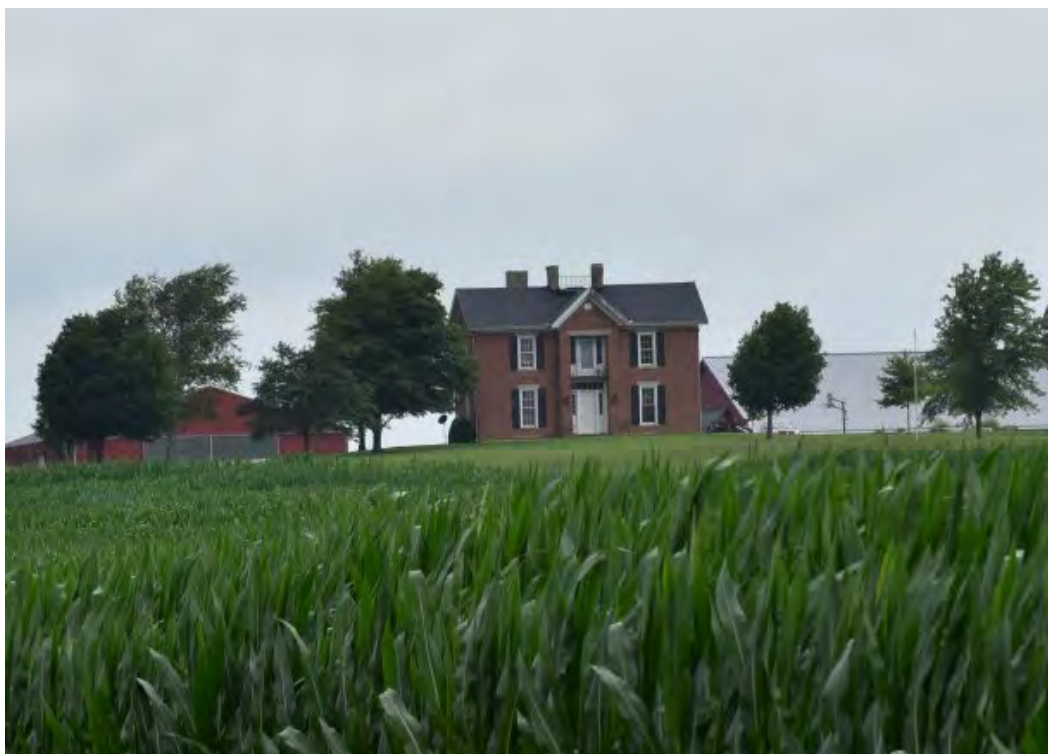
Figure 24. The Fair View Farm / Thomas Murray House, facing north.

Located at 404 Bayless Road, this single-family residence was originally constructed as a two-story I-House three bays wide by one bay deep with a central rear wing (Figure 24). The Federal style house exhibits its stylistic influence with a symmetrical design of brick construction, interior brick chimneys, six-over-six windows with stone lintels, and a slightly projecting center gable with classically inspired entrances of transoms and sidelights on the first and second stories. A one-story addition extends to the rear. Associated outbuildings are on a separate parcel and include three large barns, silos, and sheds;

This property appears potentially eligible for listing in the NRHP under Criterion C in the area of Architecture as an example of a Federal style brick I-house in rural Ohio. Further research may also indicate that it is eligible under Criterion A or B for its association with Thomas Murray and the growth of the cattle industry in the area of Agriculture. Details concerning the architectural design of the house were difficult to discern due to vegetation and the distance from the right-of-way, but the property appears to retain integrity of location, design, setting, materials, workmanship, and feeling.

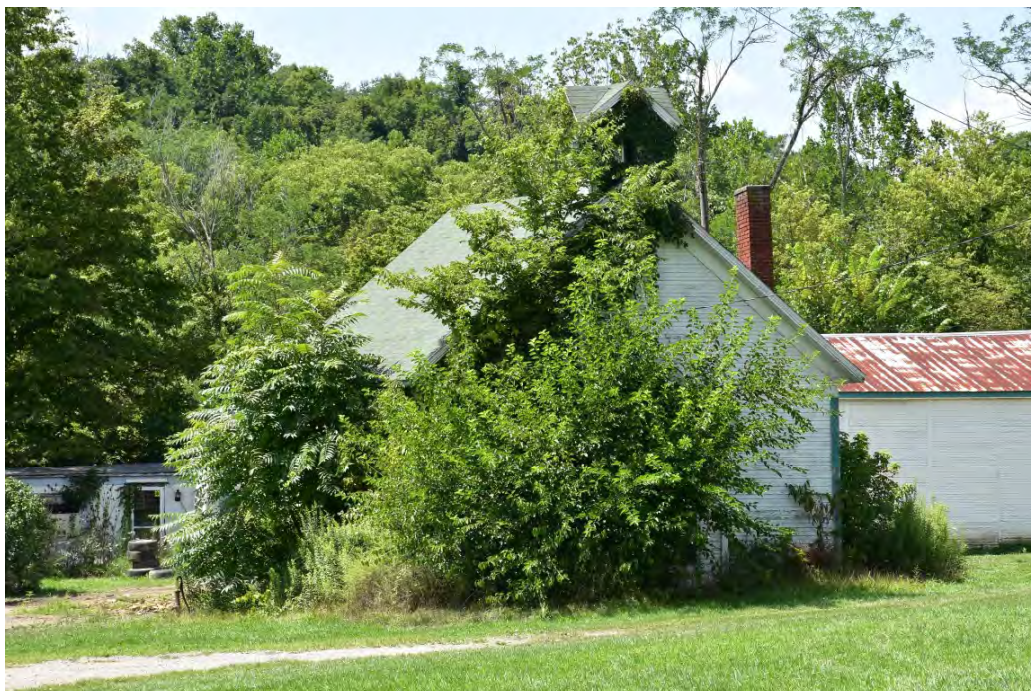
Figure 26. Fruitdale School, facing northwest.

Located at 11319-23 W. SR 41, the Fruitdale School is a former one-room school measuring one bay wide by three bays long (Figure 26). The school building is on an individual parcel, but the surrounding parcels have the same owners with a house, garage, and shed on those properties. The one-story, wood frame former school was largely obscured by vegetation at the time of the site visit. However, the exterior appears to be surfaced with novelty board siding detailed with corner boards. The front-facing gable roof is surfaced with composition shingles, and topped by a lantern with a bell. A brick chimney anchors the north wall. Wood windows remain but are broken, while the front entrance was obscured. In fair to poor condition, the original design appears to remain intact with no additions.

The Fruitdale School is one of the few remaining non-residential landmarks in the rural community. It retains the classic wood frame schoolhouse form exhibiting vernacular building traditions. Although largely obscured by vegetation, the school appears to retain integrity of location, design, setting, materials, workmanship, and feeling. It is recommended as potentially NRHP eligible under Criterion A as locally significant for Education and under Criterion C under Architecture as it is one of the few intact one-room schoolhouses in the township.

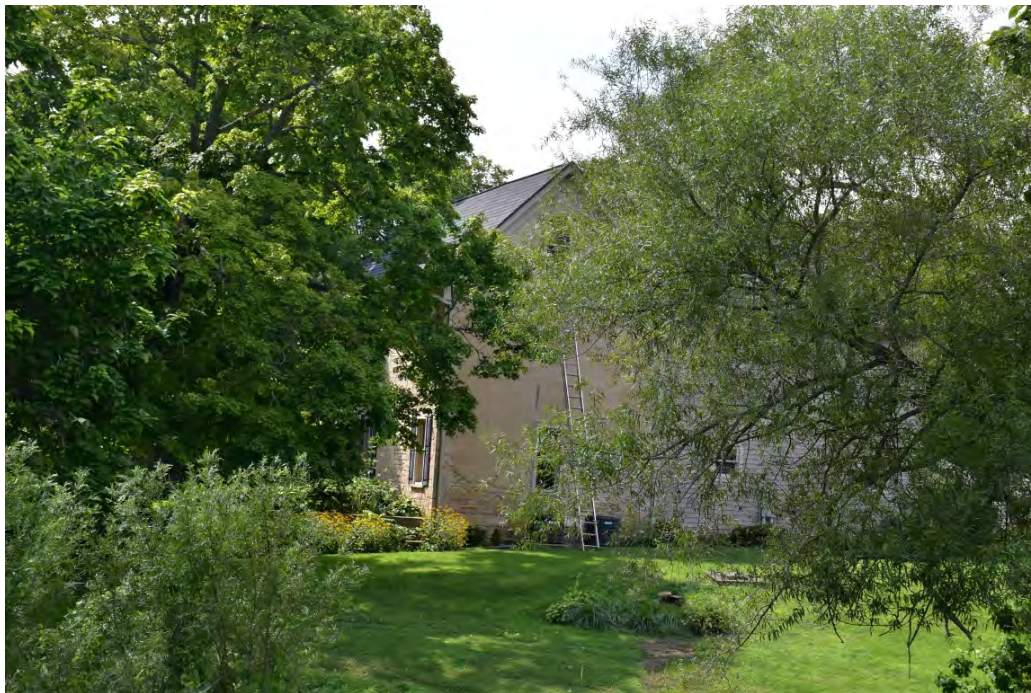
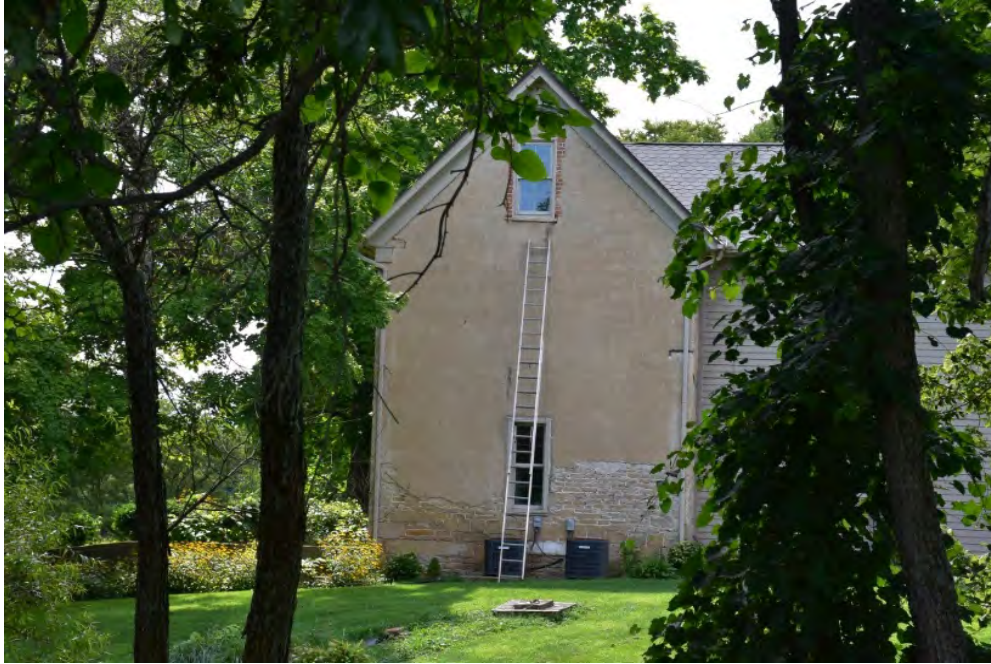
Figure 29. Irwin House, facing west.

Heavily obscured by vegetation limiting visibility from the right-of-way, the two-and-one-half-story Irwin House displays early stone construction indicative of the mid-nineteenth century (Figure 29 and Figure 30). The form is a three-bay long by one-bay wide I-House with a two-story rear wing. Constructed of coursed stone, stucco was applied over some of the stone. Indicative of the Federal style, the building has a symmetrical façade with one-over-one double-hung sash windows flanked by shutters and a classically inspired entrance (Figure 31). The side-gable roof is clad in slate. It appears that the entire building is undergoing restoration with the removal of applied vinyl siding; at present, the siding remains on the rear wing which appears to be an original wing or early addition. The Ross County Auditor indicates that outbuildings include a detached 2007 three-car garage and a hog house.

Figure 30. Irwin House, facing west.

This property appears potentially eligible for listing in the NRHP under Criterion C in the area of Architecture as an example of a rural Ohio stone vernacular I-house with Federal-style elements. In good condition, the building appears to largely retain integrity of location, design, setting, materials, workmanship, and feeling.

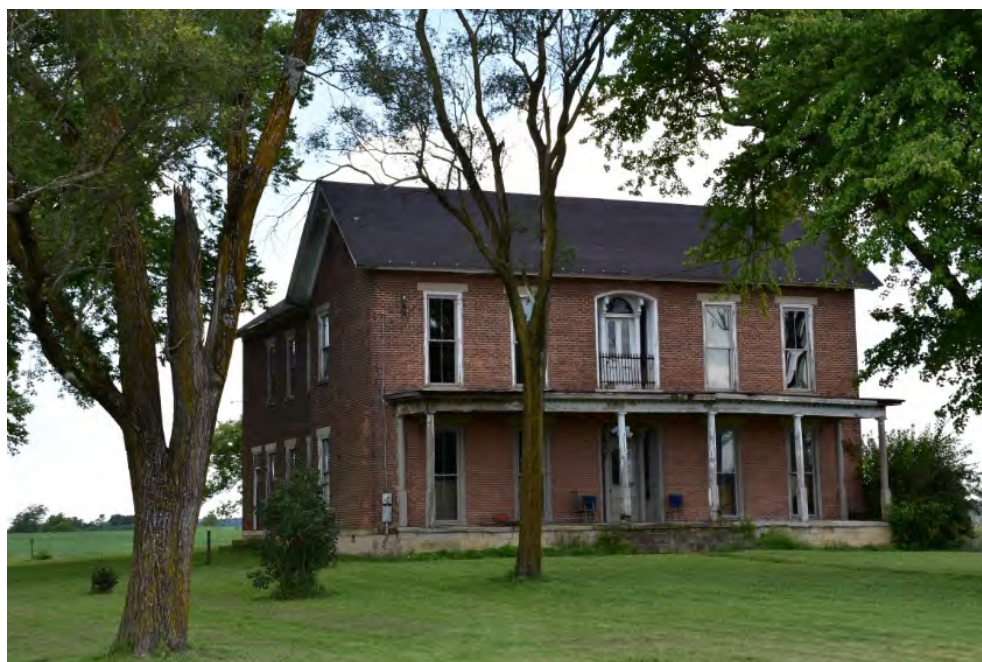
Figure 32. David S. Coyner House, facing northeast.

Located at 2687 SR 28, this three acre property has a residence which exhibits the classic I-house form with a rear wing extending north along the west elevation (Figure 32). Constructed of brick set in a common bond pattern, the house has a symmetrical five-bay wide façade with a one-story full width front porch. The main roof of the structure is side-gabled surfaced in composition shingles, and the building rests on a stone foundation. Italianate accents include narrow, two-over-two windows with stone lintels and elaborate inset entrances centrally located on the first and second floor. These entrances are set in segmental arches with crowns and feature doors with two arched lights set above two panels. A fanlight

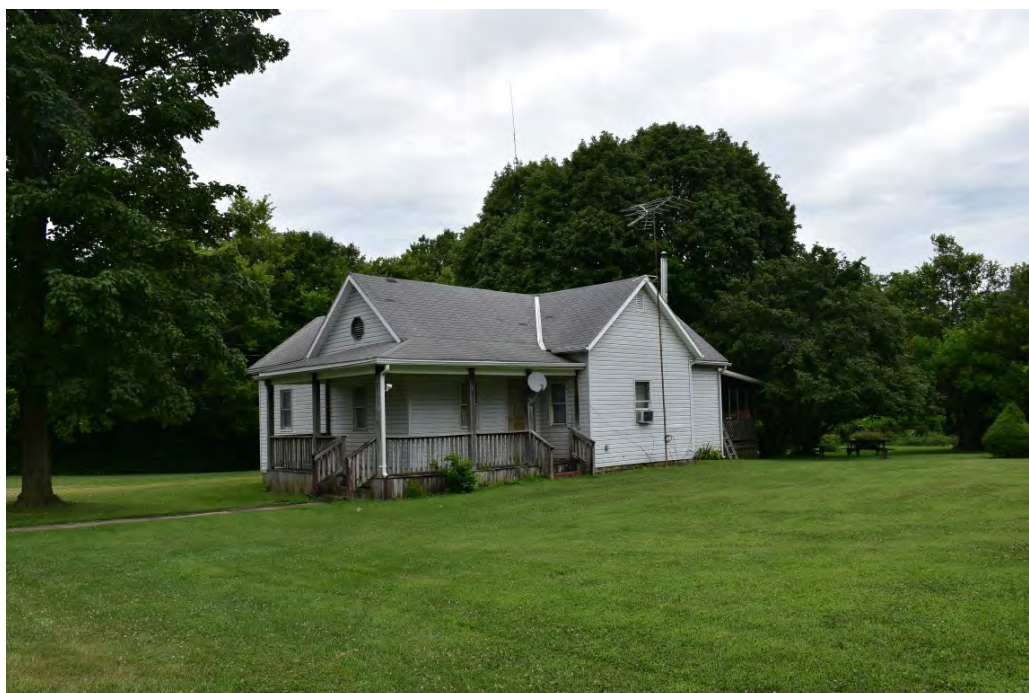
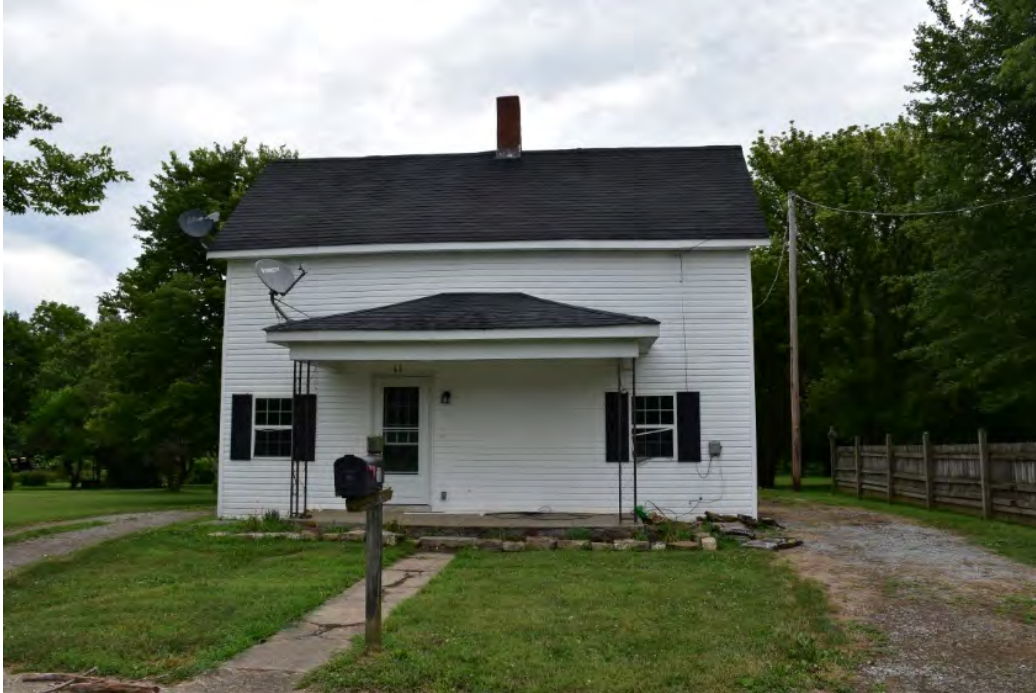
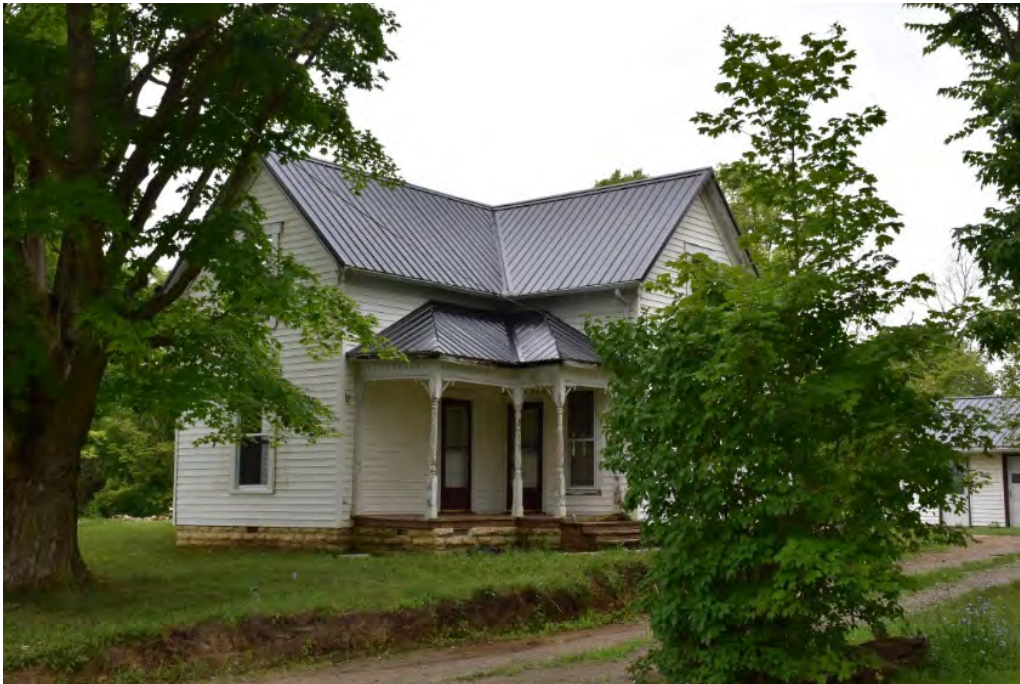
Figure 33. Resource 27, facing northeast.

There are twelve resources in the community of Thrifton within the APE (Resources 7, 24, 25, 26, 27, 28, 29, 30, 31, 32, 36, and 37) (Figure 33, Figure 34, and Figure 35). As a small late-nineteenth century community, Thrifton represents the development that occurred with the arrival of the railroad. The settlement developed due to its proximity to the transportation opportunities and construction jobs offered by the railroad; however, many such towns existed throughout the state of Ohio and it is not significant under Criterion A. The town is associated with Samuel DeVoss, a locally prominent farmer and lumberman; however, his farmstead has a more direct association with him. Therefore, the community is not significant under Criterion B. The architecture of Thrifton is vernacular and no distinctive characteristics of a type, period, or method of construction are visible; therefore, it is not eligible under Criterion C. It is unlikely to yield new information important to prehistory or history, and it is not eligible under Criterion D. Although Thrifton represents a small railroad settlement developed by Samuel DeVoss, the hamlet lacks integrity in terms of materials, design, and workmanship since most of the dwellings have had significant alterations. It also does not retain the requisite integrity in terms of the feeling and association of a railroad village. The only aspect of integrity it retains is that it is in its original location. The village of Thrifton does not retain adequate integrity to convey its significance. As such, it is not eligible for the NRHP.

Figure 34. Resource 26, facing northeast.

Figure 35. Resource 31, facing southwest.

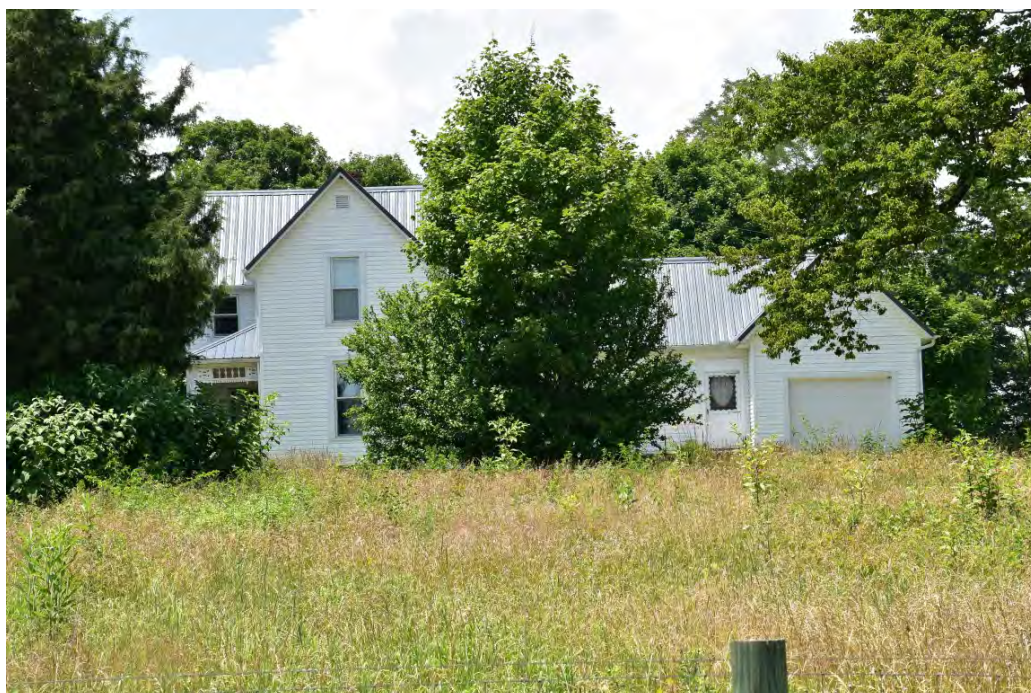
Figure 36. Maple Lane Farm, facing west.

Maple Lane Farm was established on the banks of Paint Creek in 1804 by Robert Wilson. According to the 1875 H.T. Gould Atlas Map the property was owned by A.L. Wilson and continues to serve as Maple Lane Farm today (Gould 1875). The historic house is a two-story Folk Victorian gabled ell with a large garage addition to the north (rear) of the house (Figure 36). When the building was clad with vinyl siding, much of the decorative woodwork was likely removed. The only decorative woodwork which remains is the sawnwork and spindlework on the front corner entry porch. The intersecting gable roof is surfaced with sheet metal, and the windows have been replaced with one-over-one vinyl units. In addition to a new dwelling constructed in 2010, additional buildings on the property include a 1961 barn and a 2014 shed. Although in good condition, the residence has lost integrity of design, materials, and workmanship. Even though it is of historical interest and retains its historical associations, the property lacks integrity and does not appear NRHP eligible.

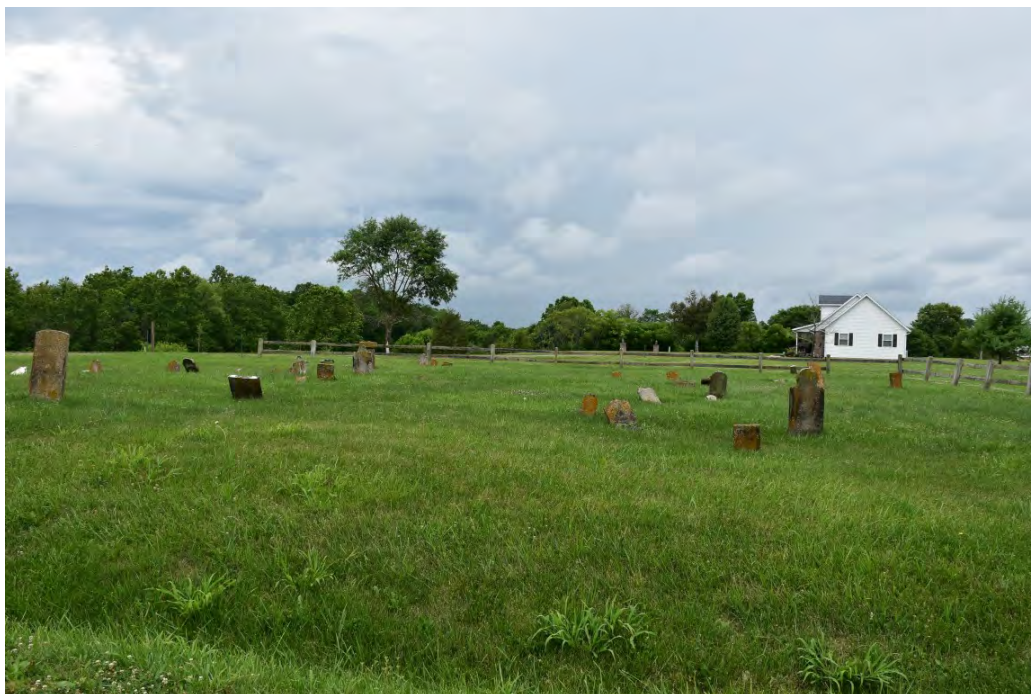
Figure 37. Old Stone Cemetery / Hop Run Cemetery / Milligan Cemetery, facing west.

The Old Stone Cemetery / Hop Run Cemetery / Milligan Cemetery consists of 33 marked graves with death dates ranging from 1821 to 1877 (Figure 37). Incorporating approximately 0.30 acres, there are likely some unmarked graves. Most of the markers are of local “blue rock” granite, but there is little iconography evident on the tombstones. A number of the markers are broken, damaged, or lying flat on the ground with some now illegible (Figure 38). In 1979, local resident H.L. Keepers noted that the cemetery was a “neglected and largely forgotten relic of a much older community,” and that a meeting house once stood on the site as the center of a community called Hop Run (*Chillicothe Gazette* 12 October 1979). Family names found in the cemetery include Bail, Beam, Blain, Caldwell, Cunningham, Greenlee, Johnson, Long, Matthews, McMurry, Milligan, Morrow, Nevin, Robinson, and Scroggs (Find-a-grave.com: Old Stone Cemetery / Hop Run Cemetery / Milligan Cemetery).

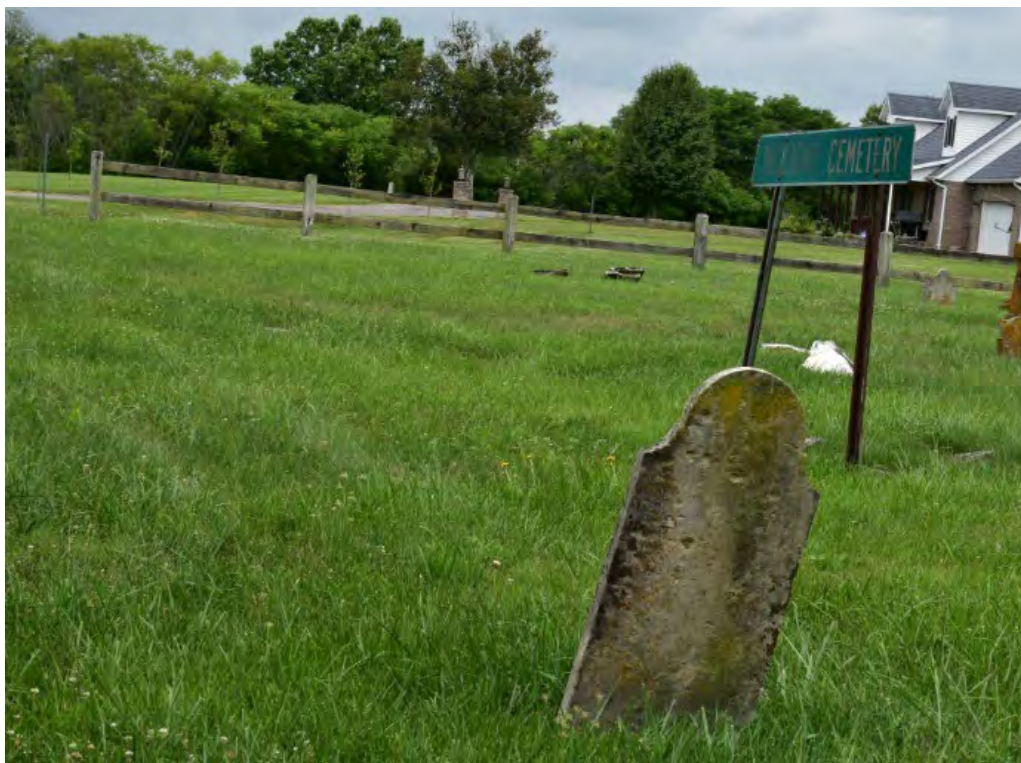
Figure 38. Old Stone Cemetery / Hop Run Cemetery / Milligan Cemetery, facing northwest.

This cemetery retains integrity of location and feeling as it continues to be recognizable as an old graveyard in its original location. Although the overall rural agricultural setting remains intact, the immediate surroundings of this cemetery have been altered by residential development since the 1950s. With the loss of markers and many of those remaining either flat on the ground or leaning, the original layout is no longer identifiable. The further damage and illegibility of the markers impacts the integrity of workmanship and materials. The majority are modest gravestones with little or no iconography exhibiting a common design. Although the cemetery retains the feeling of a rural cemetery, its identity and feeling as a community or family cemetery was lost with the subdivision of land and new construction in the area.

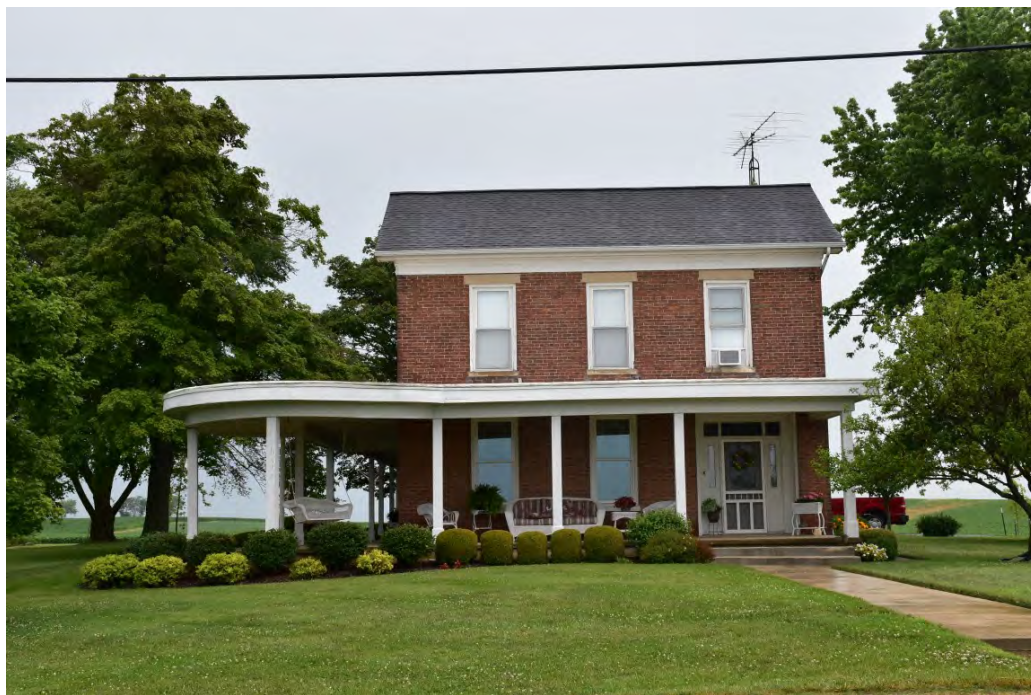
Figure 39. Isaac James Residence, facing north.

The Isaac James Residence is a two-story side hallway vernacular design likely originally constructed in the Federal style (Figure 39). Of brick construction, the building has a side-gable roof surfaced with composition shingles. The façade is largely symmetrical with the windows and entrances lining up to create a three bay wide elevation. The original two-story block of the building is only one bay deep, but a large addition extends to the north along the west elevation. A curved one-story wrap-around porch inspired by the Queen Anne Free Classic design was added ca.1910. Original windows have been replaced with one-over-one vinyl windows which are topped with stone lintels. The classically inspired entrance has a three-light transom and one-light sidelights. Outbuildings include two sheds. The 1875 H.T. Gould Atlas indicated that this property was owned by farmer Isaac James, who lived at the same location as early as 1850 (Gould 1875; Ancestry.com 2009a). Although this residence is representative of early construction in the area, the replacement of the original windows and the addition of the wrap-around porch have diminished its integrity to the point that it no longer is a good representative of the Federal style. With the limited historical significance evidenced in the available information, it does not appear NRHP eligible.

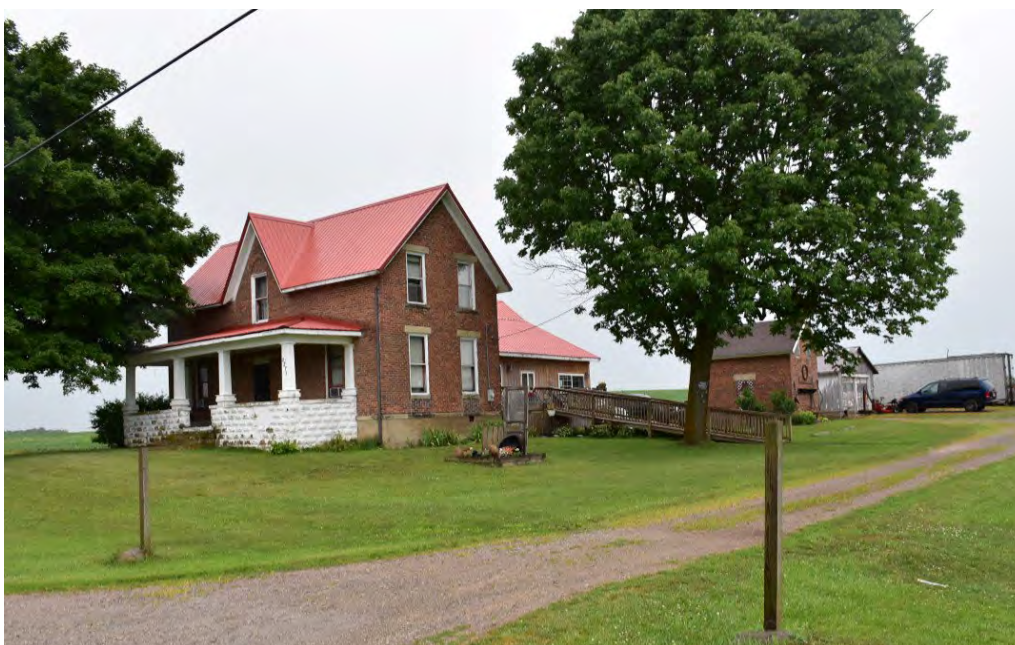
Figure 40. Henry C. Parrett Residence, facing northwest.

Originally constructed in the Gothic Revival style, this one-and-one-half-story brick residence is three bays wide by two bays deep (Figure 40). A large wood frame addition extends from the rear elevation. Notable Gothic elements include a steeply pitched side-gabled roof with a front central gable surfaced with sheet metal. The one-over-one double-hung sash window in the central gable is topped by a blind Gothic arch in the gable end. The remaining windows are independently placed one-over-one double-hung sash with stone lintels. The building rests on a stone foundation. A Craftsman inspired front porch constructed of rusticated concrete block with battered wood columns was added across almost the full width of the façade ca. 1910. Outbuildings include a brick smokehouse and a wood frame garage. The 1875 H.T. Gould Atlas indicated that this residence was occupied by farmer Henry C. Parrett, a long-time resident of the area (Gould 1875; Ancestry.com 2009a). The construction of the Craftsman inspired porch across the façade destroyed the design of the Gothic Revival brick cottage. Further, the wood frame rear addition is not compatible with the design of the house. Therefore, this house is no longer a good example of the Gothic Revival style and with limited historical significance, it does not appear NRHP eligible.
