Ross County Solar

Phase 1 History Architecture Reconnaissance Survey

Case No. 20-1380-EL-BGN

Phase I History Architecture Reconnaissance Survey

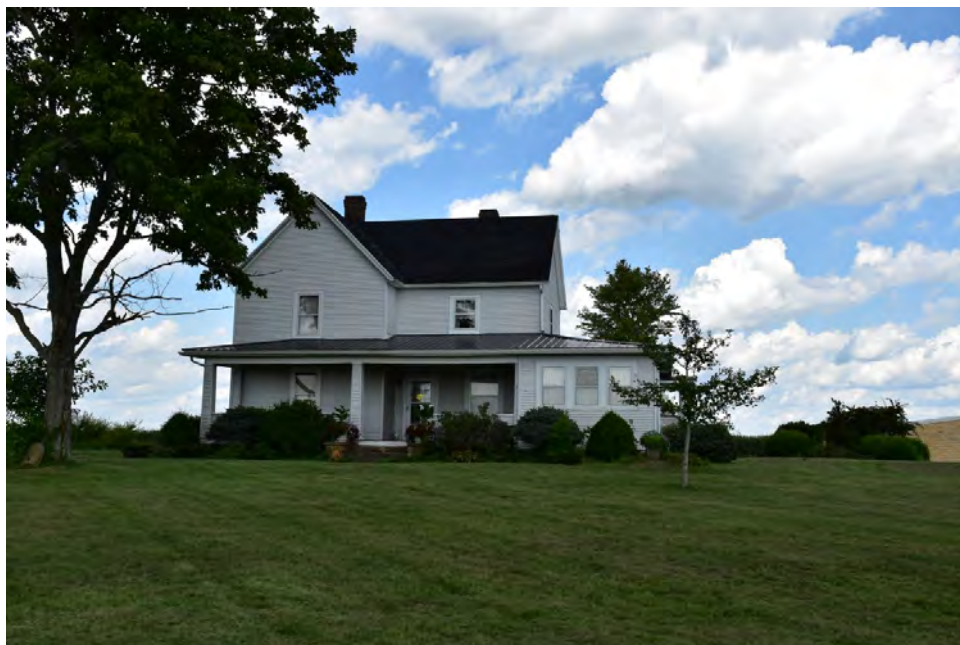
Figure 41. Moon Residence, facing east.

This gabled ell residence has an intersecting gable roof surfaced with composition shingles pierced by interior brick chimneys with corbeled tops (Figure 41). The building is clad with vinyl siding and has replacement vinyl windows. The front porch, which wrapped around the south elevation has been partially enclosed. The columns on the portion which remains open have been wrapped with vinyl siding. The front door was obscured behind a storm door. An addition to the rear extends to the east. Outbuildings include a 1970 barn, metal silo, workshop, and shed, most of which do not appear historic. The H.T. Gould Atlas indicated that this residence and property was owned by the Moon heirs in 1875 (Gould 1875). The limited research available did not indicate any significant historical associations with either events or persons. While the house is a typical gabled ell in rural Ohio, the house has suffered a loss of integrity due to numerous alterations, including vinyl siding, vinyl windows, and the partial enclosure of the front porch. These alterations denigrate the integrity of design, materials, workmanship, association, and materials. Although the house retains integrity of location and setting with an overall historic feeling, it has poor overall integrity. As such, it is recommended not eligible for the NRHP.

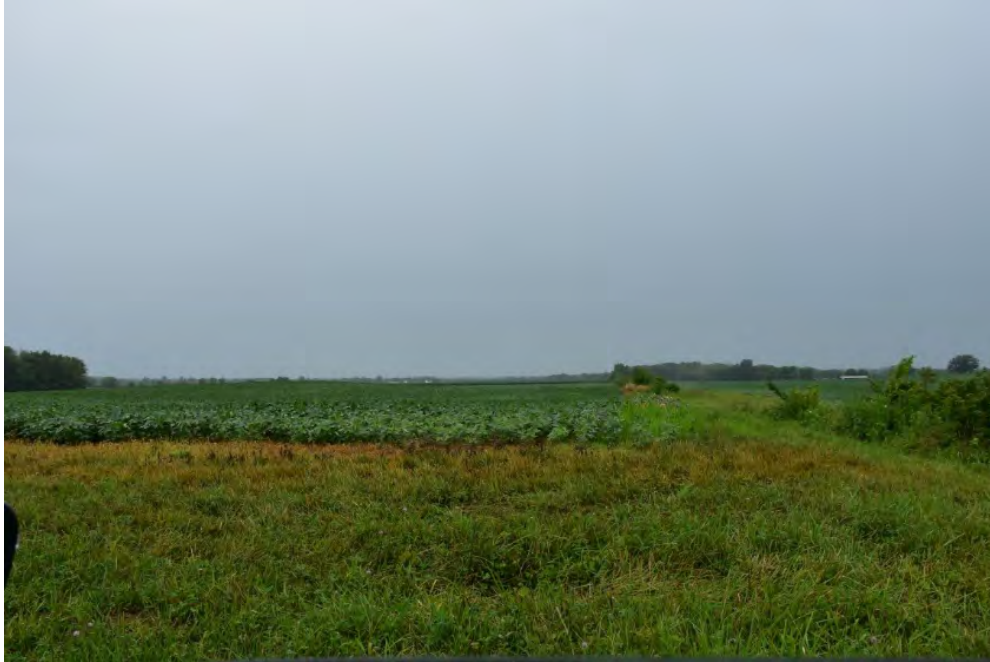
Figure 42. Looking southwest from the former Baltimore and Ohio Southwestern Railroad right-of-way from south of Resource 56 (Fairview Farm / Thomas Murray House) and Resource 73 (David S. Coyner House) toward the project area.

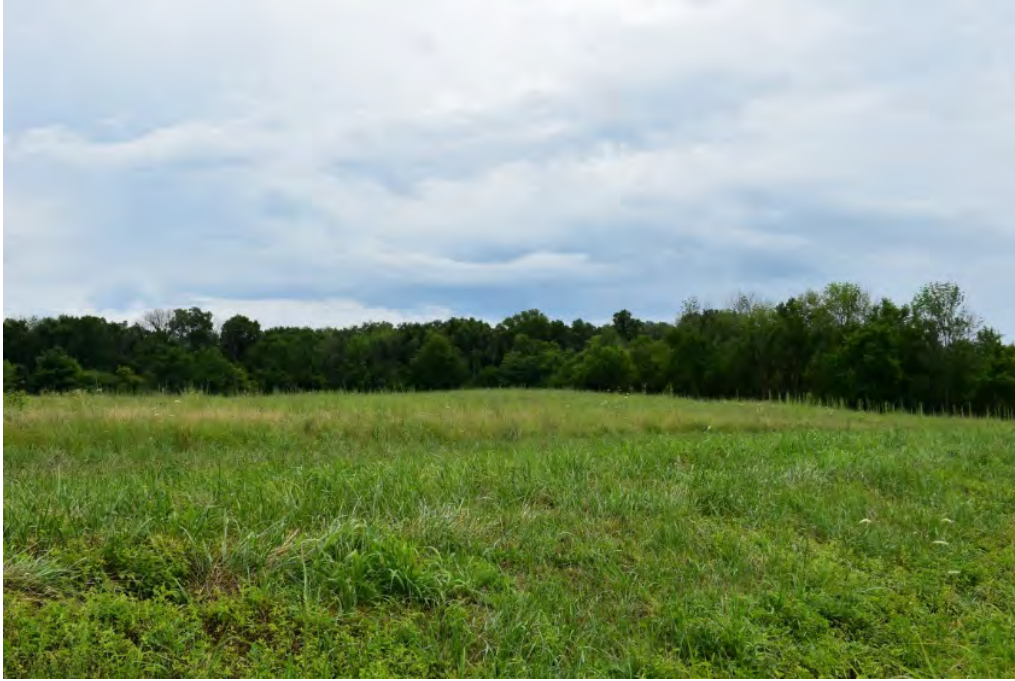
Figure 43. Looking south-southeast from the 1/2 mile radius from just north of Resource 5 (DT&I Railroad Bridge over Thrifton Road) toward the project area.

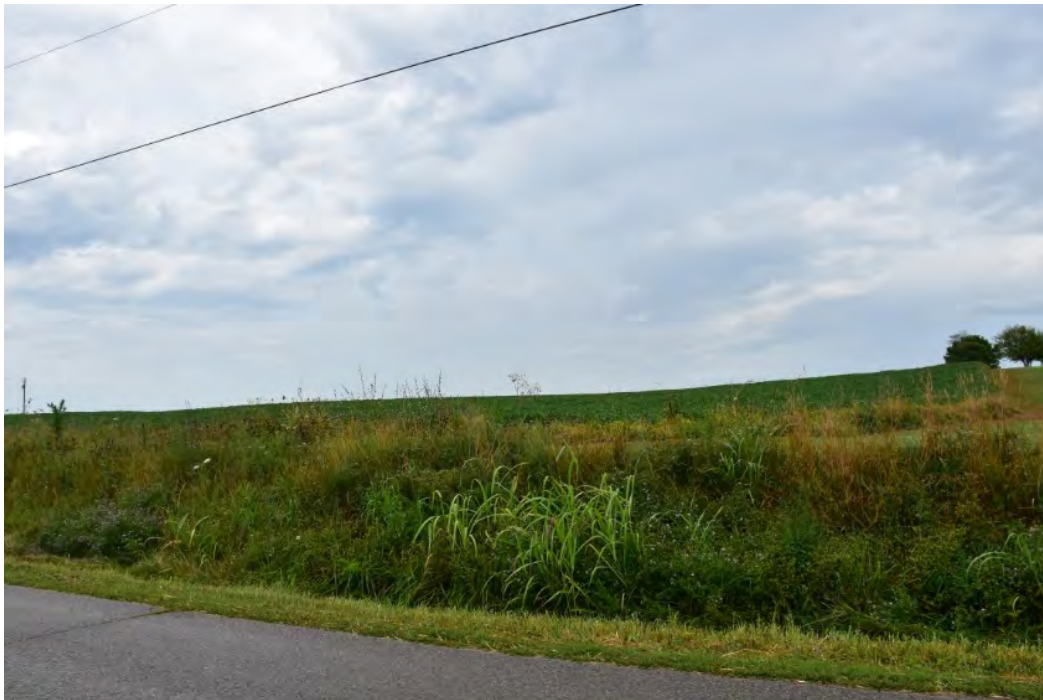
Figure 44. Looking northeast from the 1/2 mile radius toward the project area.

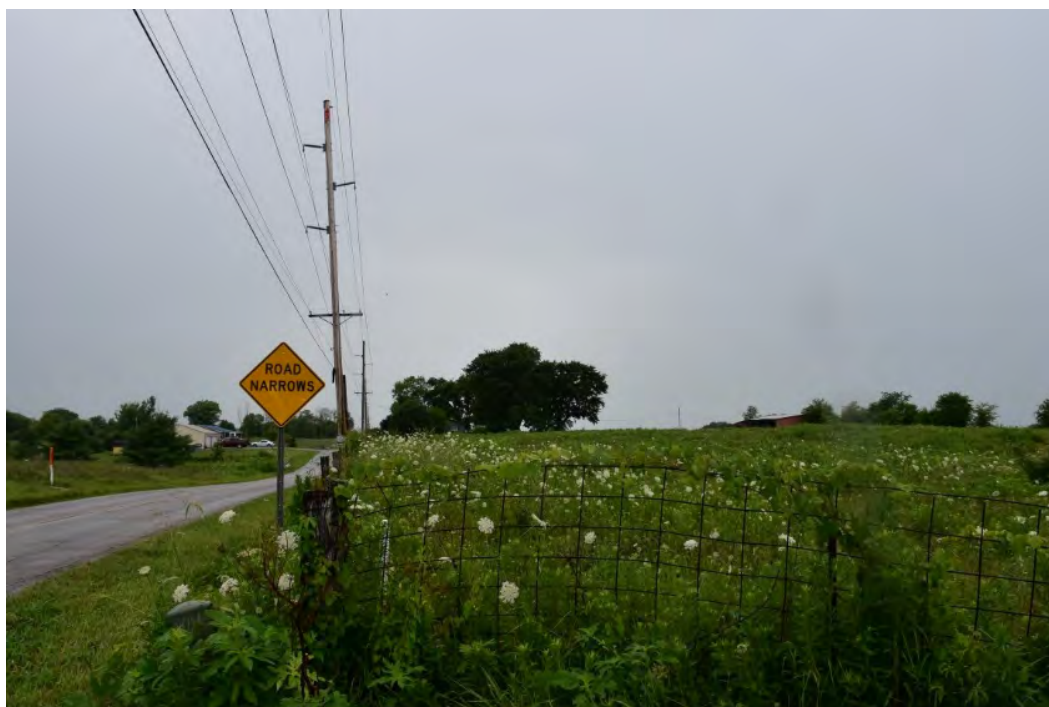
Figure 45. Looking west from the 1/2 mile radius from northwest of Resource 67 (Irwin House) toward the project area.

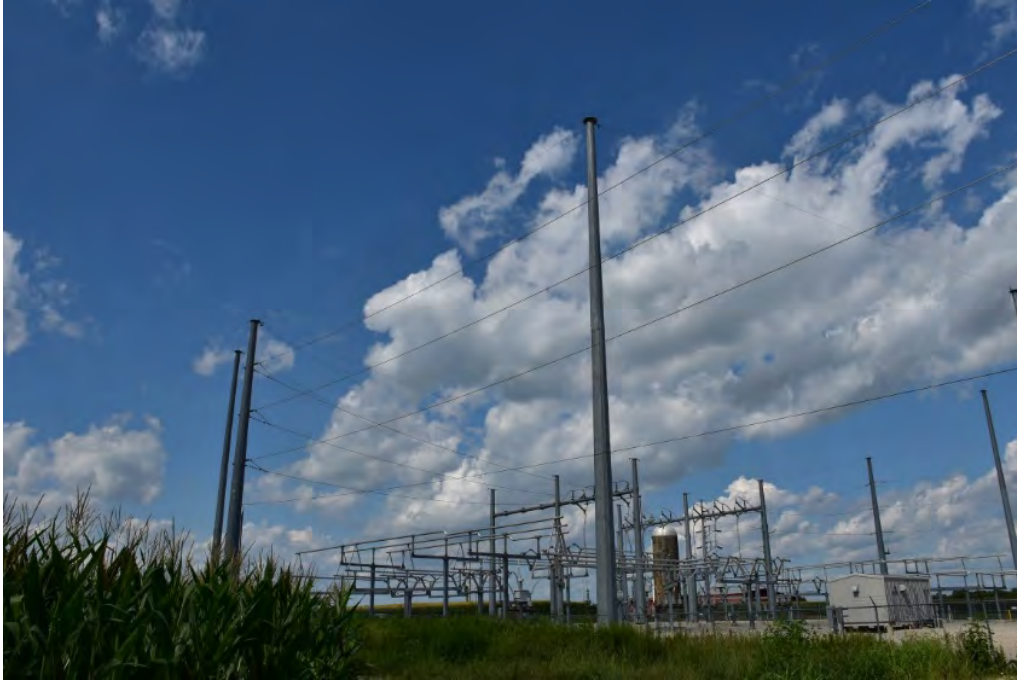
The topography and vegetation associated with the Paint Creek and Buckskin Creek valleys play a significant role in reducing visibility of the potential PV array within the viewshed (EDR 2020) (Figure 47). The proposed project includes a maximum solar panel height of 15 feet sited in the project area. The viewshed analysis indicates the PV panels may have high visibility to the northeast at the 1/2 mile to 2.5-mile range. The adjacent and surrounding fields would continue to be cultivated. The proposed substation's tallest components consist of narrow lightning masts, with a maximum height of 65 feet. The masts would be visible northeast of the project area at a distance of 2.5 miles (Figure 48). Existing 100-foot transmission lines are visible in the area along Lower Twin Road (Figure 45). New metal poles have been installed at the substation associated with the project area (Figure 46).

Figure 46. Overview of new metal tower poles and the substation associated with the project area looking north-northeast.

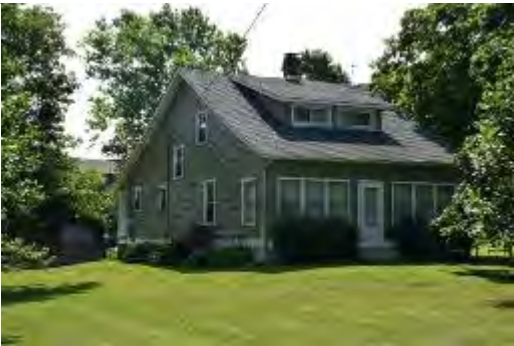
6496 Rapid Forge Road/ 201004009000	Farmstead: one-and-one-half-story Bungalow with front shed dormer, enclosed porch, vinyl siding, and replacement windows; gambrel roofed dairy barn; ruinous poultry house	ca. 1928	Good	X Location <input type="checkbox"/> Workmanship X Design <input type="checkbox"/> Feeling X Setting <input type="checkbox"/> Association <input type="checkbox"/> Materials Vinyl siding and vinyl windows, parged concrete foundation, enclosed porch	Recommended not eligible, due to a lack of significance and integrity
	NA

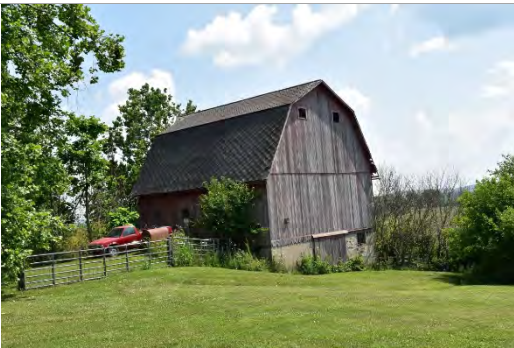
Gambrel roofed Wisconsin dairy barn; deteriorated poultry house	ca. 1928	Good	X Location X Workmanship X Design X Feeling X Setting <input type="checkbox"/> Association X Materials Poultry house has caved-in roof

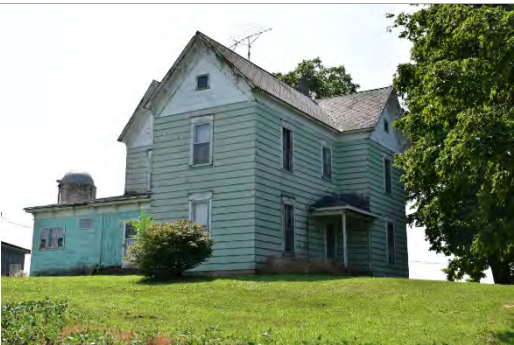
J.S. Evans House / 6672 Rapid Forge Road/ 201004013000	Farmstead: Two-story, gabled ell house with asbestos shingle siding, stone foundation, and original two-over-two wood windows, rear addition	ca. 1870	Fair	X Location <input type="checkbox"/> Workmanship X Design X Feeling X Setting <input type="checkbox"/> Association <input type="checkbox"/> Materials Asbestos shingle siding, rear additions	Recommended not eligible, due to a lack of significance and integrity
	NA

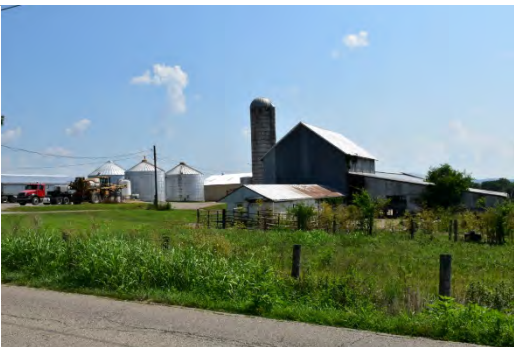
Five outbuildings including 1940 shed, and 1969 milk house, three metal silos and one concrete stave silo	ca. 1940s-1980s		X Location X Workmanship X Design X Feeling X Setting <input type="checkbox"/> Association X Materials Several new large outbuildings intermixed with historic

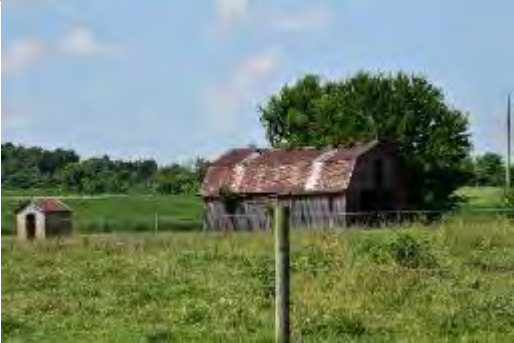
6459 Rapid Forge Road/ 201004017000	Outbuildings: Historic house demolished; County auditor lists seven outbuildings including 1969 shed, shed, hog house, shed, 1940 garage, 1945 granary	ca. 1940s, 1960s	Deteriorated	X Location <input type="checkbox"/> Workmanship <input type="checkbox"/> Design <input type="checkbox"/> Feeling X Setting <input type="checkbox"/> Association <input type="checkbox"/> Materials Historic house recently demolished	Recommended not eligible, due to a lack of significance and integrity
4	NA

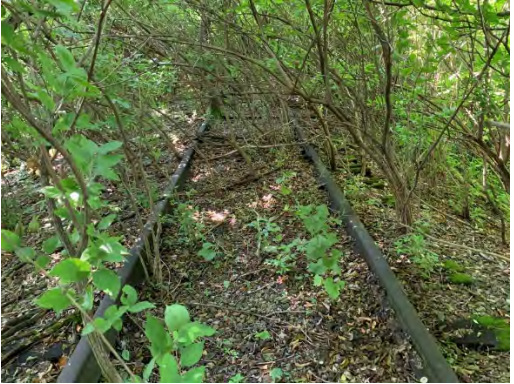
Detroit Toledo and Ironton Railroad	Intact rail and bed of abandoned railroad line	ca. 1887	Deteriorated	X Location <input type="checkbox"/> Workmanship <input type="checkbox"/> Design <input type="checkbox"/> Feeling X Setting <input type="checkbox"/> Association <input type="checkbox"/> Materials Abandoned, overgrown	Recommended not eligible, due to a lack of significance and integrity

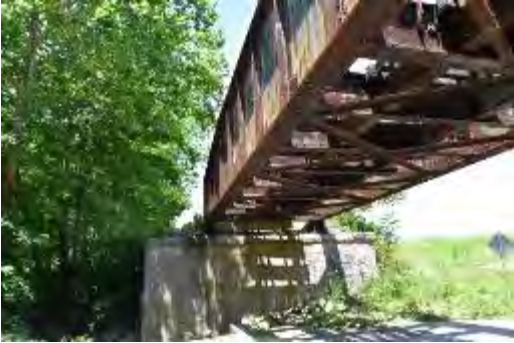
Detroit Toledo and Ironton Railroad Bridge over Thrifton Road (7130244); 0.31 miles north of Rapid Forge Road	Bridge: Steel through plate girder	1925	Fair	X Location X Workmanship X Design X Feeling X Setting X Association X Materials	Recommended potentially eligible under Criteria A and C
6	NA

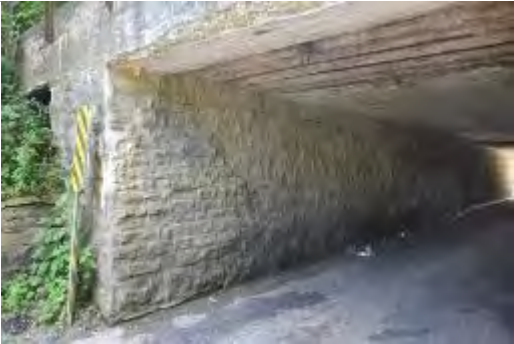
Baltimore and Ohio Southwestern Railroad overpass above Thrifton Road (7130228)	Overpass: Concrete slab	1906	Good	X Location <input type="checkbox"/> Workmanship X Design X Feeling X Setting X Association <input type="checkbox"/> Materials Portion rebuilt	Recommended not eligible, due to a lack of significance and integrity

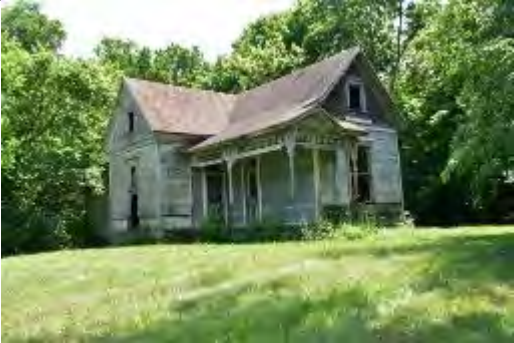
122 Thrifton Road / 021211017000	House: Folk Victorian one-story gabled ell surfaced with shaped wood shingles and novelty board siding with decorative sawnwork and spindlework on front porch	ca. 1890	Poor	X Location X Workmanship X Design X Feeling X Setting <input type="checkbox"/> Association <input type="checkbox"/> Materials Missing windows and doors, open to the elements	Recommended not eligible, due to a lack of significance and integrity.
8	NA

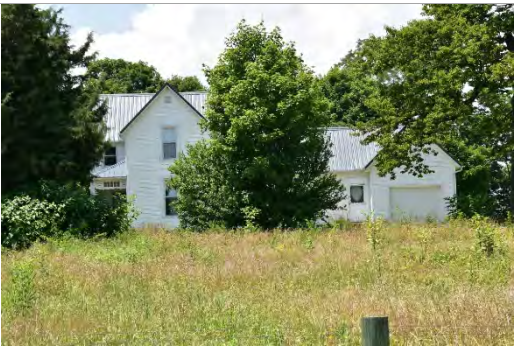
Maple Lane Farm / 7357 Rapid Forge Road/ 021211004000 Maple Lane Farm was established on banks of Paint Creek in 1804 by Robert Wilson; Property owned by A.L. Wilson in 1875.	Farmstead: Folk. Victorian two-story gabled ell clad with vinyl siding, replacement windows, decorative sawnwork and spindlework on front porch, County auditor lists a 2010 dwelling on the property as well as a 1961 barn and a 2014 shed	ca. 1880	Good	X Location <input type="checkbox"/> Workmanship <input type="checkbox"/> Design X Feeling X Setting X Association <input type="checkbox"/> Materials Replacement windows and siding, large garage addition to rear	Recommended not eligible, due to a lack of significance and integrity

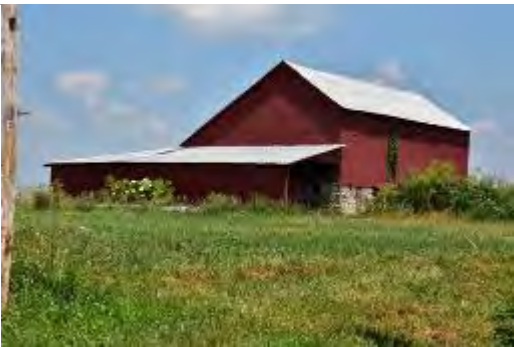
County auditor lists a 2010 dwelling on the property as well as a 1961 barn and a 2014 shed, which are set at a distance from the historic house.	ca. 1960s-2010s	Good	X Location X Workmanship X Design X Feeling X Setting <input type="checkbox"/> Association X Materials	
9	NA

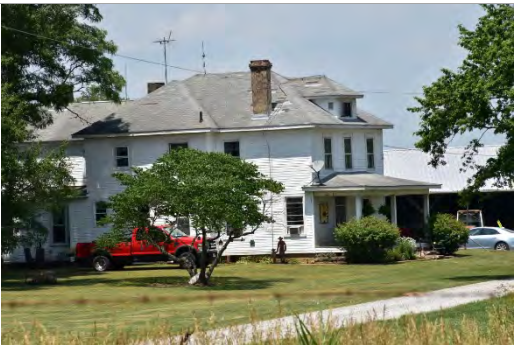
669 Rolfe Road/ 201004010000	Farmstead: American Foursquare two-story clad with vinyl siding, replacement windows, topped by pyramidal roof with hipped dormer, large addition; Gambrel roof barn, metal pole barn, two metal silos	ca. 1920 to 1960s	Good	X Location <input type="checkbox"/> Workmanship X Design X Feeling X Setting <input type="checkbox"/> Association <input type="checkbox"/> Materials	Recommended not eligible, due to a lack of significance and integrity

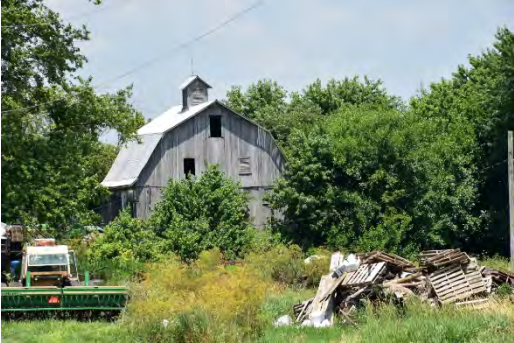
Wisconsin dairy barn with gambrel roof, metal pole barn, two metal silos; historic aerials indicate a number of outbuildings have been demolished	ca. 1920 to 2000s	Good	X Location X Workmanship X Design X Feeling X Setting <input type="checkbox"/> Association X Materials Gambrel-roofed barn appears to retain integrity, but most outbuildings in ruins or replaced with new construction	
10	NA

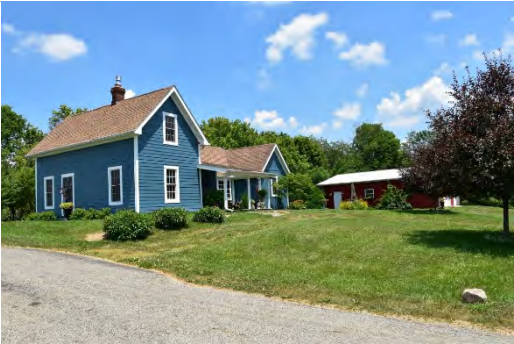
1234 Rolfe Road/201003042000	House: Vernacular one-and-one-half-story, central chimney with corbelled brick chimney, clapboard siding, original six-over-six wood double-hung sash windows, and a ca. 2005 rear addition; Modern two-car garage to rear	ca. 1904	Good	X Location X Workmanship <input type="checkbox"/> Design <input type="checkbox"/> Feeling X Setting <input type="checkbox"/> Association X Materials Rear addition	Recommended not eligible, due to a lack of significance and integrity

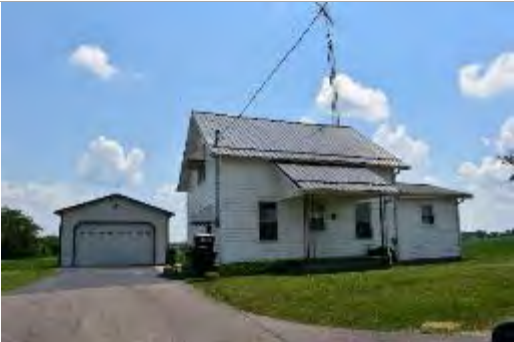
1392 Lower Twin Road/021212089000	House: Vernacular one-and-one-half story house with vinyl siding, original wood double-hung sash windows, replacement porches, and an addition on the side elevation; ca. 2000 detached garage	ca. 1940	Good	X Location <input type="checkbox"/> Workmanship <input type="checkbox"/> Design <input type="checkbox"/> Feeling X Setting <input type="checkbox"/> Association <input type="checkbox"/> Materials Vinyl siding, attached side elevation addition, replacement porches	Recommended not eligible, due to a lack of significance and integrity
12	NA

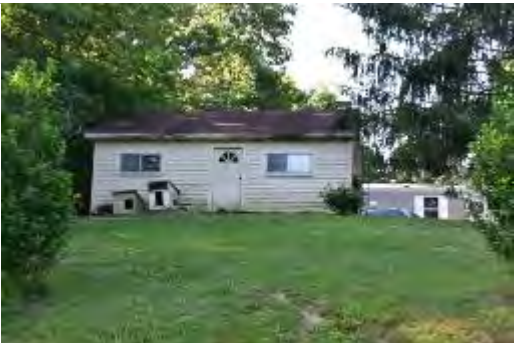
798 Moxley Road/201003046000	House/Garage: Vernacular one-story house with gable roof and wood siding converted to garage with 1989 modular house on property	ca. 1955	Fair	X Location <input type="checkbox"/> Workmanship <input type="checkbox"/> Design <input type="checkbox"/> Feeling X Setting <input type="checkbox"/> Association <input type="checkbox"/> Materials Multiple alterations to convert historic house to garage when modular home added to site	Recommended not eligible, due to a lack of significance and integrity

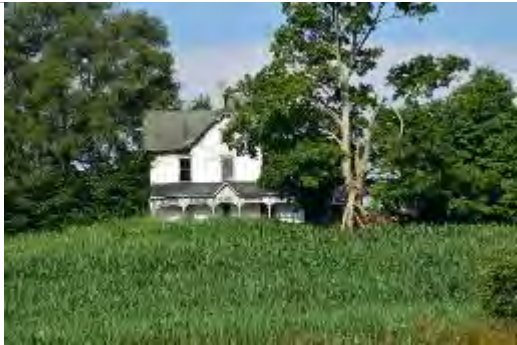
J.W. Baird Farm / 11765 SR 41 / 201003043000	Farmstead: Folk Victorian two-story side-gabled roof with a prominent central cross gable. House has Gothic Revival accents with wood siding, one-over-one wood double-hung sash windows, a decorative vergeboard, and sawnwork and spindlework on porch; County auditor lists seven outbuildings including a large traverse frame barn and granary	ca. 1853	Fair	X Location	X Workmanship	Recommended potentially eligible under Criterion C
							X Design	X Feeling	
							X Setting	<input type="checkbox"/> Association	
							X Materials

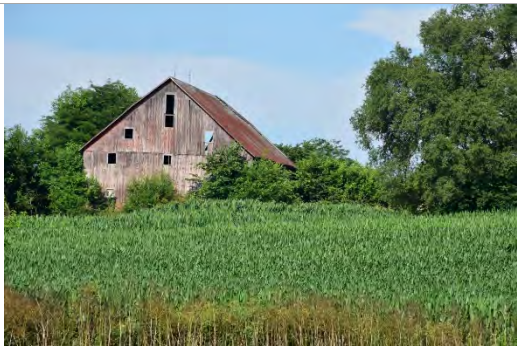
County auditor lists seven outbuildings including a large traverse frame barn and granary; four barns and two silos are evident on aerials but not from the right-of-way	ca.1900	Deteriorated	X Location	X Workmanship

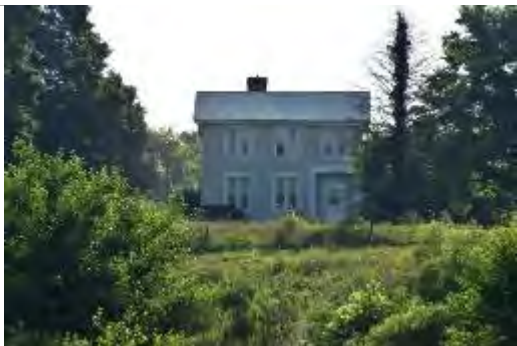
11904 SR 41 S/ 2001003036000	Farmstead: two-story vernacular form with a side gable roof, vinyl siding, replacement windows, a partially enclosed entrance, and addition to rear; five outbuildings including 1935 shed, shed, 1978 shed, tile silo, and 1978 shed	ca. 1915-1945	Good	X Location	<input type="checkbox"/> Workmanship	Recommended not eligible, due to a lack of significance and integrity
							<input type="checkbox"/> Design	<input type="checkbox"/> Feeling	
							X Setting	<input type="checkbox"/> Association	
							<input type="checkbox"/> Materials	Large addition to rear, vinyl siding, replacement windows	
15	NA

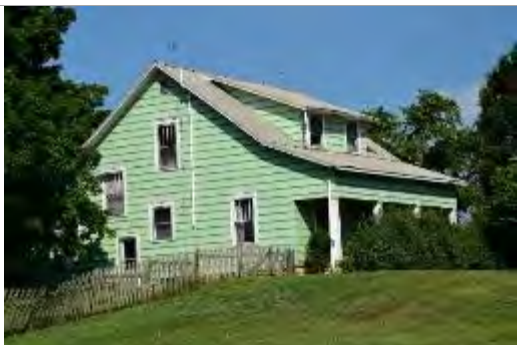
12489 SR 41/021212025000	House: Bungalow one-and-one-half story with shed dormer on front, aluminum siding, three-over-one double-hung sash windows; 1950 gambrel roof barn, garage and shed	ca. 1924-1950s, 2000	Good	X Location	X Workmanship	Recommended not eligible, due to a lack of significance and integrity

X Design	<input type="checkbox"/> Feeling	
							X Setting	<input type="checkbox"/> Association	
							<input type="checkbox"/> Materials	Aluminum siding, some replacement windows

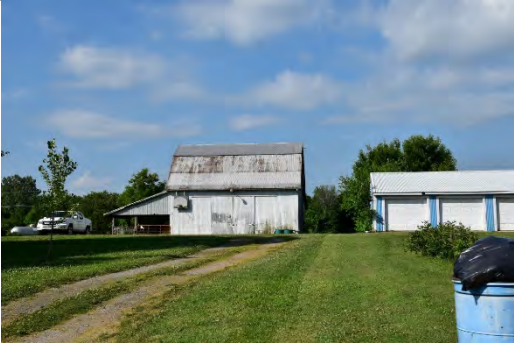
Gambrel roof barn, garage and shed	ca.1950, 2000	Good	X Location X Workmanship X Design X Feeling X Setting <input type="checkbox"/> Association X Materials Barn retains good integrity, but garage and shed are new	
16	NA

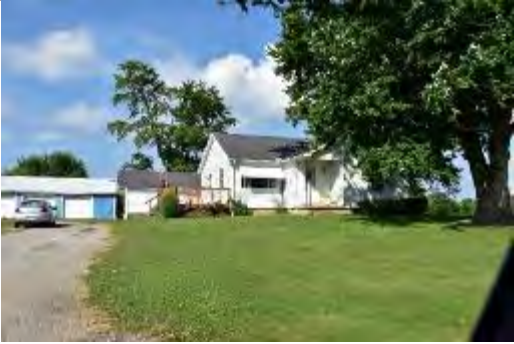
12517 SR 41 / 021212026000	House: Minimal Traditional style house with vinyl siding, intersecting gable roof, one-over-one windows, altered porch, and a deck addition; 1979 garage	ca. 1940, 1979	Good	X Location <input type="checkbox"/> Workmanship <input type="checkbox"/> Design <input type="checkbox"/> Feeling X Setting <input type="checkbox"/> Association <input type="checkbox"/> Materials Vinyl siding, some replacement windows, altered porch, deck addition	Recommended not eligible, due to a lack of significance and integrity

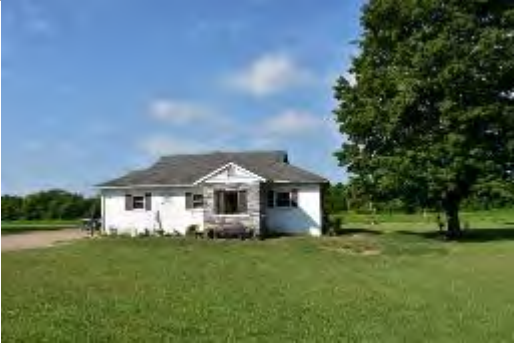
12551 SR 41 / 021212028000	House: Vernacular masonry one-story house with stucco and simulated stone siding, a gable on hip roof, and one-over-one windows; 1974 garage	ca. 1953, 1974	Good	X Location X Workmanship X Design <input type="checkbox"/> Feeling X Setting <input type="checkbox"/> Association X Materials Some replacement windows, siding	Recommended not eligible, due to a lack of significance and integrity
18	NA

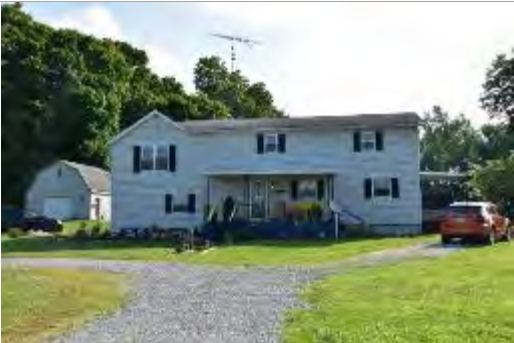
12576 SR 41 / 021212029000	House: Vernacular two-story house with intersecting gable roof, vinyl siding, and replacement windows; garage and shed	ca. 1953, 1956	Good	X Location <input type="checkbox"/> Workmanship <input type="checkbox"/> Design <input type="checkbox"/> Feeling X Setting <input type="checkbox"/> Association <input type="checkbox"/> Materials Vinyl siding, vinyl windows, addition	Recommended not eligible, due to a lack of significance and integrity

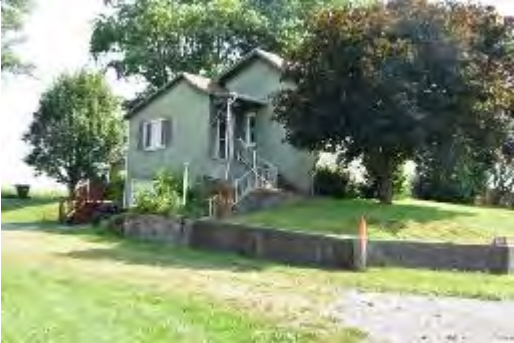
2617 Lower Twin Road/ 021212103000	House: Vernacular masonry house constructed of brick, gable roof, sliding and one-over-one windows, incorporated concrete block walk-out basement garage; modern barn, poultry house, shed	ca. 1945	Fair	X Location <input type="checkbox"/> Workmanship <input type="checkbox"/> Design <input type="checkbox"/> Feeling X Setting <input type="checkbox"/> Association <input type="checkbox"/> Materials Some replacement windows	Recommended not eligible, due to a lack of significance and integrity
20	NA

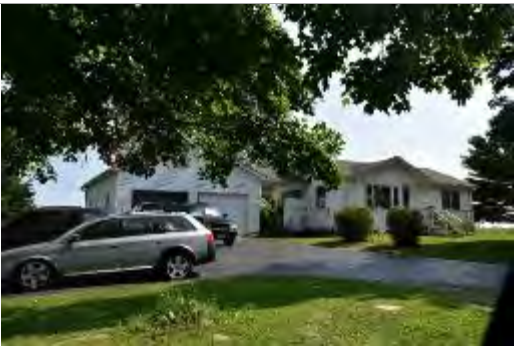
2109 Lower Twin Road/ 021212032000	House: Ranch style house with intersecting gable roof, aluminum siding, picture window, and one-over-one double-hung sash windows; two-car garage attached by breezeway, deck addition on front	ca. 1954	Good	X Location <input type="checkbox"/> Workmanship X Design <input type="checkbox"/> Feeling X Setting <input type="checkbox"/> Association <input type="checkbox"/> Materials Aluminum siding, deck and garage additions	Recommended not eligible, due to a lack of significance and integrity

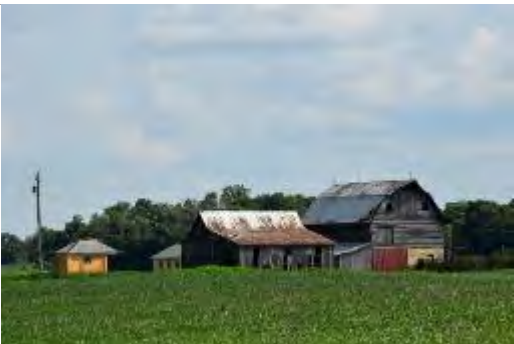
13258 SR 41 / 021212036000	Barns: County auditor lists seven outbuildings which include a large gambrel roof barn, a transverse frame gable roof barn, a milk house, shed, corn crib, and silo	ca. 1950s-1960s	Deteriorated	X Location <input type="checkbox"/> Workmanship <input type="checkbox"/> Design <input type="checkbox"/> Feeling X Setting <input type="checkbox"/> Association <input type="checkbox"/> Materials Associated historic residence demolished in 1990s	Recommended not eligible, due to a lack of significance and integrity
22	NA	 	13553 SR 41 S/ 021212093000	House: Former brick school according to 1917 and 1944 USGS quadrangles, altered with replacement windows, partially enclosed openings, conversion of portion of building to garage; outbuildings from 1990s including pole barn, barn, metal silo, sheds	ca. 1915, 1990s	Good	X Location <input type="checkbox"/> Workmanship <input type="checkbox"/> Design <input type="checkbox"/> Feeling X Setting <input type="checkbox"/> Association <input type="checkbox"/> Materials Extensive alterations to former school to convert to residence with incorporated two-car garage	Recommended not eligible, due to a lack of significance and integrity

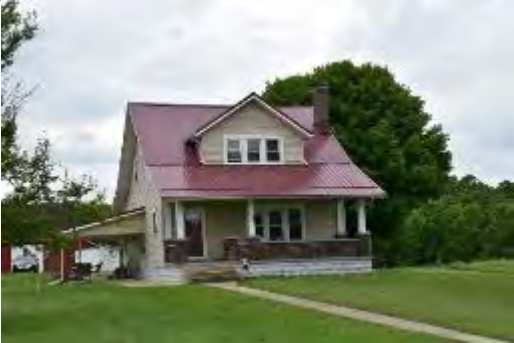
9182 Rapid Forge Road/ 021211011000	House: Bungalow, one-and-one-half-story with side-gable roof, front gabled dormer, vinyl siding, one-over-one double-hung sash windows, and carport addition; outbuildings include privy, barn	ca. 1917	Good	X Location <input type="checkbox"/> Workmanship X Design X Feeling X Setting <input type="checkbox"/> Association <input type="checkbox"/> Materials Vinyl siding, carport addition	Recommended not eligible, due to a lack of significance and integrity
24	NA

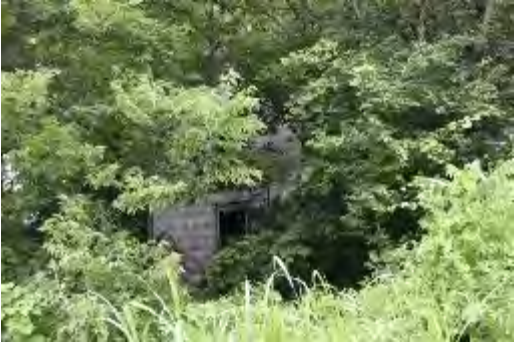
No address, North side of Rapid Forge Road/ 021211021000	House: Vernacular, wood frame house with gable roof, asbestos shingle siding, and one-over-one double-hung sash windows, largely obscured by vegetation; 2010 pole barn	ca. 1915, 2010	Ruinous	X Location <input type="checkbox"/> Workmanship <input type="checkbox"/> Design <input type="checkbox"/> Feeling <input type="checkbox"/> Setting <input type="checkbox"/> Association <input type="checkbox"/> Materials Ruinous condition	Recommended not eligible, due to a lack of significance and integrity

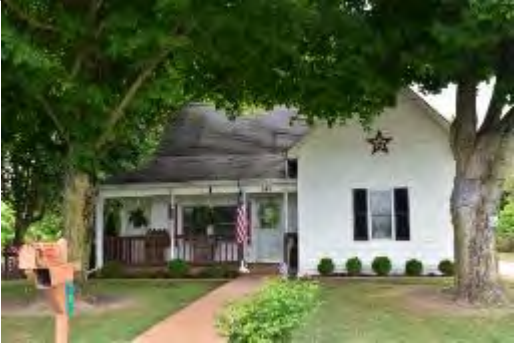
50 Thrifton Road/021211020000	House: Vernacular one-story gabled ell house with vinyl siding, replacement vinyl windows, rear addition; detached 1994 garage and shed	ca.1920, 1994	Fair	X Location <input type="checkbox"/> Workmanship <input type="checkbox"/> Design X Feeling X Setting <input type="checkbox"/> Association <input type="checkbox"/> Materials Vinyl siding and windows, rear addition	Recommended not eligible, due to a lack of significance and integrity
26	NA

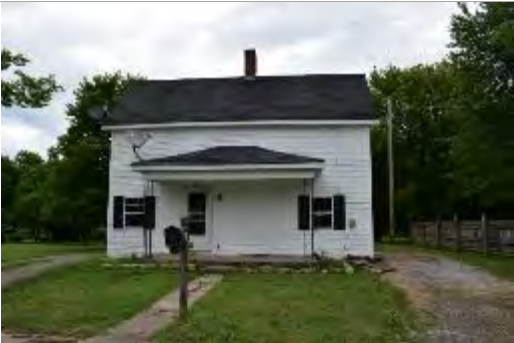
78 Thrifton Road/ 021211019000	House: Vernacular New England One-and-a-Half form extensively altered with vinyl siding, replacement windows, enclosed openings, an altered porch, and an addition to the rear; 1998 garage	ca. 1910, 1998	Fair	X Location <input type="checkbox"/> Workmanship <input type="checkbox"/> Design <input type="checkbox"/> Feeling X Setting <input type="checkbox"/> Association <input type="checkbox"/> Materials Vinyl siding, replacement windows, altered openings and porch, rear addition	Recommended not eligible, due to a lack of significance and integrity

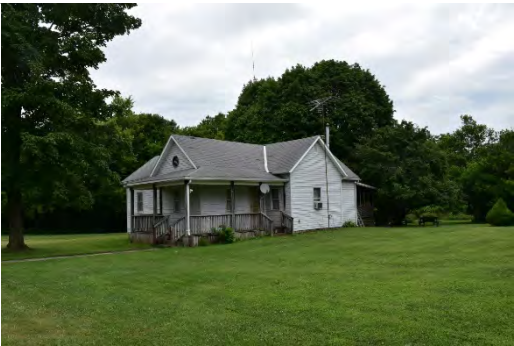
108 Thrifton Road/021211018000	House: Vernacular wood frame house with vinyl siding, one-over-one double-hung sash windows, rebuilt and expanded porch; detached carport	ca. 1955	Good	X Location <input type="checkbox"/> Workmanship <input type="checkbox"/> Design <input type="checkbox"/> Feeling X Setting <input type="checkbox"/> Association <input type="checkbox"/> Materials Vinyl siding, rebuilt porch	Recommended not eligible, due to a lack of significance and integrity
28	NA

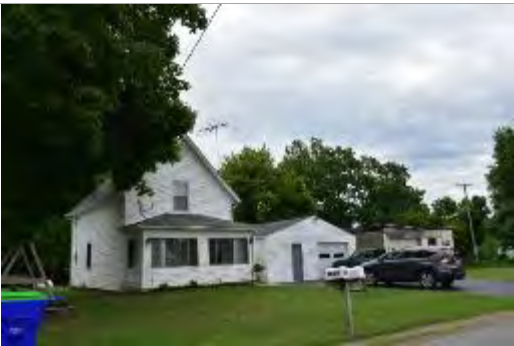
24 Thrifton Road/021211023000	House: Vernacular one-and-one-half-story house with replacement windows, enclosed front porch, enclosed openings, and vinyl siding; detached wood frame garage and detached concrete block garage and commercial building	ca. 1920	Good	X Location <input type="checkbox"/> Workmanship <input type="checkbox"/> Design <input type="checkbox"/> Feeling X Setting <input type="checkbox"/> Association <input type="checkbox"/> Materials Enclosed porch, vinyl siding, replacement windows, enclosed openings	Recommended not eligible, due to a lack of significance and integrity

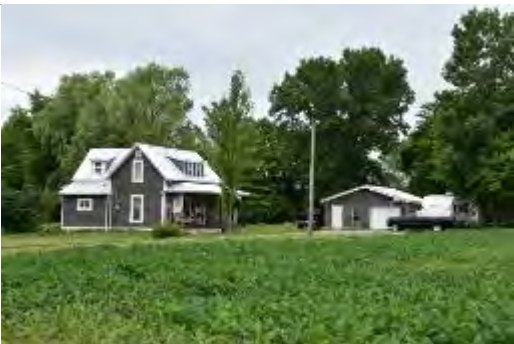
8985 Rapid Forge Road / 021211027000	House: Vernacular one-and-one-half-story wood frame house with a side gable roof with a shed dormer, vinyl siding, a full width front porch, and replacement windows; 1999 garage	ca. 1920	Good	X Location <input type="checkbox"/> Workmanship X Design X Feeling X Setting <input type="checkbox"/> Association <input type="checkbox"/> Materials Vinyl siding and windows, enclosed rear porch	Recommended not eligible, due to a lack of significance and integrity
30	NA

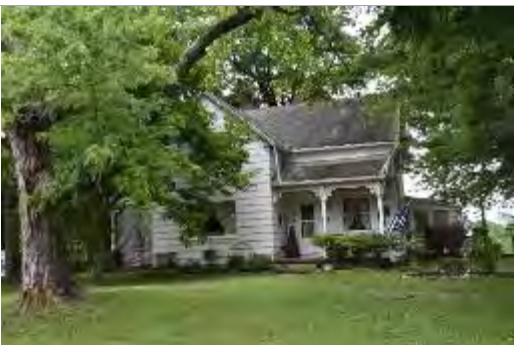
9002 Rapid Forge Road/021211030000	House: Vernacular wood frame, one-and-one-half-story house exhibiting the saddlebag form (side view in photo as front is obscured with plastic currently) with an intersecting gable roof, asbestos shingle siding, some replacement windows, and a one-story porch with decorative sawnwork; ca. 1970 barn	ca. 1890	Good	X Location <input type="checkbox"/> Workmanship X Design X Feeling X Setting <input type="checkbox"/> Association <input type="checkbox"/> Materials Asbestos shingle siding, some replacement windows, rear one-story addition	Recommended not eligible, due to a lack of significance and integrity

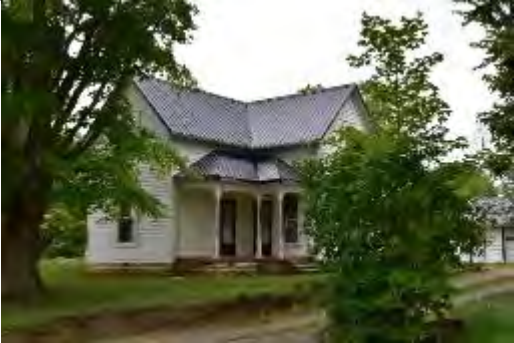
8947 Rapid Forge Road/ 021211028000	House: Vernacular wood frame one-and-one-half-story gabled ell with vinyl siding, one-over-one double-hung sash windows, sawnwork on the porch, and an addition on the south; 1987 garage, 1985 mobile home	ca. 1900	Good	X Location <input type="checkbox"/> Workmanship <input type="checkbox"/> Design X Feeling X Setting <input type="checkbox"/> Association <input type="checkbox"/> Materials Vinyl siding, addition on the south	Recommended not eligible, due to a lack of significance and integrity
32	NA

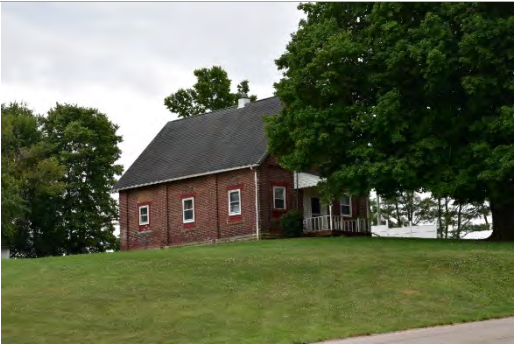
Thrifton School / 8708 Rapid Forge Road/ 021211066000	House: Former brick school according to 1917 and 1944 USGS quadrangles, set on continuous stone foundation, window openings partially enclosed and replaced with smaller vinyl sash windows, partially enclosed entrance with vinyl siding, front entry porch rebuilt and carport addition; outbuildings include a shed	ca. 1905	Fair	X Location <input type="checkbox"/> Workmanship <input type="checkbox"/> Design <input type="checkbox"/> Feeling X Setting <input type="checkbox"/> Association <input type="checkbox"/> Materials Replacement windows, altered fenestration, front entry porch rebuilt, and carport additions	Recommended not eligible, due to a lack of significance and integrity

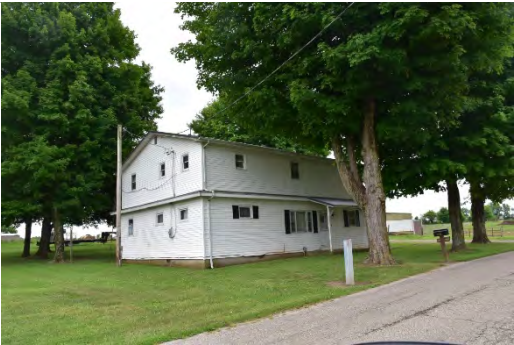
8652 Rapid Forge Road/ 021211069000	House: Vernacular wood frame two-story house with vinyl siding, replacement windows, and a concrete block foundation; outbuildings include 1995 garage and 2001 pole barn.	ca. 1955, 1995, 2001	Fair	X Location <input type="checkbox"/> Workmanship <input type="checkbox"/> Design <input type="checkbox"/> Feeling X Setting <input type="checkbox"/> Association <input type="checkbox"/> Materials Vinyl siding and windows	Recommended not eligible, due to a lack of significance and integrity
34	NA

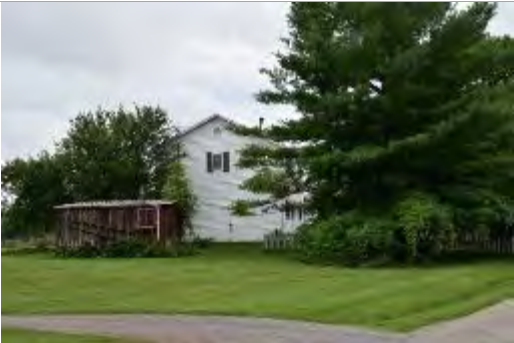
8474 Rapid Forge Road/ 021211008000	House: Vernacular one-story wood frame residence with ca. 2000 two-story addition. Vinyl siding and windows, side gable roof surfaced with composition shingles, front porch across width of original front façade; Outbuildings include 1990 shed and two ca. 1999 barns.	ca. 1965, 1990s	Fair	X Location <input type="checkbox"/> Workmanship <input type="checkbox"/> Design <input type="checkbox"/> Feeling X Setting <input type="checkbox"/> Association <input type="checkbox"/> Materials Vinyl siding and windows, large two-story addition	Recommended not eligible, due to a lack of significance and integrity

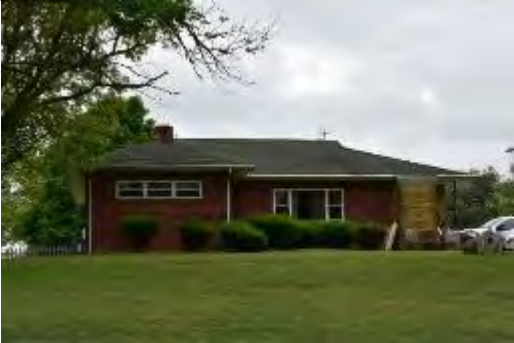
8310-16 Rapid Forge Road / 021211104000	House: Ranch style residence with a brick exterior, vinyl clad replacement windows, and permastone around the corner inset entry porch. Decorative elements include the gable on hip roof, a brick chimney, and a picture window; Outbuildings include a 1957 gambrel roofed Erie Shore barn and an implement shed	ca. 1957	Good	X Location X Workmanship X Design X Feeling X Setting <input type="checkbox"/> Association X Materials	Recommended not eligible, due to a lack of significance
36	ROS0097706

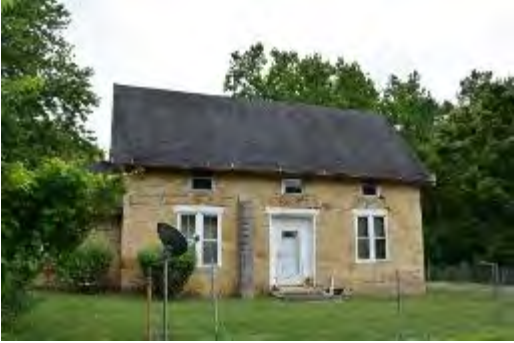
8860 Rapid Forge Road / 021211031000	House: New England One-and-a-Half with a side-gabled roof with small, rectangular frieze windows, replacement vinyl windows; outbuildings include a garage	ca. 1880	Good	X Location X Workmanship X Design X Feeling X Setting <input type="checkbox"/> Association X Materials Vinyl replacement windows, partially enclosed replacement entrance, partially demolished non-historic concrete block chimney	Recommended potentially eligible under Criterion C

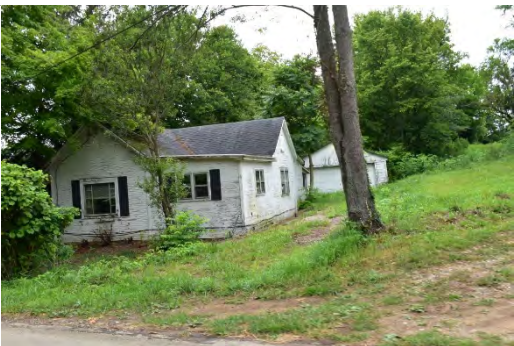
8895 Rapid Forge Road / 021211029000	House: Vernacular wood frame one-story house with wood siding, replacement metal windows, and several shed roofed additions ; Outbuildings include a 1969 garage	ca. 1910	Fair	X Location <input type="checkbox"/> Workmanship <input type="checkbox"/> Design <input type="checkbox"/> Feeling X Setting <input type="checkbox"/> Association <input type="checkbox"/> Materials Replacement windows, multiple additions	Recommended not eligible, due to a lack of significance and integrity
38	NA

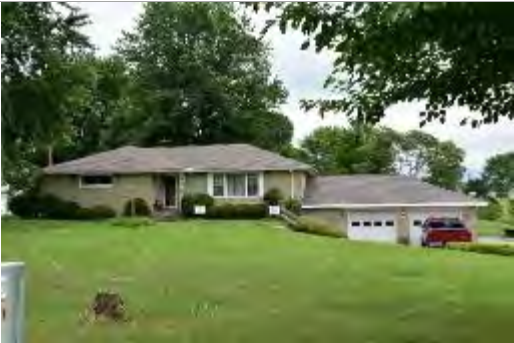
90 Moon Road / 021212133000	House: Ranch style with hipped roof, a walk-out basement two-car garage, stone veneer siding, and a picture window	ca. 1969	Good	X Location X Workmanship X Design X Feeling X Setting <input type="checkbox"/> Association X Materials Possible vinyl replacement windows; garage may have been enlarged	Recommended not eligible, due to a lack of significance

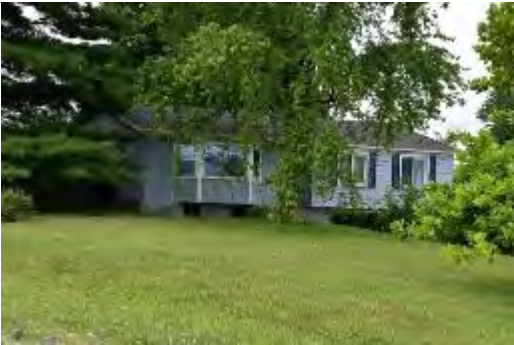
272 Moon Road/ 021212059000	House: Mid-century Split Level house with aluminum siding, replacement sliding vinyl windows, a bay window, a gable roof, and brick chimney; detached garage	ca. 1965	Fair	X Location <input type="checkbox"/> Workmanship <input type="checkbox"/> Design <input type="checkbox"/> Feeling X Setting <input type="checkbox"/> Association <input type="checkbox"/> Materials Aluminum siding, vinyl windows, bay window	Recommended not eligible, due to a lack of significance and integrity
44	NA

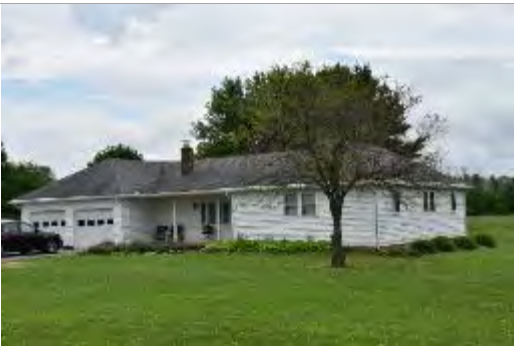
536 Moon Road/ 021212067000	House: Ranch style house with a hipped roof, incorporated two-car garage, inset entry porch, and vinyl siding	ca. 1971	Good	X Location <input type="checkbox"/> Workmanship X Design X Feeling X Setting X Association <input type="checkbox"/> Materials Vinyl siding	Recommended not eligible, due to a lack of significance and integrity

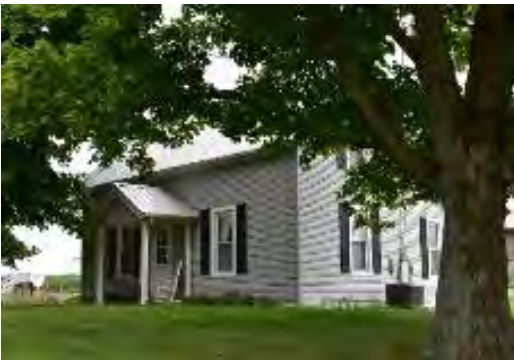
647 Moon Road/ 021212040000	House: Vernacular one-and-a-half story wood frame house with a side-gable metal roof, vinyl siding, replacement windows, replacement entry portico, and a rear room and porch addition; Associated outbuildings on separate parcel including barn, shed, modern equipment barn	ca. 1900	Good	X Location <input type="checkbox"/> Workmanship <input type="checkbox"/> Design <input type="checkbox"/> Feeling X Setting <input type="checkbox"/> Association <input type="checkbox"/> Materials Vinyl siding and windows, replacement entry portico, rear additions	Recommended not eligible, due to a lack of significance and integrity
46	NA

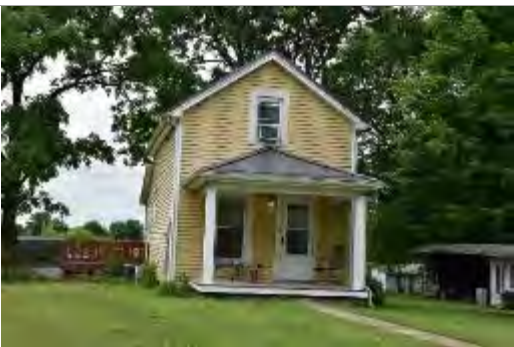
662 Moon Road/ 021212069000	House: Vernacular wood frame one-and-one-half story house with a front-gable metal roof, vinyl siding, replacement windows, a one-story rear addition and attached deck; outbuildings include 1958 garage, 1967 church, and several modern sheds	ca. 1920, 1958, 1960	Good	X Location <input type="checkbox"/> Workmanship X Design X Feeling X Setting <input type="checkbox"/> Association <input type="checkbox"/> Materials Vinyl siding, windows, and rear additions	Recommended not eligible, due to a lack of significance and integrity

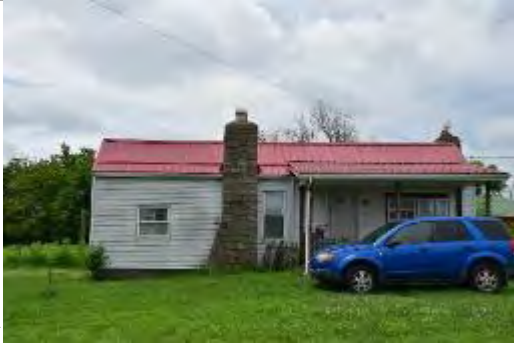
730 Moon Road/ 021212070000	House: Vernacular one-story wood frame residence with vinyl siding, vinyl windows, a metal side-gable roof, two fieldstone chimneys, and an altered front porch; Outbuildings include 1949 barn and a garage	ca. 1945	Good	X Location <input type="checkbox"/> Workmanship <input type="checkbox"/> Design <input type="checkbox"/> Feeling X Setting <input type="checkbox"/> Association <input type="checkbox"/> Materials Vinyl siding and windows, altered porch	Recommended not eligible, due to a lack of significance and integrity
48	NA

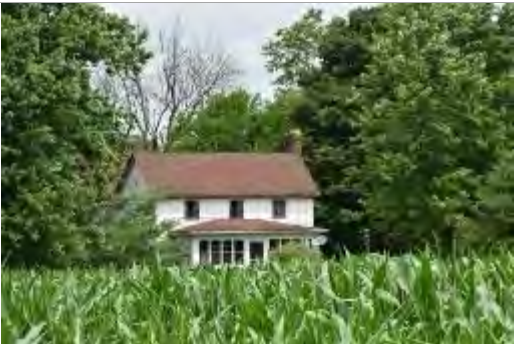
William Long Residence / 875 Moon Road/ 021212038000	House: Vernacular two-story I-house with a side-gabled roof, one end chimney on the east, aluminum siding, replacement windows, and an enclosed front porch; Outbuildings include a 1960 concrete block garage, a 1998 barn, a poultry house, a silo , and shed	ca. 1870	Fair	X Location <input type="checkbox"/> Workmanship X Design X Feeling X Setting <input type="checkbox"/> Association <input type="checkbox"/> Materials Aluminum siding, replacement windows, enclosed porch	Recommended not eligible, due to a lack of significance and integrity

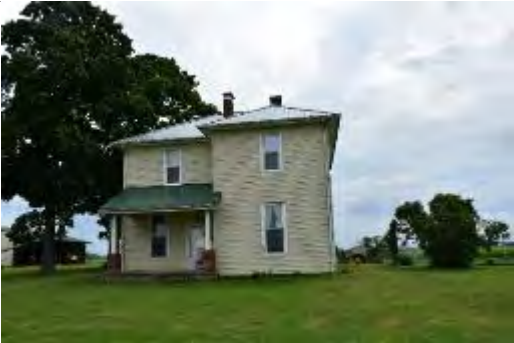
T. Seacour Residence / 1113 Moon Road/ 021212037000	House: Vernacular two-story, wood frame residence with a metal-clad hipped roof, vinyl siding, replacement windows, and two interior brick chimneys; Outbuildings include a modern equipment shed, two metal silos, and a deteriorated poultry house	ca. 1875	Good	X Location <input type="checkbox"/> Workmanship <input type="checkbox"/> Design X Feeling X Setting <input type="checkbox"/> Association <input type="checkbox"/> Materials Vinyl siding, replacement windows, replacement porch elements, loss of decorative features, rear addition	Recommended not eligible, due to a lack of significance and integrity
50	NA

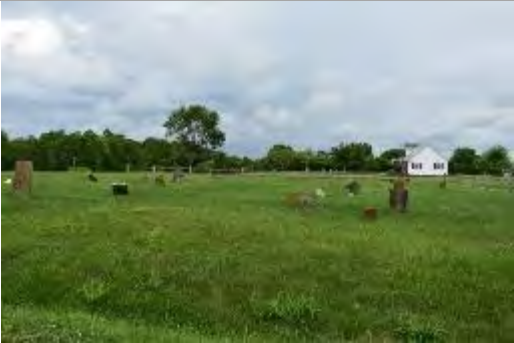
Old Stone Cemetery / Hop Run Cemetery / Milligan Cemetery / Moon Road / 021212045000 (OGS #10346)	Cemetery: 33 marked graves with death dates ranging from 1821 to 1877. Most markers of local “blue rock” granite. Some unmarked graves. A few marked graves are now illegible. Family names include Bail, Beam, Blain, Caldwell, Cunningham, Greenlee, Johnson, Long, Matthews, McMurry, Milligan, Morrow, Nevin, Robinson, and Scroggs (Find-a-grave.com).	ca. 1821-1877	Fair	X Location <input type="checkbox"/> Workmanship <input type="checkbox"/> Design X Feeling <input type="checkbox"/> Setting <input type="checkbox"/> Association <input type="checkbox"/> Materials Missing markers	Recommended not eligible, due to a lack of integrity

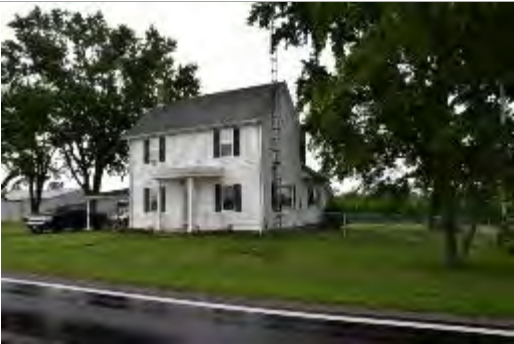
13952 SR 41/ 021212066000	House: Two-story I-house with a side-gabled roof, rounded one-story entrance portico, and altered with vinyl siding, replacement windows, and an addition on the side elevation; Outbuildings include a metal shed	ca. 1875	Fair	X Location <input type="checkbox"/> Workmanship <input type="checkbox"/> Design X Feeling <input type="checkbox"/> Setting <input type="checkbox"/> Association <input type="checkbox"/> Materials Vinyl siding, replacement windows, addition to the side and rear	Recommended not eligible, due to a lack of significance and integrity

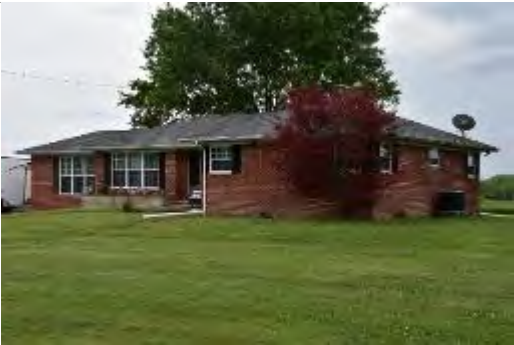
53	NA

13877 SR 41/021212074000	House: Ranch style brick residence with a hipped roof surfaced with composition shingles, replacement windows, and an inset entrance; detached brick, three-car garage	ca. 1956	Good	X Location <input type="checkbox"/> Workmanship X Design X Feeling X Setting <input type="checkbox"/> Association <input type="checkbox"/> Materials Replacement vinyl windows	Recommended not eligible, due to a lack of significance and integrity
54	NA

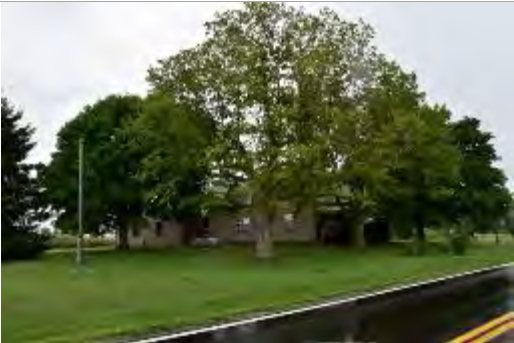
13840 SR 41/021212072000	House: Vernacular wood frame, one-story gabled ell residence with a metal intersecting gable roof, vinyl siding, replacement windows, and a large addition to the rear; Outbuildings include sheds	ca.1900	Good	X Location <input type="checkbox"/> Workmanship <input type="checkbox"/> Design X Feeling X Setting <input type="checkbox"/> Association <input type="checkbox"/> Materials Large rear addition, replacement windows, vinyl siding	Recommended not eligible, due to a lack of significance and integrity
