Ross County Solar

Phase 1 History Architecture Reconnaissance Survey

Case No. 20-1380-EL-BGN

Phase I History Architecture Reconnaissance Survey

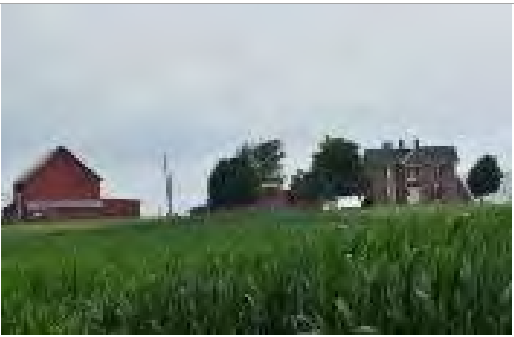
56	ROS0097806

Fair View Farm, Thomas Murray House / 404 Bayless Road/ 021208029000	Farmstead: Georgian style symmetrical brick residence with a side-gabled roof, interior brick chimneys, a three-bay front façade with a slightly projecting center gabled pavilion, classically inspired entrance and windows, and a rear addition; Associated outbuildings on separate parcel include barns, silos, sheds; the Murray Farm Cemetery (OGS 10351) is on this property but the exact location was not found	ca. 1849	Good	<div> X Location X Workmanship </div> <div> X Design X Feeling </div> <div> X Setting <input type="checkbox"/> Association </div> <div> X Materials </div> Large one-story addition	Recommended potentially eligible under Criteria A, B, and C
57	NA

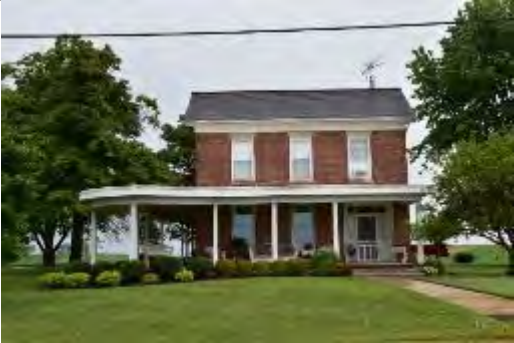
Isaac James Residence / 2111 SR 28 E/ 021208044000	House: Side Hallway House, two-story, brick construction with a side-gable roof, a curved one-story wrap-around porch added ca.1910, and a classically inspired entrance, rear wing and garage addition; outbuildings include two sheds	ca. 1848	Good	<div> X Location X Workmanship </div> <div> X Design X Feeling </div> <div> X Setting <input type="checkbox"/> Association </div> <div> X Materials </div> Rear addition, replacement windows	Recommended not eligible, due to a lack of significance

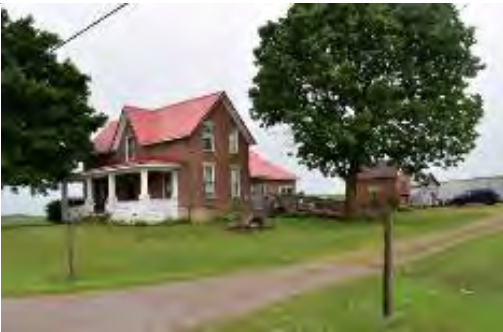
58	NA

H.C. Parrett Residence / 2271 SR 28/021208059000	House: Gothic Revival style one-and-one-half-story brick residence with a steeply pitched side-gabled roof and front central gable with a blind Gothic arch above the double-hung sash window, a Craftsman inspired front porch with battered columns set on a rusticated concrete block rail was added ca. 1910. Wood frame rear addition; Outbuildings include a brick smokehouse, wood frame garage	ca. 1820	Good	<div> X Location X Workmanship </div> <div> X Design X Feeling </div> <div> X Setting <input type="checkbox"/> Association </div> <div> X Materials </div> Ca. 1910 front porch addition, rear addition	Recommended not eligible, due to a lack of significance

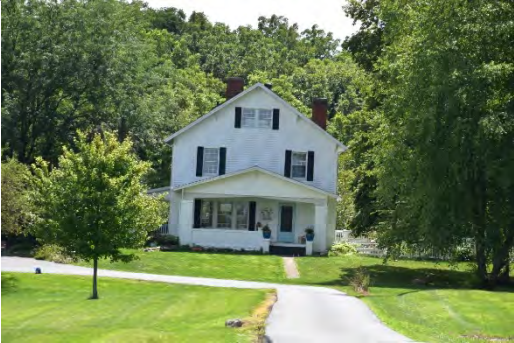
374 Moxley Road/ 201004033000 A.P. Middleton	Farmstead: Vernacular two-and-a-half-story residence with a front-facing gable, vinyl siding, and replacement windows. Craftsman elements include the front porch supported by massive piers and knee braces; Outbuildings include several modern sheds, and a 1996 garage and barn	ca. 1915	Good	X Location <input type="checkbox"/> Workmanship <input type="checkbox"/> Design <input type="checkbox"/> Feeling X Setting <input type="checkbox"/> Association <input type="checkbox"/> Materials Vinyl siding, replacement windows, side porch and rear addition	Recommended not eligible, due to a lack of significance and integrity

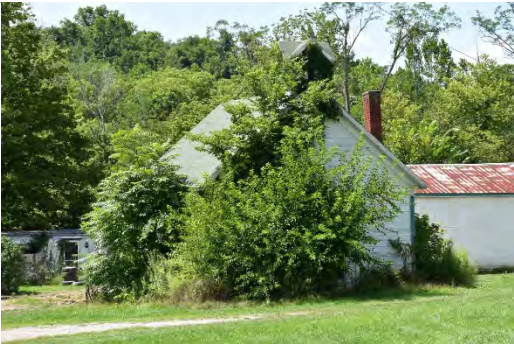
60	ROS98211

Fruitdale School / 11319-23 W SR 41 / 201003066000 Note: School is on individual parcel but surrounding parcels 201003067000 and 201003068000 have same owners with a house, garage & shed	School: Vernacular, wood frame one-room school largely obscured by vegetation but apparent novelty board siding with corner boards, a brick chimney, wood windows, and a gable roof surfaced with composition shingles topped by a lantern	ca. 1890	Fair	X Location X Workmanship X Design X Feeling X Setting <input type="checkbox"/> Association X Materials	Recommended potentially eligible under Criteria A and C
61	NA

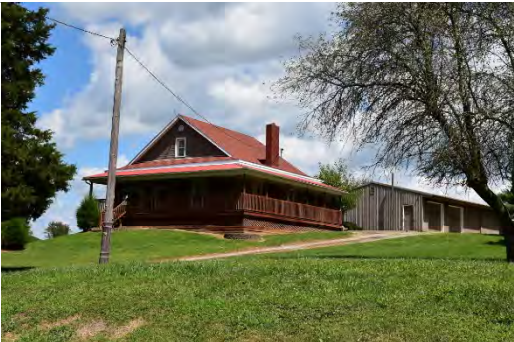
11474 SR 41 S / 201003039000	Farmstead: Bungalow, one-and-one-half-story, with a front-facing gable, vinyl siding, and replacement windows. Addition along north elevation and wrap-around porch around west and south elevations; Outbuildings include a 1981 equipment shed, 2010 poultry house, and 2011 shed	ca. 1915, 1981, 2010, 2011	Good	X Location <input type="checkbox"/> Workmanship <input type="checkbox"/> Design <input type="checkbox"/> Feeling X Setting <input type="checkbox"/> Association <input type="checkbox"/> Materials Vinyl siding, replacement windows, room and wrap-around porch additions	Recommended not eligible, due to a lack of significance and integrity

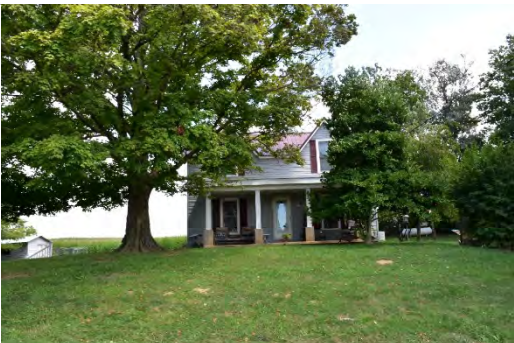
62	NA

11382 SR 41 S / 201003051000	Farmstead: Vernacular two-story house with Gothic Revival inspired steeply pitched side-gable roof with two front-facing paired gables. Original windows appear to be behind storm windows. Vinyl siding and rebuilt front porch are alterations. Outbuildings include a 1980 garage.	ca. 1915, 1980	Good	X Location <input type="checkbox"/> Workmanship <input type="checkbox"/> Design X Feeling X Setting X Association <input type="checkbox"/> Materials Rebuilt and altered front porch, vinyl siding	Recommended not eligible, due to a lack of significance and integrity

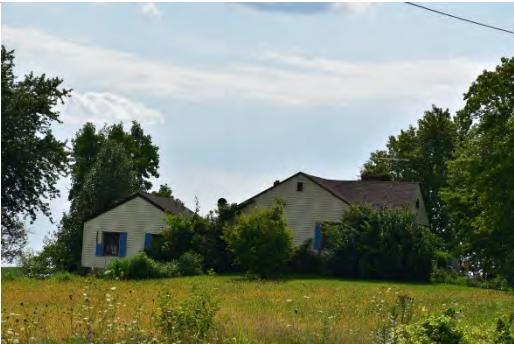
2308 SR 28/ 021208033000	House: Minimal Traditional with an intersecting gable roof with minimal overhanging eaves, clad with vinyl siding, the front-facing gable has a lunette in the gable end and houses an inset entrance. Windows are six-over-six with exterior storms applied. Outbuildings include a 1939 transverse frame barn, poultry house, and sheds	ca. 1939	Good	X Location <input type="checkbox"/> Workmanship X Design X Feeling X Setting <input type="checkbox"/> Association <input type="checkbox"/> Materials Vinyl siding, storm windows, addition on rear	Recommended not eligible, due to a lack of significance and integrity

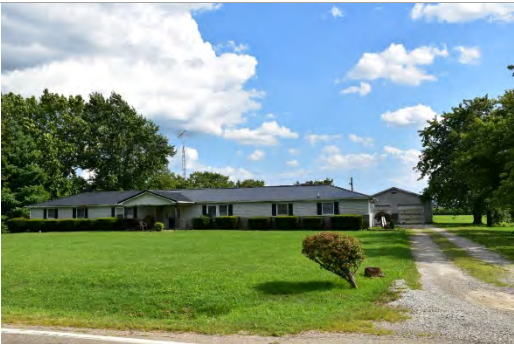
1956 SR 28 / 021208038000	House: Ranch, horizontal form with a metal clad hipped roof and projecting gable at the central entrance supported by wrought iron columns, stone veneer, and vinyl siding; Outbuildings include a 1976 two-car garage and several sheds	ca. 1971, 1976	Fair	X Location <input type="checkbox"/> Workmanship <input type="checkbox"/> Design X Feeling X Setting <input type="checkbox"/> Association <input type="checkbox"/> Materials Vinyl siding	Recommended not eligible, due to a lack of significance and integrity

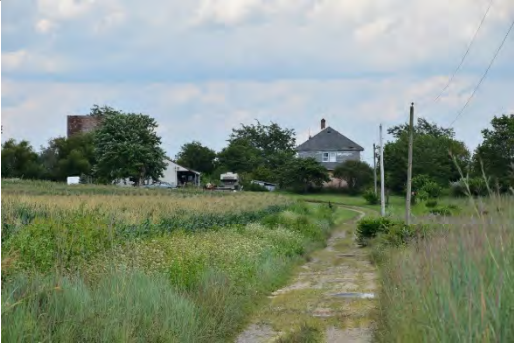
734 Blain Lane/ 021208047000	House: American Foursquare, two-story house with hipped roof and interior corbelled chimney, wood siding, altered fenestration with replacement windows, and an enclosed porch; ruins of a barn and tile silo, ca. 2005 equipment shed, difficult to view due to vegetation and distance from right-of-way	ca. 1915, 2005	Poor	X Location <input type="checkbox"/> Workmanship <input type="checkbox"/> Design <input type="checkbox"/> Feeling X Setting <input type="checkbox"/> Association <input type="checkbox"/> Materials Replacement windows, altered fenestration, enclosed porch	Recommended not eligible, due to a lack of significance and integrity

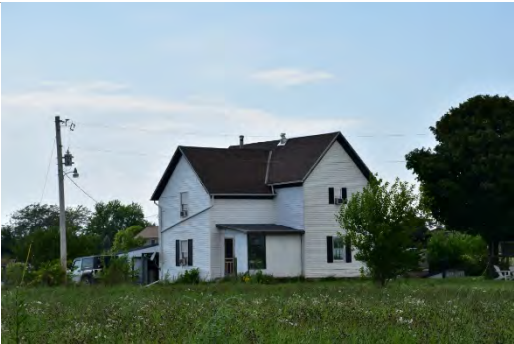
76	NA

801 Blain Lane/ 021208020000	House: Vernacular gabled ell wood frame residence with intersecting gable roof, vinyl siding, some replacement windows, altered fenestration, and an enclosed front porch; ca. 2005 workshop behind house	ca. 1900	Poor	X Location <input type="checkbox"/> Workmanship <input type="checkbox"/> Design <input type="checkbox"/> Feeling X Setting <input type="checkbox"/> Association <input type="checkbox"/> Materials Vinyl siding, altered fenestration, enclosed front porch, and some replacement windows	Recommended not eligible, due to a lack of significance and integrity
77	NA

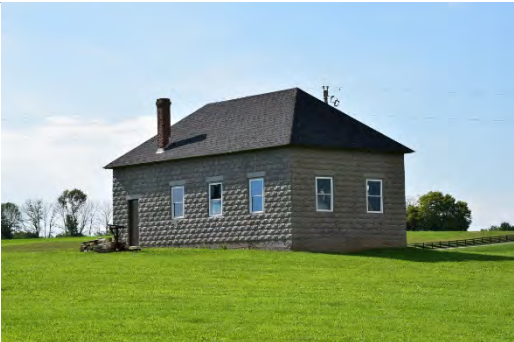
1694 SR 138 / 021208022000	House/Garage: Historic building on this property was a house converted to a garage ca. 2018, constructed of rusticated concrete block, hipped roof, corbelled brick chimney, and one-over-one windows below stone lintels; garage doors installed on one elevation; main house on property constructed in 2018	ca. 1910	Good	X Location <input type="checkbox"/> Workmanship <input type="checkbox"/> Design <input type="checkbox"/> Feeling X Setting <input type="checkbox"/> Association <input type="checkbox"/> Materials House converted to garage ca. 2018	Recommended not eligible, due to a lack of significance and integrity

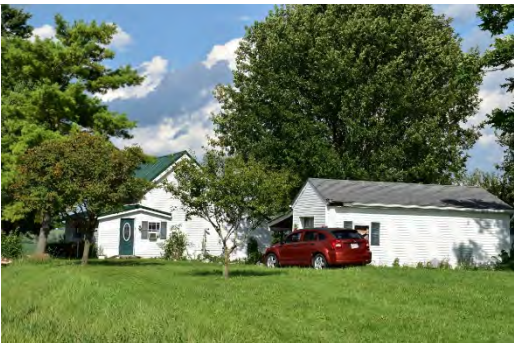
78	NA

2084 SR 138 NE/ 021208032000	House: Vernacular wood frame, one-story residence with vinyl siding, replacement windows, enclosed front porch, and a relocated entrance; Outbuildings: 1999 garage, 2000 carport	ca. 1900	Fair	X Location <input type="checkbox"/> Workmanship <input type="checkbox"/> Design <input type="checkbox"/> Feeling X Setting <input type="checkbox"/> Association <input type="checkbox"/> Materials Enclosed front porch, relocated entrance, replacement siding and windows	Recommended not eligible, due to a lack of significance and integrity

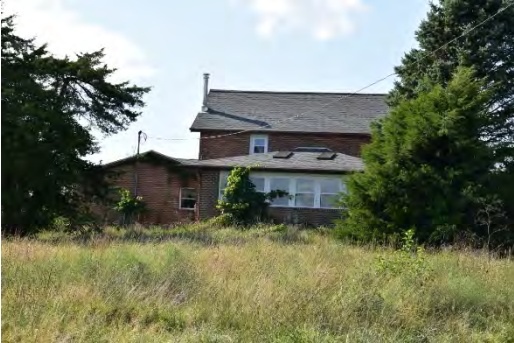
J. Blain Residence / 1499 SR 138 NE / 021207076000	House: I-House, two-story brick with side-gabled roof, front porch addition (later enclosed), enclosed windows, replacement windows, modern brick side addition, wood frame rear addition; Outbuildings: 1980 garage; partially obscured due to heavy vegetation and distance from right-of-way	ca. 1850	Fair	X Location <input type="checkbox"/> Workmanship <input type="checkbox"/> Design <input type="checkbox"/> Feeling X Setting <input type="checkbox"/> Association <input type="checkbox"/> Materials Front porch addition (later enclosed), large brick and wood frame additions, replacement vinyl windows, enclosed window openings	Recommended not eligible, due to a lack of significance and integrity

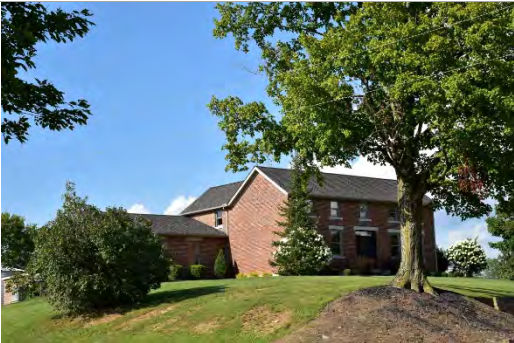
80	NA

Blain Residence / 1255 SR 138 NE / 021207009000	Farmstead: Federal two-story, brick house with replacement windows and entrance, stone lintels and sills, smaller window openings on second floor than on first floor, large brick one- and two-story additions to rear; Outbuildings: barn, silo, equipment shed, garage, and shed	ca. 1850	Excellent	X Location <input type="checkbox"/> Workmanship <input type="checkbox"/> Design X Feeling X Setting <input type="checkbox"/> Association <input type="checkbox"/> Materials Replacement entrance and windows, large one- and two-story brick additions	Recommended not eligible, due to a lack of significance and integrity
81	NA

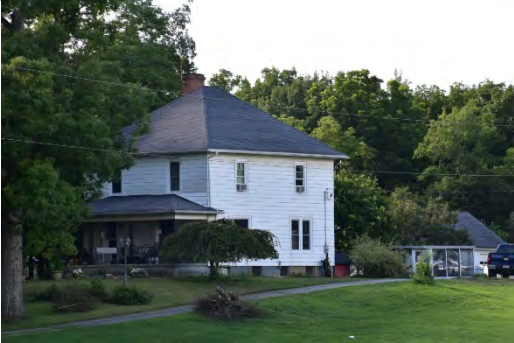
573-575 SR 28 / 021207067000	House: American Foursquare, two-story, wood frame, pyramidal roof; one-over-one double-hung sash wood windows, aluminum siding, replacement porch, Outbuildings: implement shed, 1968 garage	ca. 1918, 1968	Good	X Location <input type="checkbox"/> Workmanship X Design X Feeling X Setting <input type="checkbox"/> Association <input type="checkbox"/> Materials Aluminum siding, replacement porch	Recommended not eligible, due to a lack of significance and integrity

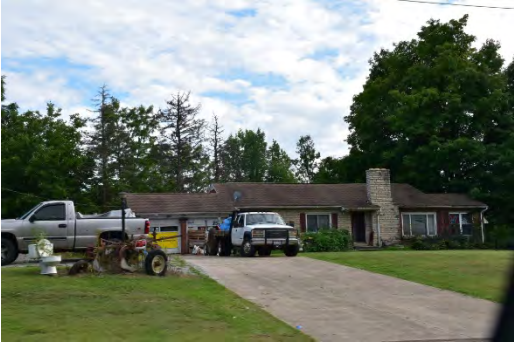
82	NA

542 SR 28 / 021207040000	House: Ranch style, one-story, side-gabled roof, brick and stone veneer exterior, slab chimney of stone on façade, replacement windows, incorporated two-car garage; 1968 garage	ca. 1953, 1968	Fair	X Location <input type="checkbox"/> Workmanship X Design X Feeling X Setting <input type="checkbox"/> Association <input type="checkbox"/> Materials Replacement windows	Recommended not eligible, due to a lack of significance and integrity

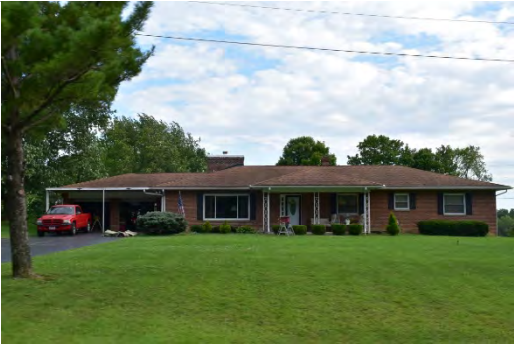
474-502 SR 28 / 021207002000	House: Ranch, brick, complex hipped roof, front porch supported by wrought iron posts, replacement windows, walk-out rear basement, incorporated two-car garage with carport addition; 1983 shed	ca. 1952, 1983	Good	X Location <input type="checkbox"/> Workmanship X Design X Feeling X Setting <input type="checkbox"/> Association <input type="checkbox"/> Materials Replacement windows	Recommended not eligible, due to a lack of significance and integrity
