# LETTER OF NOTIFICATION FOR WINDSOR JUNCTION- TILTONSVILLE 138 kV CONDUCTOR PROJECT

PUCO Case No. 20-1735-EL-BLN

Submitted to:  
The Ohio Power Siting Board  
Pursuant to Ohio Administrative Code  
Section 4906-6-05

Submitted by:  
Ohio Power Company

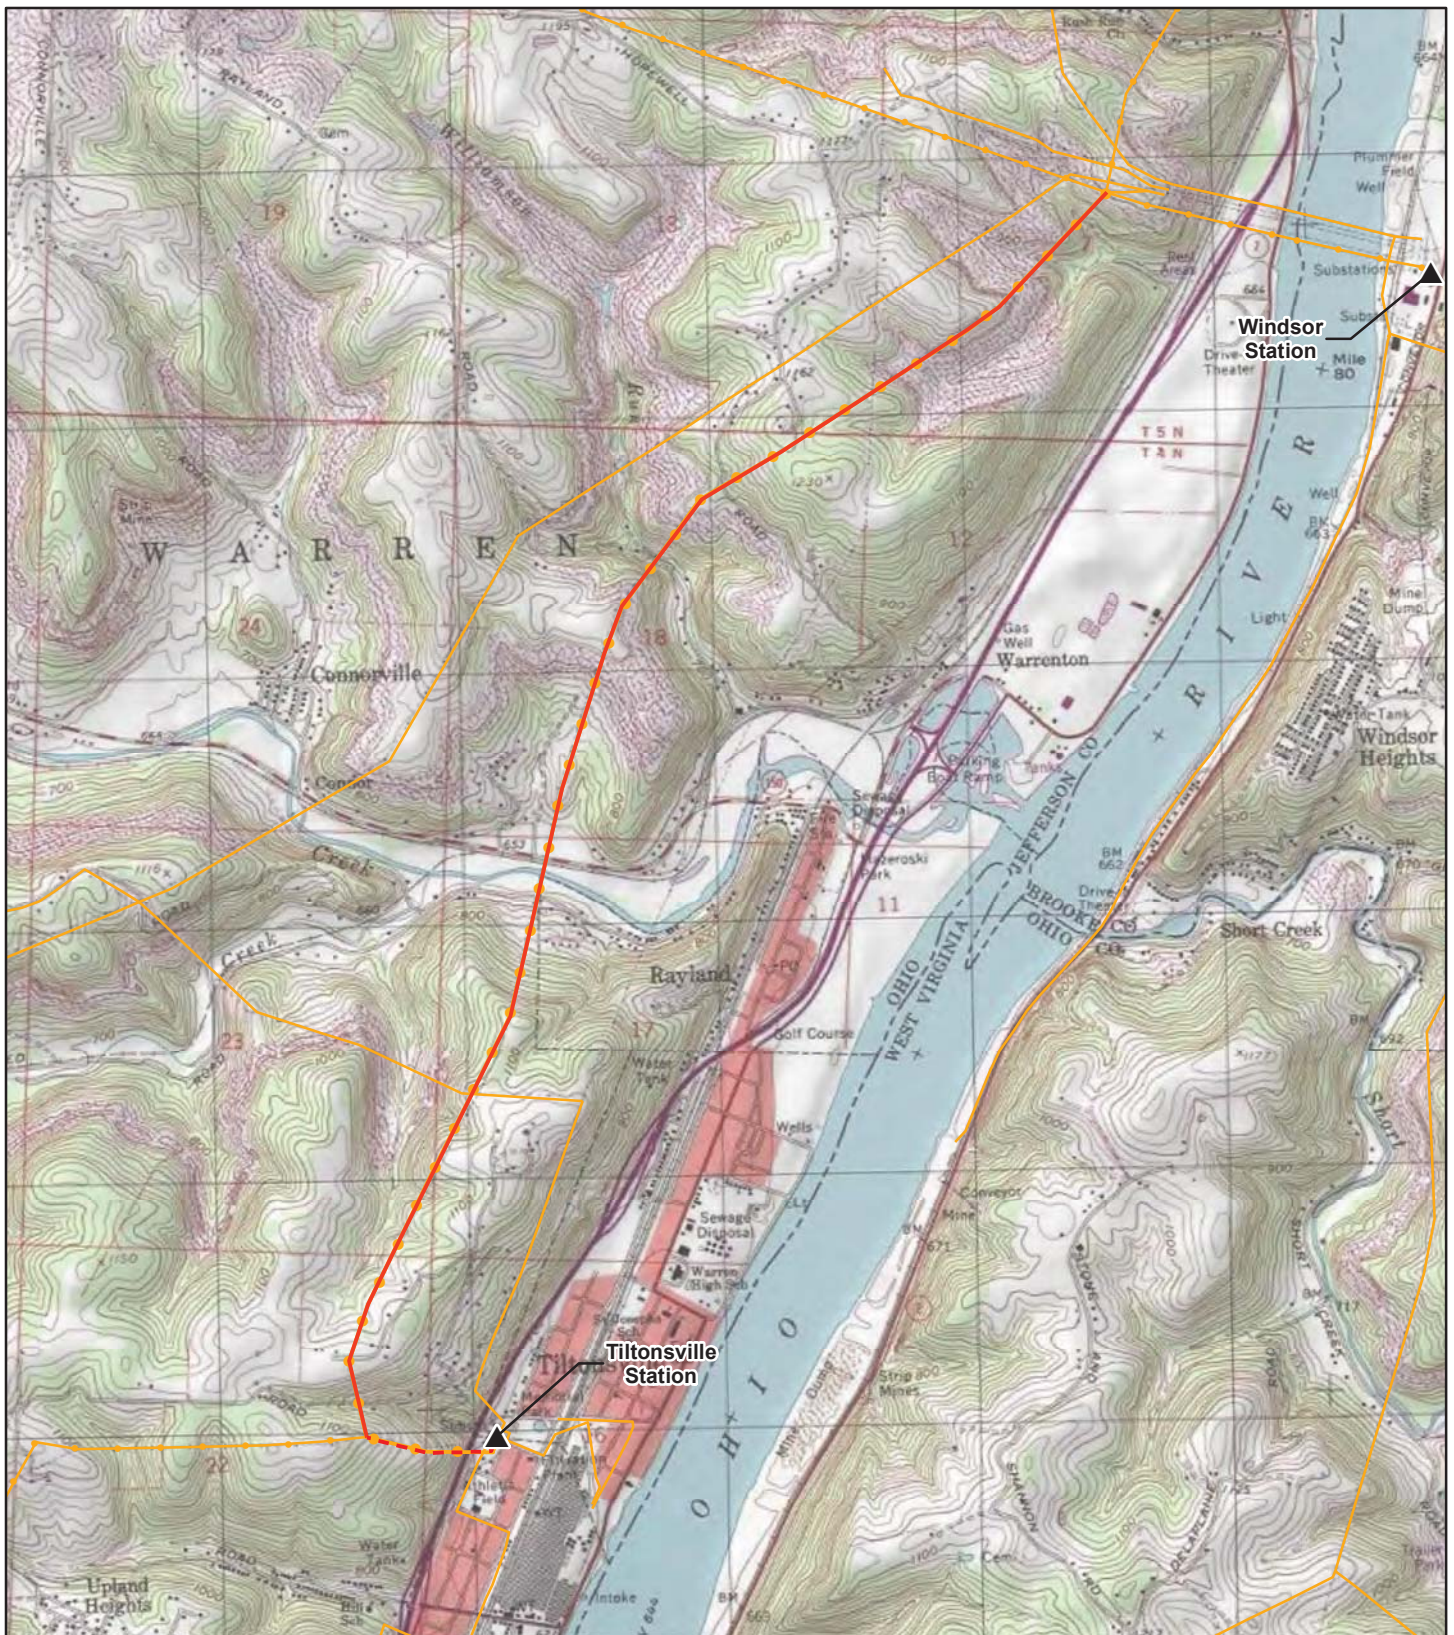
Windsor Junction-Tiltonville  
138 kV Ratings Increase Project

- ▲ Existing Station
- Existing Transmission
- String Additional Conductor
- - - Existing Transmission Reconductor
- Existing 69-kV Transmission Line
- Existing 138-kV Transmission Line

The Project will be constructed within the existing 100 foot-wide transmission line right-of-way (“ROW”). Supplementing additional easements may be required to accommodate the Project. The location of the Project is shown on Map 1 in Appendix A.

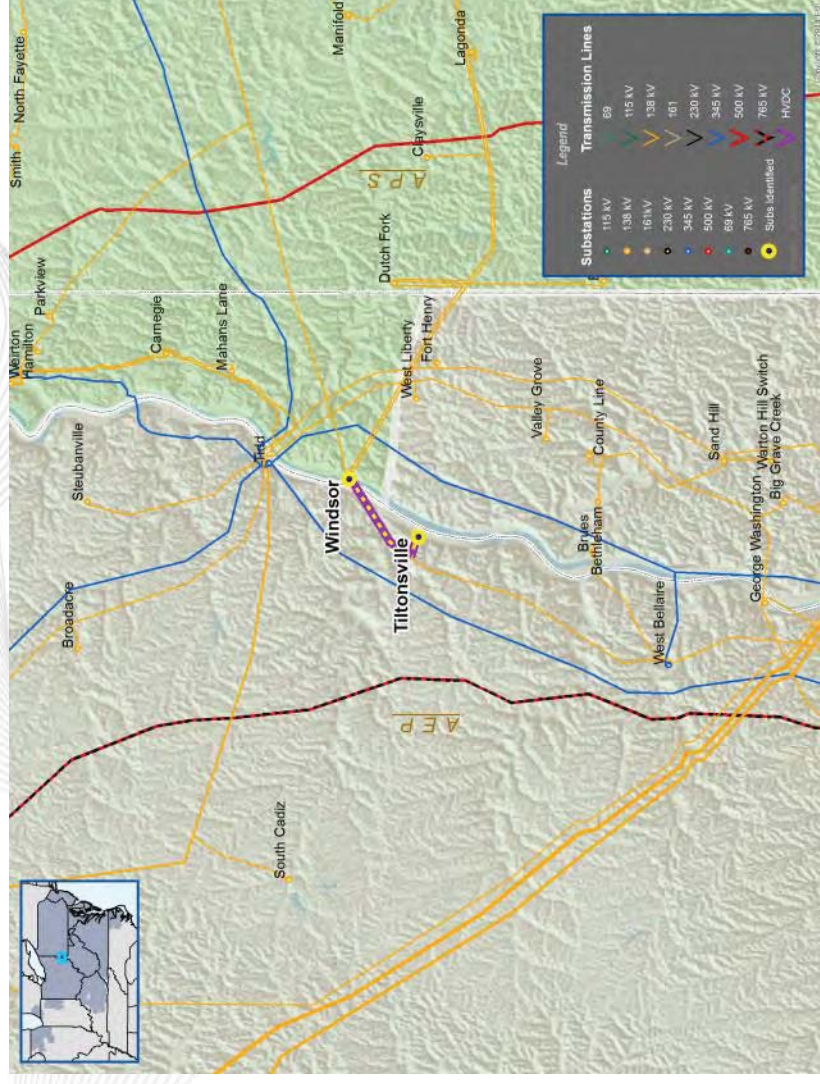
# AEP/APS Transmission Zone

- **Baseline (FG# 133, 204, 205) and Generator Deliverability /Common Mode Outage**
- **2014 RTEP Proposal Window #1 Violation (FG# 232, 234, 799, 1042)**

- The Tilton – Windsor 138kV is overloaded for system normal and multiple contingencies.
- Recommended Solution: Reconductor 0.5 miles of Tiltonsville-Windsor 138 kV and string the vacant side of the 4.5 mile section using 556 ACSR in a six wire configuration. (B2555) (P2014\_1-2A)
- Estimated Project Cost: \$2.0M
- Required IS Date: 6/1/2019
