# Clearview Solar I, LLC

Preliminary Drain Tile Assessment

**Case No. 20-1362-EL-BGN**

Location: Champaign County, OH  
Date: December 8, 2020

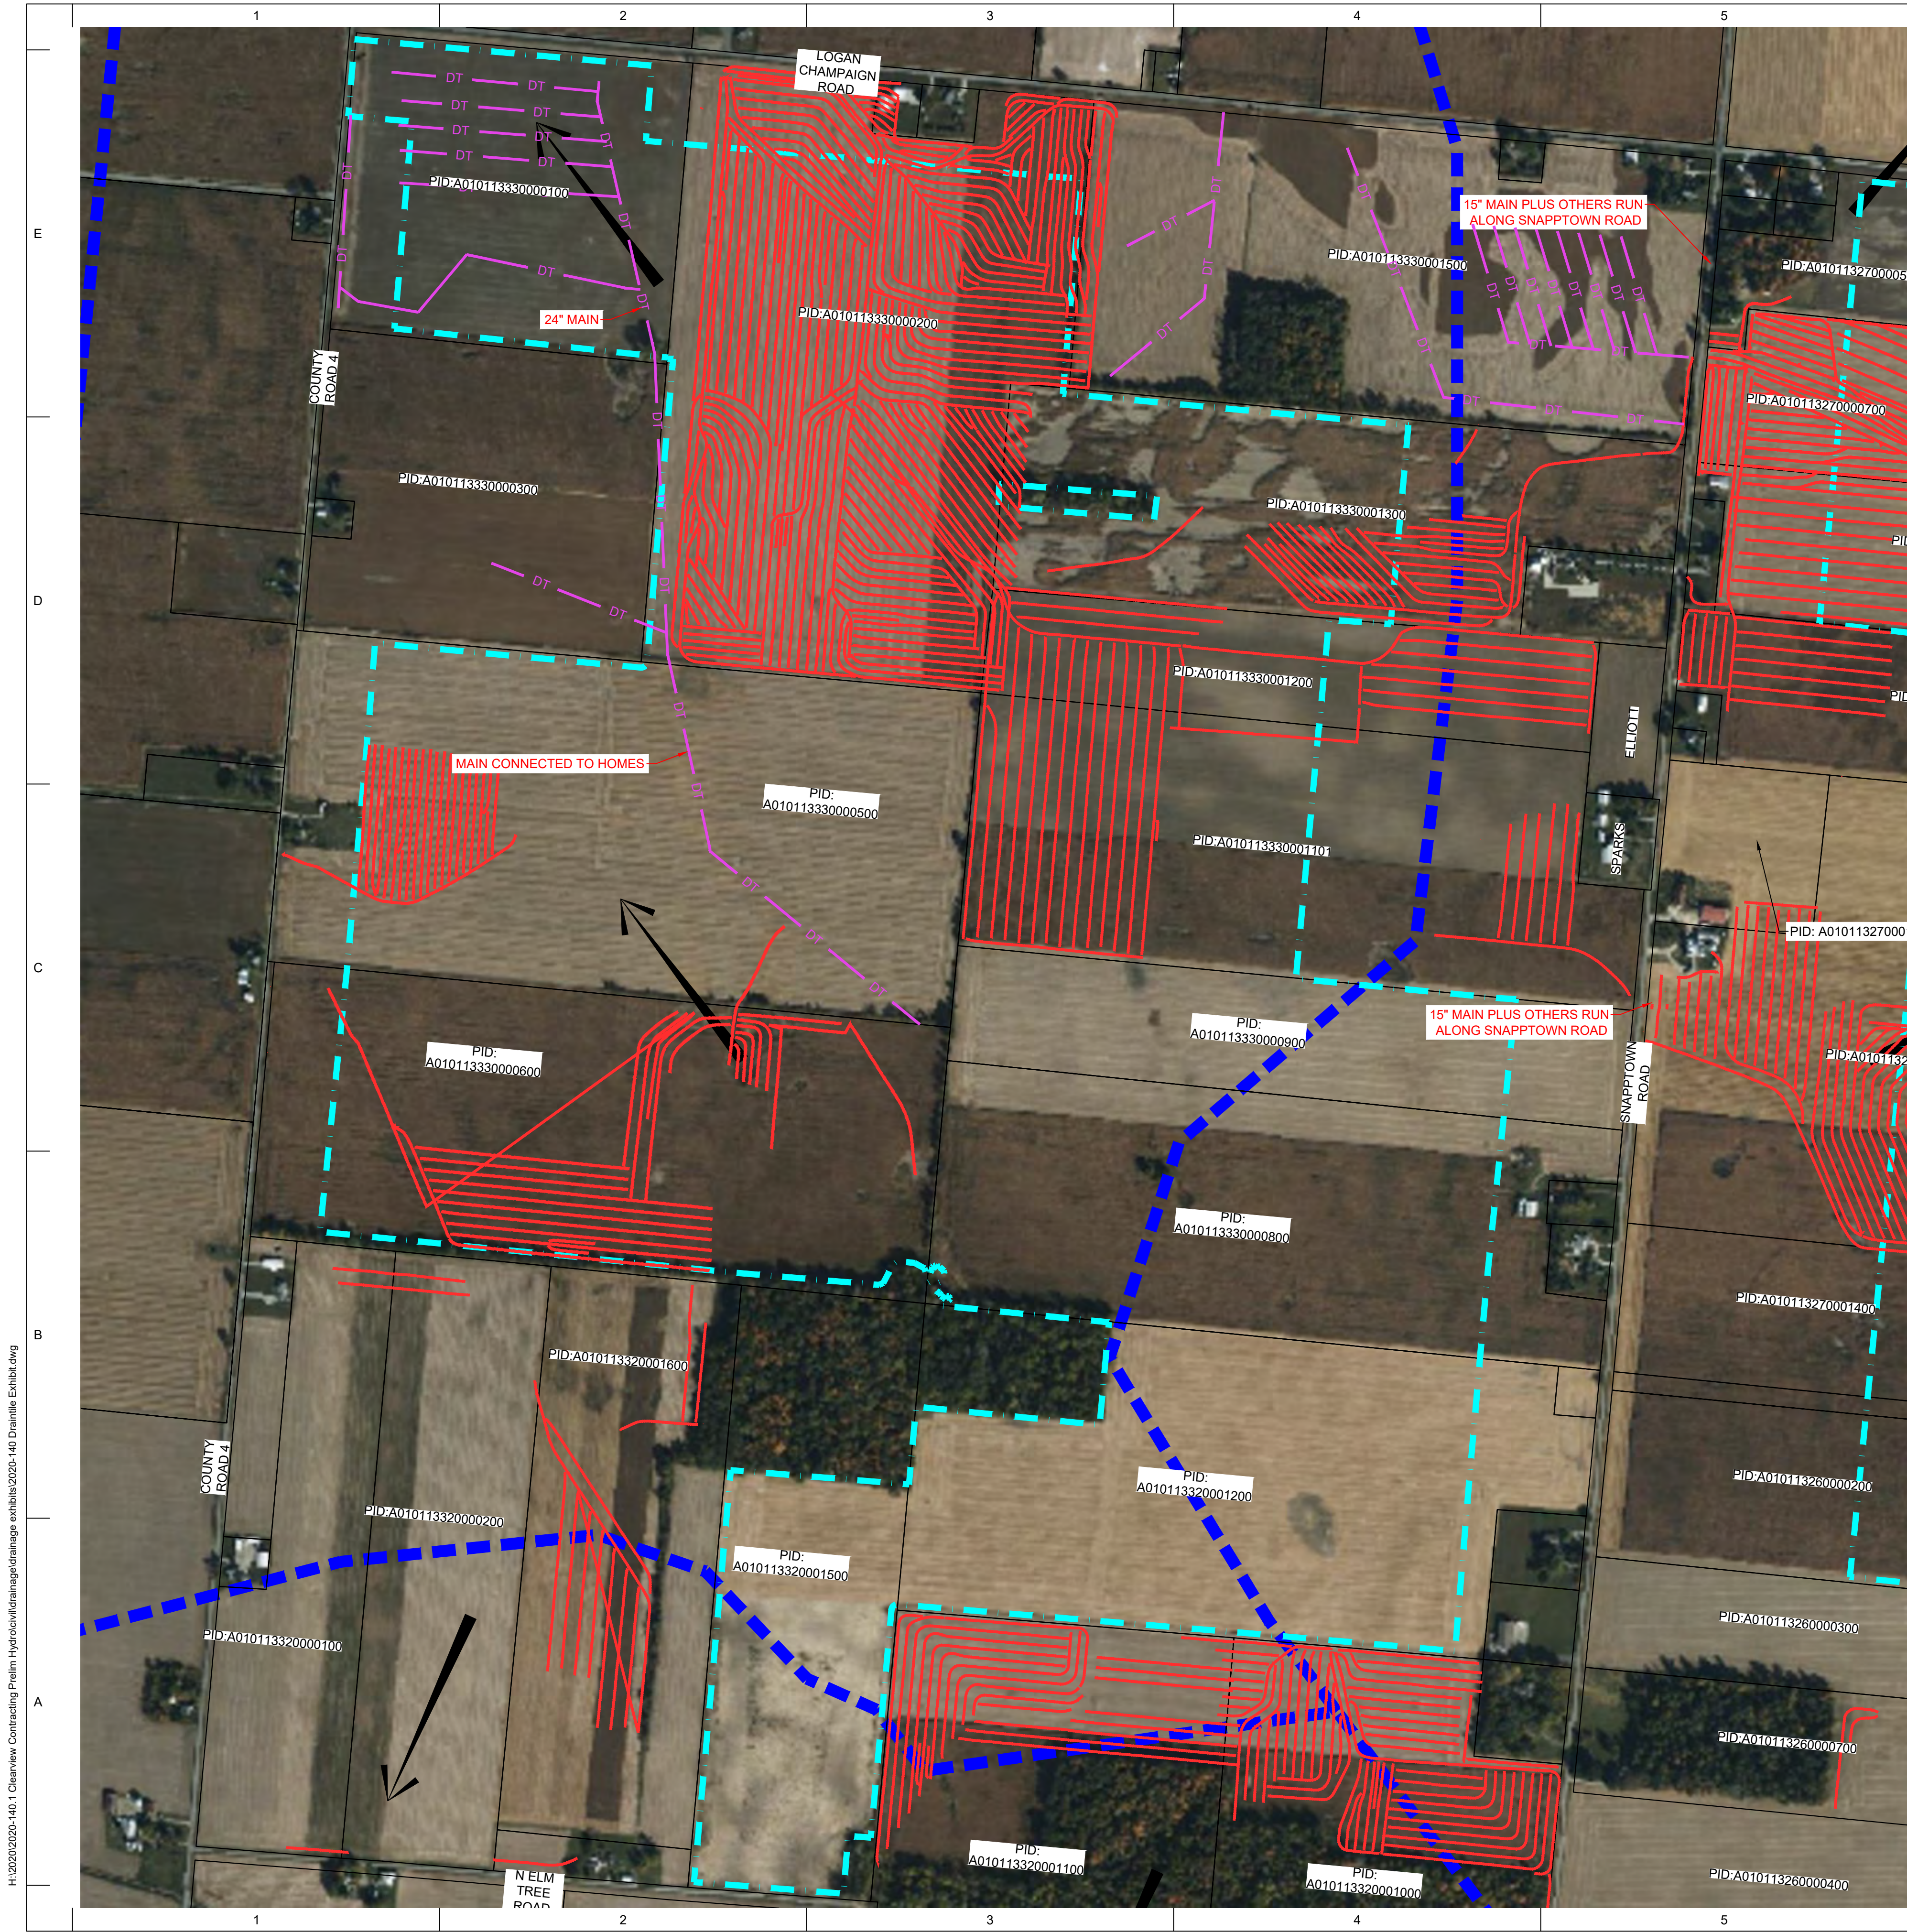
SHEET NUMBER  
EX-DT-1

SHEET NAME  
DRAINTILE EXHIBIT

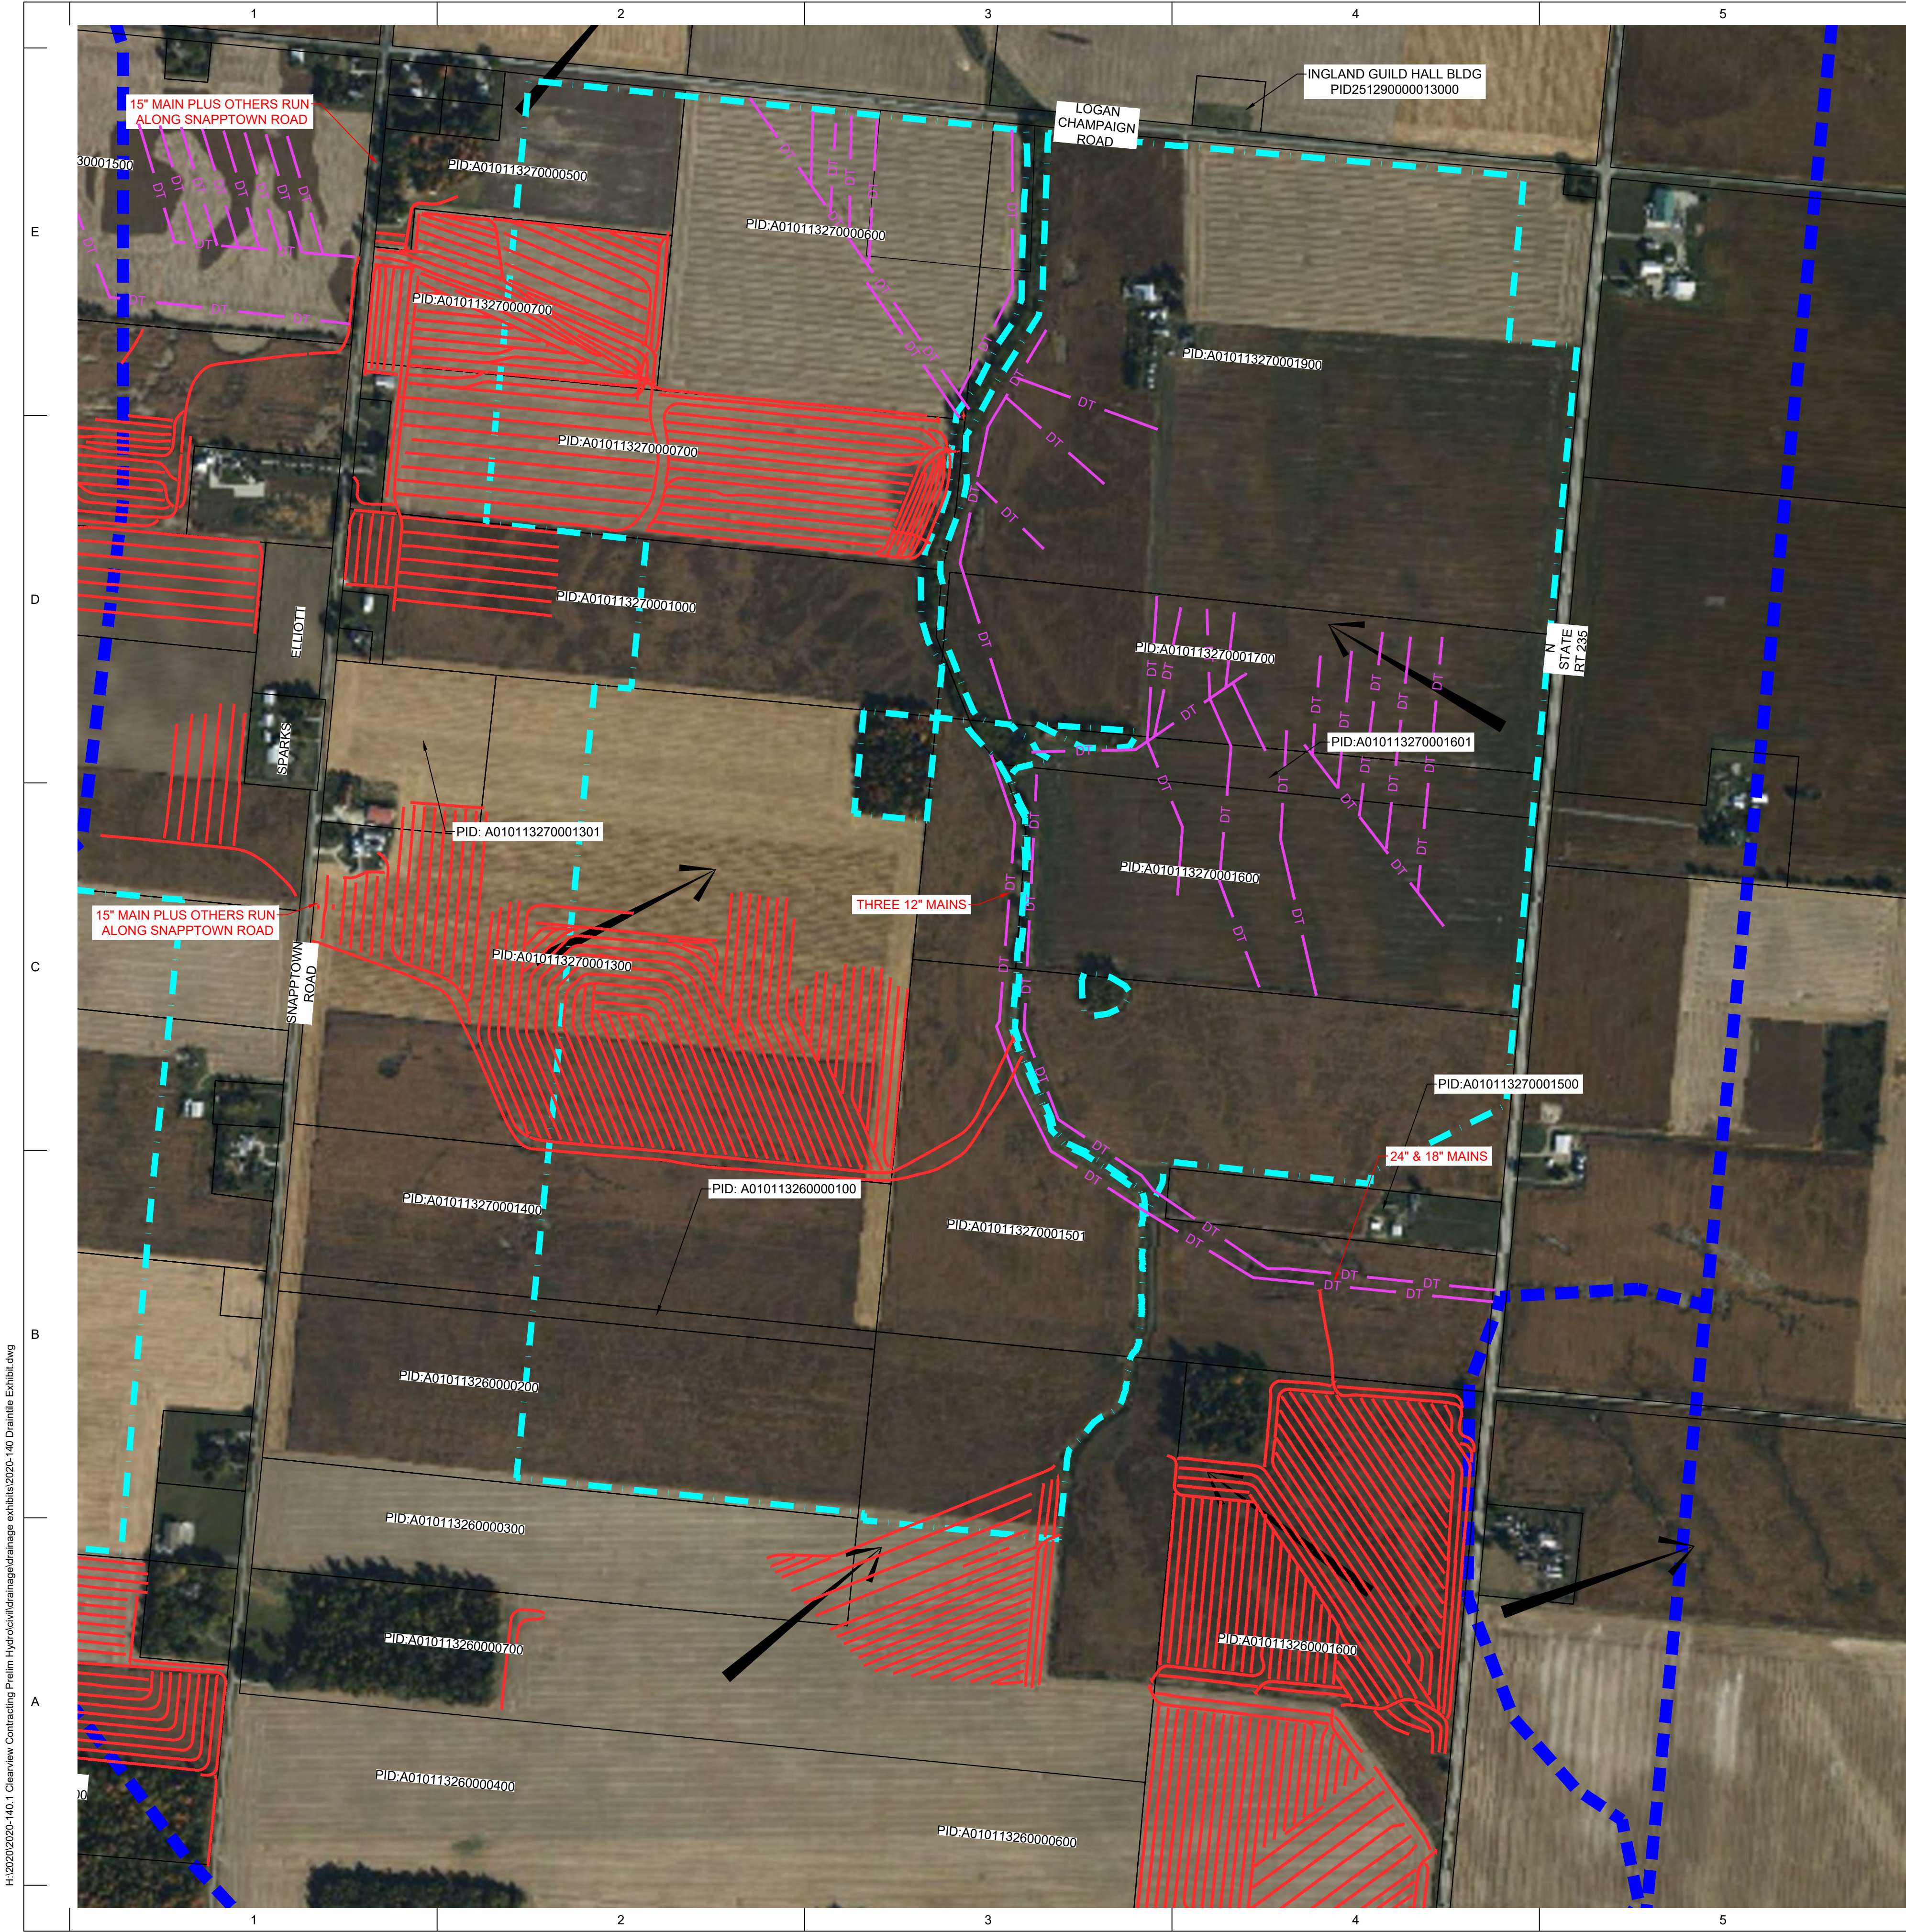
**EX-DT-2**

**DRAINTILE EXHIBIT**
