Union Ridge Solar

Exhibit Q

Phase I History Architecture Reconnaissance Survey

Case No. 20-1757-EL-BGN

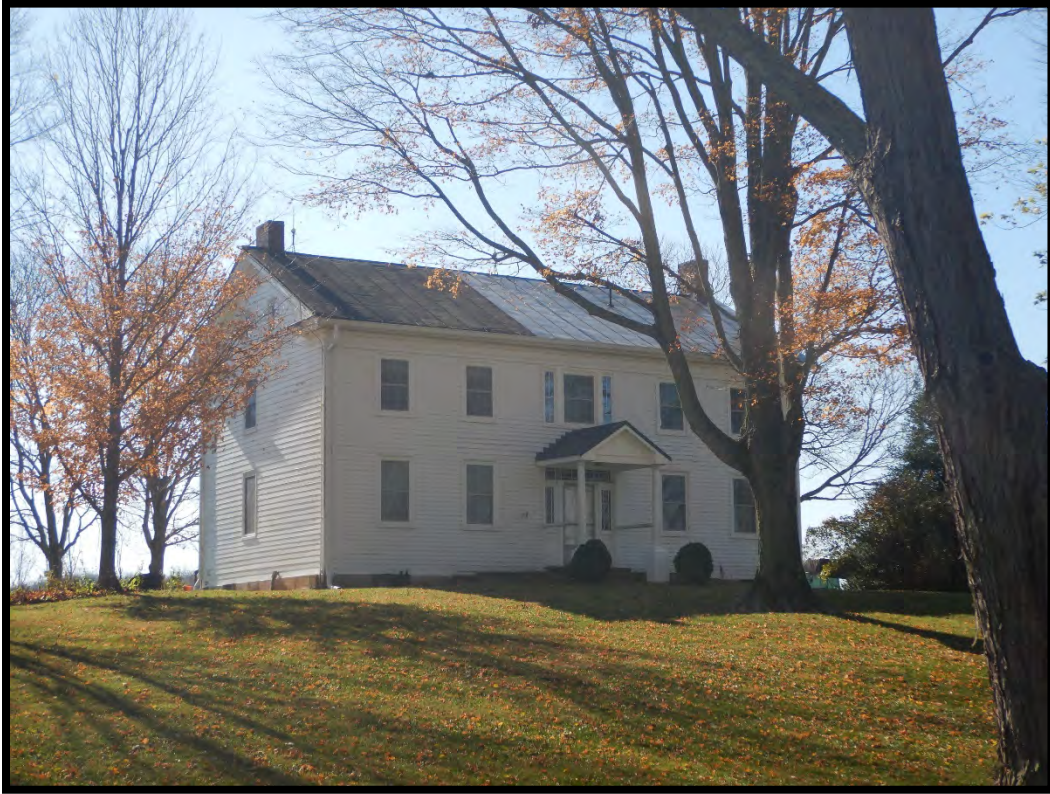
Figure 88. South view of S-1/ LIC0155120 from Creek Road SW.

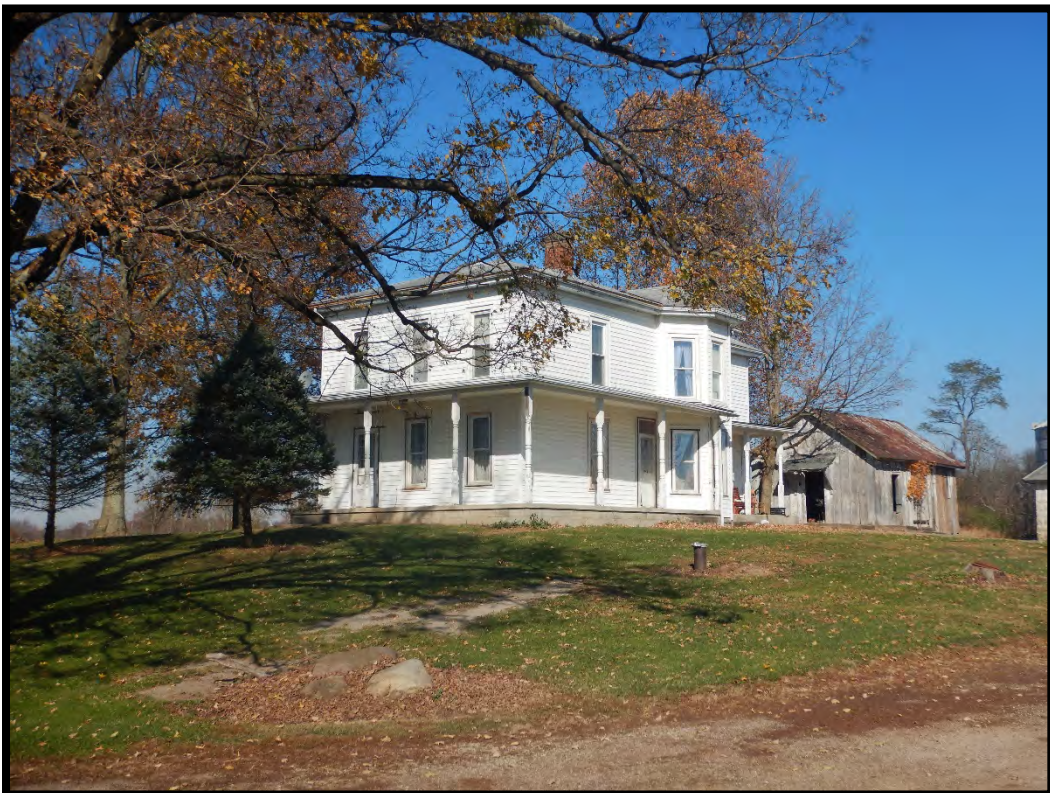
Figure 89. Southwest view of S-2/ LIC0155220 from Creek Road SW.

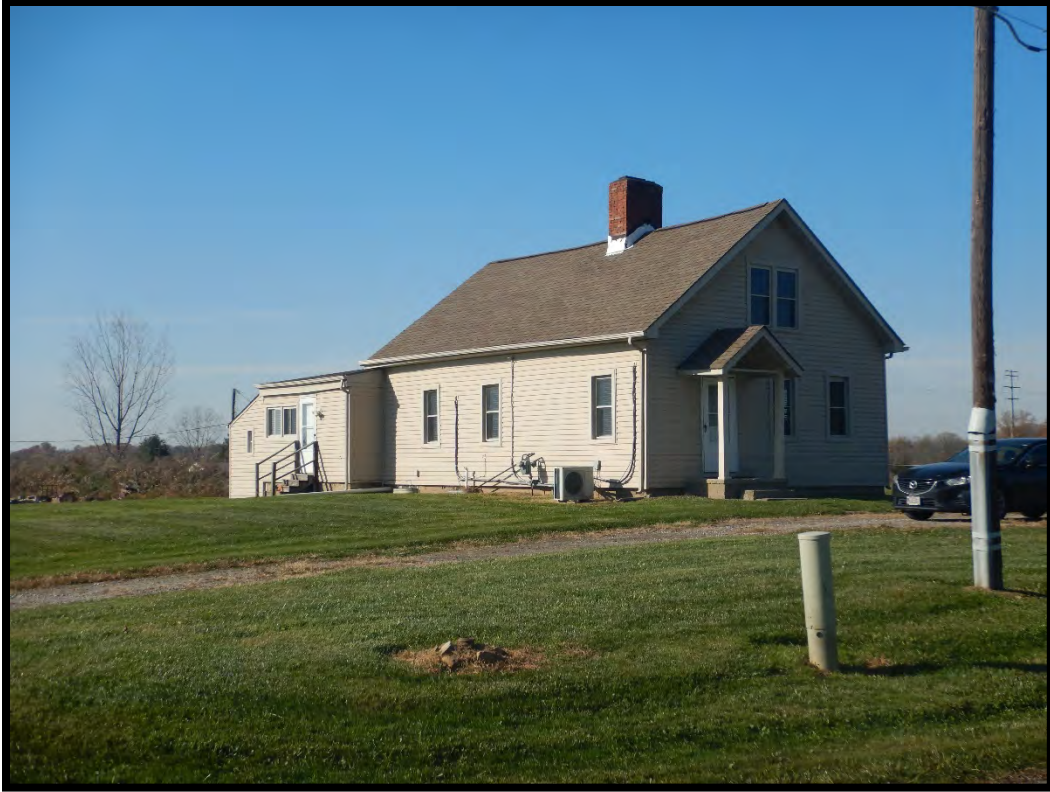
Figure 104. Northwest view of S-17/ LIC0155420 from York Road SW.

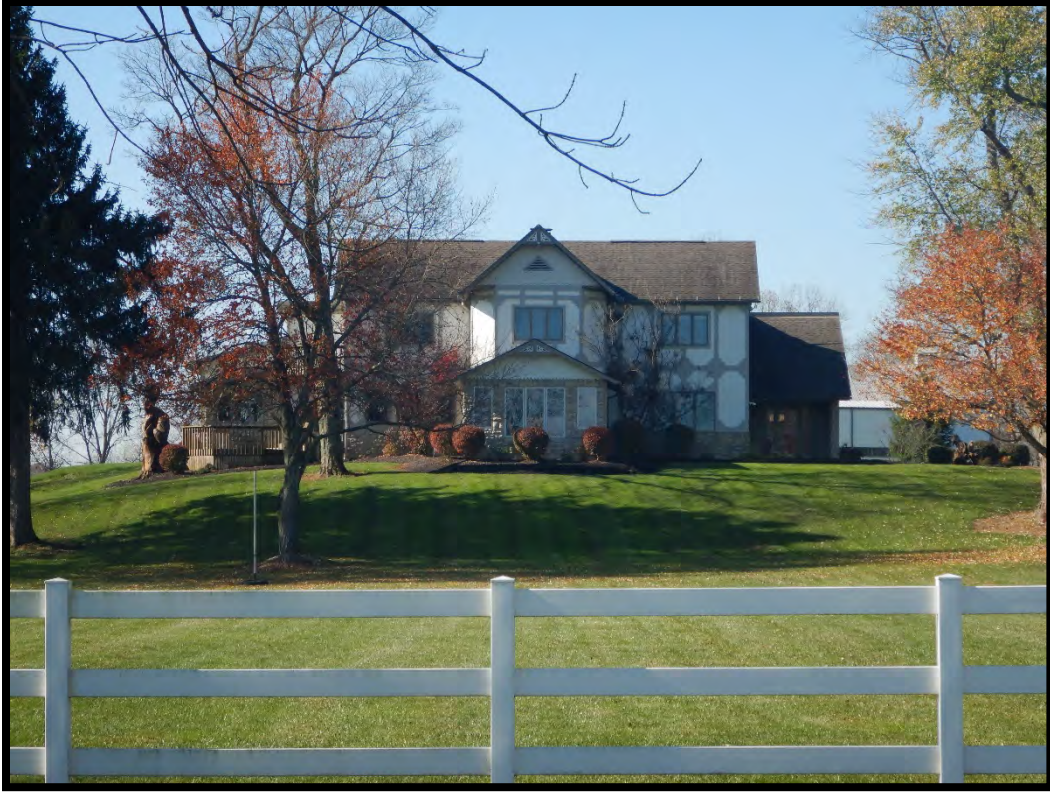
Figure 110. West view of S-23/ LIC0155320 from Watkins Road SW.

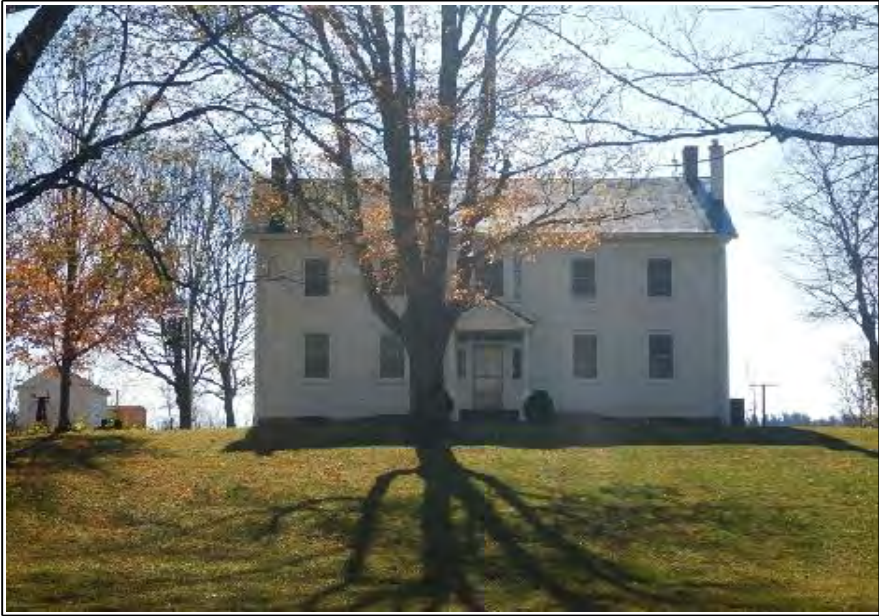
The resource is a two-story, frame, end-gable, Greek Revival house. The roof is covered in historic standing seam metal. The historic windows are six-over-six and the exterior walls are clad in historic clap board. The center window on the second floor has multi-pane sidelights. The pedimented porch is supported by round Doric columns standing on square plinths. The front door has an elaborate surround that includes Ionic pilasters and narrow panes of glass in the sidelights and transom.

The resource has all the exterior character-defining features that identify Greek Revival. Character-defining features exhibited in this resource include the low pitched roof, a wide band of trim at the cornice, multi-pane window sash, pediment porch supported by columns and the elaborate door surround that includes narrow panes of glass in the sidelights and transom. The property maintains superb integrity of exterior materials as the siding, trim, windows and porch all appear to be historic.

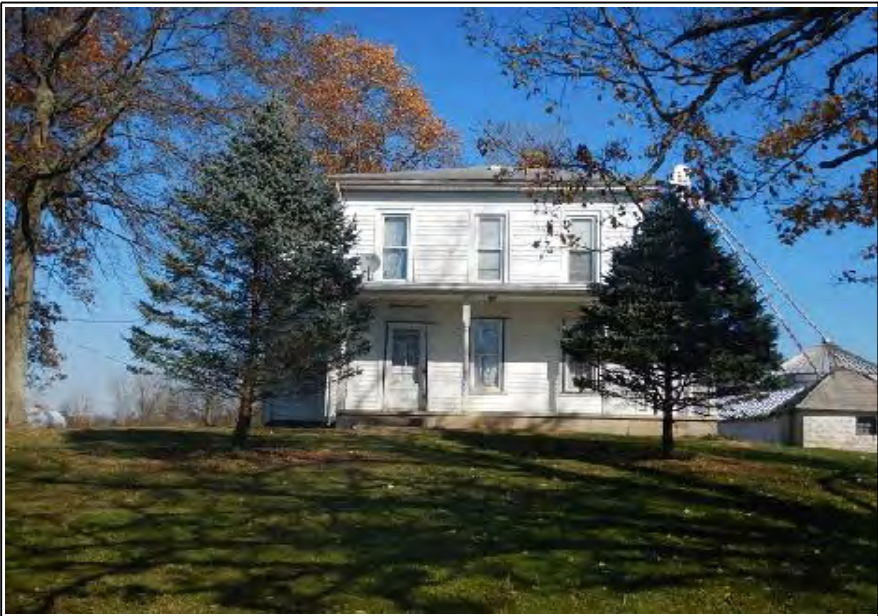
The resource is a two-story, frame, hipped cross-gable, Italianate house. The roof is covered in asphalt shingles and the exterior walls are clad in vinyl siding. The windows are modern replacements. A porch wraps around the southeast corner and is supported by turned wooden posts. A brick chimney is located off-center within the roof plane.

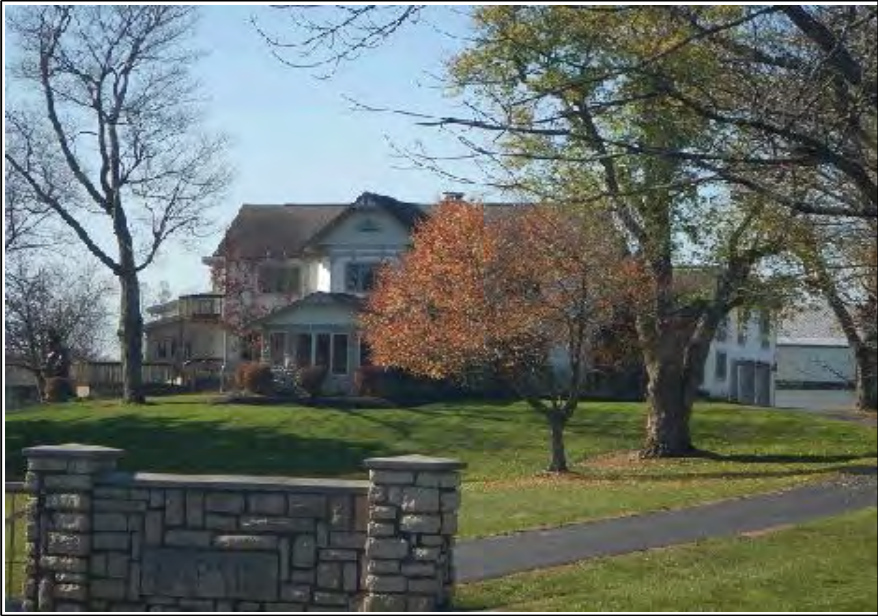
The resource is a two-story, frame, cross-gable, eclectic house. The roof is covered in asphalt shingles and the exterior walls are clad in stucco and stone veneer. The windows are modern replacements. A very large addition has been constructed at the rear (west) elevation. The front porch has been enclosed (or an addition constructed) obscuring the front door. The house appears to be highly altered.

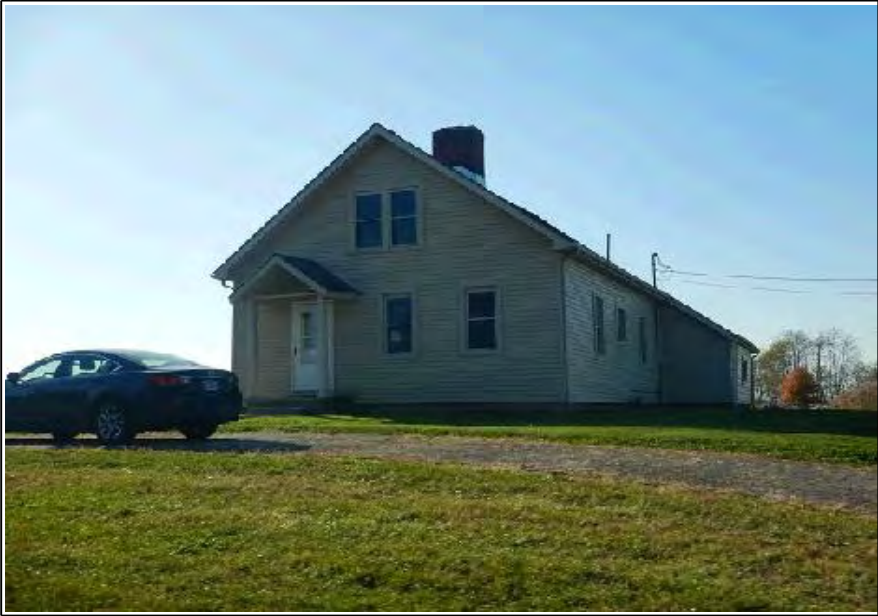
42. Further Description of Important Interior and Exterior Features
- The resource is a on and one half-story, frame, front-gable, vernacular house. The roof is covered in asphalt shingles and the exterior walls are clad in vinyl siding. The windows and front door are modern replacements. A small, pediment porch covers the front entrance and is supported by square wooden posts. A brick chimney is located center within the ridgeline. A lean-to addition has been constructed at the rear (west) elevation.

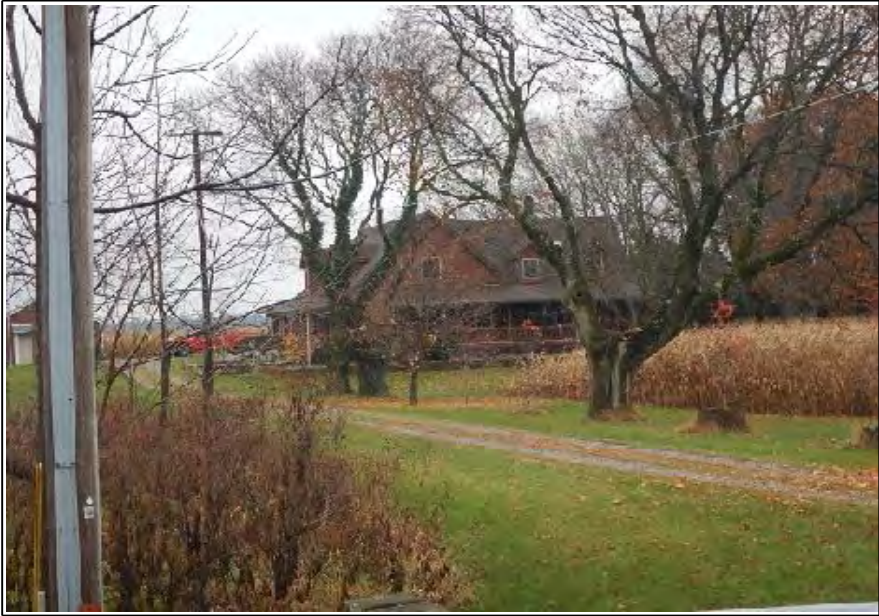
The resource appears to be a heavily modified and expanded one and one half-story, frame, front-gable, vernacular house. The roof is covered in asphalt shingles and the exterior walls are clad in wooden siding. The windows and exterior doors are modern replacements. Dormer windows pierce the roof at the west and south elevations. A large, covered porch and balustrade also wraps around the west and south elevations. A hyphenated garage has been constructed at the north elevation.

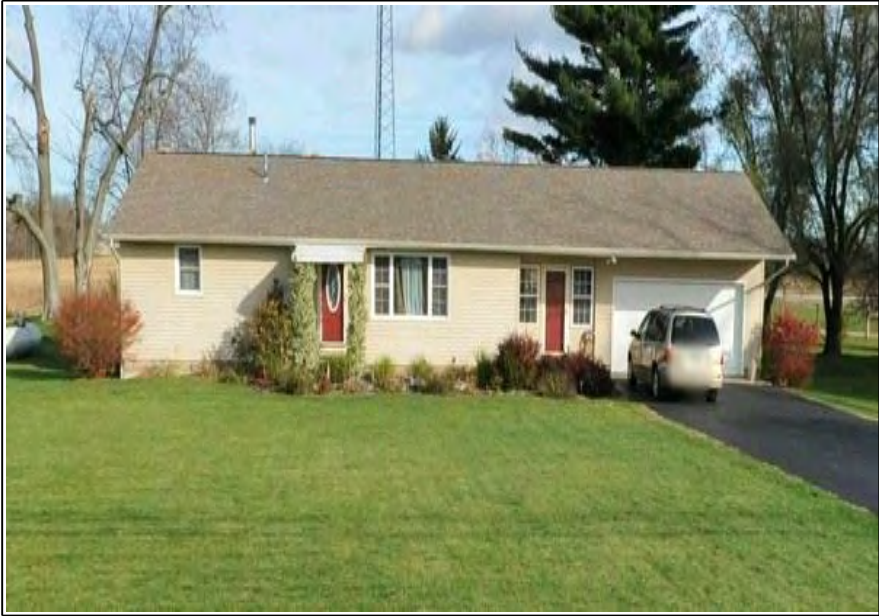
The resource is a one-story, frame, side-gable, vernacular Ranch house with integrated garage. The roof is covered in asphalt shingles and the exterior walls are clad in vinyl siding. The windows and exterior door are modern replacements. A small, shed porch covers the front entrance and is supported by metal posts. The house stands on a concrete block foundation. Typical of Ranch houses, the house has two front entrances, a large picture window and smaller secondary windows.

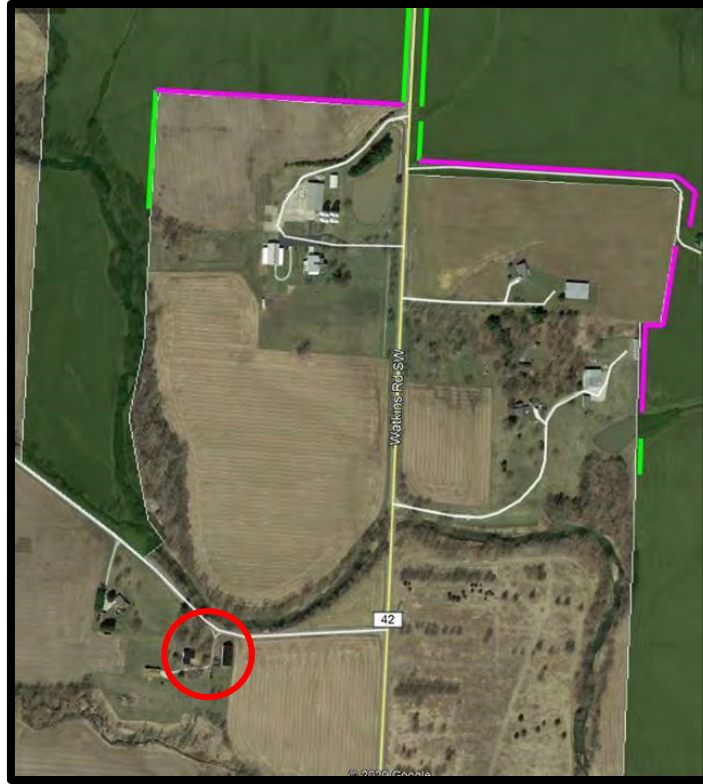
Exhibit A. Aerial image showing portion of project area, S-1/ LIC0155120, and proposed vegetative screens.
