# CONSTRUCTION NOTICE FOR HARMAR HILL 138- kV SWITCH INSTALL PROJECT

PUCO Case No. 21-0266-EL-BNR

**CONSTRUCTION NOTICE**  
**AEP Ohio Transmission Company, Inc. (AEP Ohio Transco)**  
**Harmar Hill 138-kV Switch Install Project**

The existing lattice frame switch will be replaced with a steel monopole phase-over-phase switch. The location of the Project is shown on Figure 1 in Appendix A.

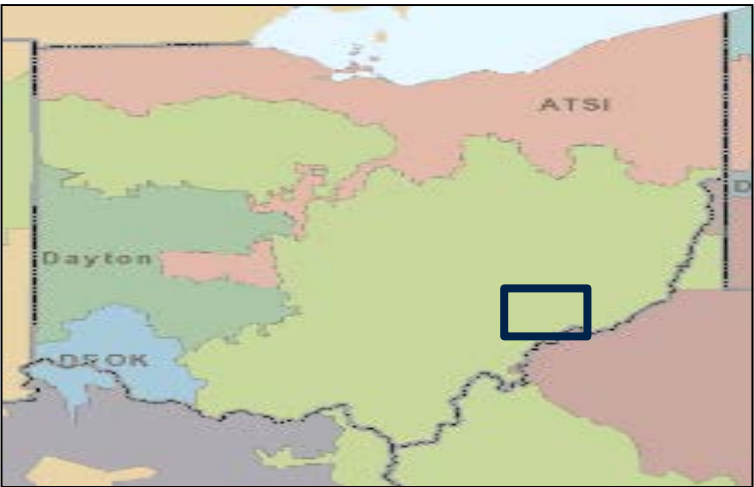
RJF is a customer owned substation that is served off a 138kV hard tap. Harmar Hill is served from a tap with a one way switch. Any line work along between Mill Creek and Gorsuch causes considerable outages to both customer loads. There is limited transfer capability at Harmar Hill and no transfer capability for RJF. AEP's internal guidelines justify sectionalizing on this line (FOI: 10.17).  
 Mill Creek will be replaced by a new substation Devola as part of an unrelated project (S1125).

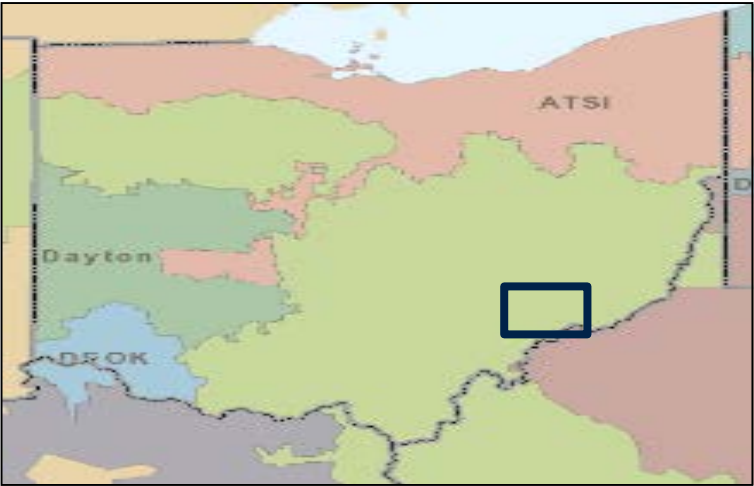
**Proposed Solution:**  
Install a 3-way, SCADA-controlled phase-over-phase switch at Harmar Hill to replace the one-way line switch on the Gorsuch – Mill Creek 138 kV circuit.
