Letter of Notification for Adjustment to Seaman-Adams 138 kV Line Rebuild Project

PUCO Case No. 21-0265-EL-BLN

Submitted to:
The Ohio Power Siting Board
Pursuant to Ohio Administrative Code
Section 4906-6-05

Submitted by:
AEP Ohio Transmission Company, Inc.

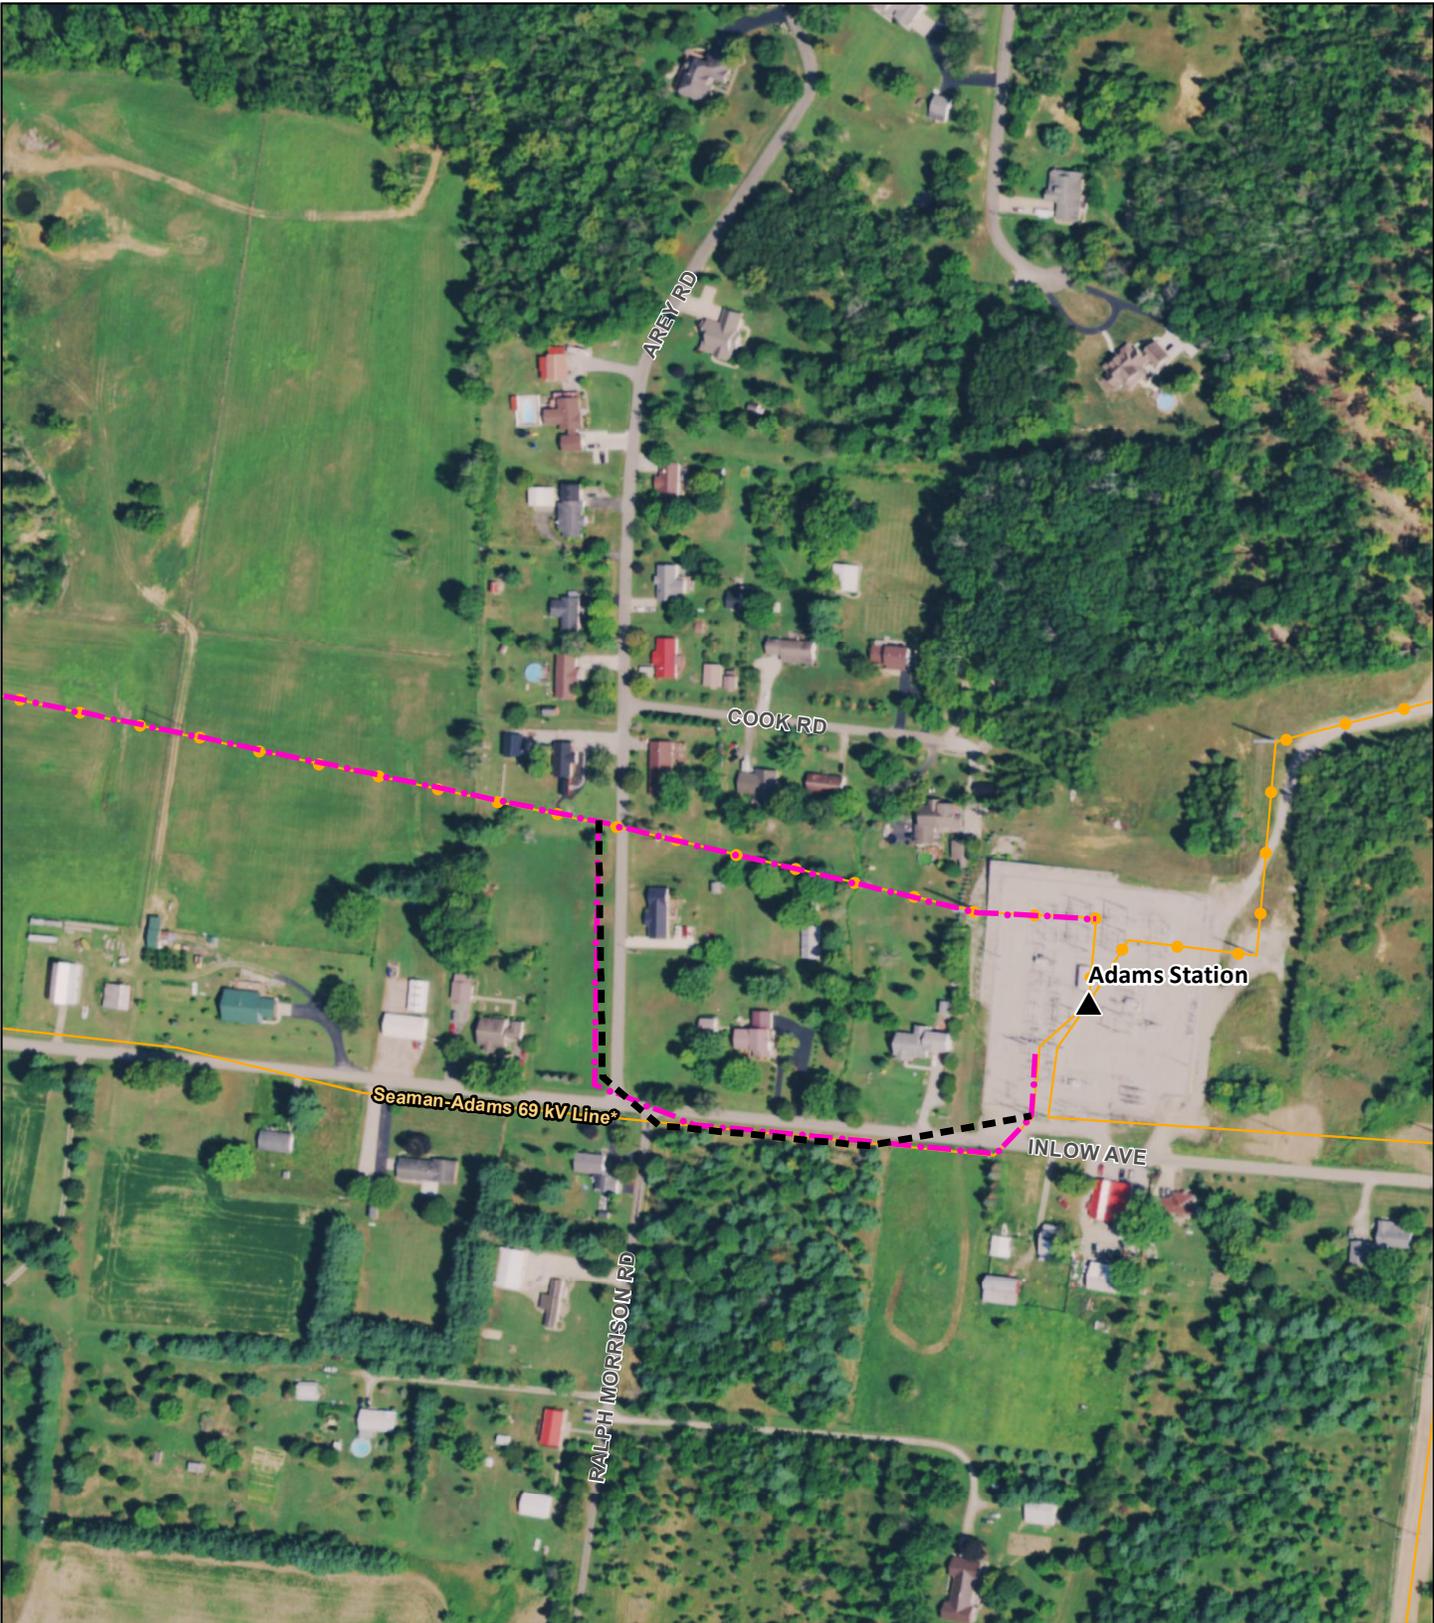
**FIGURE 1
TOPOGRAPHIC OVERVIEW
MAP**

Adjustment to
Seaman-Adams
138 kV Transmission
Rebuild Project

The Project is located in Meigs Township, Adams County, Ohio. Figures 1 and 2 in Appendix A show the location of the proposed Project in relation to existing facilities, including existing substations and transmission lines.

Appendix A, Figure 1 provides a map with existing and proposed facilities, and clearly marked roads and highways at 1:24,000, and Figure 2 provides an aerial showing project components, at a scale of 1:2,400.
