Hillsboro to Millbrook Park  
138 kV Transmission Line  
Rebuild Project

**Appendix A**  
**U.S. Army Corps of Engineers (USACE) Wetland**  
**Determination Forms – Midwest and Eastern**  
**Mountains & Piedmont Regions**

# WETLAND DETERMINATION DATA FORM – Midwest Region

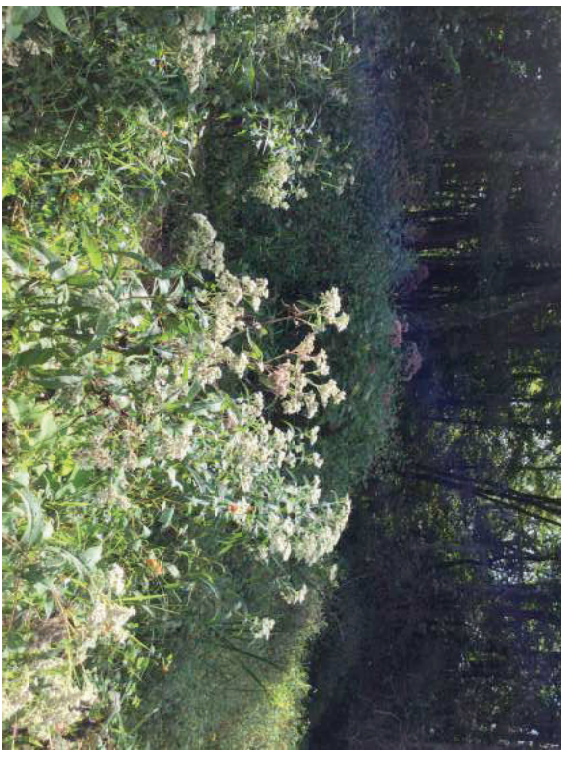
North

**Remarks:**  
 PEM hillside seep wetland. Soils are very dark--organic material likely masking redox concentrations. Very strong vegetation and hydrology indicators confirm wetland status.

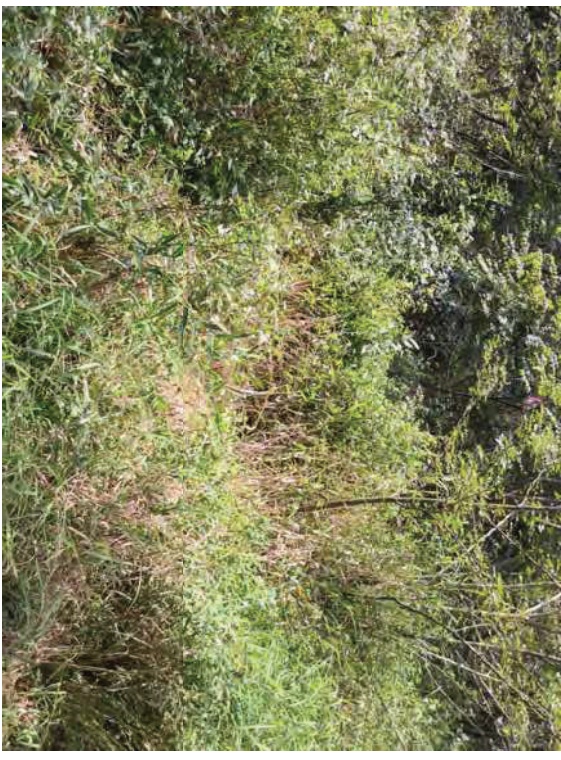
North

Data point for Wetland HM-002 (W-MJA-091719-01). This is a PEM situated under the T-Line ROW, surrounded by young forest and shrub/scrub.

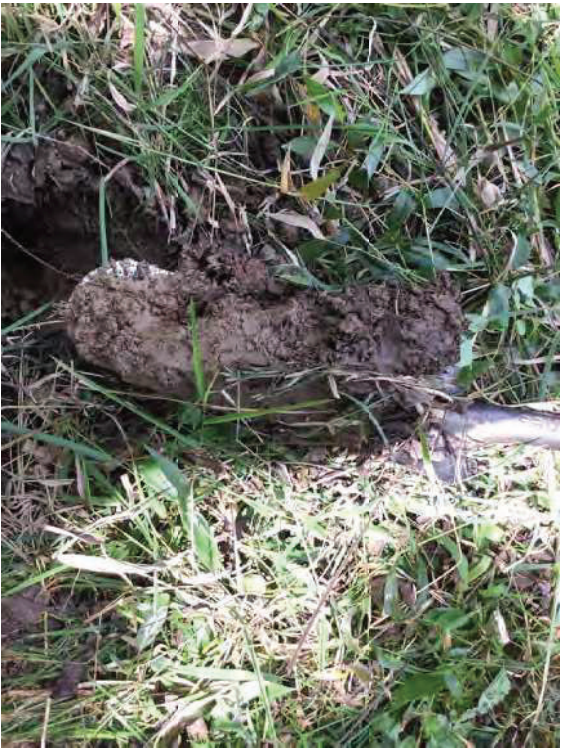
Soil Profile

Depth (inches)	Matrix		Redox Features			Texture	Remarks
	Color (moist)	%	Color (moist)	%	Type <sup>1</sup>		
0 - 10	10YR 4/2	85	5YR 4/6	15	C	PL	Silty loam Prominent Redox Concentrations
10 - 18	2.5Y 5/2	75	5YR 4/6	25	C	PL	Clay loam Prominent Redox Concentrations
-							
-							
-							
-							
-							
-							
-							
-

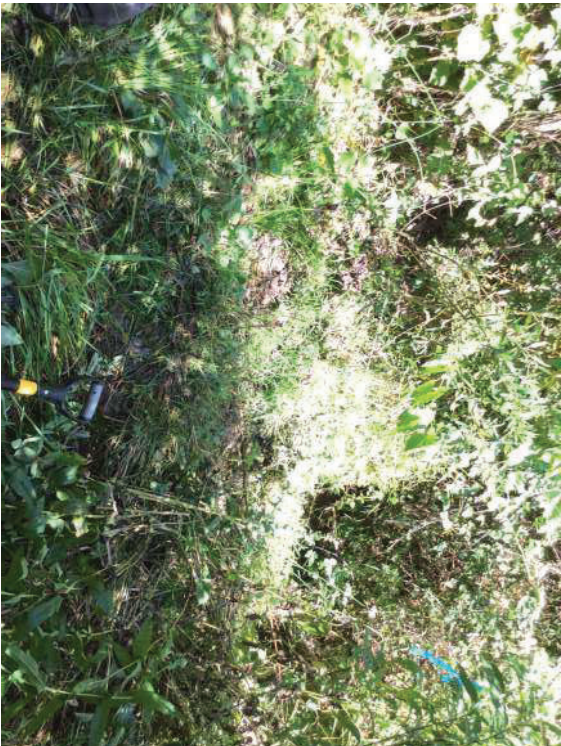
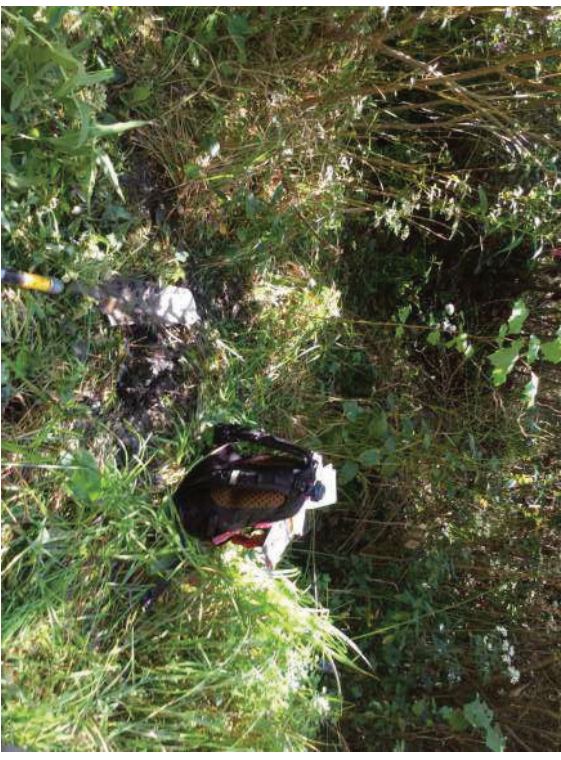
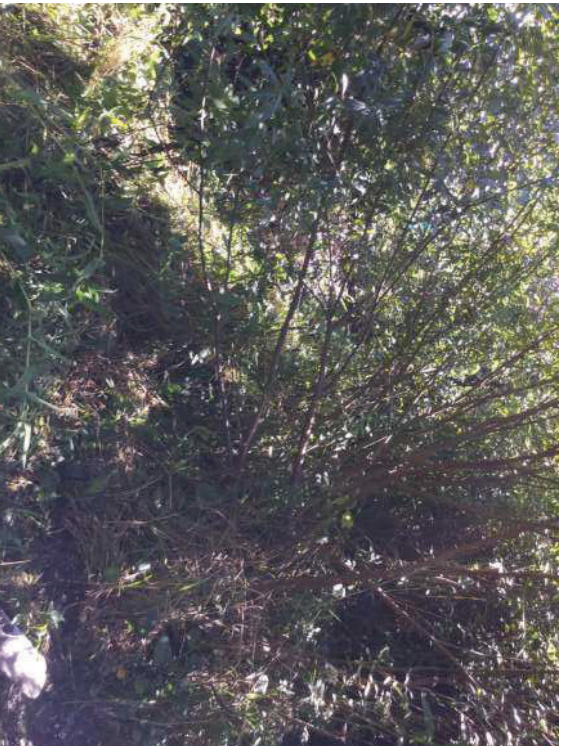
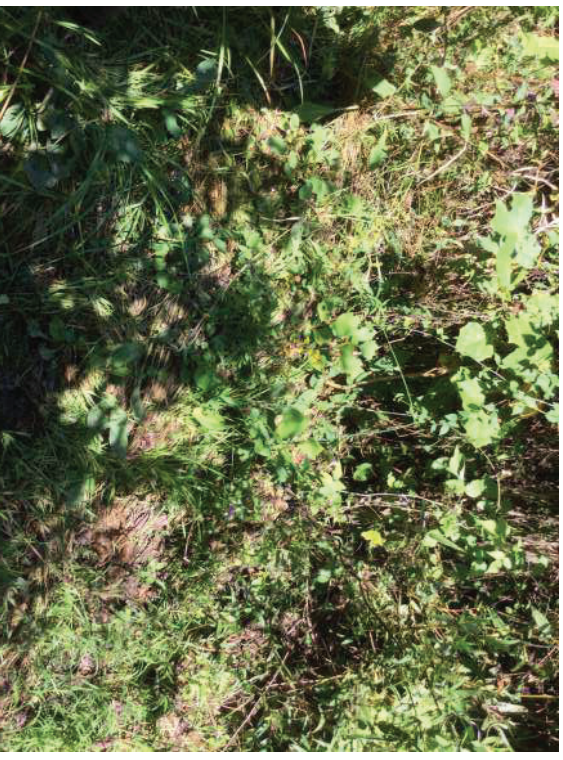
Saturation Present?	Yes <input type="checkbox"/> No <input type="checkbox"/>	Depth (inches):	<input type="text" value="0.00"/>
(includes capillary fringe)		<b>Wetland Hydrology Present?</b> Yes <input checked="" type="checkbox"/> No <input type="checkbox"/>	
Describe Recorded Data (stream gauge, monitoring well, aerial photos, previous inspections), if available:			
Remarks:			
Hillside seep.

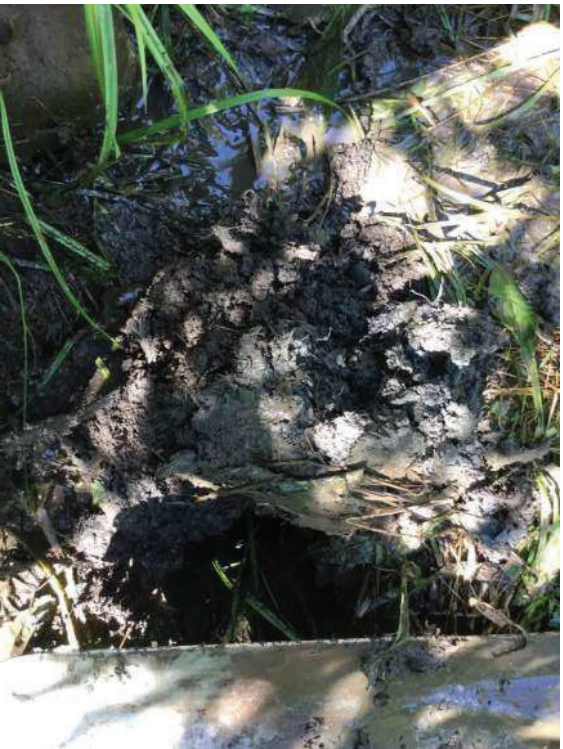
Soil Profile

Profile Description: (Describe to the depth needed to document the indicator or confirm the absence of indicators.)						
Depth (inches)	Matrix Color (moist)	%	Redox Features		Texture	Remarks
			Color (moist)	%		
0 - 6	10YR 2/1	100	/		Silt	Some grit
6 - 18	10YR 3/1	100	/		Silt	Some grit

<b>Restrictive Layer (if observed):</b> No						
Type: _____ Depth (inches): _____					Hydric Soil Present?    Yes <input checked="" type="checkbox"/> No _____	
Remarks: Very dark soils. Organic material likely masking redox concentrations.

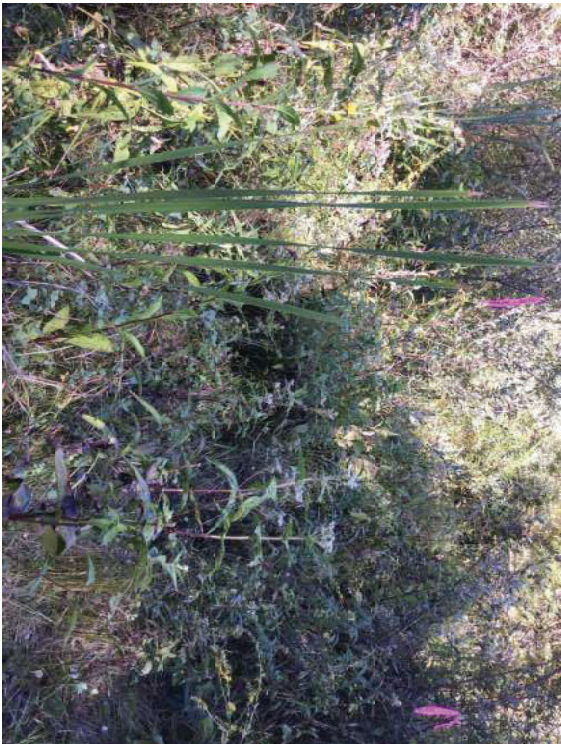
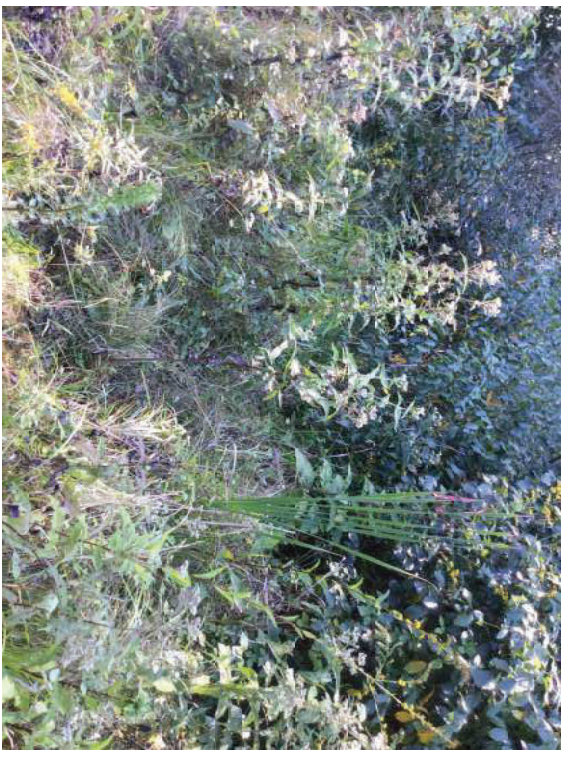
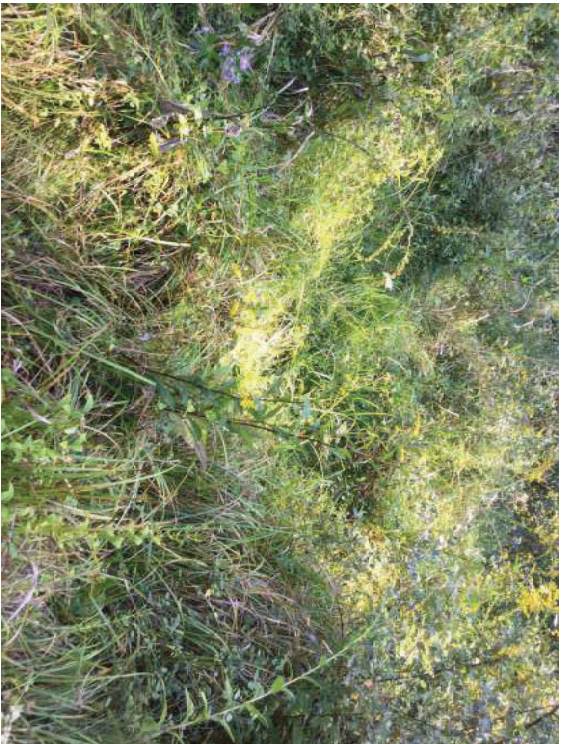
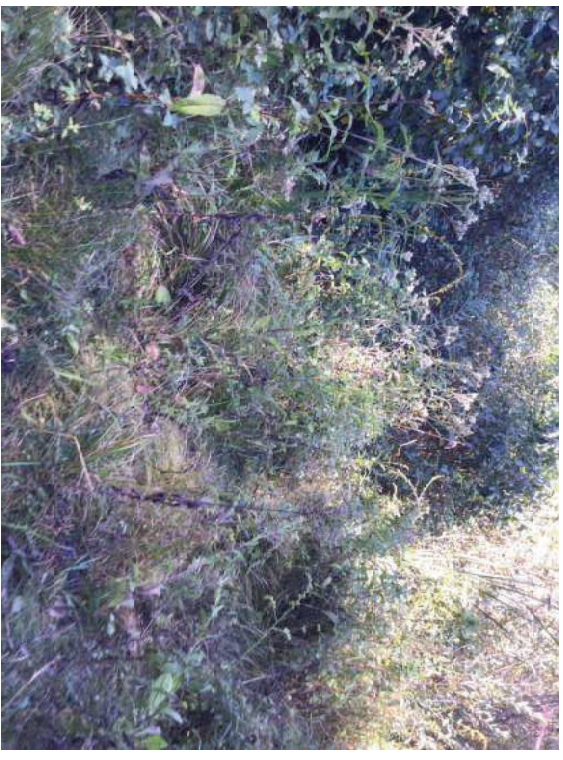
Hillside seep.

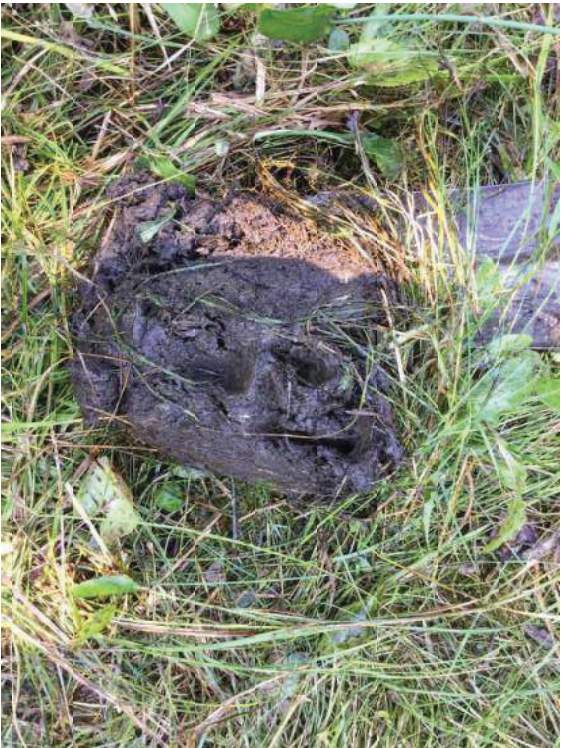
Soil Profile

Depth (inches)	Matrix		Redox Features			Texture	Remarks
	Color (moist)	%	Color (moist)	%	Type <sup>1</sup>		
0 - 18	10YR 2/1	100				Silt	Organic, some grit
-							
-							
-							
-							
-							
-							
-							
-

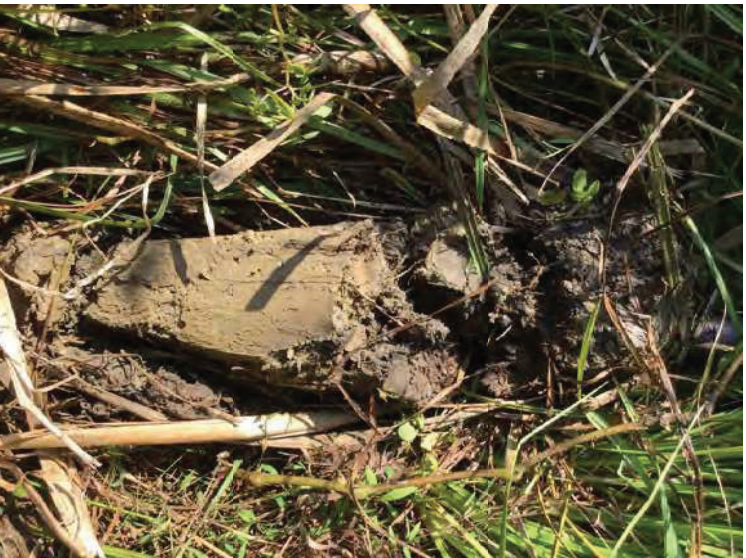
Soil Profile

Depth (inches)	Matrix		Redox Features			Texture	Remarks
	Color (moist)	%	Color (moist)	%	Type <sup>1</sup>		
0 - 4	10YR 3/2	95	5YR 4/4	5	C	M	Silty loam Prominent Redox Concentrations
4 - 18	10YR 5/2	60	10YR 5/6	40	C	M	Clay loam Prominent Redox Concentrations
