January 27, 2021
Project No. 20212714.001A

**Subject: Geotechnical Report
Union Ridge Solar Project
Licking County, Ohio**

**GEOTECHNICAL REPORT
UNION RIDGE SOLAR PROJECT
LICKING COUNTY, OHIO
KLEINFELDER PROJECT NO. 20212714.001A**

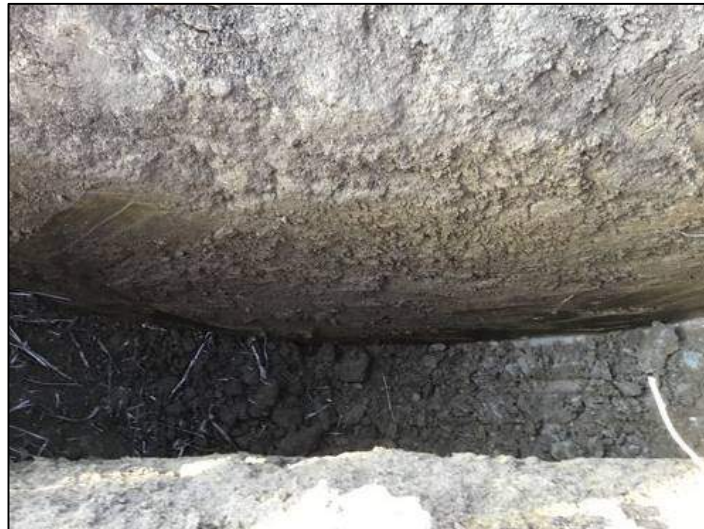
GROUNDWATER LEVEL INFORMATION:
Groundwater was not observed during excavation or after completion.

GENERAL NOTES:
A iPad integrated GPS unit was used to locate the exploration with an accuracy of 5 meters.

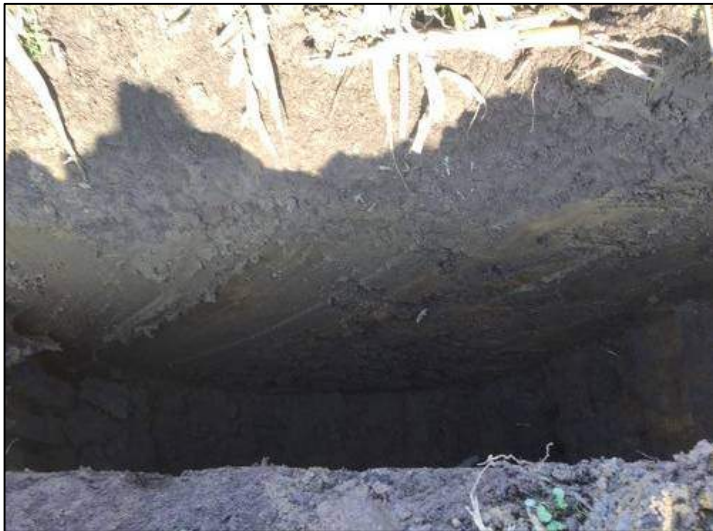
CL	22.9		89	51	31	13	ASTM D698 Method B= Max. Dry Unit Wt.: 111.4 pcf Opt. Water Content: 13.3%	
	Sandy Lean CLAY (CL): yellowish brown, moist, trace gravel											
5	Lean CLAY with Sand (CL): light brownish gray, moist, trace gravel											
10	<p>The test pit was terminated at approximately 8 ft. below ground surface. The test pit was backfilled with excavated material on December 09, 2020.</p> <p>GROUNDWATER LEVEL INFORMATION: Groundwater was not observed during excavation or after completion. GENERAL NOTES: A iPad integrated GPS unit was used to locate the exploration with an accuracy of 5 meters.</p>
