Letter of Notification for Bellefonte Extension 138 kV Line Rebuild Project

PUCO Case No. 21-0111-EL-BLN

May 27, 2021

**AEP Ohio Transmission Company, Inc. (AEP Ohio Transco)
Bellefonte Extension 138 kV Line Rebuild Project**

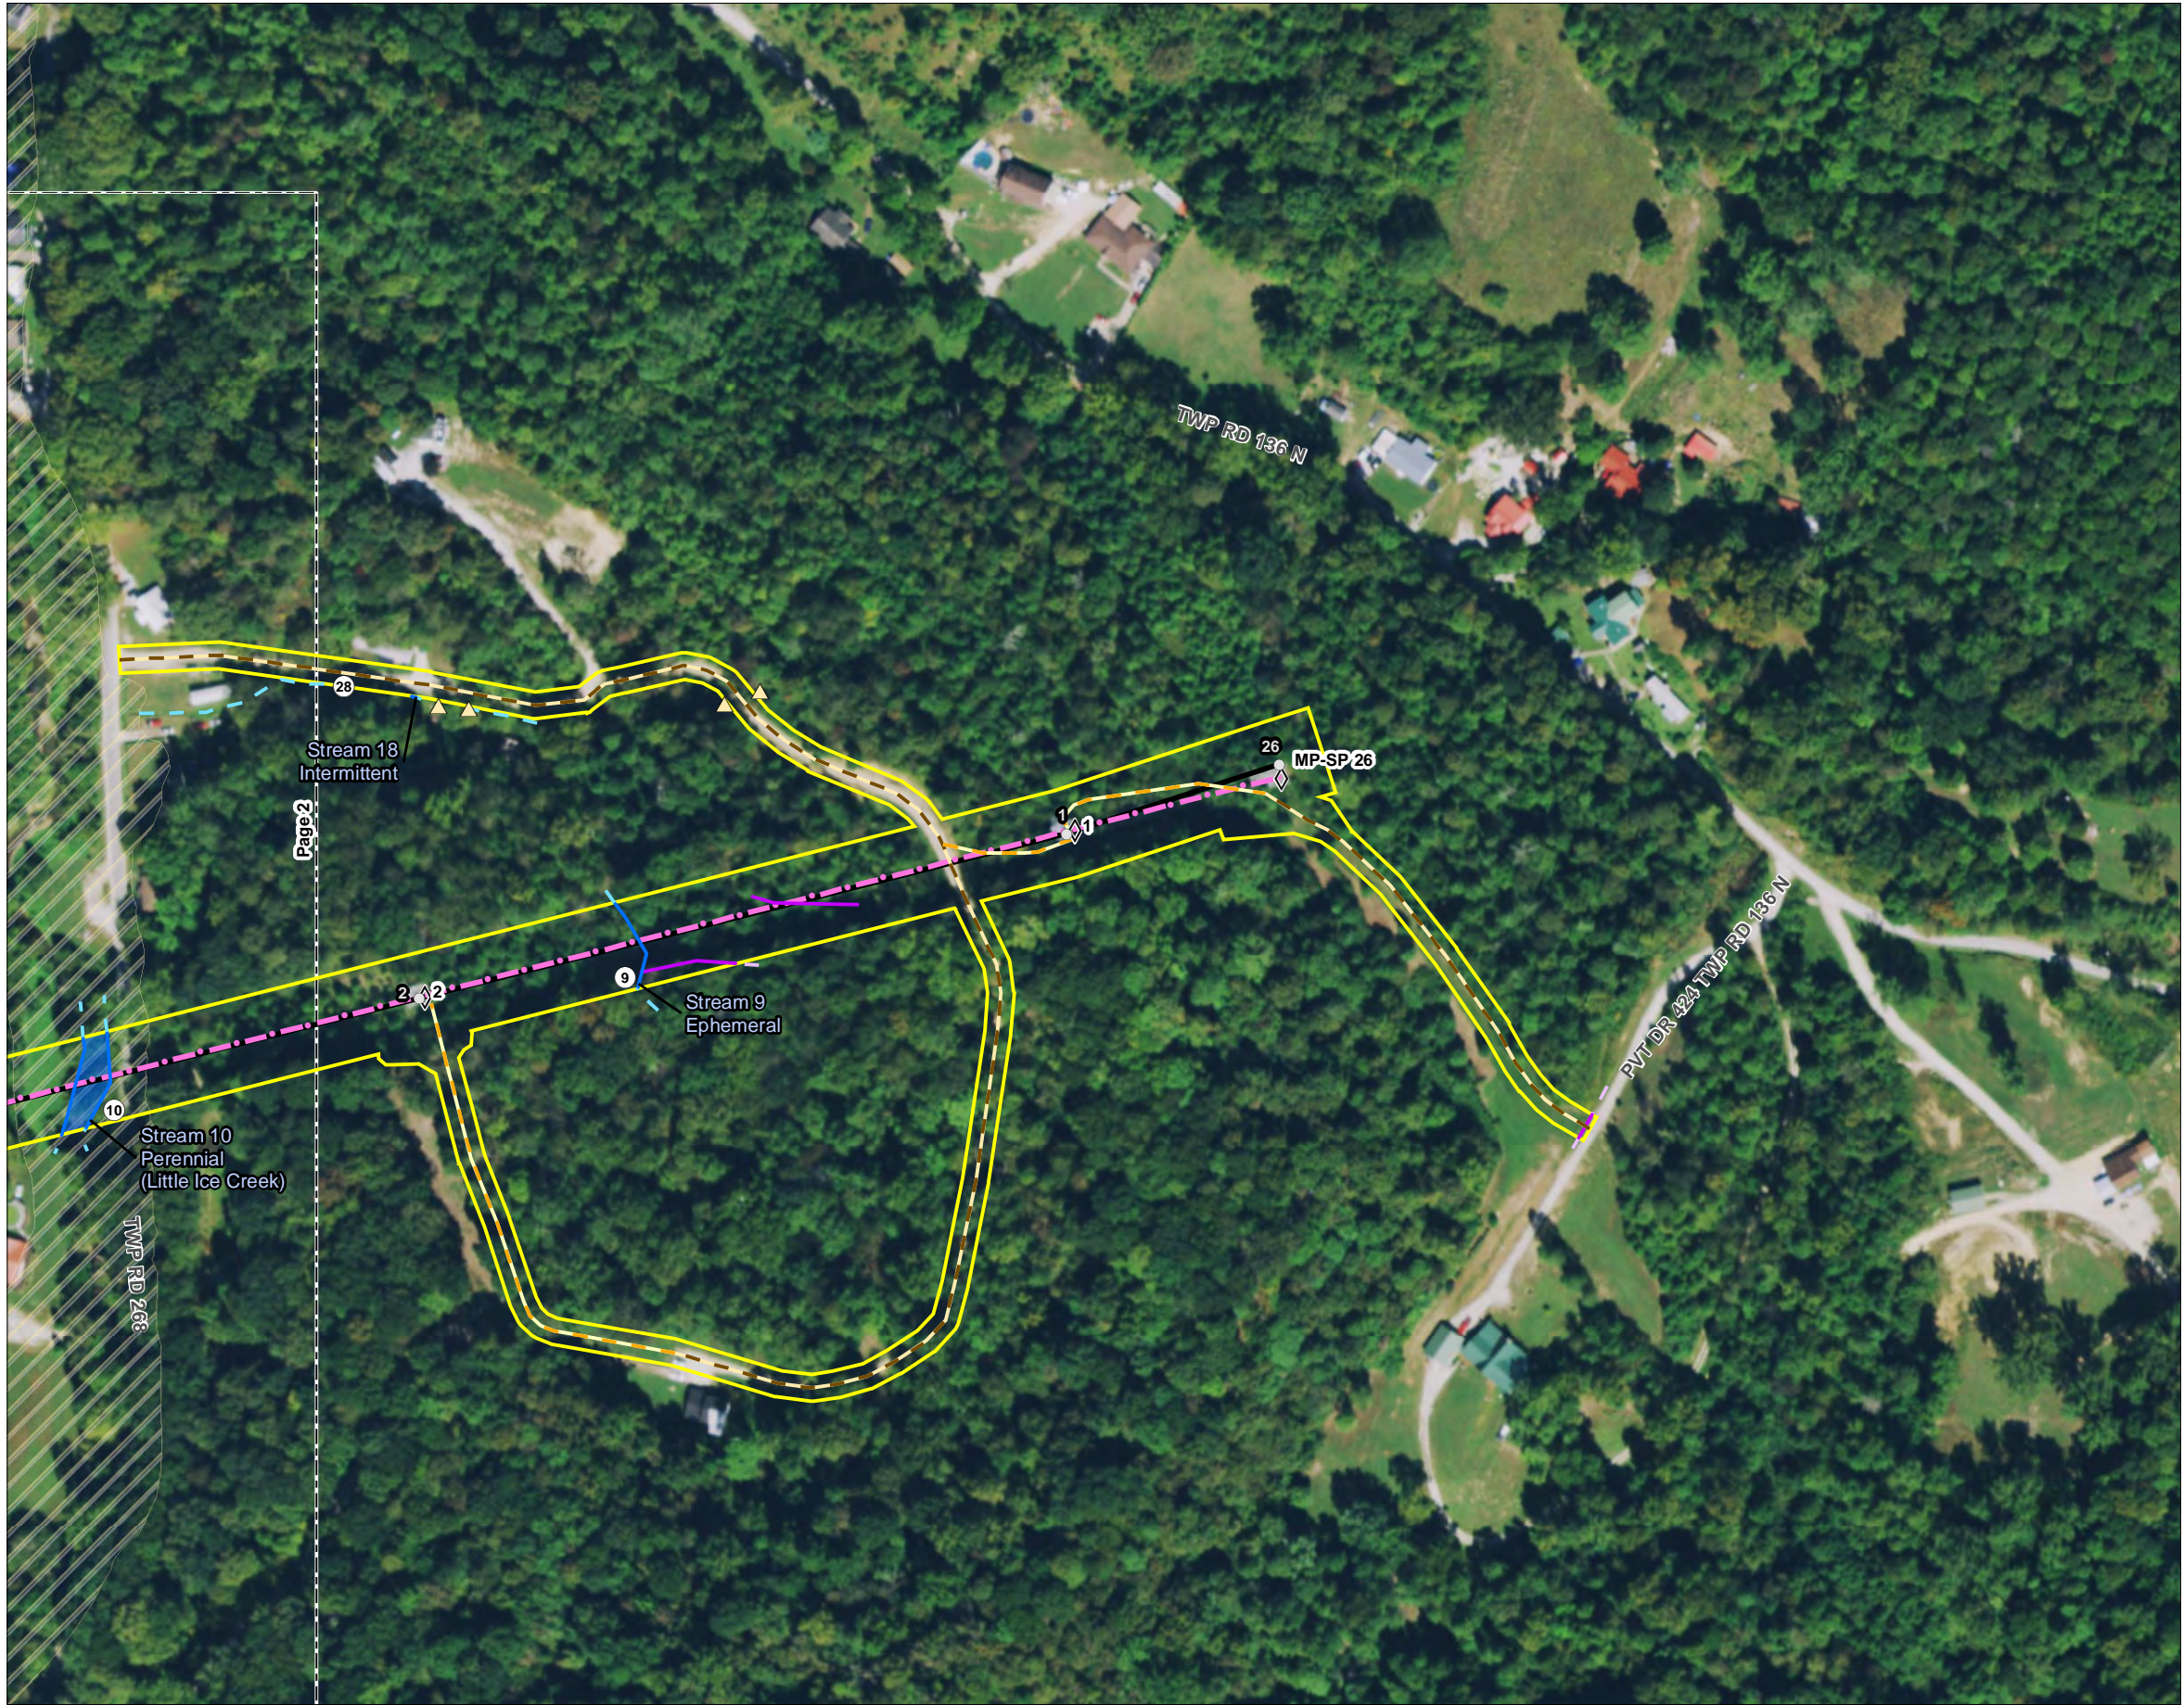
Figure No.
2

Title
Wetland and Waterbody
Delineation Map
