WETLAND AND WATERBODY DELINEATION REPORT FOR THE CADENCE SOLAR ENERGY CENTER, UNION COUNTY, OHIO

JANUARY 2021

**SWCA Environmental Consultants**

SWCA Project No. 58990

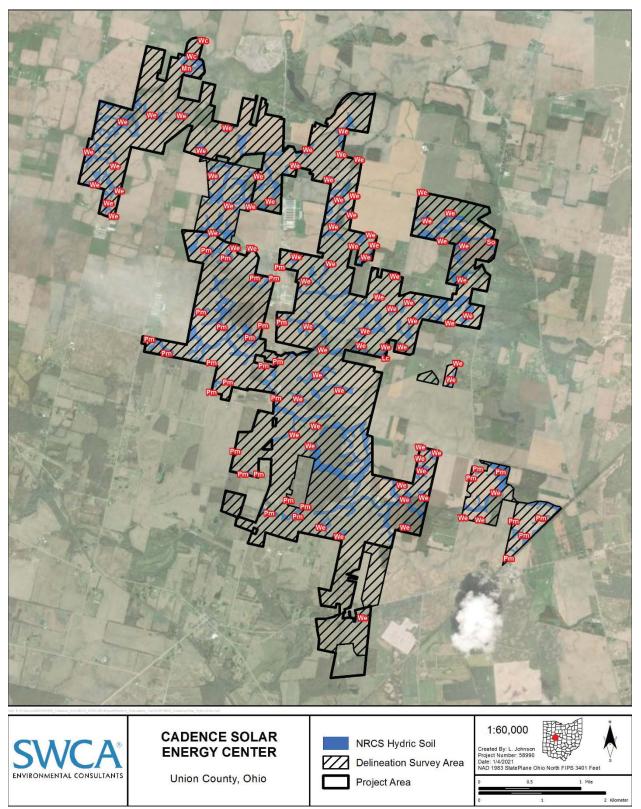
Figure 3. Soil Map Units within the Cadence Solar Energy Center, Union County, Ohio, 2020.

Thirty mapped soil types are present within the Project Area according to the USDA NRCS (2020; Table 1). Figure 4 shows geographic extent of hydric soil map units. Hydric soils are those that formed under conditions of flooding, saturation, or ponding for a long enough period during the growing season, developing anaerobic conditions (Federal Register 1994). These soils are saturated long enough during the growing season to support the growth and reproduction of hydrophytic vegetation and have distinctive color patterns within the upper layers. Presence of hydric soils is one of the three parameters required to make a wetland determination in a given location. However, the designation of "hydric" for a given soil map unit assigned by NRCS (Table 1) does not satisfy the hydric soil parameter requirement under the routine USACE wetland determination methods; documentation of hydric soil indicators in the field is necessary to confirm hydric soils for the purposes of wetland delineation.

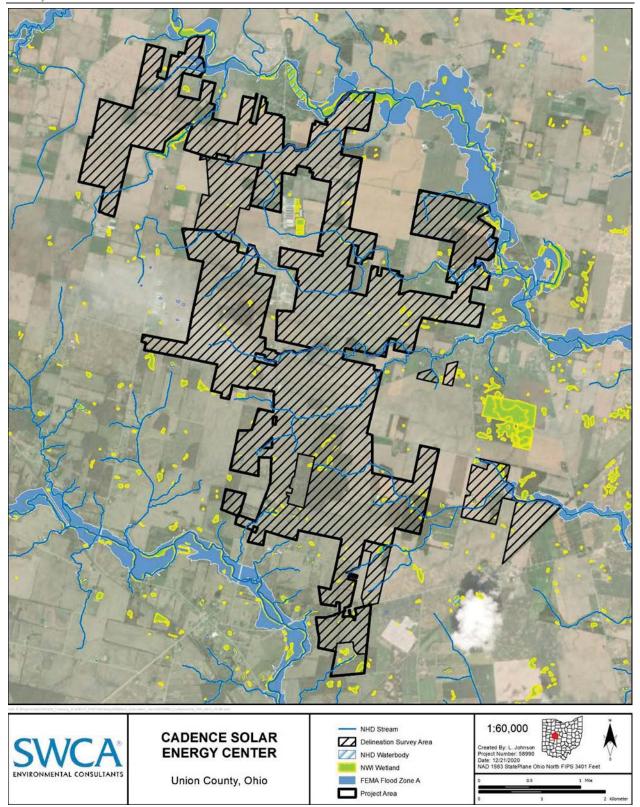
Figure 4. National Wetlands Inventory, National Hydrography Dataset, and Flood Zone map of the Cadence Solar Energy Center, Union County, Ohio, 2020.

Topography within the Project Area is relatively flat, with the elevation ranging from approximately 989 to 1,087 feet above mean sea level. A review of the FEMA National Flood Hazard Layer (Figure 4) showed that 60.28 acres of the Project Area is located within Zone A (areas subject to inundation by the 1-percent-annual-chance flood event) of the 100-year floodplain (FEMA 2020).

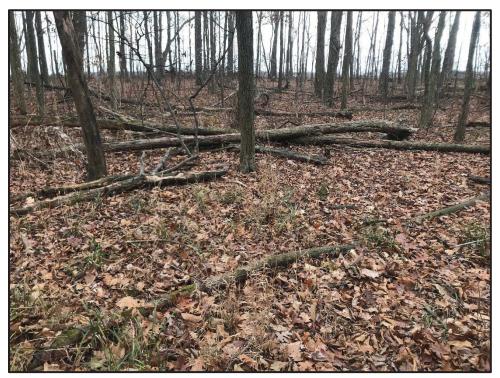
Photograph 5. PEM Wetland WA05, view facing north (December 11, 2019 by D. Carson).

WA05 is a depressional wetland at the confluence of a drainage swale and a roadside ditch. It appears that a broken drain tile system provides the hydrology for this wetland. SWCA has determined, using the ORAM methodology, that WA05 is a Category 1 wetland.

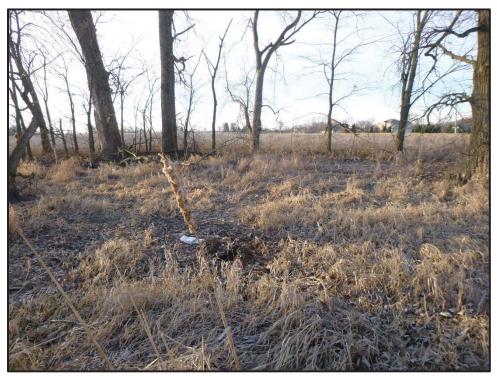
Photograph 61. PFO Wetland WC05, view facing north (January 8, 2020 by K. Barnett.

Wetland WC05 is depressional PFO wetland located within a disturbed, though recovering woodlot adjacent to SB17. While no discreet surface channel was observed, this feature is likely to be considered jurisdictional due to connectivity to SB17. This wetland is buffered by upland deciduous forest and stream bank. SWCA has determined, using the ORAM methodology, that WC05 falls within the "gray zone" for Category 1 or 2 and thus defaults to Category 2.

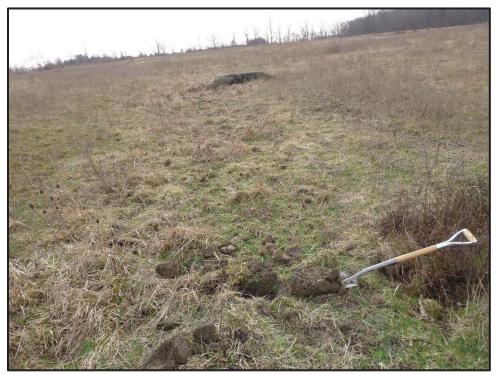
Photograph 68. PEM Wetland WC12, view facing south (January 9, 2020 by K. Barnett).

Wetland WC12 is a linear depressional PEM wetland located within an actively grazed pasture, which is connected to SC03 by a culvert. The vegetation, hydrology, and soil are significantly affected by the livestock within this field. Further, a drain tile system had been installed in low-lying areas, however there was evidence that the system had failed, further altering hydrology. This wetland is buffered by upland pastures. SWCA has determined, using the ORAM methodology, that WC12 is a Category 1 wetland.

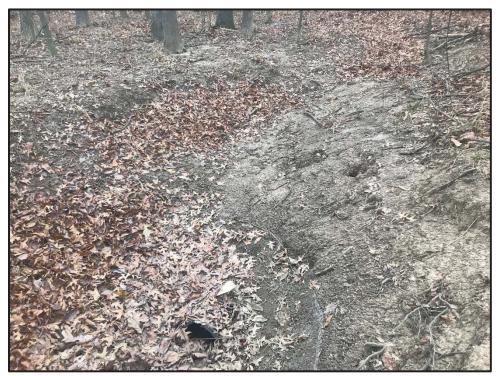
Photograph 74. Downstream view of SA03, (December 10, 2019 by D. Carson).

Stream SA03 is an ephemeral UNT to Bokes Creek flowing southeast to northwest through the Project Area. Its hydrology appears to have been severely impacted by a drain tile system that has fallen into disrepair, resulting in an irregular and inconsistent channel. No macrobenthos or fish were observed within the stream reach.

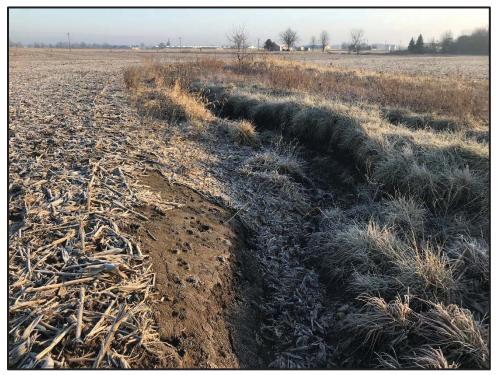
Photograph 79. Upstream view of SA08, (January 16, 2020 by D. Carson).

SA08 is an ephemeral UNT to Bokes Creek flowing from west to east through the Project Area. This stream is supported by hydrology provided from drain tile systems in adjoining fields. An erosional feature with an inconsistent channel that appears to have been scoured by heavy rains prior to survey also supports this stream. The stream ends in a drain tile system on the eastern terminus of the reach as depicted in mapping provided in Appendix A. No macrobenthos or fish were observed within the stream reach.

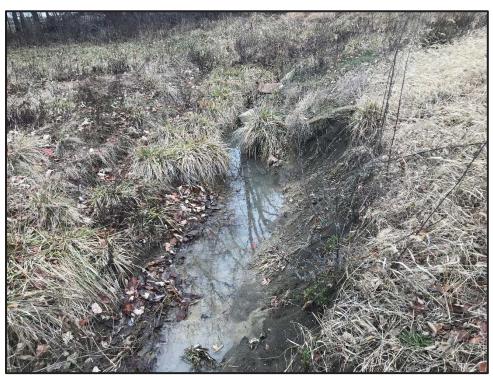
Photograph 81. Upstream view of SA10, (January 14, 2020 by D. Carson).

SA10 is an ephemeral UNT to Powder Lick Run (SB08) that flows from west to east through the Project Area. This stream is supported by hydrology provided from drain tile systems in the adjoining field. No macrobenthos or fish were observed within the stream reach.
