Construction Notice Southwest Lima-West Moulton and St Mary's- West Moulton 138 kV Transmission Line Adjustment Project

PUCO Case No. 21-0893-EL-BNR

Submitted by:
Ohio Power Company

October 1, 2021

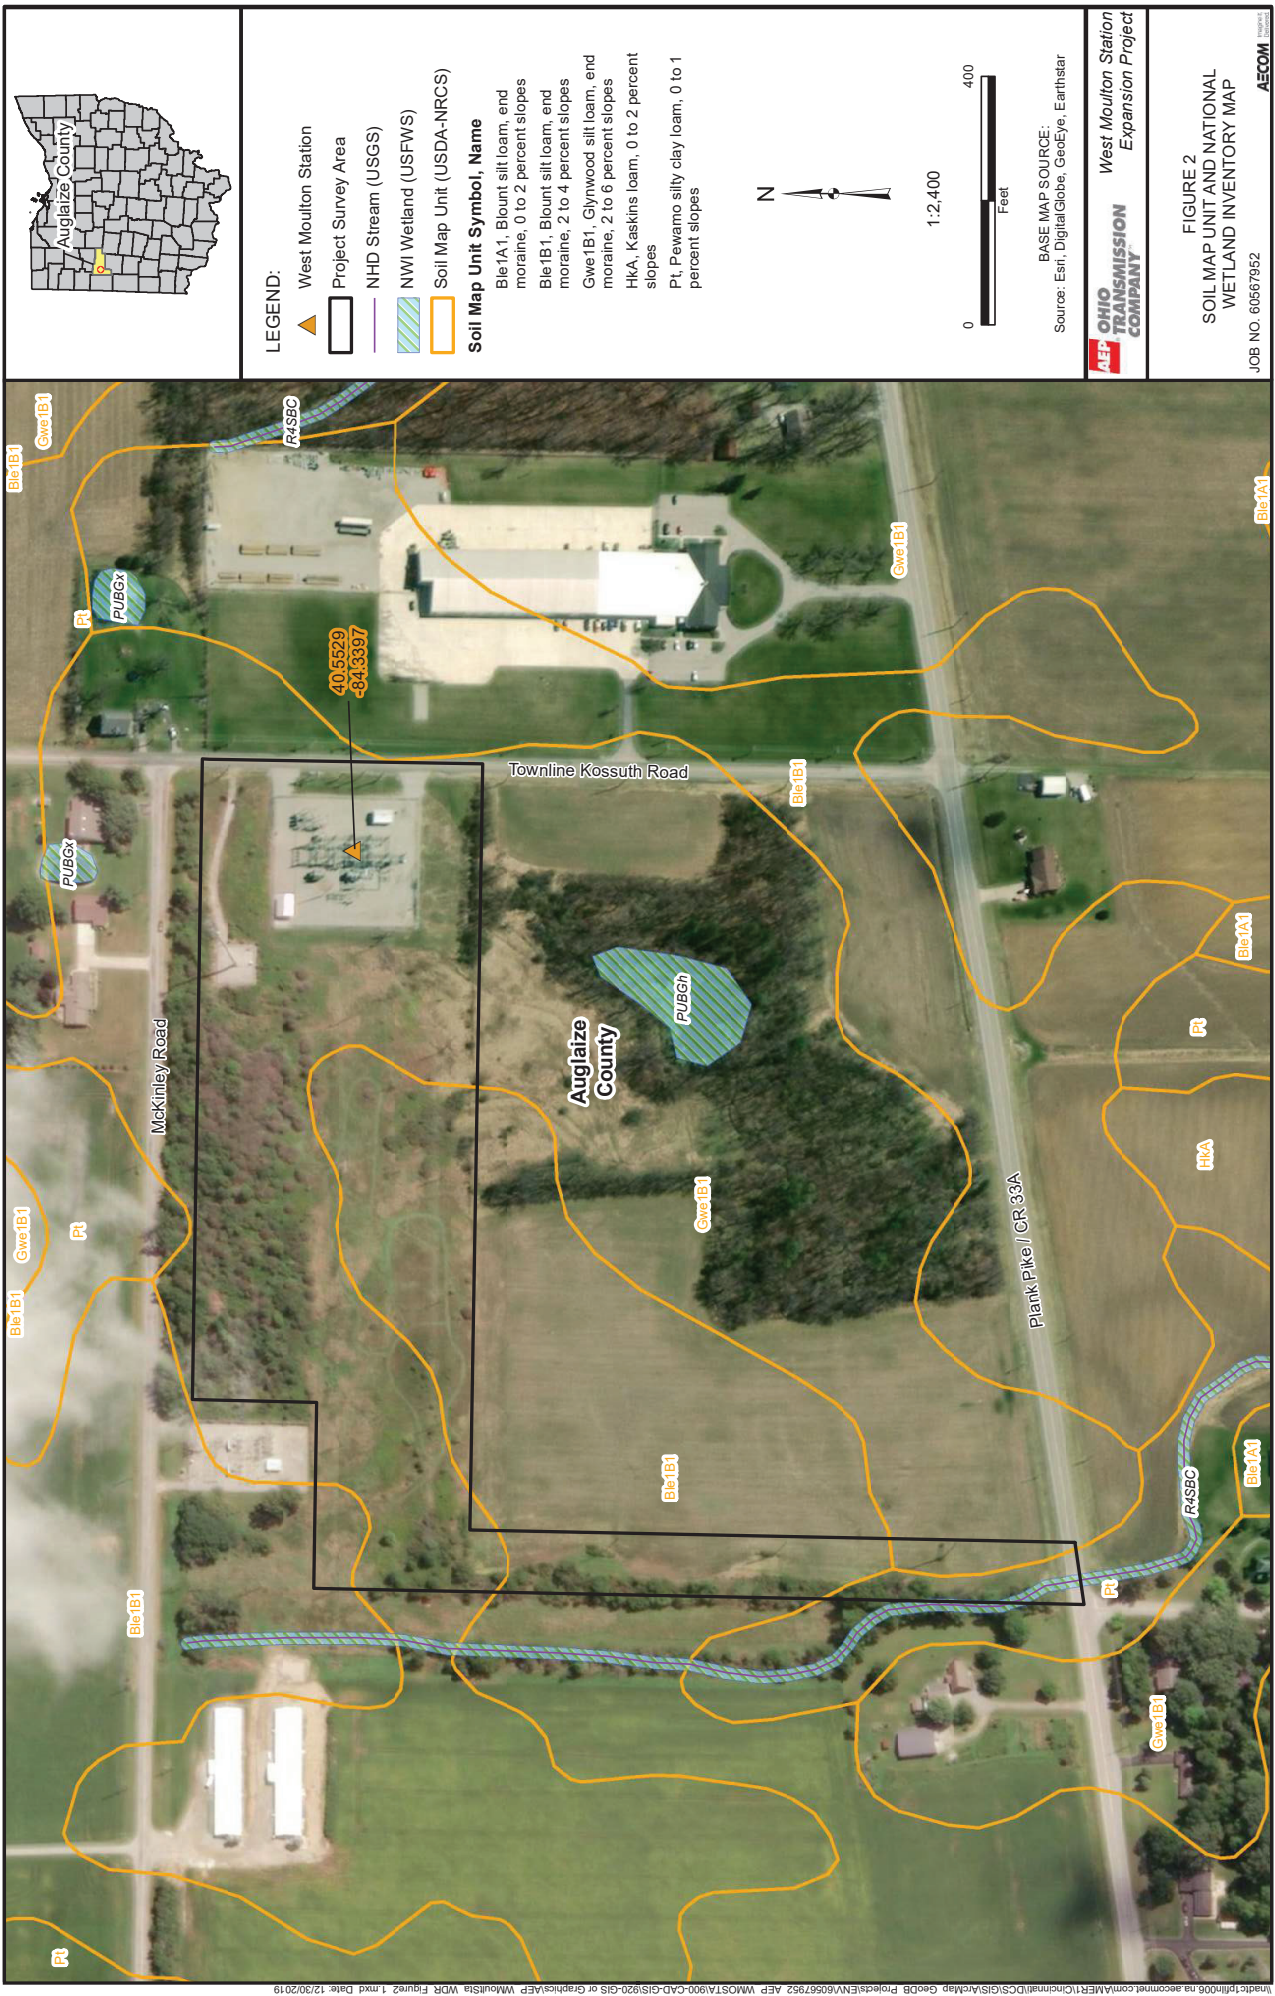
- West Moulton Station
 - Project Survey Area
 - NHD Stream (USGS)
 - NWI Wetland (USFWS)
 - Soil Map Unit (USDA-NRCS)
- Soil Map Unit Symbol, Name**
- Ble1A1, Blount silt loam, end moraine, 0 to 2 percent slopes
 - Ble1B1, Blount silt loam, end moraine, 2 to 4 percent slopes
 - Gwe1B1, Glynwood silt loam, end moraine, 2 to 6 percent slopes
 - H1A, Kaskins loam, 0 to 2 percent slopes
 - Pt, Pewamo silty clay loam, 0 to 1 percent slopes

Soils in delineated wetlands were observed and documented as part of the delineation methodology. According to the USDA NRCS Web Soil Survey of Auglaize County, Ohio, and the USDA NRCS Hydric Soils Lists of Ohio, three soil types are mapped within the Project survey area (NRCS, 2019). One soil map unit is identified as hydric, while the other map unit has hydric components that may comprise nine percent of the area mapped within the unit. Table 1 provides a detailed overview of all soil series and soil map units within the Project survey area. Soil map units located within the Project survey area are shown on Figure 2.

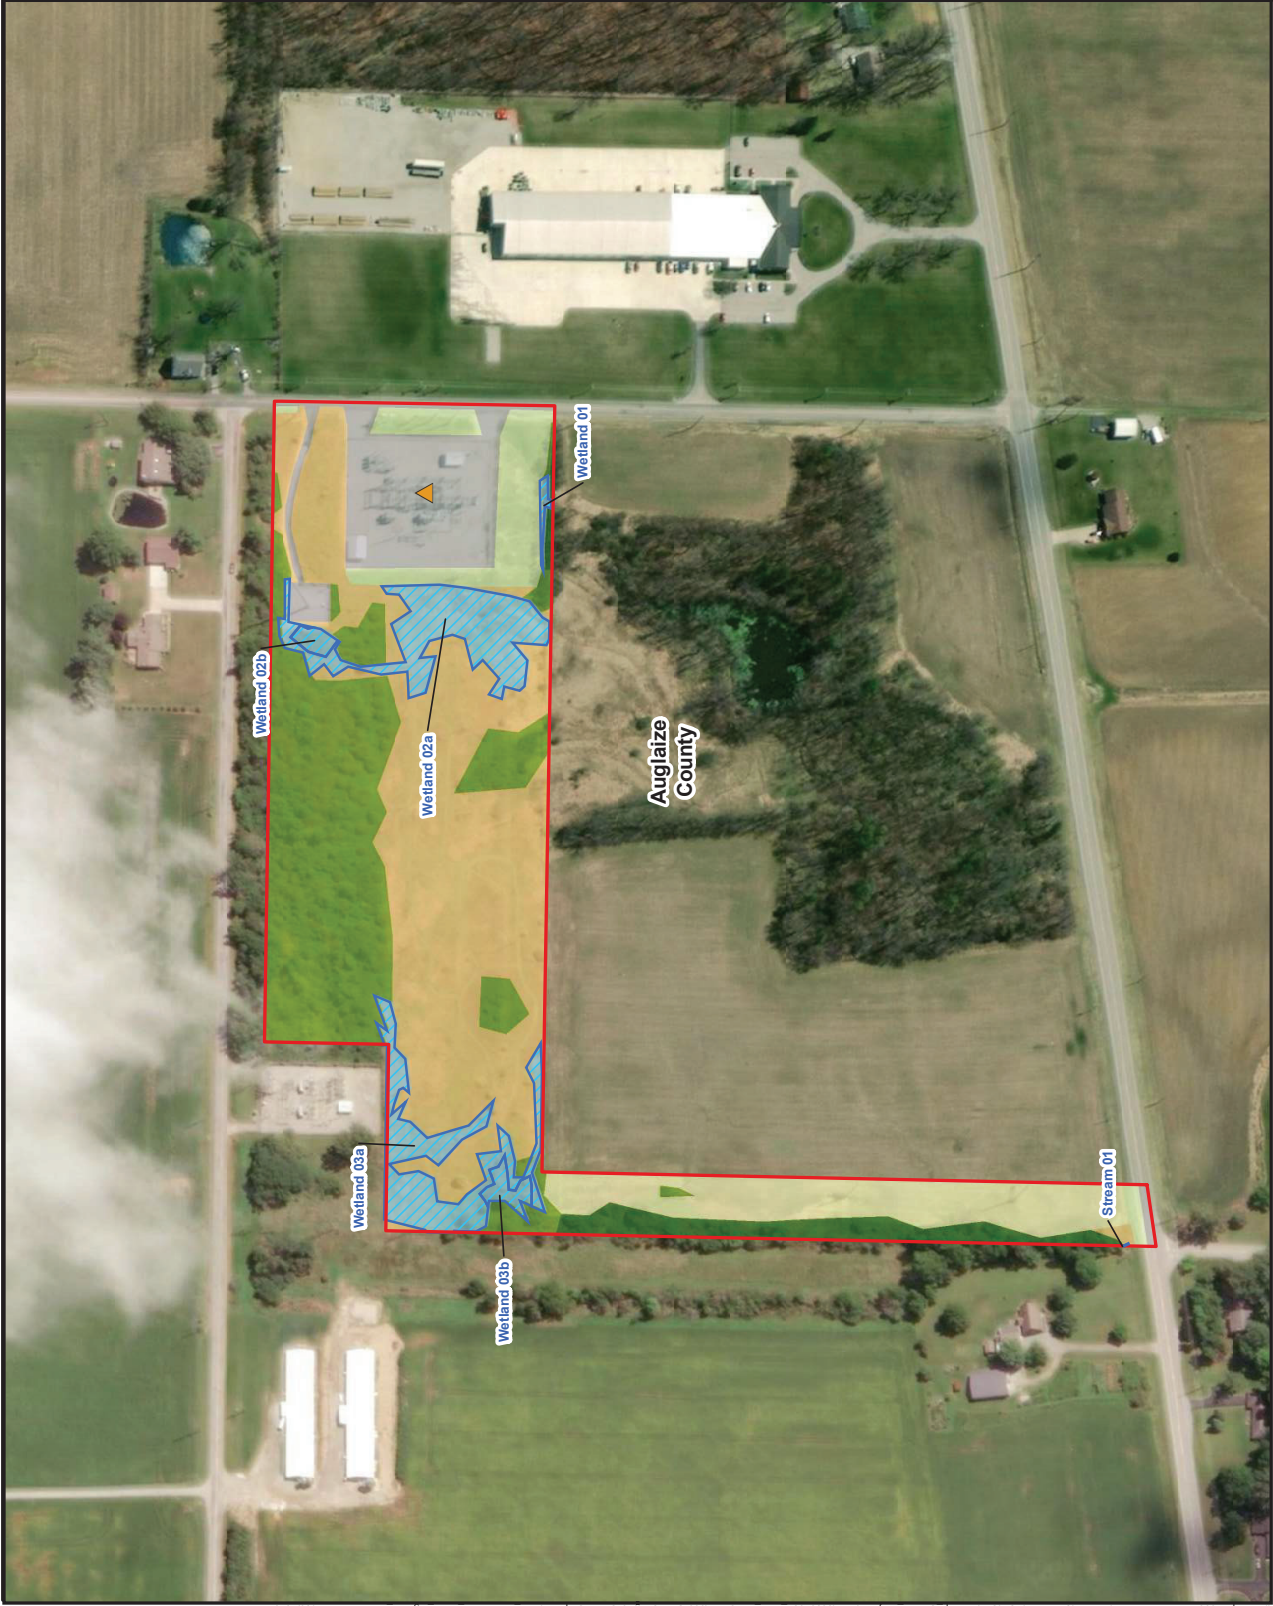
- West Moulton Station
- Project Survey Area
- Delineated Wetland
- Delineated Intermittent Stream

- Agricultural Land
- Landscaped Areas
- Old Field
- Shrub-scrub
- Stream/Wetland
- Successional Woodland
- Urban

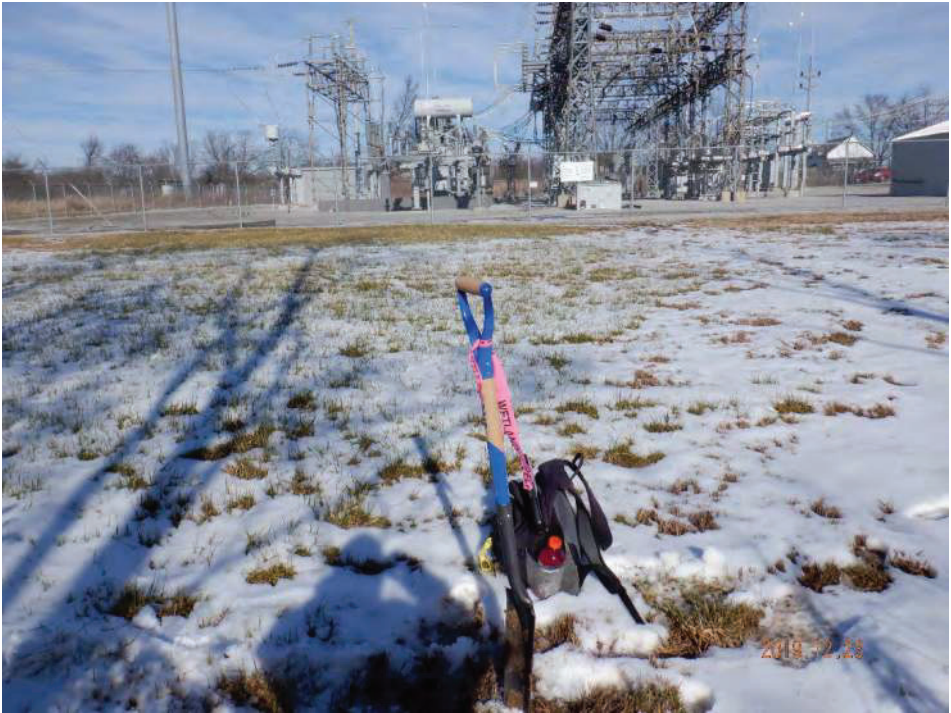
Upland 01

Date: December 23, 2019	
Description: Facing North

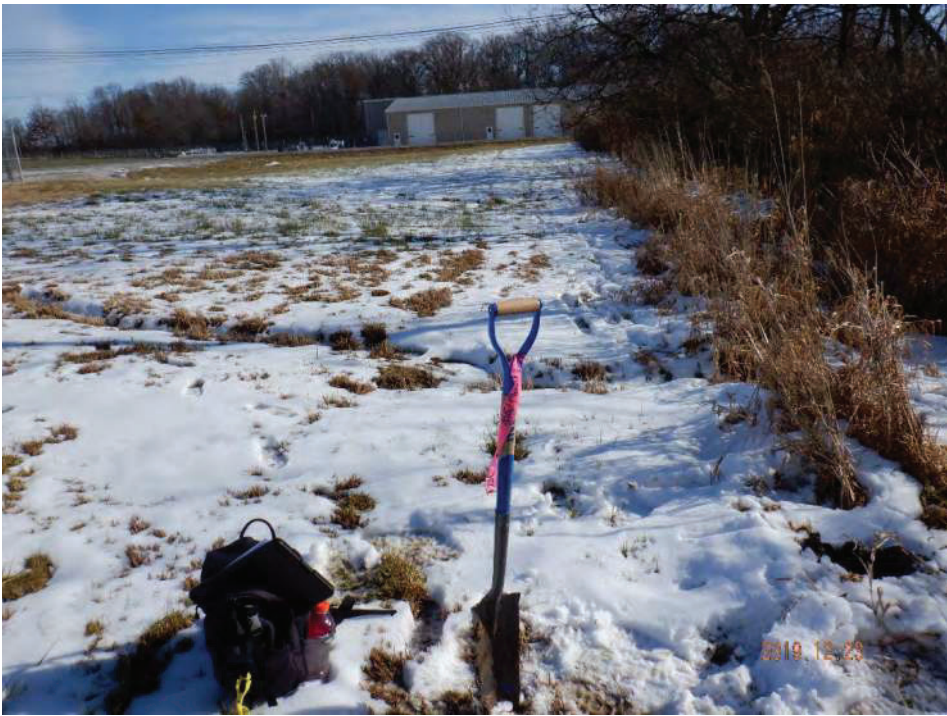
Upland 01

Date: December 23, 2019	
Description: Facing East

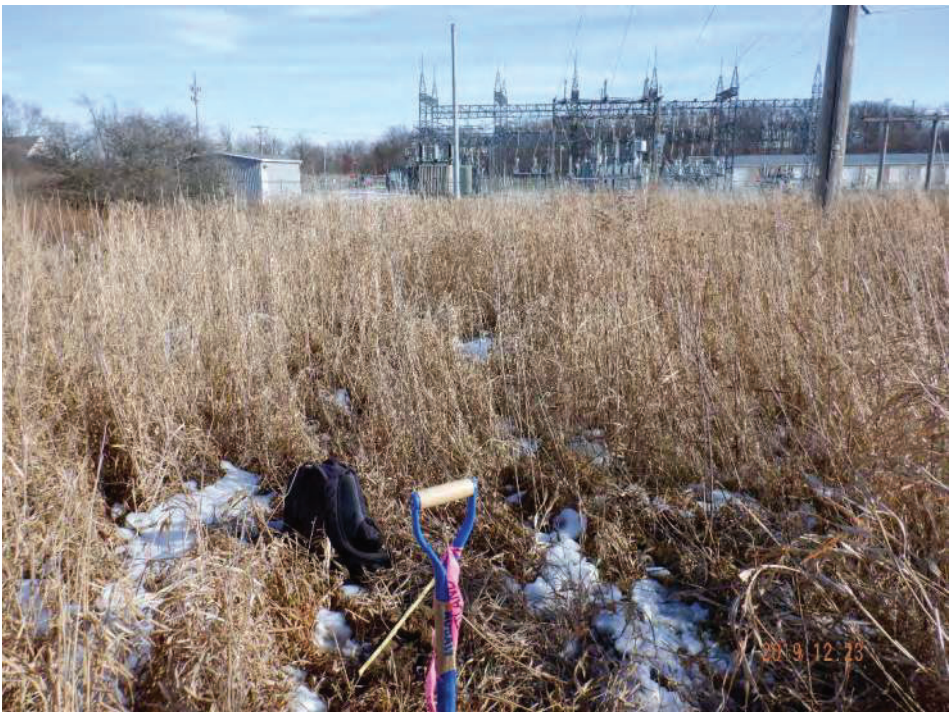
Wetland 02a

Date: December 23, 2019	
Description: PEM Category 1 Facing East

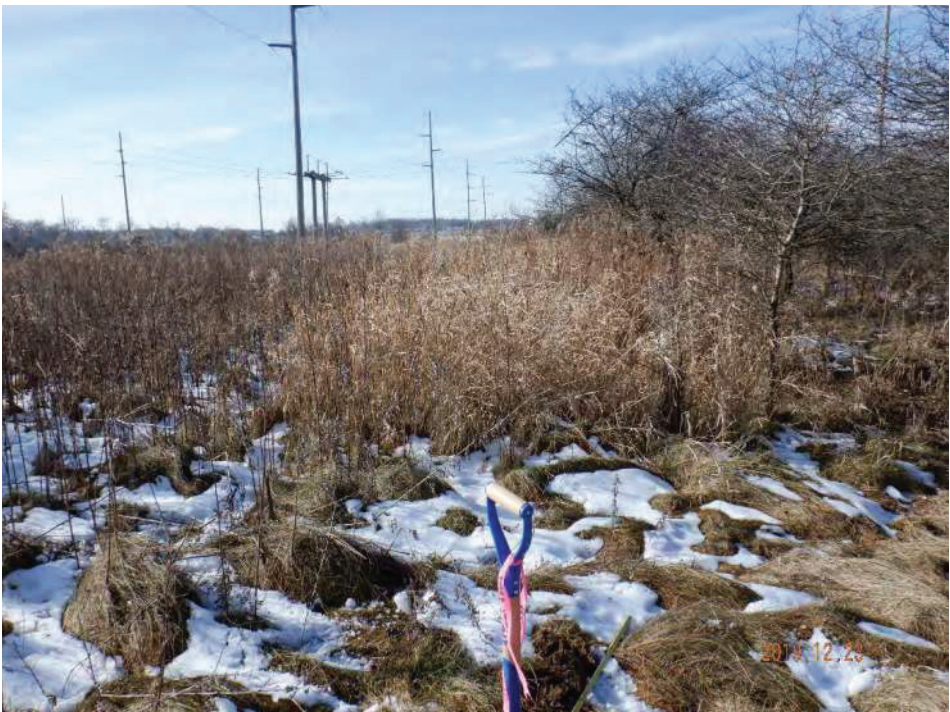
Upland 02

Date: December 23, 2019	
Description: Facing West

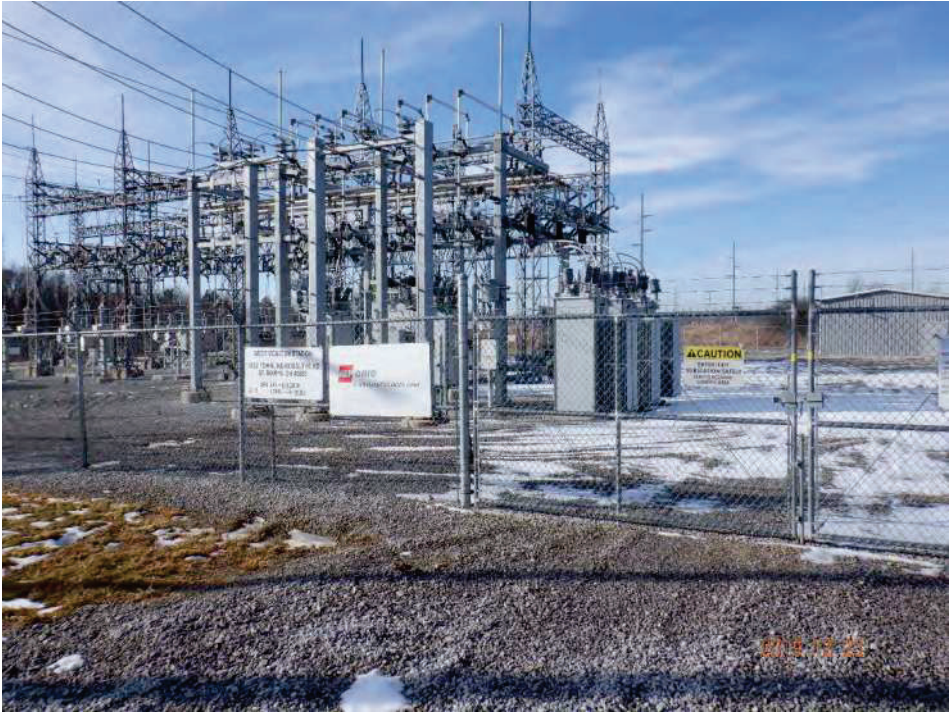
Description: Urban vegetative community; existing West Moulton Station Facing West
