Wild Grains Solar Project

Tile Maintenance Plan

Case No. 21-0823-EL-BGN

October 2021

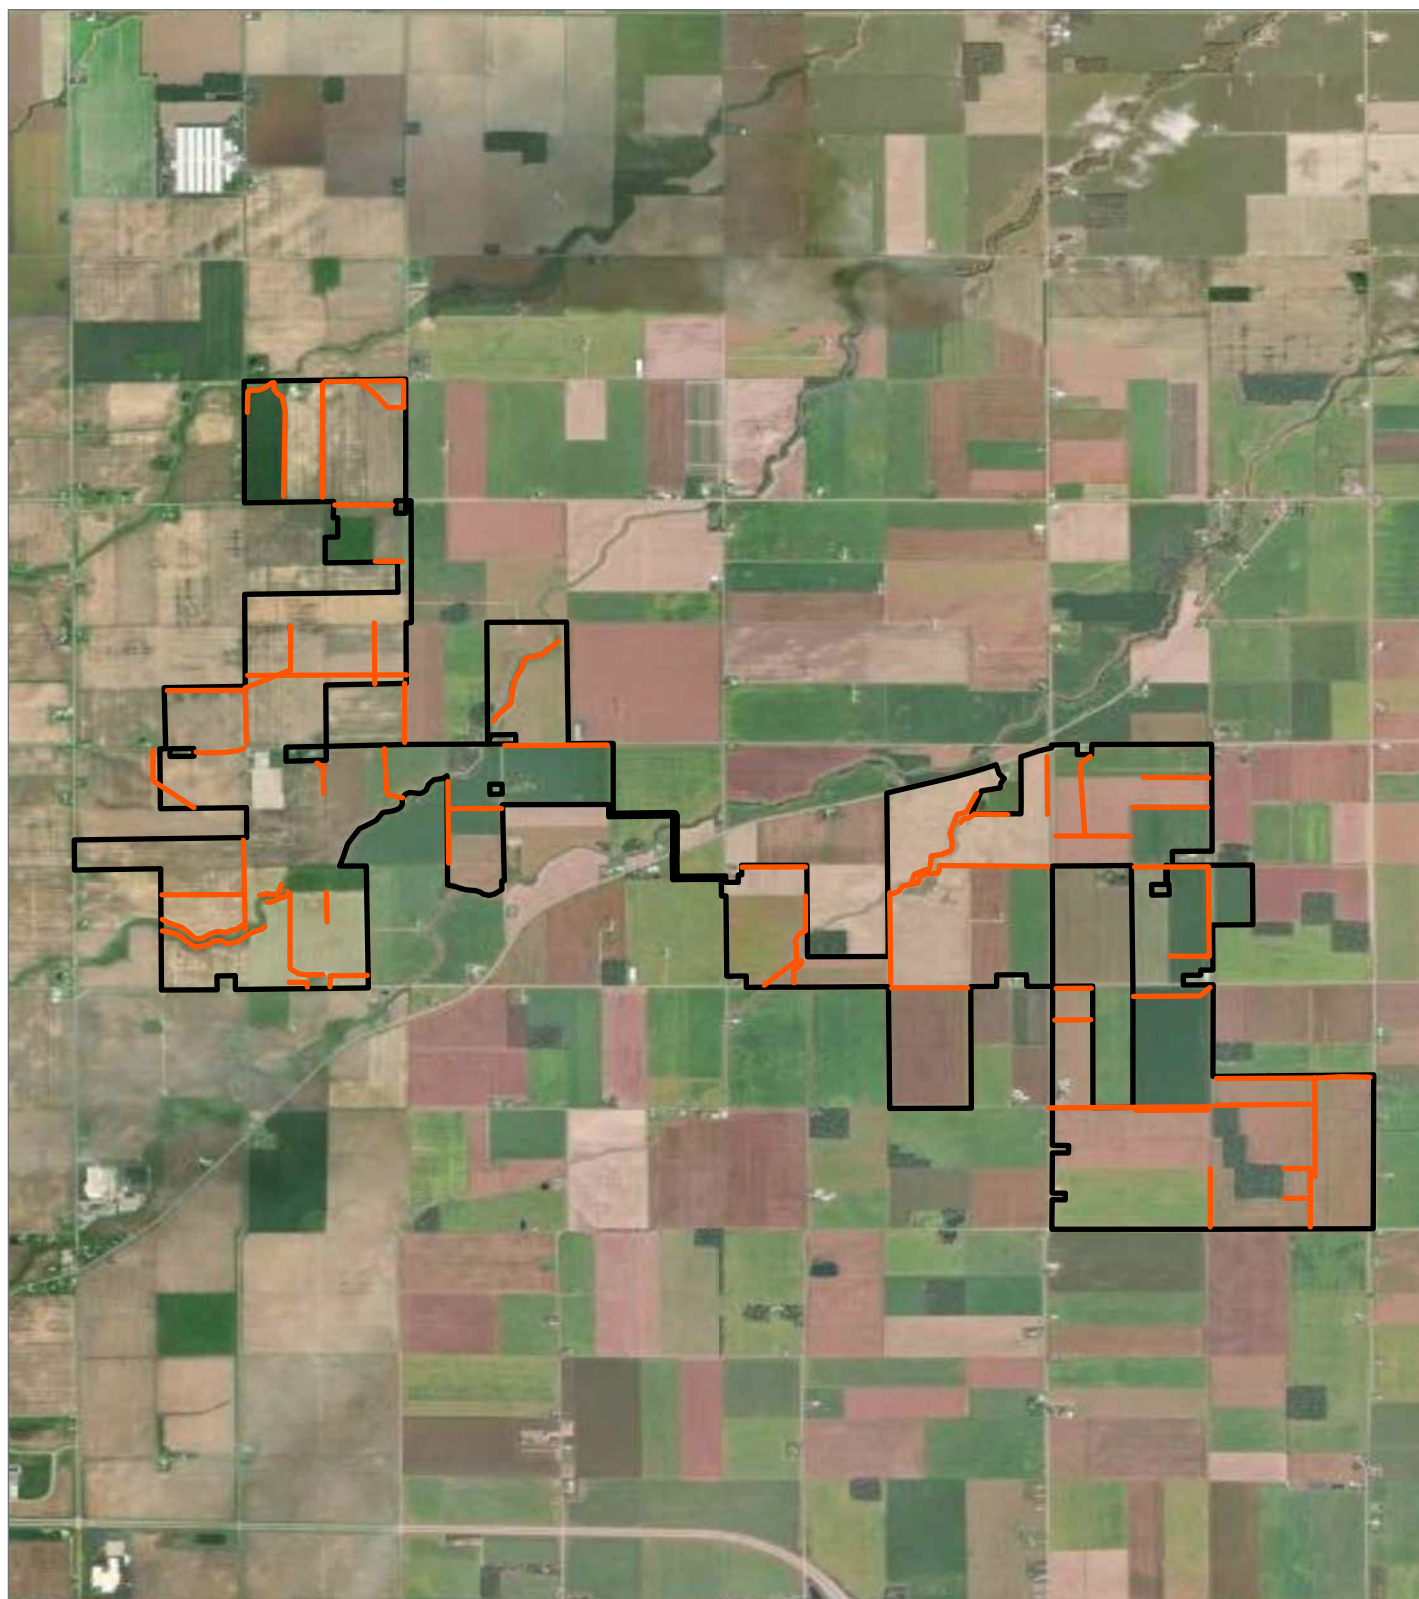
Figure 1. Main Drainage Systems

- Main Drainage System
- Project Area

in the Project Area. The Tile Repair Contractor will work with local landowners and stakeholders, and use their experience and expertise in this field to produce maps of known drain tile mains locations that will be considered in the final design of the Project. A preliminary map of main drainage systems in the Project Area is included as Figure 1.

After the coordination work between Avangrid, the Tile Repair Contractor, County, Township, landowners, and stakeholders has been substantially completed, the Tile Repair Contractor will produce maps that indicate approximate locations of drain tiles that will be considered in the design of the system. A preliminary map, showing main drainage systems in the Project Area, is included as Figure 1. While Avangrid has made efforts to identify all known locations of drain tile, the locations identified on the map will contain some degree of inherent error as there is not survey-level detailed information available on these systems. Therefore, there may be drain tiles encountered during Project construction that were not identified through consultations described above.
