Application for Amendment of a Certificate of Environmental Compatibility and Public Need

Marion Road-Mound Street 138-kV Transmission Line Project

OPSB Case No. 21-1184-EL-BTA

Application for Amendment to the Marion Road-Mound Street 138-kV Transmission Line Project

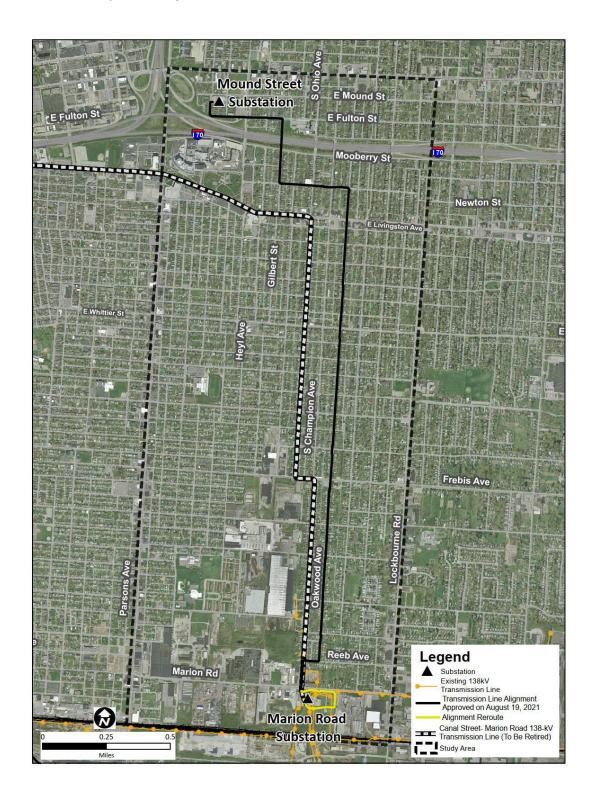
Exhibit 1: Summary of the Alignment Reroutes to the Preferred Route

Since approval of the Application, AEP Ohio has determined that a change to the Preferred Route alignment within AEP Ohio's Marion Road Substation property is necessary as a result of engineering considerations for the future use of Marion Road Substation. The alignment reroute is designed to accommodate a future substation expansion by routing the Project alignment along the edges of the substation parcel to avert impacts on future expansion plans. AEP Ohio currently does not have detailed plans for the substation expansion but is carrying out planning in order to prevent assets from interfering with the space when a substation expansion becomes necessary. This is the only alignment reroute proposed as part of this amendment. Exhibit 1 provides the location of this alignment reroute relative to the entire Preferred Route.

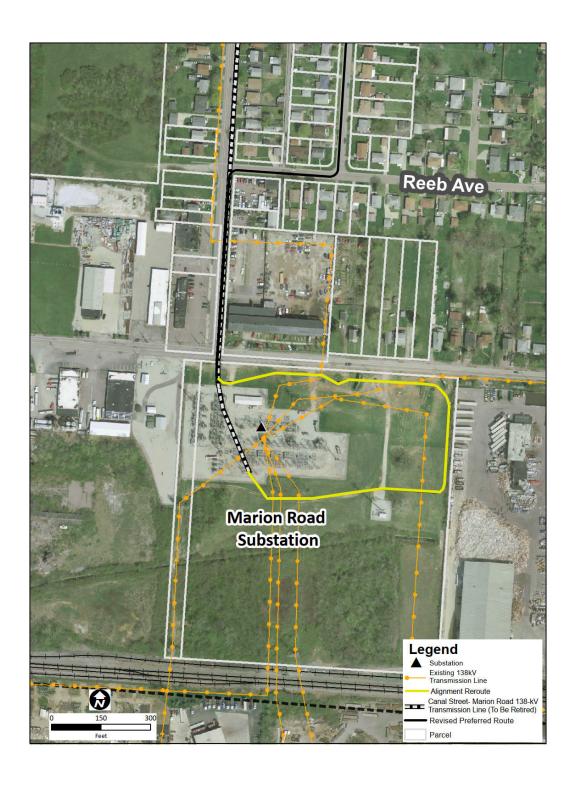
Exhibit 2: Map Illustration of Alignment Reroute

From the intersection of South Champion Avenue and Marion Road, the alignment reroute turns east as it enters the Marion Road Susbtation property and runs approximately 0.15 mile along the northern edge of the parcel. The alignment then turns south, following the parcel boundary for approximately 0.05 mile. The alignment then turns west as it aligns just south of the existing substation footprint and runs for approximately 0.10 mile before connecting into the Marion Road Substation. The total alignment reroute is approximately 0.30 mile. The total length of the revised Preferred Route is 3.22 miles. The reroute is shown in Exhibit 2.

The reroute is proposed on AEP Ohio property. No new property owners are directly affected as a result of this reroute. Construction activites are to be contained to AEP Ohio property. This reroute will have no additional environmental or cultural resources impacts. The Wetland and Waterbody Delineation Report Addendum and State Historic Preservation Office coordination letter capturing this reroute area is provided as Appendix A. A letter summarizing the results of additional environmental surveys completed for the revised Preferred Route will be directly provided to the OPSB. Specific changes to other portions of the Application are provided within the amended OPSB application.

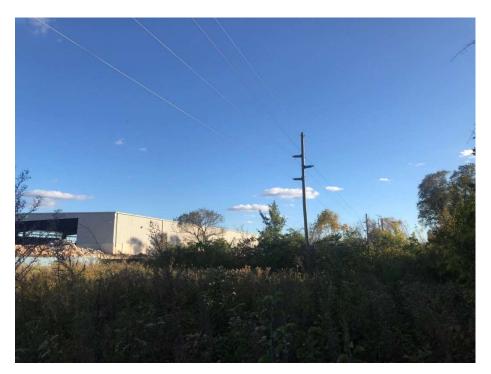
Looking south at vegetation within expanded survey corridor.

Jacobs' biologists surveyed the Project reroute area on October 22nd, 2021 by walking the expanded ESC to evaluate for wetlands and other waters of the United States (U.S.). No wetlands or waterbodies were documented within the expanded ESC. The surveyed expansion area was dominated by upland herbaceous vegetation (Solidago canadensis, Canada Goldenrod) with no indications of past or present hydrology. No trees were present within the expanded survey corridor. Site photographs can be found immediately following the text and the USACE upland data determination form can be found in Appendix B.
