# Letter of Notification for Amlin-Dublin 138 kV Transmission Line Adjustment Project

PUCO Case No. 21-1114-EL-BLN

Submitted to:  
The Ohio Power Siting Board  
Pursuant to Ohio Administrative Code  
Section 4906-6-05

Submitted by:  
AEP Ohio Transmission Company, Inc.

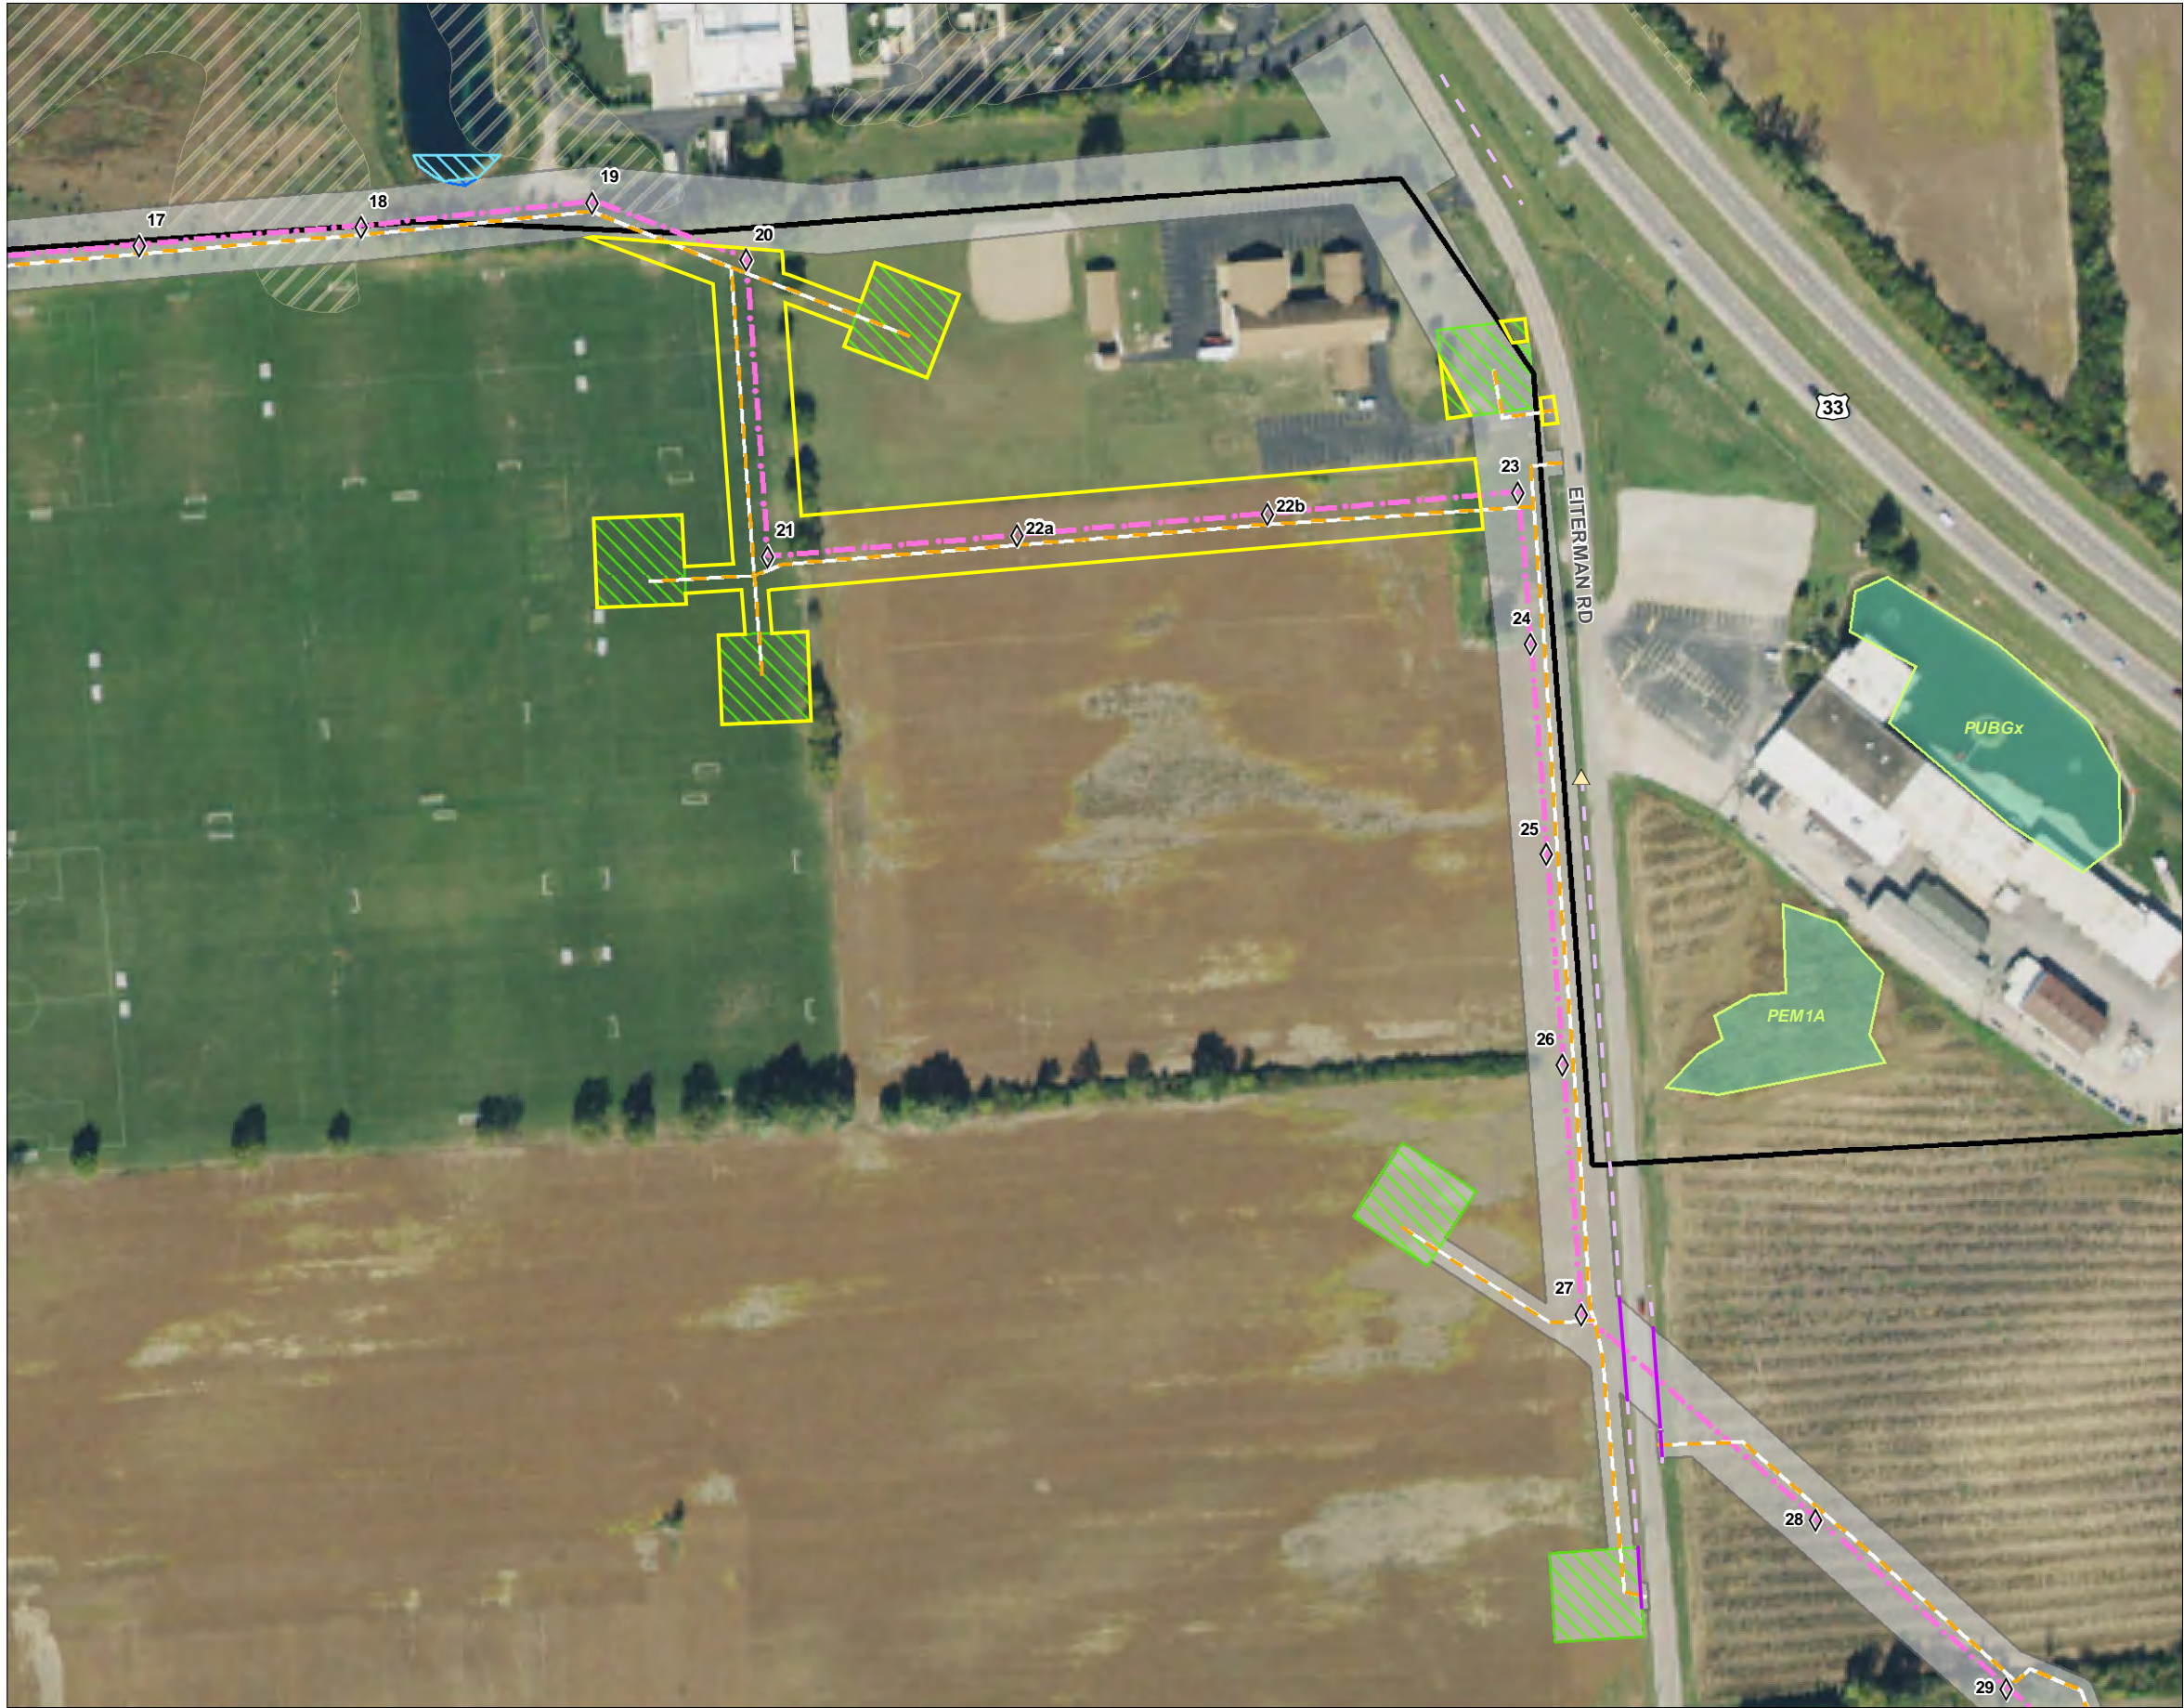
Figure No.  
**2**

Title  
**Wetland and Waterbody Delineation Map**

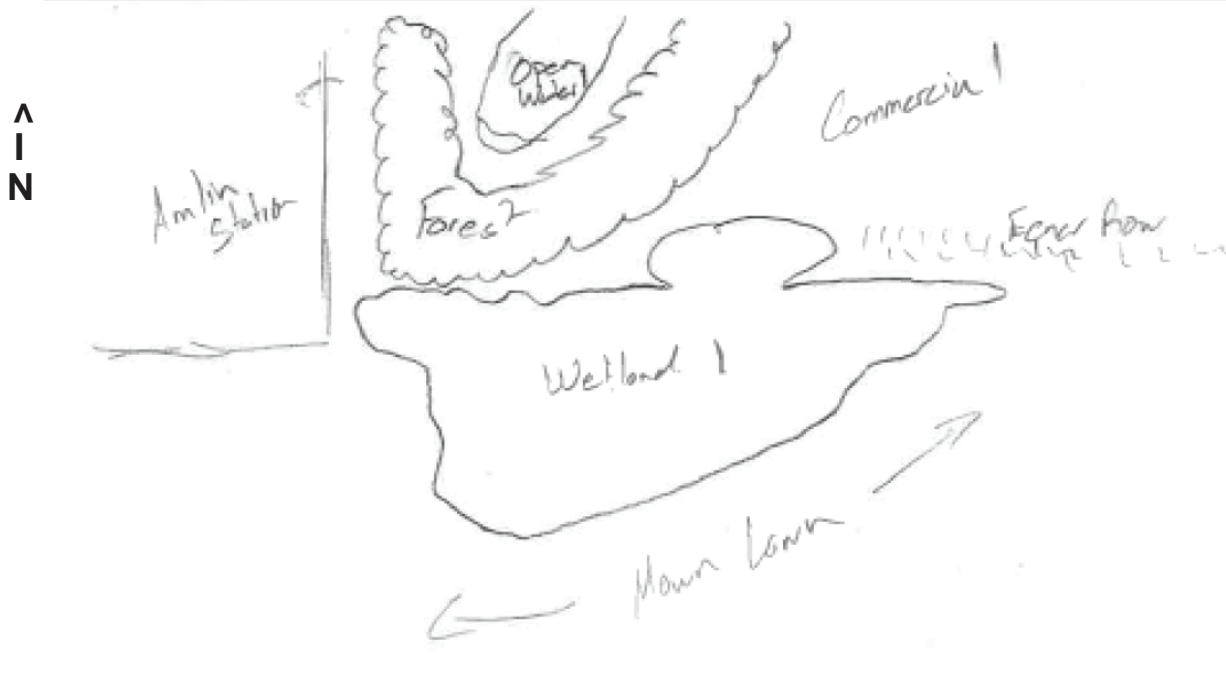
Name of Wetland: Wetland 1	
Wetland Size (acres, hectares): 0.54 ac. (XX ac. within the Project area)	
Sketch: Include north arrow, relationship with other surface waters, vegetation zones, etc.

Comments, Narrative Discussion, Justification of Category Changes:	
Final score : 24	Category: 1

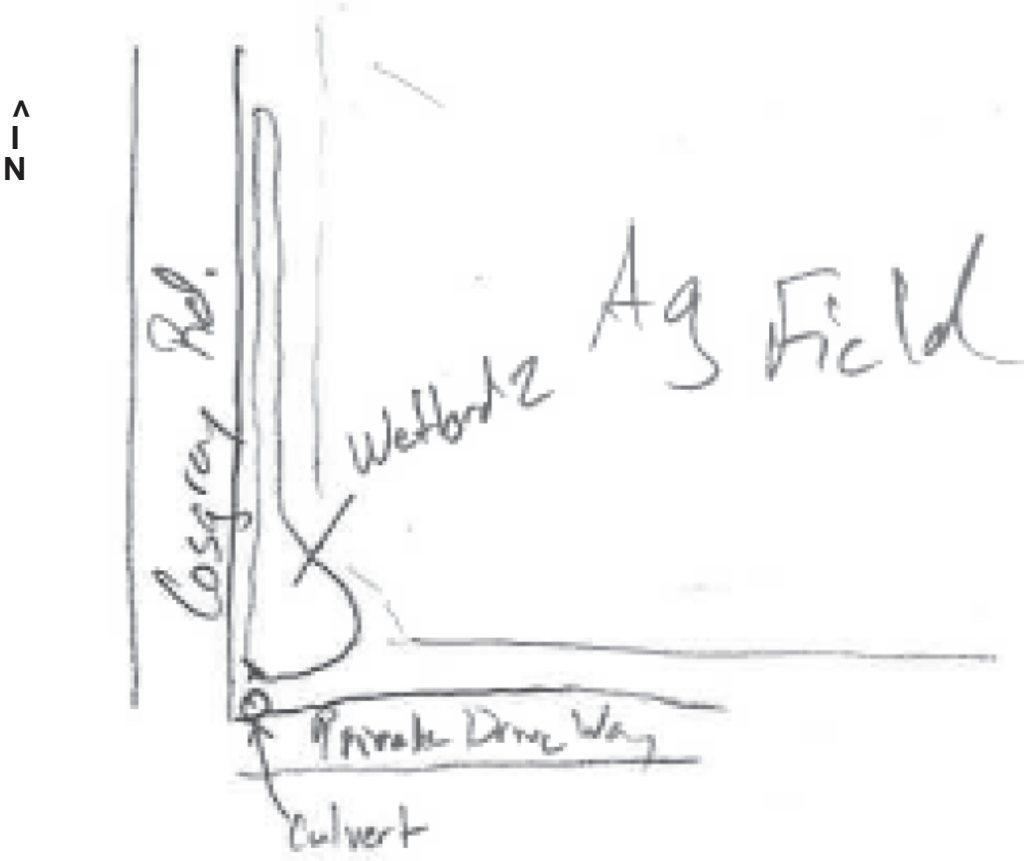
Name of Wetland: Wetland 2	
Wetland Size (acres, hectares): 0.02ac.	
Sketch: Include north arrow, relationship with other surface waters, vegetation zones, etc.

Comments, Narrative Discussion, Justification of Category Changes:	
Final score : 14	Category: 1

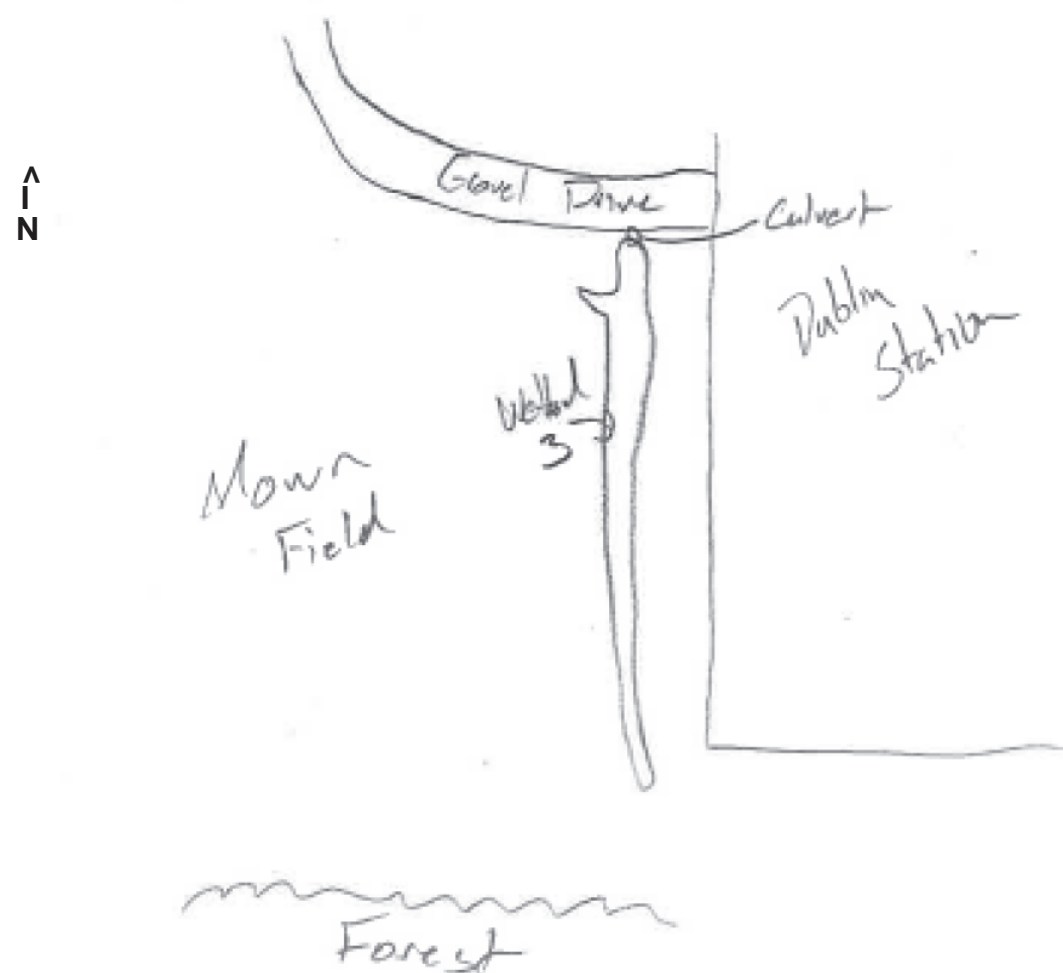
Name of Wetland: Wetland 3	
Wetland Size (acres, hectares): 0.01 ac.	
Sketch: Include north arrow, relationship with other surface waters, vegetation zones, etc.

Comments, Narrative Discussion, Justification of Category Changes:	
Final score : 16	Category: 1
