## PHOTOGRAPHIC RECORD **STREAMS**

AEP

Crooksville-North Newark 138 kV Transmission Line **Rebuild Project**

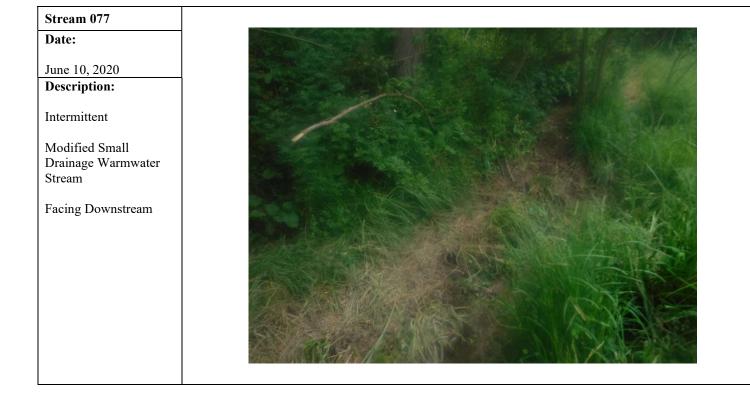
Stream 077 Date:

June 10, 2020 **Description:**

Intermittent

Stream

Modified Small Drainage Warmwater

Facing Upstream

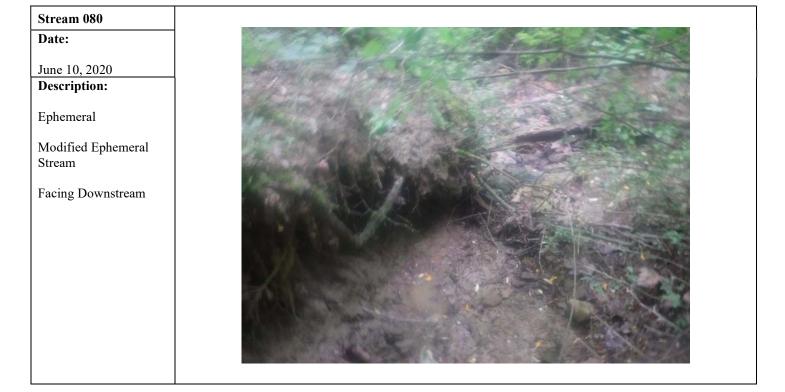
## Stream 080 Date: June 10, 2020 **Description:** Ephemeral Modified Ephemeral Stream Facing Upstream

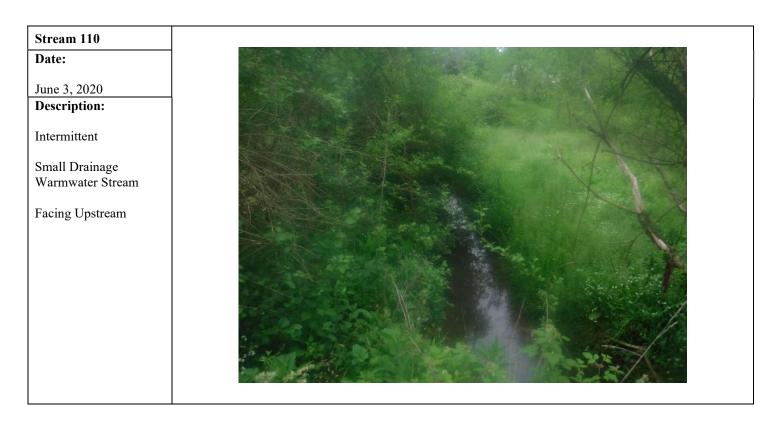
# Stream 110 Date: June 3, 2020 **Description:** Intermittent Small Drainage Warmwater Stream Facing Downstream
