# Letter of Notification for the Arboles 138 kV Station Project

PUCO Case No. 21-1084-EL-BLN

Submitted by:  
AEP Ohio Transmission Company, Inc.

December 9, 2021

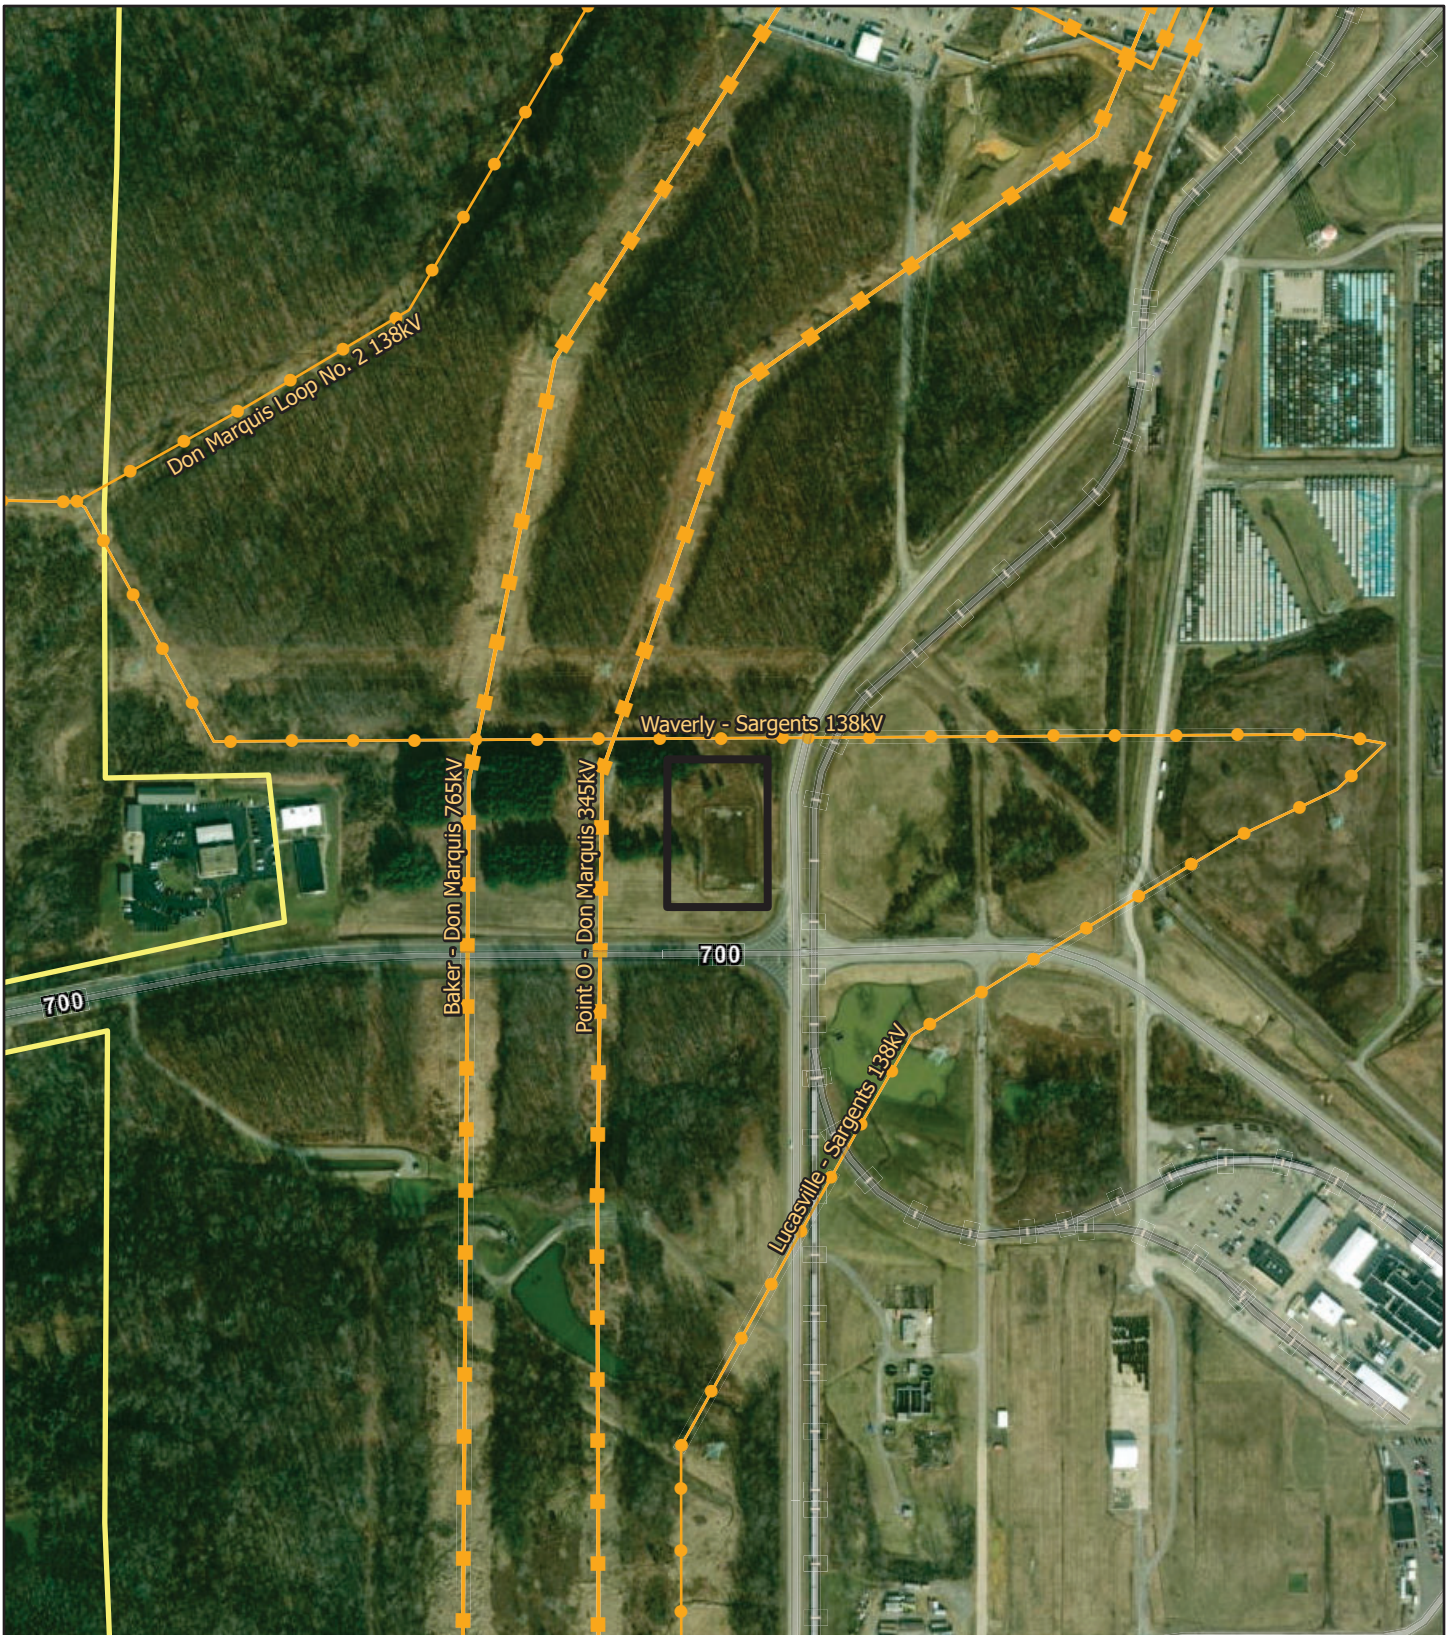
The Company is proposing the Arboles 138 kilovolt (kV) Station Project (the “Project”), in Scioto Township, Pike County, Ohio. The Project consists of constructing a new approximately 2.6-acre 138 kV electric transmission station on a site near the Company’s existing Don Marquis 345/765 kV Station. The Project is located on property owned by a governmental agency customer (the “Customer”) and will support the Customer’s request for electric service due to the planned decommissioning of their 345 kV station. The new station will receive service from three existing 138-kV circuits from Don Marquis, Waverly and South Lucasville. The purpose of the new station is to feed four circuits supplying the customer’s 138-12 kV delivery points. Transmission line components associated with Arboles Station will be filed separately with the OPSB. The location of the Project is shown on Figures 1 and 2 in Appendix A.

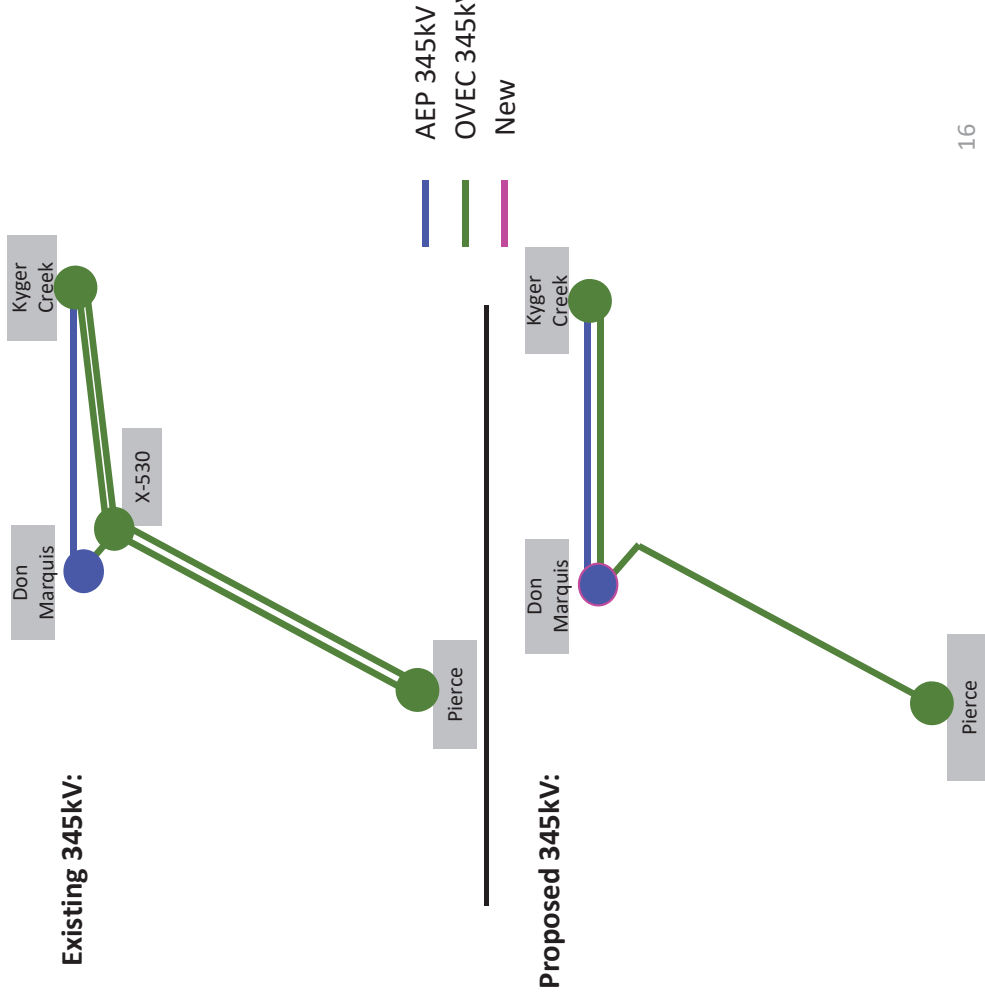
## AEP Transmission Zone M-3 Process DOE X-350

- At Don Marquis 345 kV, install 3-345kV 4000A 63kA circuit breakers to terminate the OVEC lines from Pierce and Kyger Creek. **(s2213.6) Estimated Cost: \$8.8M (AEP)**

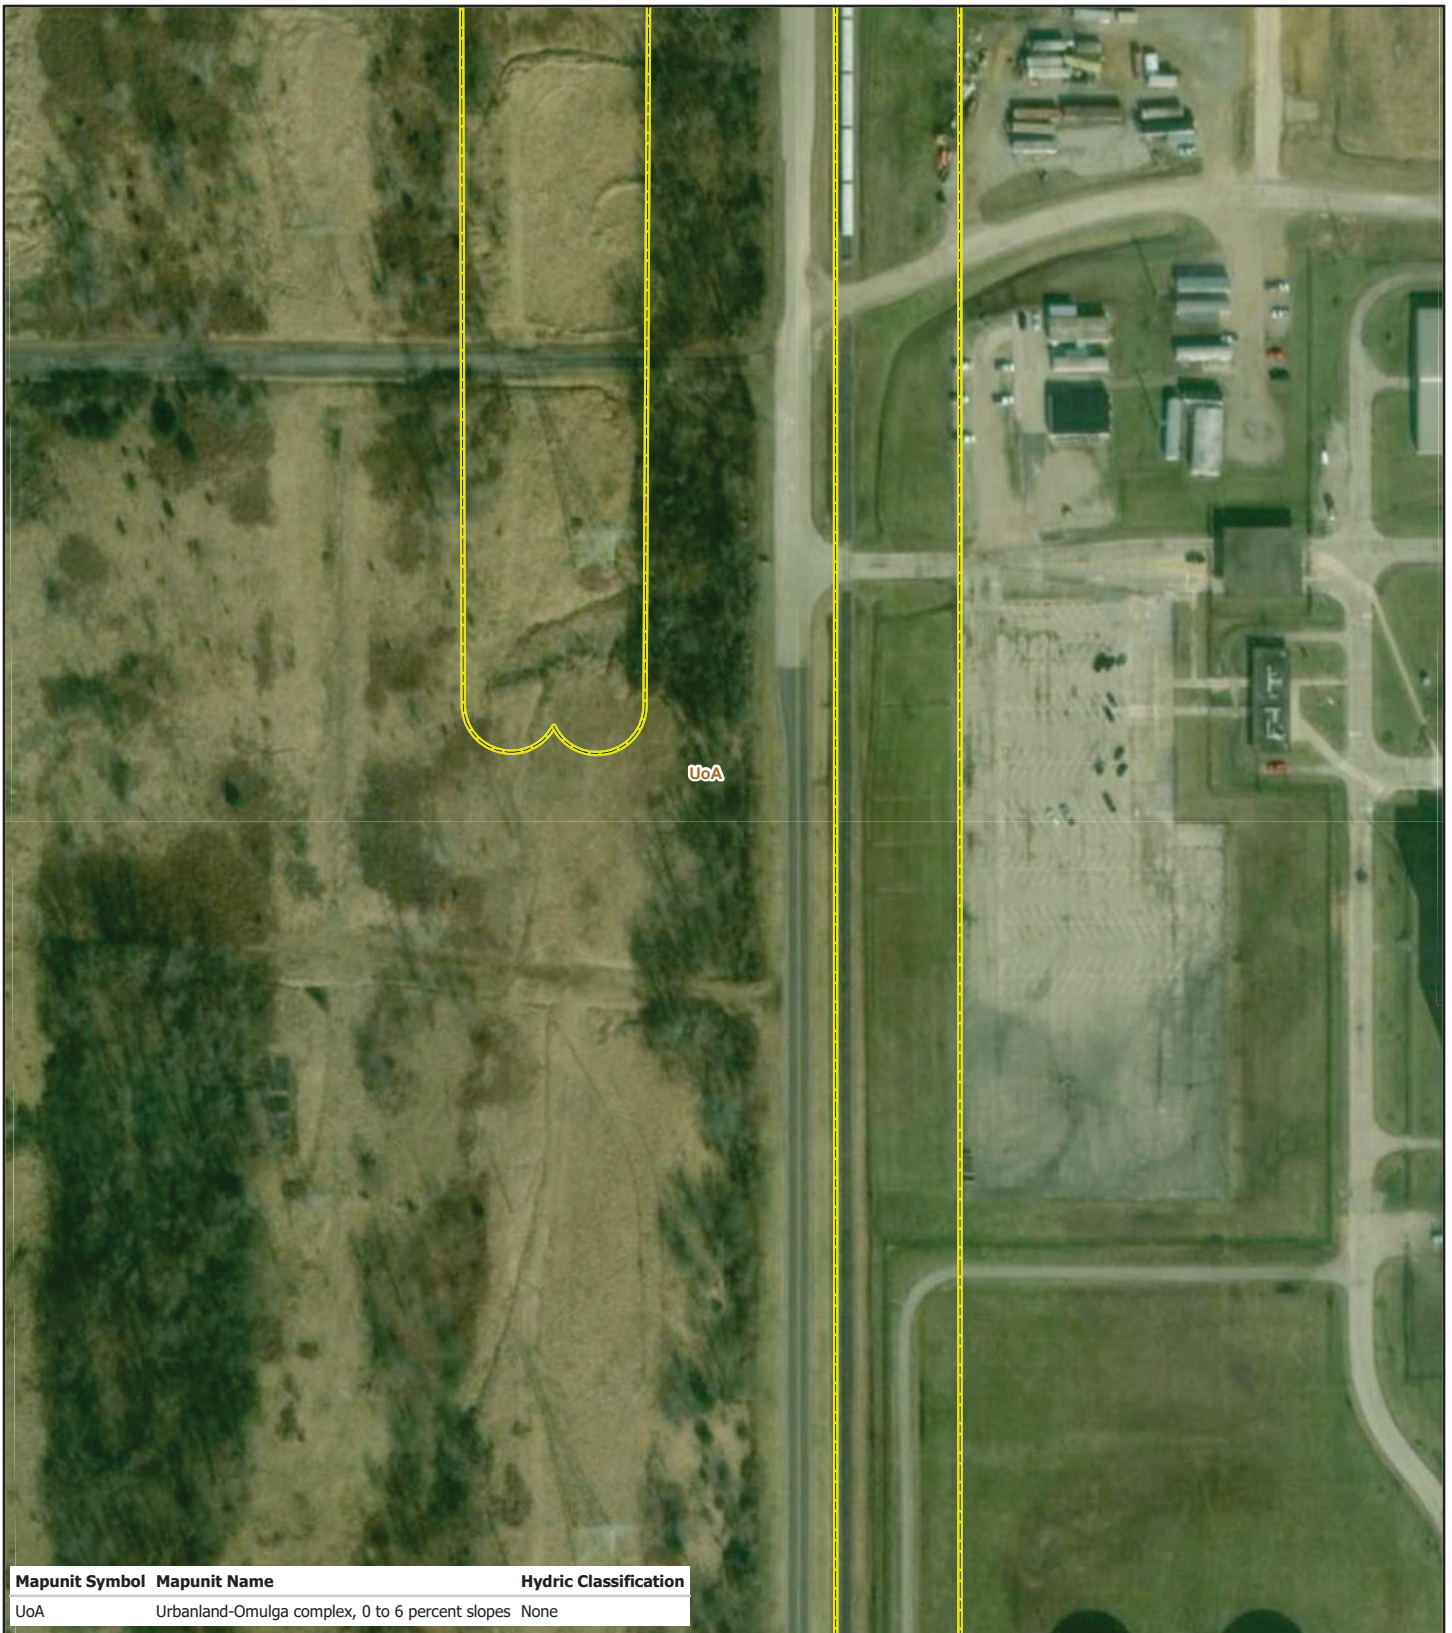
Mapunit Symbol	Mapunit Name	Hydric Classification
UoA	Urbanland-Omulga complex, 0 to 6 percent slopes	None

According to the NRCS soil survey of Pike County (NRCS, 2019), nine soil map units are crossed by the ESC, all of which are listed as non-hydric (Figures 2.1 to 2.9; Table 3-1). Generally, hydric soils are those soils that indicate through their color and structure that they have experienced dominantly reducing (i.e. oxygen poor) conditions. Oxygen-poor conditions result from inundation and/or saturation by water. Partially hydric soils have both hydric and non-hydric soil components identified in the mapped soil unit.
