**Transmission Line Case No. 19-1073-EL-
BTX Historic Resources Survey
June 2020
Environmental Design & Research**

Historic Resources Survey

Emerson Creek Transmission Facility

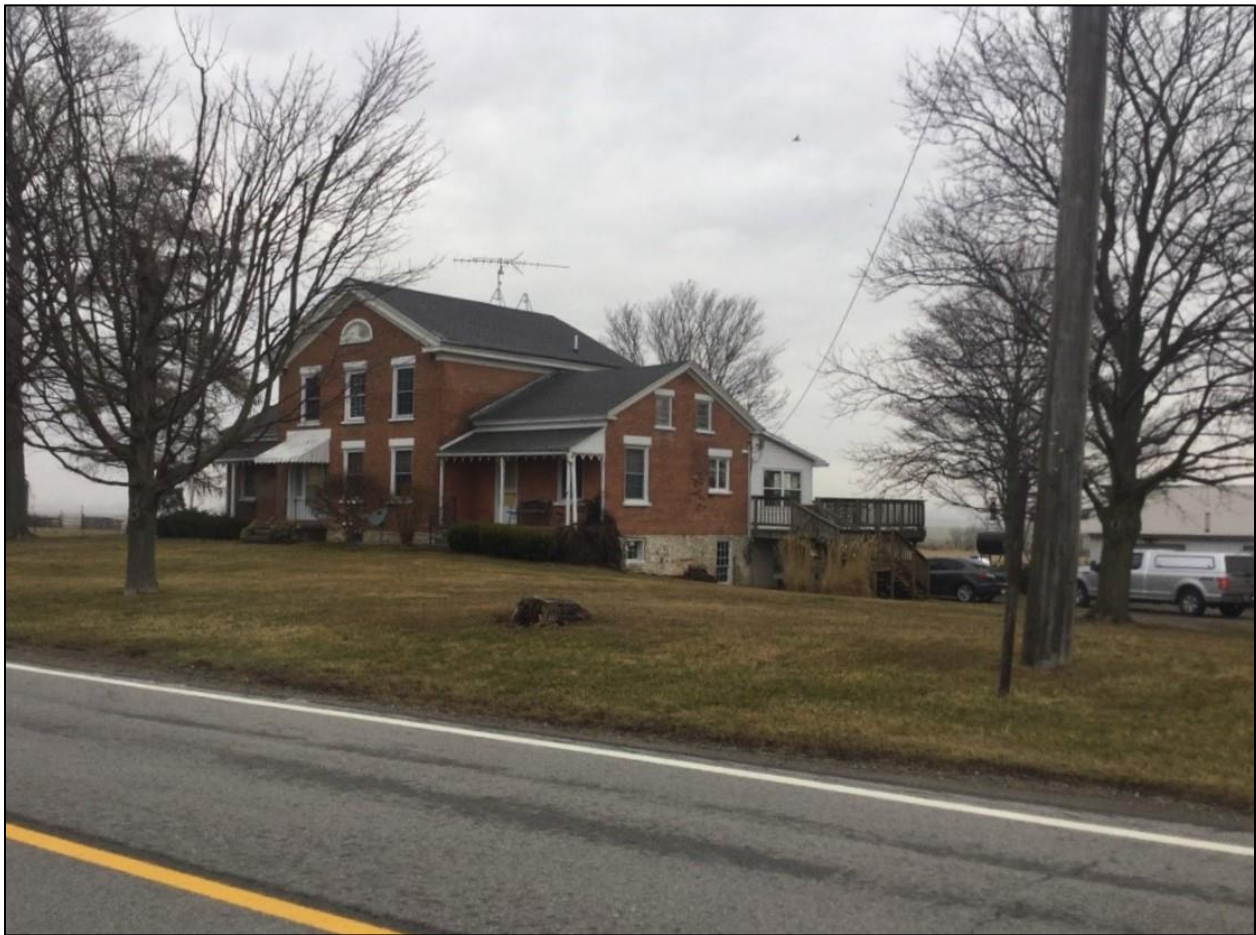
7703 State Route 113 West (ERI0222606) is an historic farmstead consisting of a brick, Greek Revival-style influenced residence, a one-story wood bay barn, a one-story cement block barn, a metal three-car garage, and a one-story wood garage/carriage house. The farmstead is situated in an agricultural setting on a secondary state transportation route. Open farm fields encompass the property, with a few neighboring farmsteads and residences nearby. A low hedgerow bounds the east and north property lines. The house is composed of a two-story, three-bay, front gable principal block flanked by one-story, side-gable wings. The house, depicted in Insets 1 and 2, is composed of a two-story, three-bay, front gable principal block flanked by one-story, side-gable wings. The house features partial cornice returns, stone windowsills and lintels, and a sunburst fan detail in the gable. A wood-frame, bank-barn, with sliding doors on the broadside sits closest to the road. Beyond that are a wood-frame shed and two modern, metal barns. The property retains a high degree of integrity of location, materials, design, feeling, and workmanship. In 1874 and 1896 the property was owned by Lafayette H. Jennison (b.1825, d. 1912), a farmer (Stewart and Page, 1874; Atlas, 1896; US Find a Grave, 2020).

Inset 1: View northwest toward farmhouse at 7703 State Route 113 West. Note the presence of tall trees and existing transmission infrastructure in the view of and from the house.

Although the farmhouse and barn are located in a rural agrarian context, views toward these structures from the right-of-way are not looking in the direction of the ECTF; therefore, the historic setting of the farmstead is not anticipated to be impacted by the ECTF. Views toward the ECTF from the farmstead will be screened by vegetation, intervening structures, topography and distance.

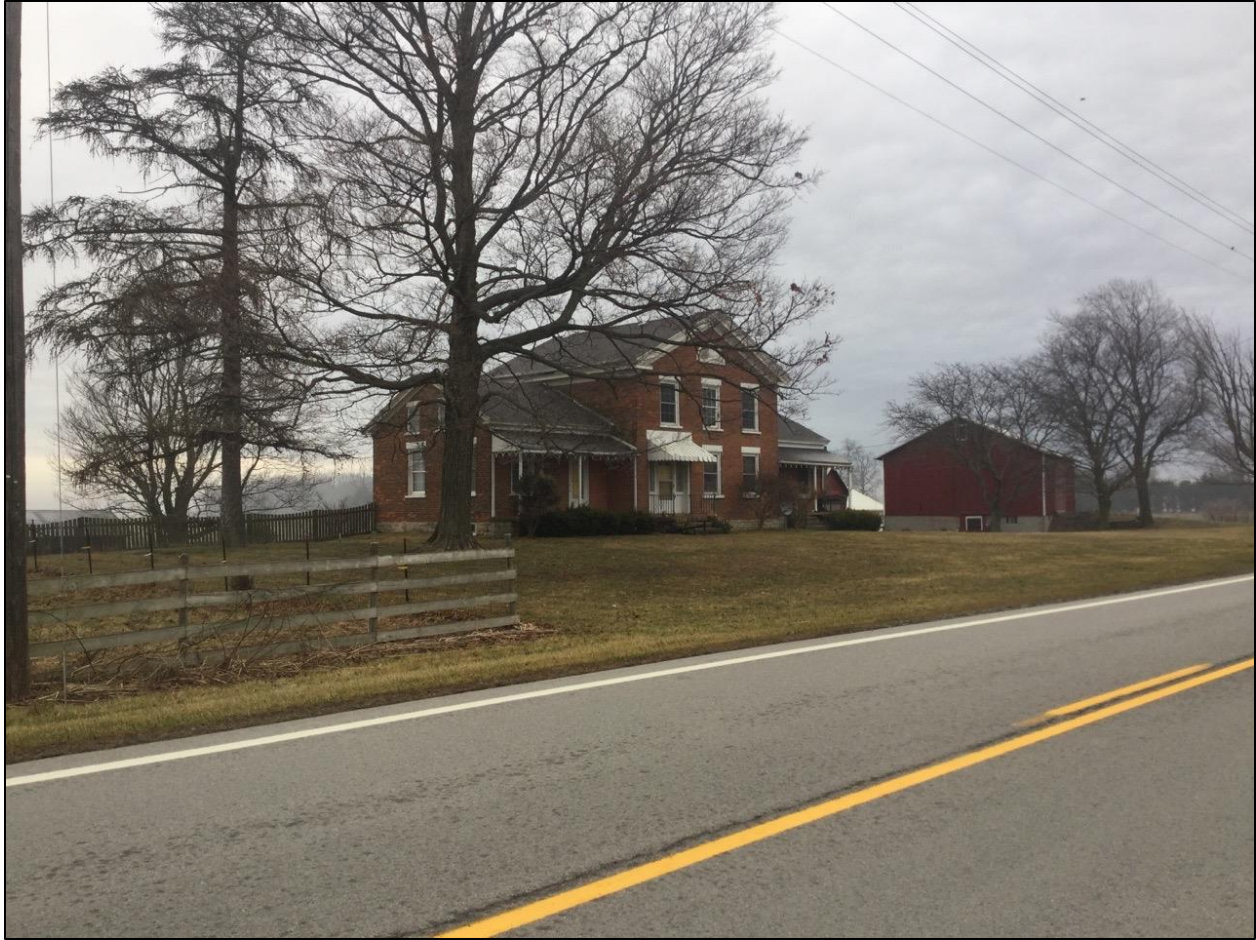
Inset 2: View northeast toward farmhouse and barn at 7703 State Route 113 West. Note the presence of tall trees and existing transmission infrastructure in the view of and from the house.

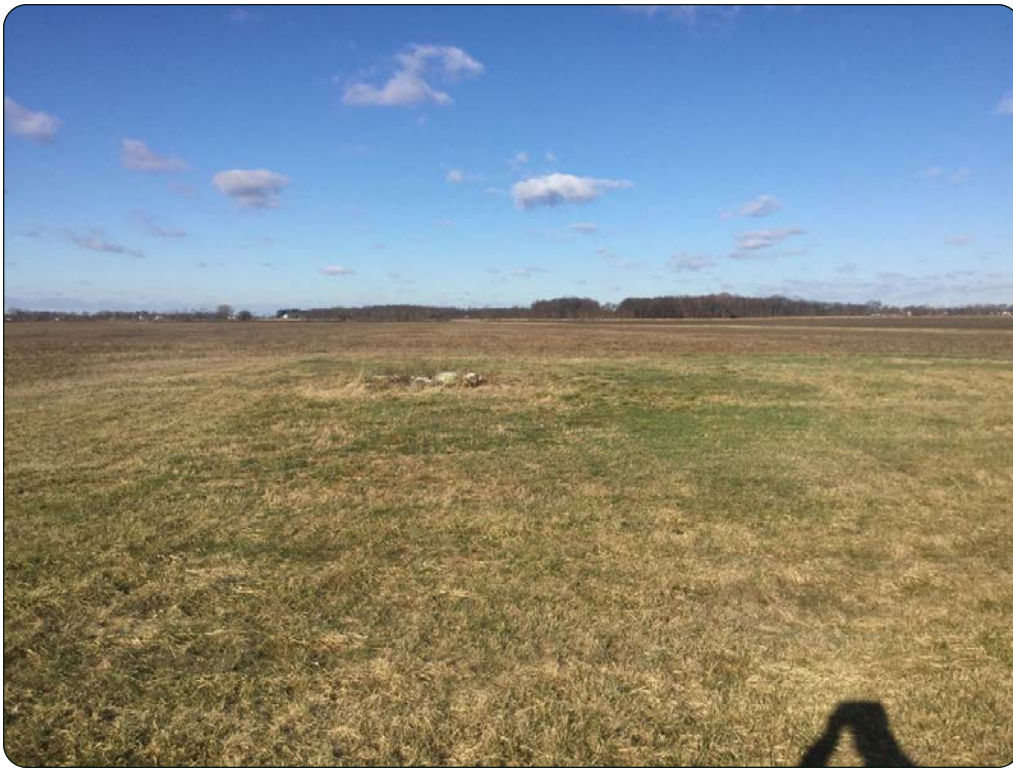
Photograph Number 9

Address: 11911 Ransom Road, Erie County, Ohio

Appears to Satisfy NRHP Eligibility Criteria: Resource No Longer Extant

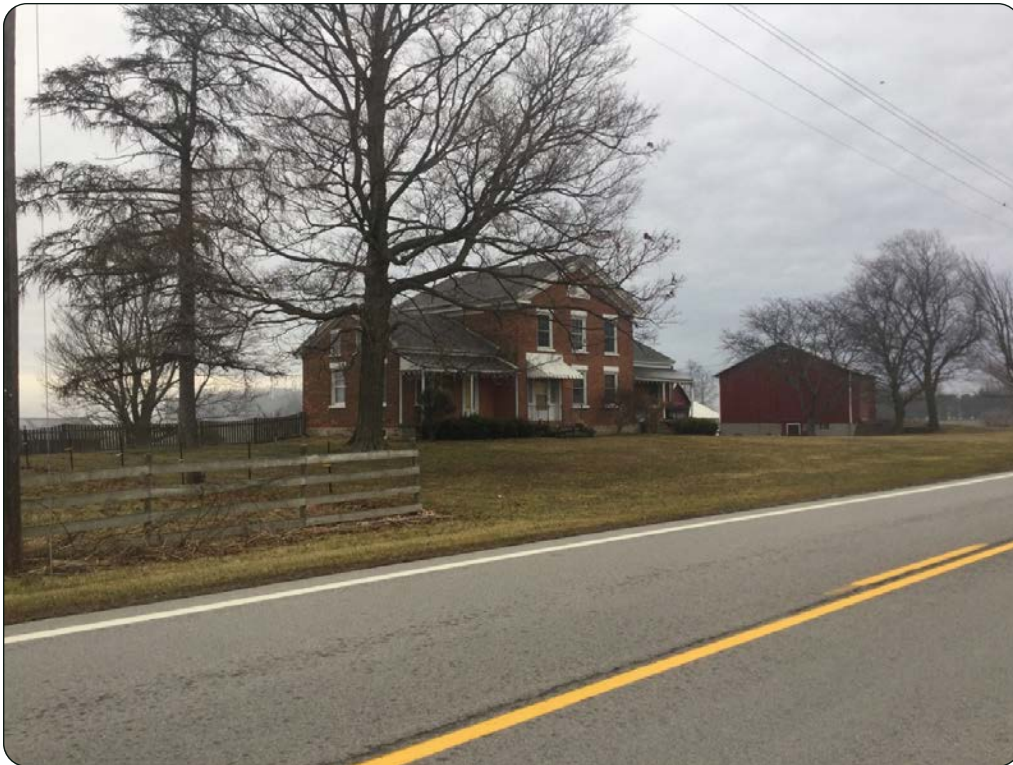
Photograph Number 16

Address: 7703 State Route 113 W, Erie County, Ohio

Appears to Satisfy NRHP
Eligibility Criteria: Yes
(Criterion C)

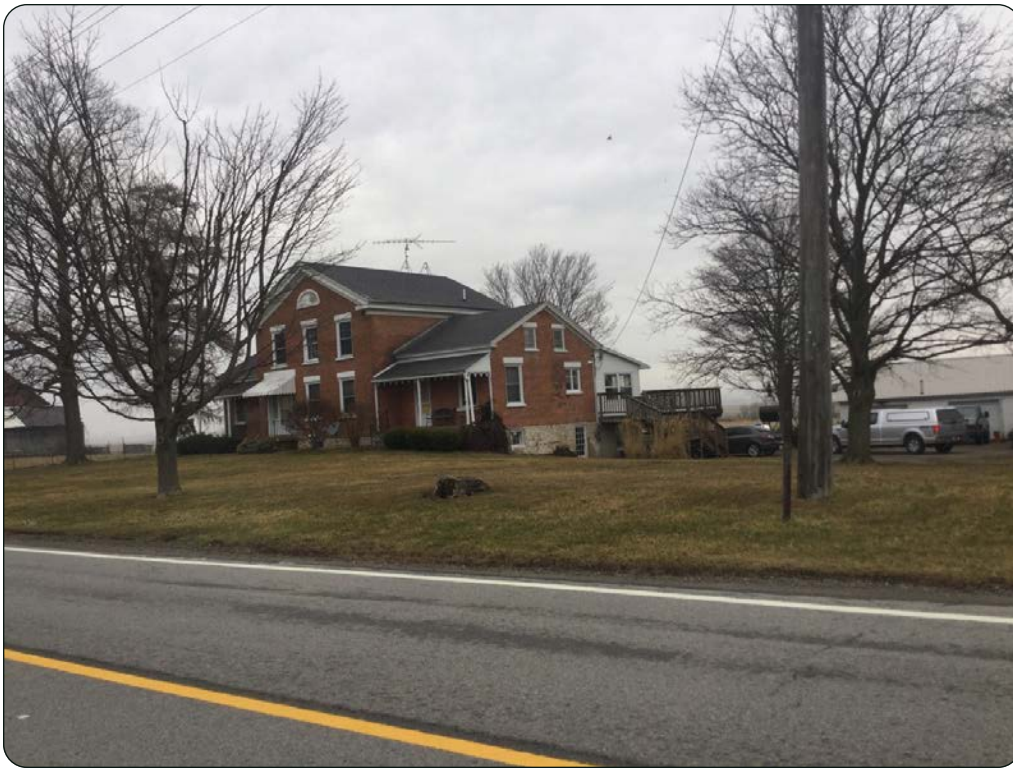
Photograph Number 17

Address: 7703 State Route
113 W, Erie County, Ohio

Appears to Satisfy NRHP
Eligibility Criteria: Yes
(Criterion C)

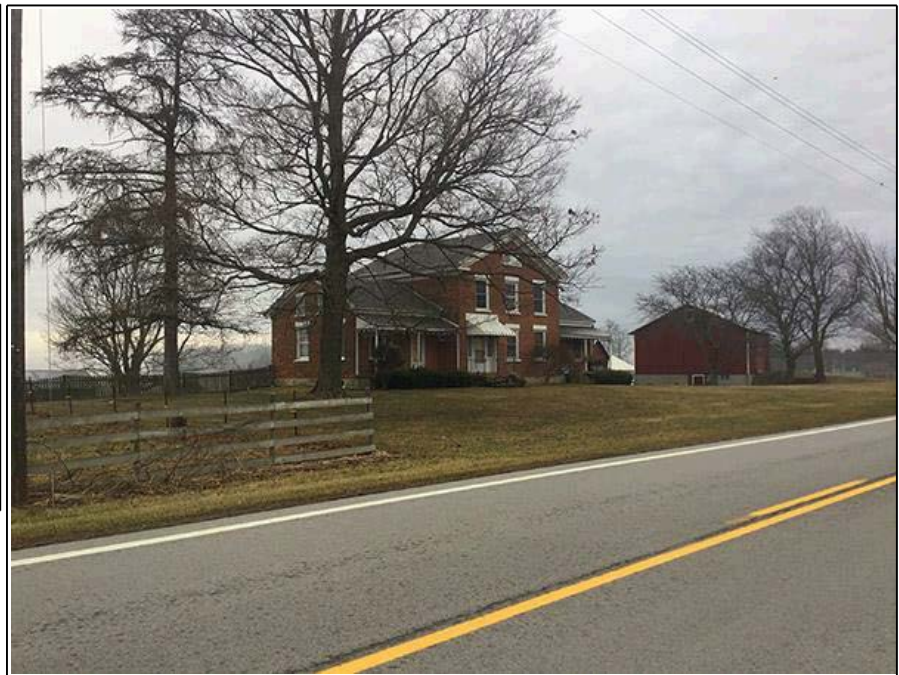
16. Thematic Associations: General Mixed Farm	29. Basement? Yes	Date(s): unknown unknown
17. Date(s) or Period: 1870	30. Foundation Material: Ashlar Stone, w/no water table	Associated Activity: Unknown Addition

19. Architect or Engineer: Unknown	34. Exterior Wall Material(s): Brick

6. Specific Address or Location: **7703 SR 113 W**
