Visual Resource Assessment and Mitigation Plan Harvey Solar Project

Harvey Solar Project

Hartford Township Licking County, Ohio

Harvey Solar 21-164-EL-BGN Revised Pages to Application Exhibit W Applicant Exhibit 31 Evidentiary Hearing

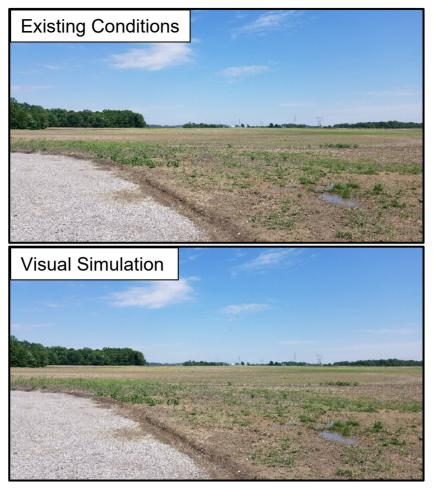
Figure 3-9 Viewpoint 10 - Existing Conditions, Visual Simulation, and 5-7 Year Mitigation

Viewpoint 10 is situated along TR 26 (N County Line Rd), facing east towards an open agricultural field. The existing conditions in this view show the rural field that extends from the foreground to the background of the visual. The forested woodlot on the left side of the image is located approximately 0.32 miles from the viewpoint, and the residences in the background of the image are located approximately 0.9 miles from the viewpoint. (Figure 3-9, Existing Conditions).

With the addition of the proposed Project, panel arrays and associated fence line can be viewed in the image background, but are not highly visible from this viewpoint. Because of the lack of visibility from this roadside viewpoint, which is approximately 0.61 miles from the panels in view, no additional plantings are proposed (Figure 3-9, Visual Simulation).
