# Letter of Notification for the Arboles Station 138 kV Transmission Line Adjustment Project

PUCO Case No. 22-0447-EL-BLN

Submitted by: Ohio Power Company, Inc.

June 21, 2022

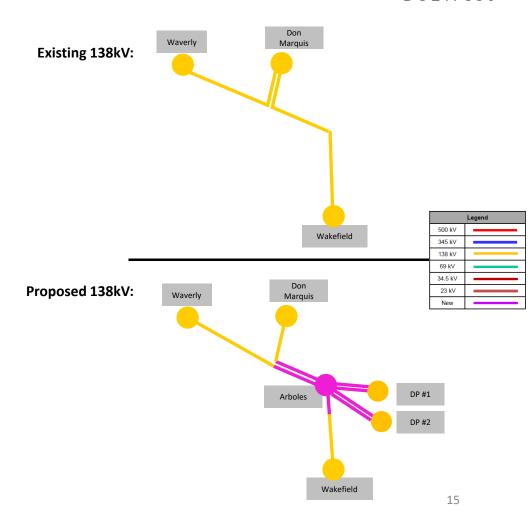
- Construct ~0.3 miles of new line to terminate the South Lucasville circuit into Arboles. (s2213.3) Estimated Cost: \$1.3M (AEP)
- Construct two independent lines to serve the X-555 substation (DP #1). The lines will be ~0.4 miles long each. (s2213.4) Estimated Cost: \$1.7M (AEP)

- Construct two independent lines to serve the X-5001 substation (DP #2). The lines will be ~0.8 miles long each. (s2213.5) Estimated Cost: \$3.5M (AEP)
