MUDDY CREEK EMERGENT POLE REPLACEMENTS PROJECT

Duke Energy Ohio, Inc.
OPSB Case No. 22-746-EL-BNR

F6885 EMERGENCY WOOD POLE REPLACEMENTS NATURAL RESOURCE ASSESSMENT

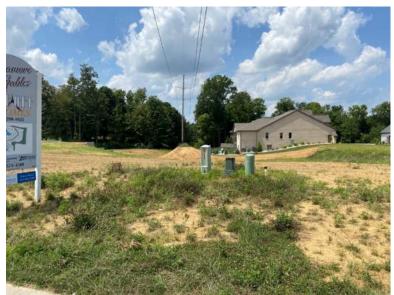
Photo: 3

This DP was collected in the southeastern portion of the SITE. The dominant vegetation present consisted of Japanese stiltgrass (*Microstegium vimineum*, FAC), Canada goldenrod (*Solidago canadensis*, FACU), wingstem (*Verbesina alternifolia*, FACW), and orange jewelweed (*Impatiens capensis*, FACW), which met the hydrophytic vegetation criterion. However, examination of the soil profile using the Munsell Color Chart revealed a matrix color of 10YR 5/4 and 10YR 3/2 to a depth of

18 inches, which did not meet the hydric soil criterion. No evidence of hydrologic features was observed. Since all three criteria were not met, this area did not qualify as a wetland.

DP 1/Erosional
Drainage Feature

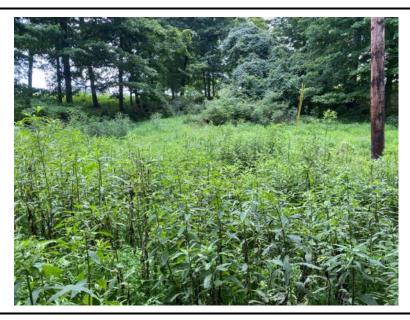
DP 1/Erosional
Drainage Feature 1

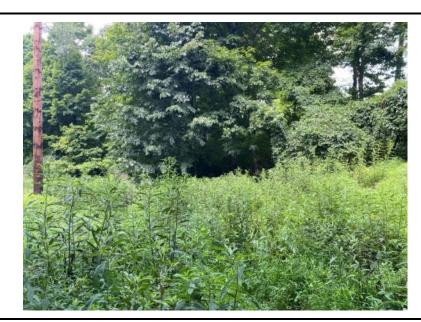
Photo: 5

Two erosional drainage features were identified on-SITE. These features did not exhibit a OHWM or a defined bed and bank. These features are shown on **Figure 6**. Photos of these features are provided in **Appendix B**. No other streams potential "Waters of the U.S." were observed on-SITE.

Erosional Drainage Feature 1

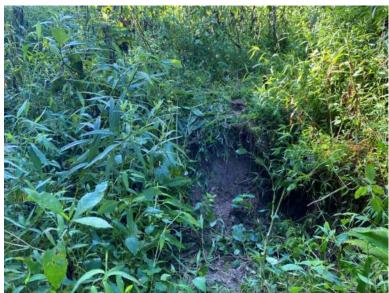
Photo: 6

This DP was collected in the southeastern portion of the SITE approximately 75 feet northwest of DP 1. The dominant vegetation present consisted of Japanese stiltgrass (FAC), Kentucky bluegrass, (*Poa pratensis*, FAC), fox sedge (Carex vulpinoidea, FACW), and Frank's sedge (Carex frankii, OBL), which met the hydrophytic vegetation criterion. Examination of the soil profile using the Munsell Color Chart revealed a matrix color of 10YR 4/4 and 10YR 5/6 to a depth of 18 inches, which did not meet the hydric soil criterion. No evidence of hydrologic features was observed. Since all three criteria were not met, this area did not qualify as a wetland.

Data Point 2

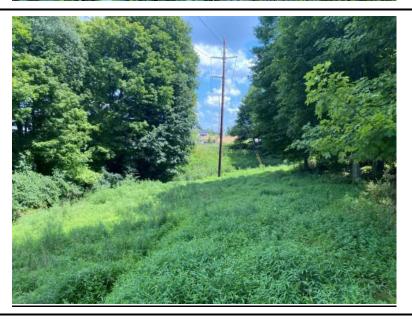
Southern project area view of two structures to be replaced

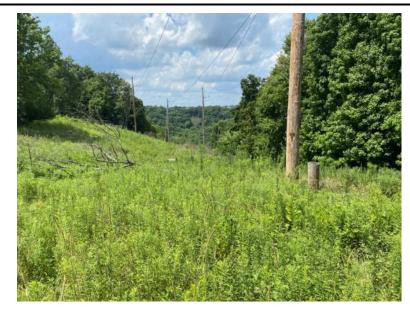
Photo: 8

This DP was collected in the northwestern portion of the SITE. The dominant vegetation present consisted of red fescue (*Festuca rubra*, FACU), japanese whistlegrass (Setaria faberi, FACU), white snakeroot (Ageratina altissima, FACU) and annual ragweed (*Ambrosia artemisiifolia*, FACU), which did not meet the hydrophytic vegetation criterion. Examination of the soil profile using the Munsell Color Chart revealed a matrix color of 10YR 3/2 to a depth of 18 inches, which did not meet the hydric soil criterion. No evidence of hydrologic features was observed. Since all three criteria were not met, this area did not qualify as a wetland.

Data Point 3

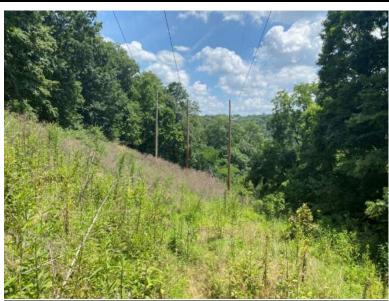
Photo: 9

Data Point 3

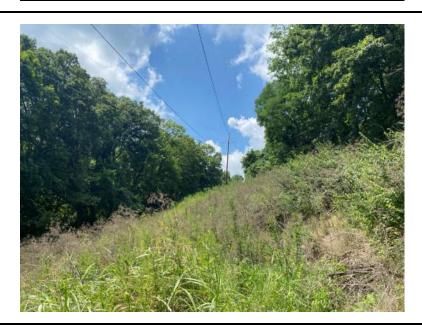
Drainage Feature 2

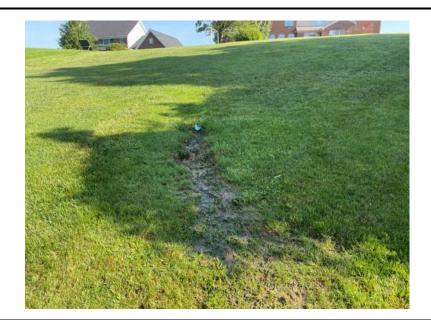
Photo: 11

Drainage Feature 2
