Siting Study

New Liberty-East Leipsic 138 kV Upgrade Project

Jacobs Engineering Group, Inc.
2 Crowne Point Court
Cincinnati, Ohio

December 2022

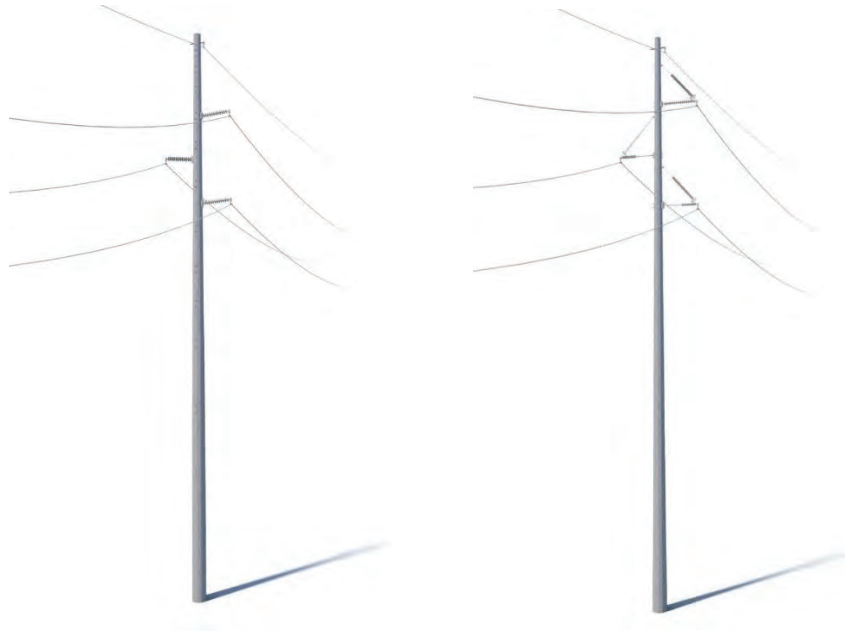
Figure 2. Typical Steel Monopole Transmission Line Structures

The Project will replace existing wooden poles with steel monopole structures ranging between 75 to 95 feet tall. The ROW will be approximately 55 feet wide (where the line is adjacent to road ROW) to 100 feet in other locations. The poles will support a single 138 kV circuit. The exact structure, height, and ROW widths may vary subject to final engineering design.

Examples of the steel monopole structures is shown on **Figure 2**, one with horizontal arms and one with braced horizontal arms. Portions of the transmission line route and structures may be underbuilt with distribution lines, but the extent is not yet known. Replacing existing wooden structures with steel pole structures will bring the transmission line up to modern operating standards.

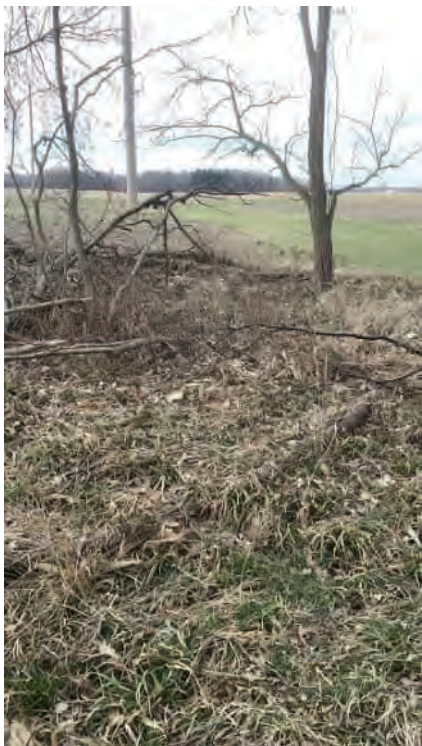
S

Remarks:
Only 1 secondary indicator was observed (geomorphic position), therefore sample point does not meet wetland hydrology

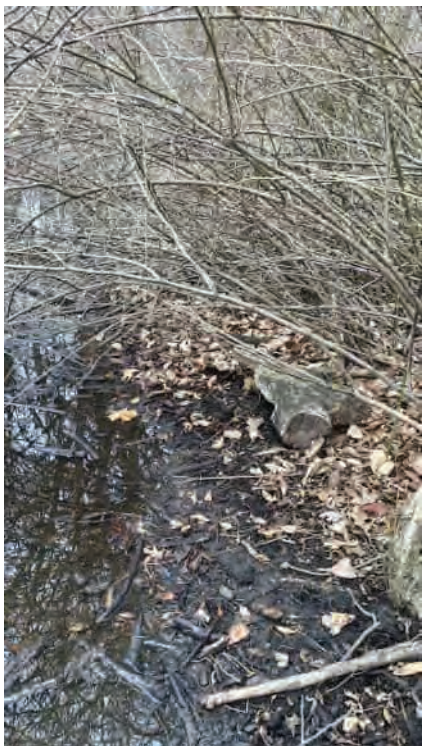
N

Remarks:
multiple primary and secondary hydrology indicators observed. Wetland receives hydrology via precipitation and surface runoff from surrounding landscape
