Appendix 8-2 Correspondence with Ohio Department of Natural Resources and U.S. Fish & Wildlife Service

Project/Site: Dowling-Fulton 345 kV Transmission Line Tap to Melbo Cit	y/County: Fulton County Sampling Date: 10/04/2022
Applicant/Owner: FirstEnergy	State: OH Sampling Point: Upland DFN-01,02
Investigator(s): MJA Se	ection, Township, Range: S 1 T 7N R 7E
Landform (hillslope, terrace, etc.): Toeslope Local	
	008 Long: -84.01673416699998 Datum: NAD 83
Soil Map Unit Name: Millgrove-Mermill (s6036)	NWI classification: NA
Are climatic / hydrologic conditions on the site typical for this time of year?	
Are Vegetation X, Soil , or Hydrology significantly dis	
Are Vegetation, Soil, or Hydrology naturally proble	ematic? (If needed, explain any answers in Remarks.)
SUMMARY OF FINDINGS – Attach site map showing s	ampling point locations, transects, important features, etc.
Hydrophytic Vegetation Present? Yes NoX	Is the Sampled Area
Hydric Soil Present? Yes X No	within a Wetland? Yes No X
Wetland Hydrology Present? Yes X No	If yes, optional Wetland Site ID: Upland DFN-01,02

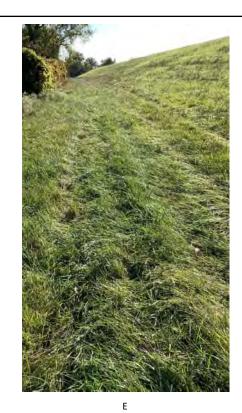
Sandy Gleyed Matrix (S4)	Redox Depress	ions (F8)			Mesic	Spodic (TA6) (MLRA 144A, 145, 149B)		
Sandy Redox (S5)					Red Pa	arent Material (F21)		
Stripped Matrix (S6)					Very S	hallow Dark Surface (TF12)		
Dark Surface (S7) (LRR R, MLRA 149	9B)				Other (Explain in Remarks)		
³ Indicators of hydrophytic vegetation and v	etland hydrology mus	t be present	t, unless	disturbed	or problematic			
Restrictive Layer (if observed): X								
Type: Compacted	-					v		
Depth (inches): 6.0 Remarks:	-				Hydric Soil	Present? Yes X No No		
Remarks.

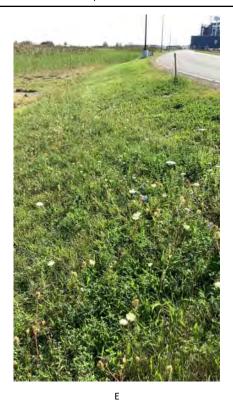
-	leyed Matrix (S4) edox (S5)	_	_ Redox Depress	sions (Fo)				Spodic (TA6) (MLRA 144A, 145, 149B) arent Material (F21)
-	Matrix (S6)							Shallow Dark Surface (TF12)
	face (S7) (LRR R, M	LRA 149B)						(Explain in Remarks)
	hydrophytic vegetati	on and wetla	and hydrology mus	st be prese	nt, unless	disturbed	or problemation	C
	ayer (if observed):							
Type:								5 10 V
	ches):						Hydric Soil	Present? Yes No _X
Remarks:								
shovel refusa	al at 6 inches. No hyd	dric soil indic	ators present

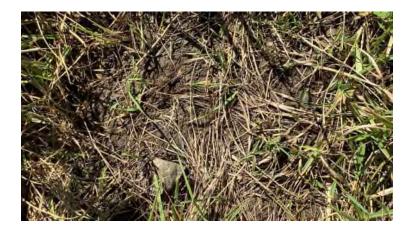
Upstream Downstream

SITE NAME/LOCATION Stream DFN-08 Dowling-Fulton 345 kV	Transmission Line Tap to Melbourne Substation	
SITE NUMBER S-JFW-100422-02 RIVER BASIN 04100009	RIVER CODE DRAINAGE AREA (mi²) 0.1	8
LENGTH OF STREAM REACH (ft) LAT 41.595901	136166667 LONG <u>-83.98945078916668</u> RIVER MILE	
DATE 10/04/2022 SCORER JFW COMME	NTS Do not have access to ODOT parcel, done remotely. Constructed roadside ditc	n with NHD
NOTE: Complete All Items On This Form - Refer to "He	adwater Habitat Evaluation Index Field Manual" for Inst	ructions
STREAM CHANNEL MODIFICATIONS: TO NOVE (NATUR	AL CHANNEL ☐ RECOVERED ☐ RECOVERING ☐ RECENT OR N	
NONE / NATURA	AL CHANNEL RECOVERED RECOVERING X RECENT OR N	URECOVERY
(Max of 32). Add total number of significant substrate ty	nt). Check ONLY two predominant substrate TYPE boxes. Prese found (Max of 8). Final metric score is sum of boxes A & B YPE SILT [3 pt] LEAF PACK/WOODY DEBRIS [3 pts] FINE DETRITUS [3 pts] CLAY or HARDPAN [0 pt] MUCK [0 pts] ARTIFICIAL [3 pts]	HHEI Metric Points Substrate Max = 40

Total of Percentages of	ARTIFICIAL [5 pts]	
Bldr Slabs, Boulder, Cobble, Bedrock 0 (A SCORE OF TWO MOST PREDOMINATE SUBSTRATE TYPES	` 2	A + B
	depth within the 61 meter (200 feet) evaluation reach at the	Pool Depth
time of evaluation. Avoid plunge pools from road culver	ts or storm water pipes) (Check ONLY one box):	Max = 30
> 30 centimeters [20 pts] > 22.5 - 30 cm [30 pts]	5 cm - 10 cm [15 pts] < 5 cm [5pts]	0
> 10 - 22.5 cm [25 pts]	NO WATER OR MOIST CHANNEL [0pts]	
COMMENTS	MAXIMUM POOL DEPTH (inches): 0

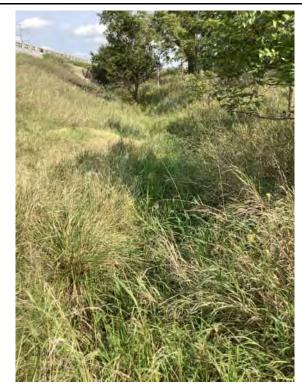
Downstream

COBBLE (65-256 mm)[12 pts] GRAVEL (2-64 mm) [9 pts] SAND (<2 mm) [6 pts]	X □ CLAY or HARDPAN [0 pt] 50 □ □ MUCK [0 pts]	6
Total of Percentages of	A) 2 (B) 2	A + B
	I depth within the 61 meter (200 feet) evaluation reach at the	Pool Depth
time of evaluation. Avoid plunge pools from road culve > 30 centimeters [20 pts]	erts or storm water pipes) (Check <i>ONLY</i> one box): 5 cm - 10 cm [15 pts]	Max = 30
> 22.5 - 30 cm [30 pts]	<pre>5 cm [5pts]</pre>	20
> 10 - 22.5 cm [25 pts]	NO WATER OR MOIST CHANNEL [0pts] MAXIMUM POOL DEPTH (inches): 12	
COMMENTS		
COMMENTS	(

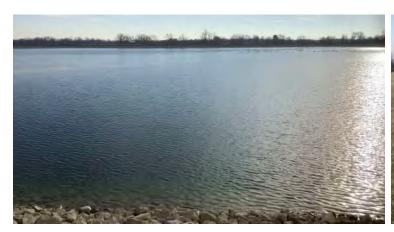
OND DA	TA OTTEET		
FEATURE ID Pond DFN-02	Pond DFN-02 ASSOCIATED FEATURES:				
Survey Type: Wetland and waterbodies delineation					
DATE: 12/20/2022	CLIENT/PROJECT NAME:		Dowling-Fulton 345 kV Tra	ansmission Line Tap to Melbourne Substation	
INVESTIGATORS: MJA		ROUTE:			
STATE/COUNTY:			Is this a Mapped NWI Feature?: yes	L1UBHx	
	l	WATERBODY CH	IARACTERISTICS		
WATERBODY TYPE:	Reservoir				
AVG. DEPTH:	>3 ft				
AVG. WIDTH (WATER SURFACE):	1,200 ft at crossing				
APPROXIMATE SIZE:	50 acres				
		QUALITATIVE	ATTRIBUTES		
AVERAGE WATER APPEARANCE:	Clear				
PRIMARY SUBSTRATE (IF OBSERVED):	Silt and riprap				
POTENTIAL HABITAT FOR:	Waterfowl, fish, am	phibians			
Surrounding Land Use: Agriculture, secondary forest					
WETLAND FRINGE (IF PRESENT):	N/A				
COMMENTS

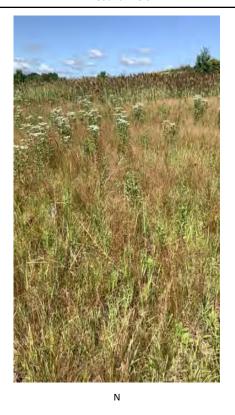
Ε

-	Matrix (S6)							hallow Darl			2)
	face (S7) (LRR R, M	LRA 149E	3)					Explain in I			-/
	(, (,		-,					(.,	
³ Indicators of	hydrophytic vegetati	on and we	tland hydrology mus	t be prese	ent, unless	disturbed	l or problemation).			
	ayer (if observed):		, 0,				1				
Type:	• , ,										
Depth (inc	hos):						Hydric Soil	Drosont?	Vos	X	No
	1165)						Hydric 30ii	rieseiit:	162	<u> </u>	140
Remarks:											
hydric soil ind	icator present as dep	oleted mat	rix

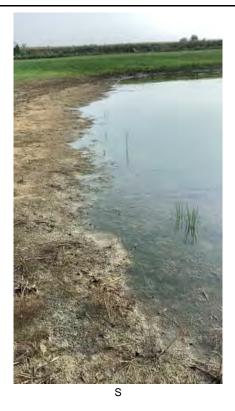
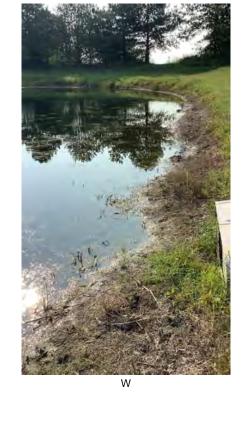
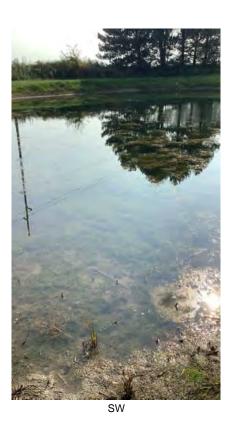
POND DATA SHEET FEATURE ID Pond DFS-01 **ASSOCIATED FEATURES:** Survey Type: Wetland and waterbodies delineation CLIENT/PROJECT NAME: FirstEnergy DATE: 09/14/2022 Dowling-Fulton 345 kV Transmission Line Tap to Melbourne Substation **INVESTIGATORS: ROUTE:** Is this a Mapped NWI Feature?: yes STATE/COUNTY: OH Fulton **PUBGx WATERBODY CHARACTERISTICS** WATERBODY TYPE: Residential pond 1 ft AVG. DEPTH: AVG. WIDTH (WATER SURFACE): 60 ft 1/4 acre **APPROXIMATE SIZE: QUALITATIVE ATTRIBUTES AVERAGE WATER APPEARANCE:** Clear PRIMARY SUBSTRATE (IF Silt OBSERVED): **POTENTIAL HABITAT FOR:** Fish, amphibians, insects **SURROUNDING LAND USE:** Mowed lawn None WETLAND FRINGE (IF PRESENT): **COMMENTS**

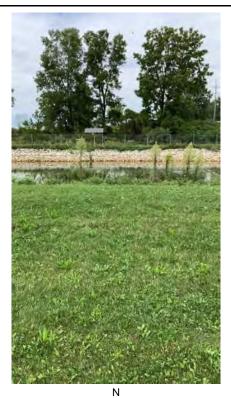
POND DATA SHEET FEATURE ID Pond DFS-02 **ASSOCIATED FEATURES:** Survey Type: Wetland and waterbodies delineation CLIENT/PROJECT NAME: FirstEnergy DATE: 09/06/2022 Dowling-Fulton 345 kV Transmission Line Tap to Melbourne Substation **ROUTE: INVESTIGATORS:** STATE/COUNTY: OH IS THIS A MAPPED NWI FEATURE?: no Fulton **WATERBODY CHARACTERISTICS** WATERBODY TYPE: Sewage treatment 10 AVG. DEPTH: AVG. WIDTH (WATER SURFACE): 50 0.25 **APPROXIMATE SIZE: QUALITATIVE ATTRIBUTES AVERAGE WATER APPEARANCE:** Cloudy PRIMARY SUBSTRATE (IF OBSERVED): **POTENTIAL HABITAT FOR: SURROUNDING LAND USE:** WETLAND FRINGE (IF PRESENT): **COMMENTS**
