A report by the Staff of the **Public Utilities Commission of Ohio**

In the Matter of the Investigation of the **Dominion East Ohio Gas Company Relative** to its Compliance with the Natural Gas Pipeline Safety Standards and Related Matters.

Case Number 12-380-GA-GPS

January 23, 2012

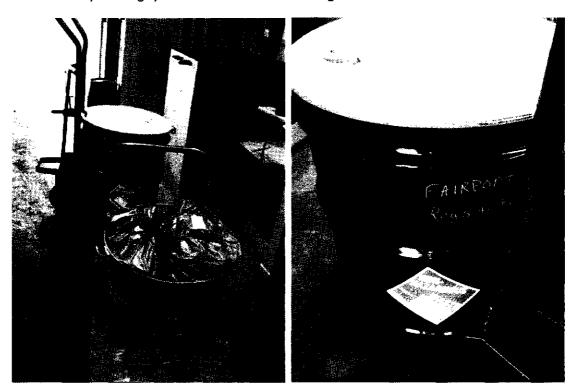
Figure 1: Containers Received by GTI

• The parts to be investigated were received from Dominion on 2/16/2011, and entered into the laboratory tracking system as batch 111108. See Figures 1-4.

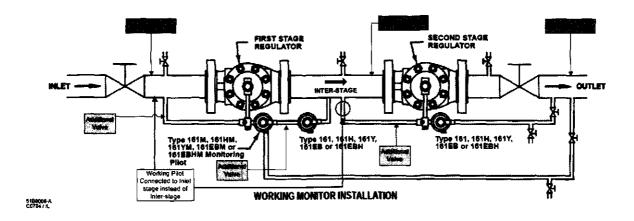
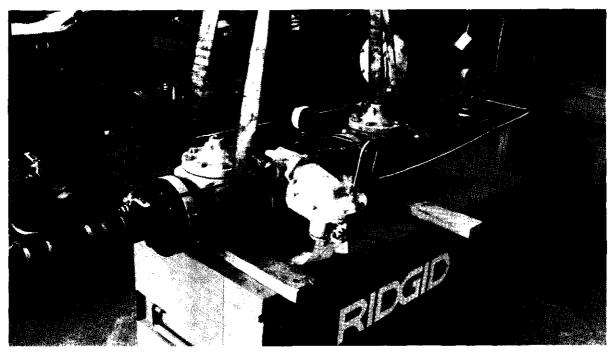
Figure 6: GTI Assembled Test Configuration for 22 JUN 2011

- The monitor regulator is the first stage regulator, and the working regulator is the second stage regulator.
- Upon completion of the test rig assembly, no pressurization or flow test was carried out. See
 Figure 6.

- Testing for the day was videotaped for documentary purposes.
 - Test rig at GTI was pressurized and checked for leaks.
 - Several leaks were found not only during the initial leak test, but also during the initial
 test runs. These leaks were found on the GTI test rig. Leaks were not found in the field
 at the site where the regulators came from.

- The globe valve at the outlet end was opened to 25% of its travel.
 - During these initial test runs the inlet and mid stage pressures were found to be equal at approximately 150-180psig with an outlet pressure greater than 14.31 psig.

- The actual output pressure may have been higher since the gauge was at the maximum range.
 - More leak testing indicated leaks were found at threaded connections as well as at the pilot regulators.

- o The pilot regulator diaphragm housings had to be resealed at the sealing edge.
 - With these leaks repaired there were no changes in the pressures and adjustments to the system regulators did not make any observable change in pressures.

The globe valve was fully opened and it was noted that the inlet and mid-stage pressures were identical but the outlet pressure had dropped to approximately 0.13 psig. Slowly closing down the globe valve back to 25% of its travel indicated that the test pressures were stable holding these values. For all test conditions the inlet and mid-stage pressures remained equal and with the mid-stage pressures well above the reported 90 psig setting.

- The results of the testing on 6/22/2011 indicated a consistently high mid-stage pressure equal
 to the inlet pressure and far in excess of the reported 90psig setting. This will require a more
 thorough component by component investigation. Therefore it is respectfully recommended
 that:
 - 1. The test rig piping will be modified for additional pressure gauges to monitor the inlet and outlet pressures of each of the pilot regulators along with valves to facilitate isolation and testing using ANSI B109 as a guide. Alternatively, each regulator could be removed from the

- rig and mounted to facilitate testing. Should this testing indicate a malfunction, the regulators should be disassembled and subjected to forensic analysis.
- 2. If pilot regulator performance is verified. Reinstall them into the test rig and evaluate the system using the previously established protocol.
- 3. If the system is still not performing, isolate and test the monitor and worker regulators using (1) above.

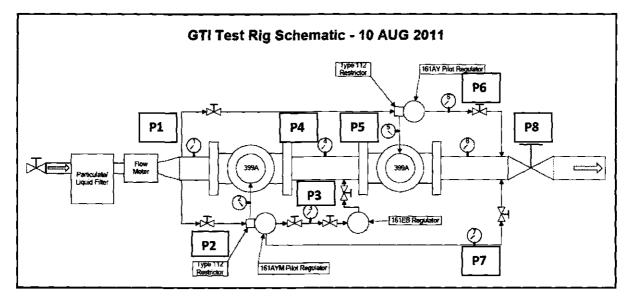
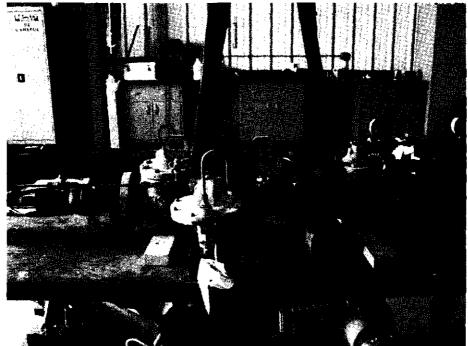
Figure 7: GTI Assembled Test Configuration for 10 AUG 2011

- The testing was videotaped for documentary purposes. Test rig was pressurized to 150 psig and checked for leaks. Eight (8) pressure gauges and one (1) flow-meter were used for this testing.
 All instrumentation is certified.
- Both pilot regulators were adjusted all the way out so that they only have atmospheric pressure.

This is the beginning of the start-up procedure for the Fisher 399A regulators.
- Caps were unplugged on crosses from P6 and P7 from figure 7 in order to vent to atmosphere. Start-up was done by isolating the pilot regulators by closing their respective inlet and outlet valves while unpressurised. The main valve to the system inlet was then opened, introducing pressure to the system. The main outlet valve was then opened to induce flow through the 399A regulators. The valve to the outlet of the monitor pilot regulator was then opened, followed by the inlet valve to that pilot. Upon opening of the pilot inlet valve the monitor regulator locked-up.

- The pilot regulator on the working regulator was tested in the same manner. The pilot shut off flow on the working regulator. See Test Run 2 in Table 1 for flow data.
- The working and monitor regulators were taken apart and inspected. It was found that the monitor regulator had a torn diaphragm. Figure 10 shows the tear in the diaphragm.

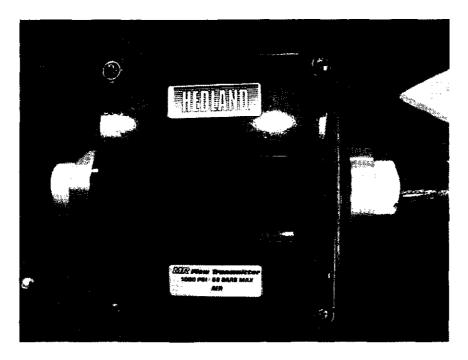
Figure 9: Flow-meter used for regulator testing

After the start-up procedure was completed, the pilot regulator on the monitor regulator was tested. See Test Run 1 in Table 1 for flow data. Figure 9 below shows a picture of the flowmeter.
