Re: Supplement to Application

Case No. 18-1360-EL-BGN In the Matter of the Application of Hardin Solar Energy II LLC for a Certificate of Environmental Compatibility and Public Need to Construct a Solar-Powered Electric Generation Facility in Hardin County, Ohio.

- <u>Attachment 1</u>: In response to O.A.C. Rules 4906-4-03(B)(2)(i) and 4906-4-06(F)(3) (pages 16 and 35 of the Application, respectively), the Applicant stated that the Road Survey Report would be provided shortly following the filing of the Application. At this time, the Applicant is providing, as Attachment 1, the Road Survey Report completed by Barr dated October 2018.

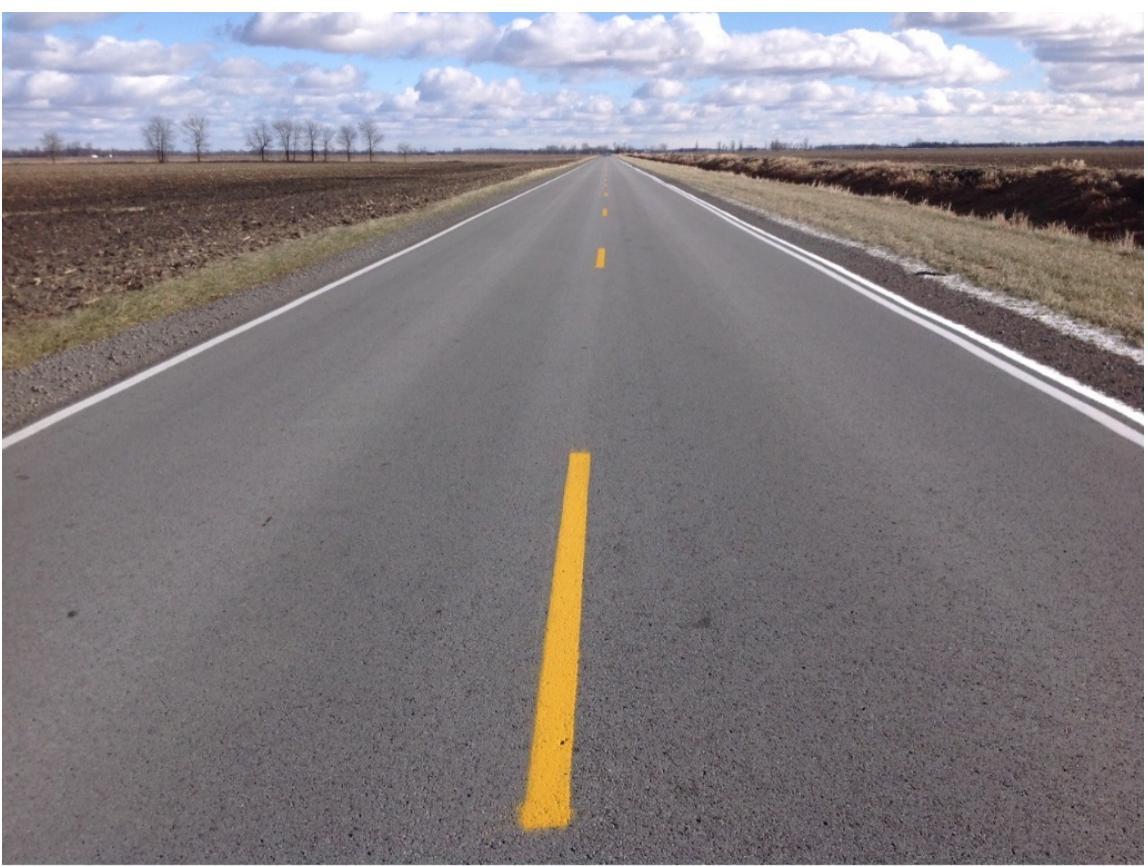
Figure 4-2 CR-110 Section 2

Table 4-3	CR-110 Section 2 -	PCI Summary
SAMPLE UNIT	PCI	RATING
1	88	GOOD
2	77	CATICEACTORY

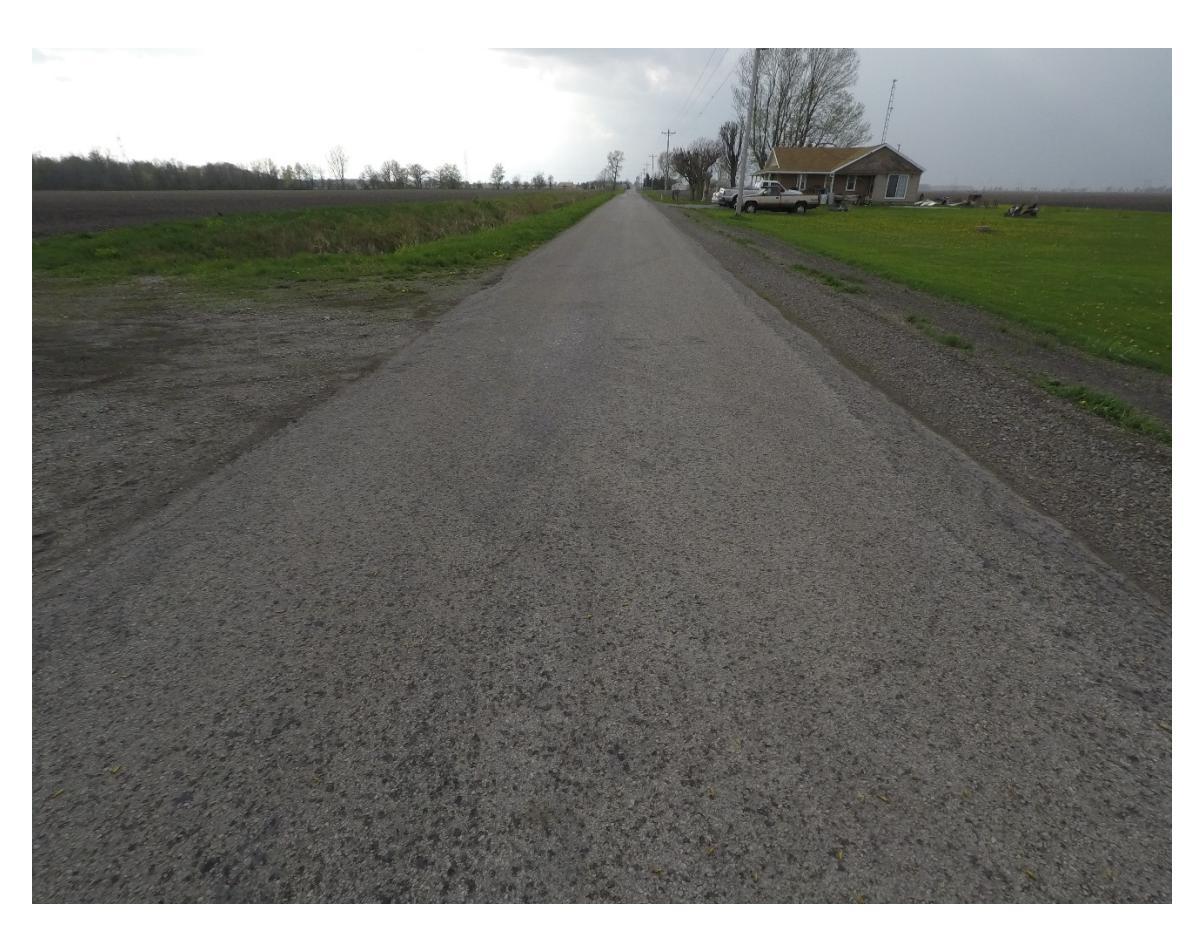
Figure 4-5 TR-120 Section 3

Section 3 from 51+50 to 78+00 was observed generally in satisfactory condition. The pavement has some distress such as bleeding, edge cracking, and small depressions. There are two areas where the asphalt was removed to place culverts. One of the areas was patched with bituminous asphalt and is in good condition, while the other was only filled with gravel and is starting to erode creating a dip.

SAMPLE UNIT	PCI	RATING
1	78	SATISFACTORY
2	70	SATISFACTORY
3	92	GOOD

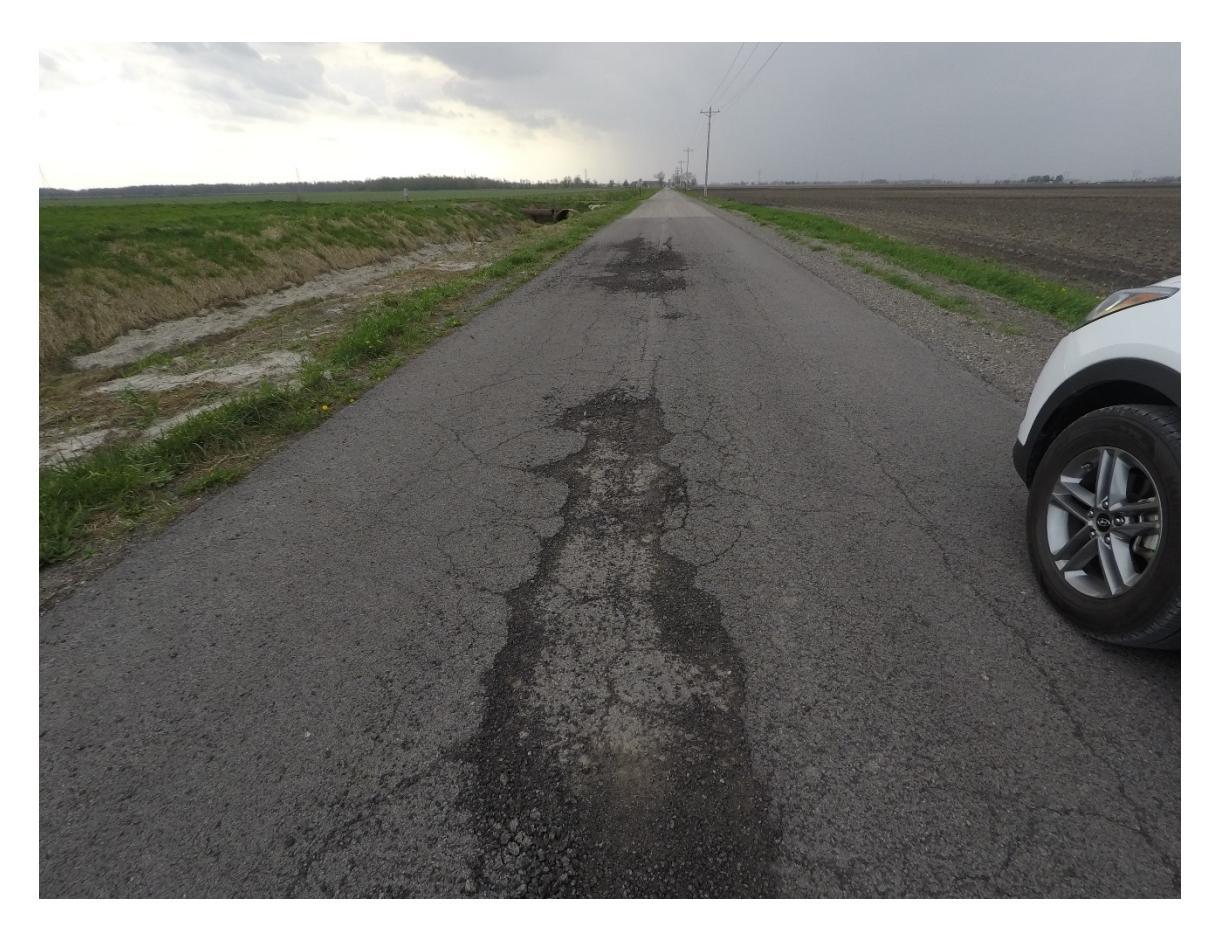
Section 5 from 104+00 to 117+00 was observed generally in poor condition. The pavement has several patches, bumps and sags, shoulder drop-off, pavement weathering, and block cracking throughout the section. The ride quality for this section is poor. Driving at posted speeds presents vehicle vibration. Some areas require slight reduction in speed due to the size of the bumps and dips.

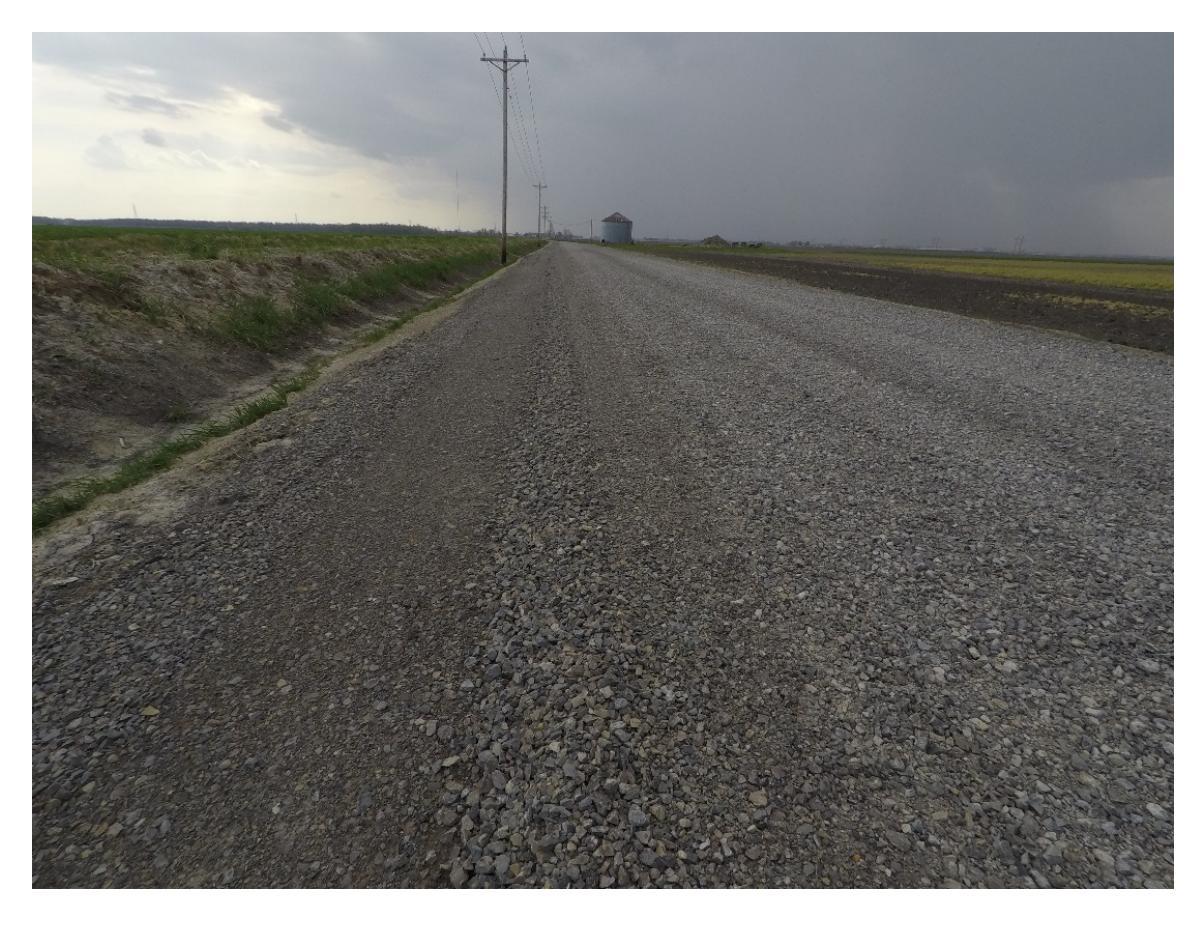
Section 6 from 117+00 to OH-195 is gravel with no bituminous asphalt. Gravel roads are not subject to pavement assessment. Gravel section seems in good shape. Areas measured show over 6 inches of new gravel over a subgrade that appears to be a base for the old road section. There are no visible washout areas. Ride is consistent without any mayor bumps.

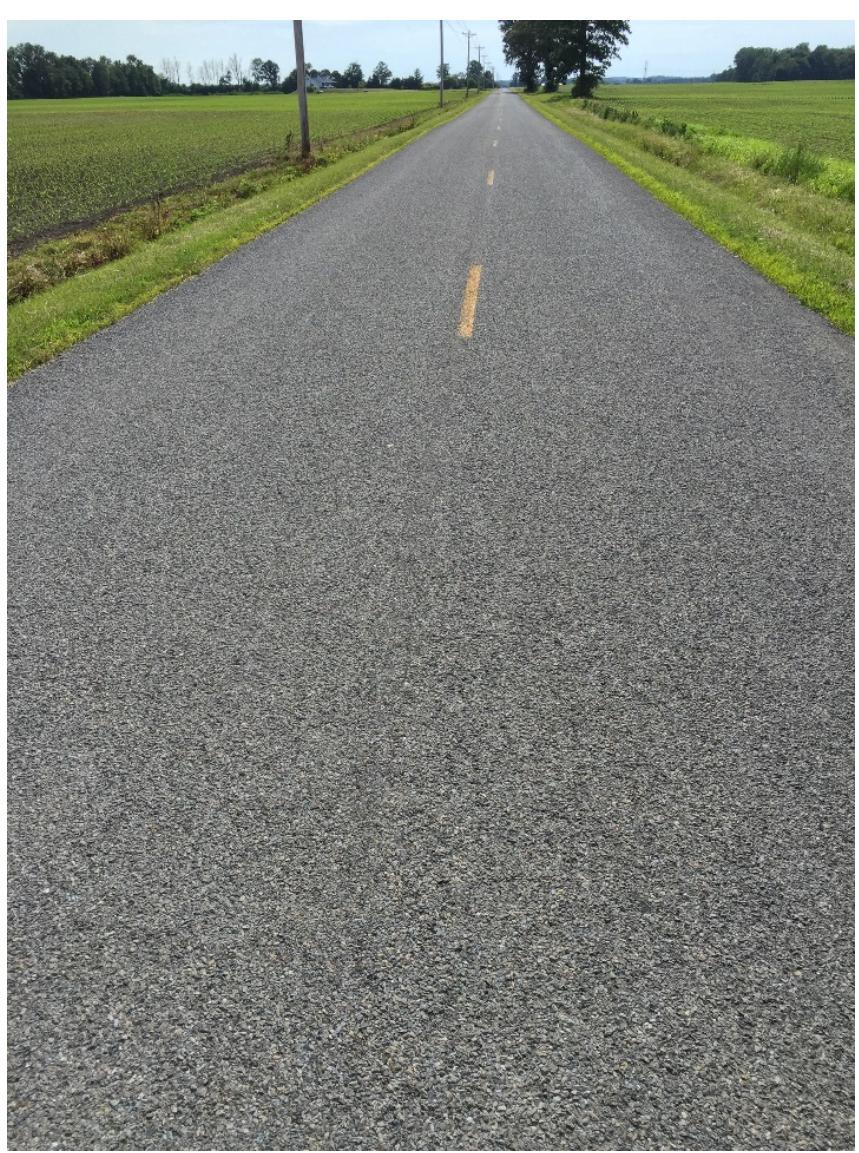
Figure 4-15 CR-130 Section 7

Section 7 from TR-65 to CR-75 was observed generally in good condition. The pavement has minimal distresses such as edge cracking.

SAMPLE UNIT	PCI	RATING
1	79	SATISFACTORY
2	92	GOOD
3	92	GOOD

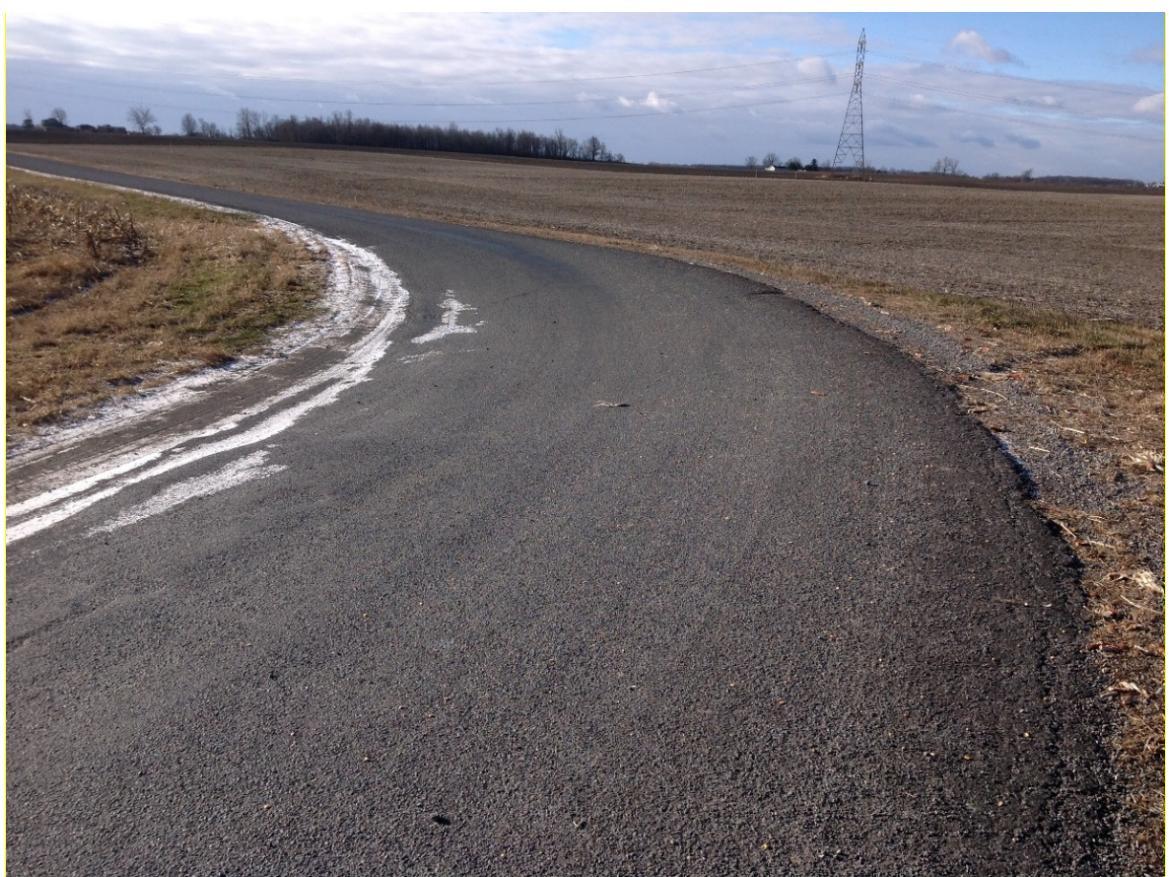
Figure 4-17 TR-65 Section 2

Section 2 from the road's 90° bend to 1,500 feet to the south was observed generally in satisfactory condition, except for the curve section, where fair conditions were observed due to a depression at the internal lane, and therefore the ride quality was noticeably affected. The rest of the inspected section had low distresses such as bleeding and edge cracking.

SAMPLE UNIT	PCI	RATING
1	59	FAIR
2	84	SATISFACTORY
3	82	SATISFACTORY

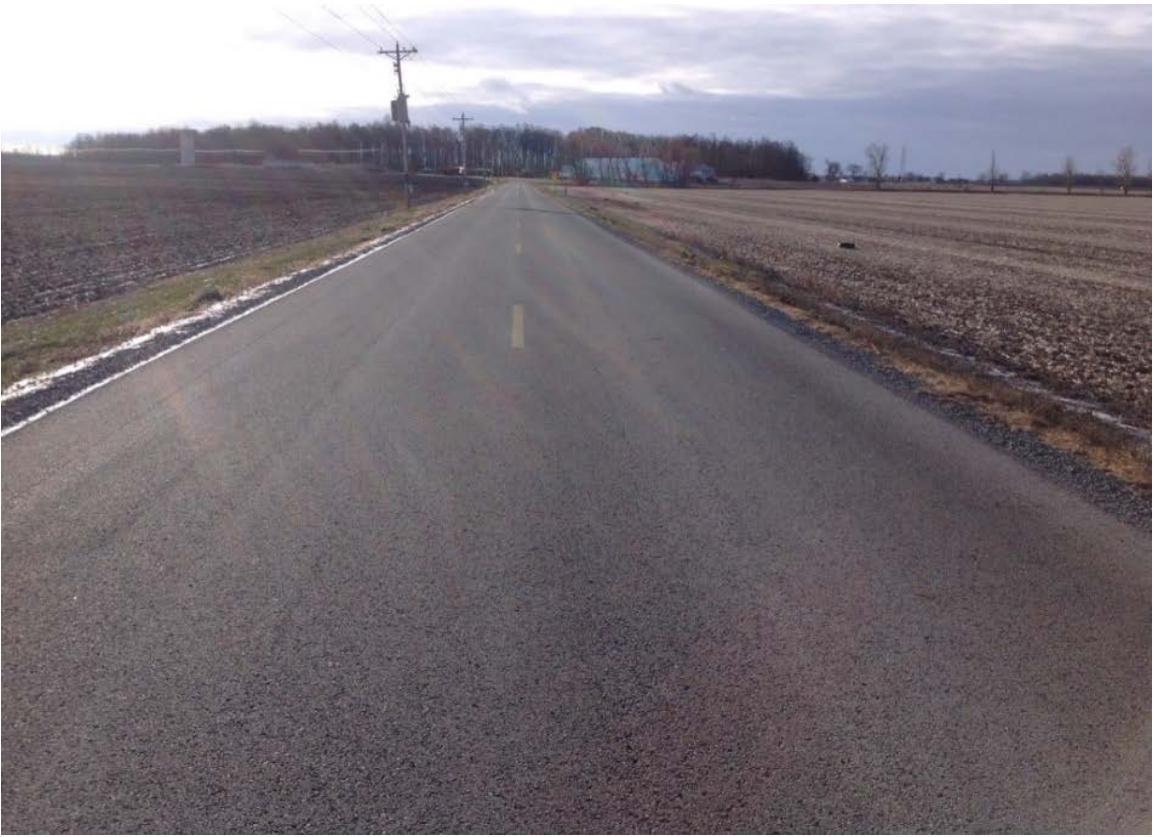
Figure 4-18 CR-65

CR-65 was inspected from the intersection with CR-130 to approximately 4,500 feet the north. CR-95 was measured at 20-foot wide and was observed in good condition. Low severity distresses such as shoulder drop-off and patching were observed, especially near the intersection with CR-130.

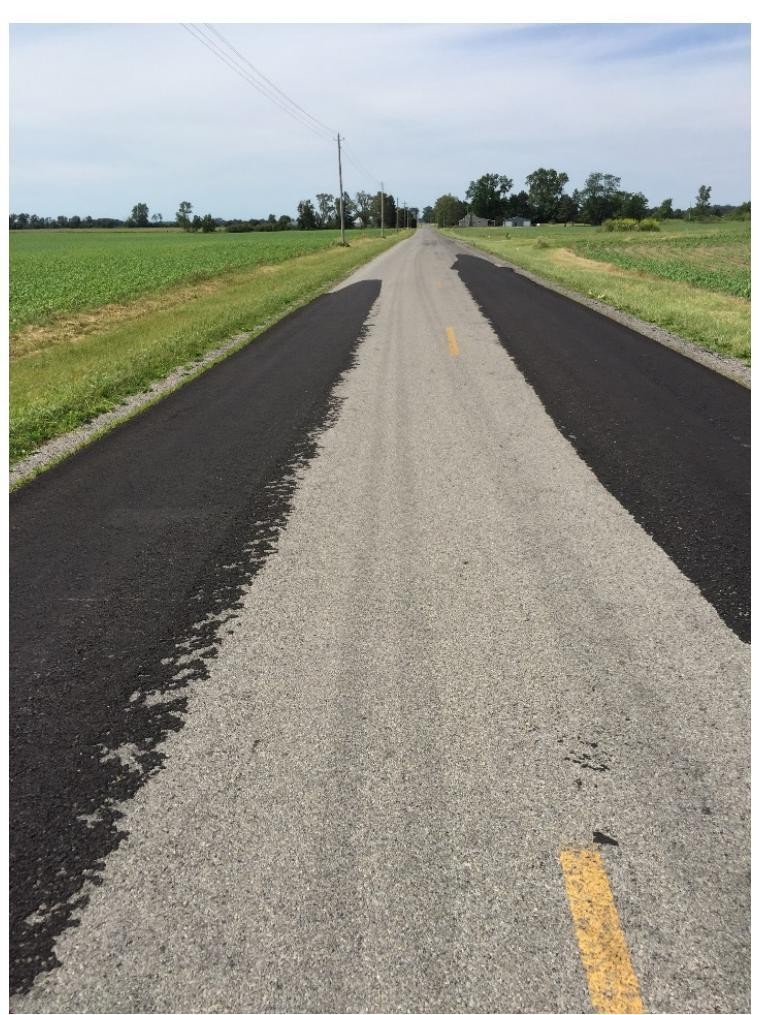
Figure 4-22 CR-75 Section 4

SAMPLE UNIT	PCI	RATING
1	70	SATISFACTORY
2	67	FAIR
3	75	SATISFACTORY
4	88	GOOD
5	84	SATISFACTORY
6	93	GOOD
