**BEFORE
THE OHIO SITING BOARD**

In the matter of the Application of Birch)	
Solar 1, LLC for a Certificate of)	
Environmental Compatibility and Public)	Case No. 20-1605-EL-BGN
Need to Construct a Solar-Powered Electric)	
Generation Facility in Allen and Auglaize)	
Counties, Ohio.)

TESTIMONY OF

May 11, 2022

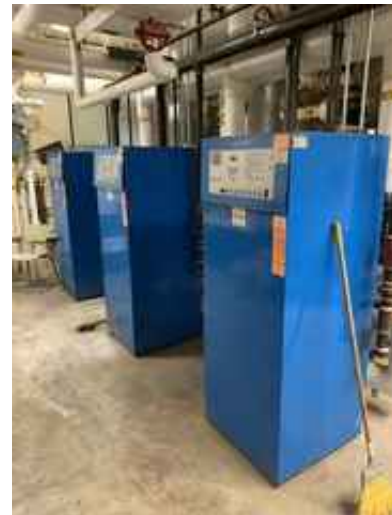
Hot water boiler (west building)

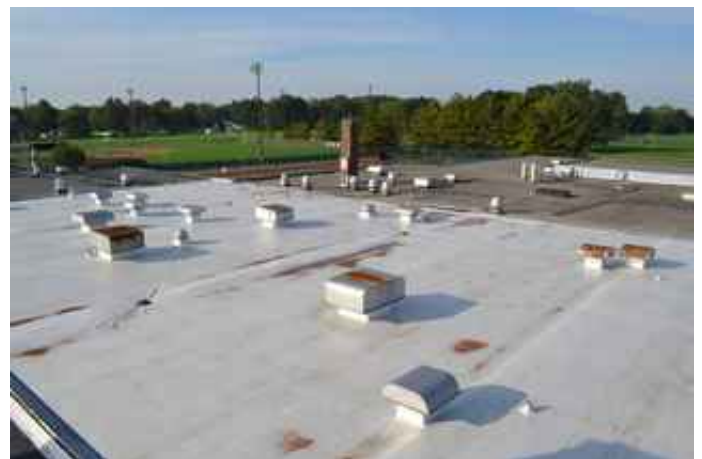
TPO with Signs of Past Ponding

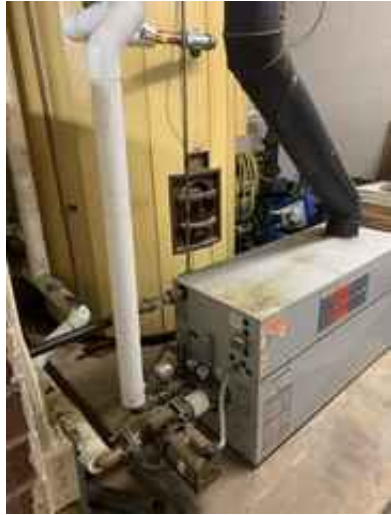
Domestic water boiler

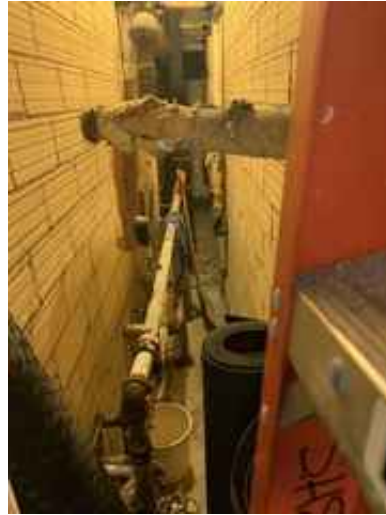
galvanized pipingt

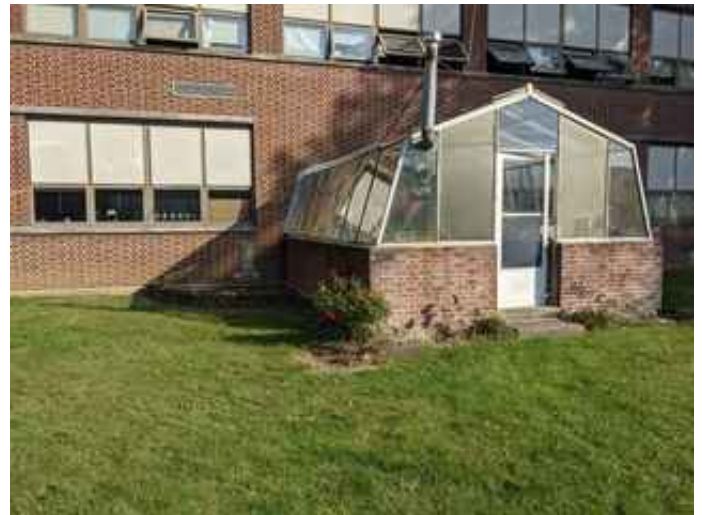
Greenhouse

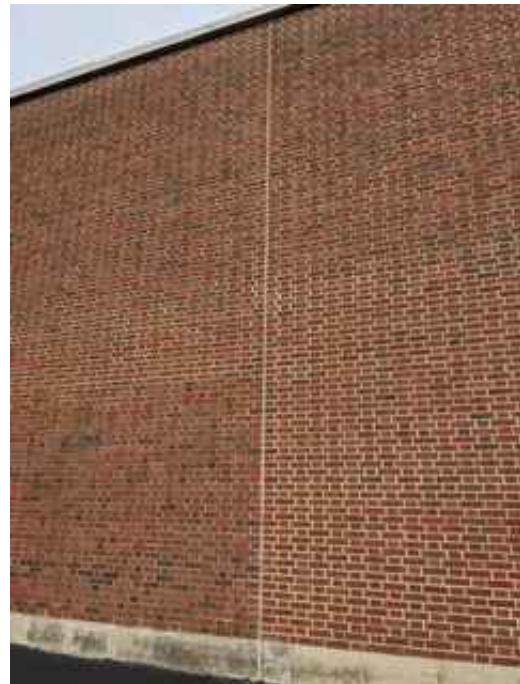
Control Joint Between Additions

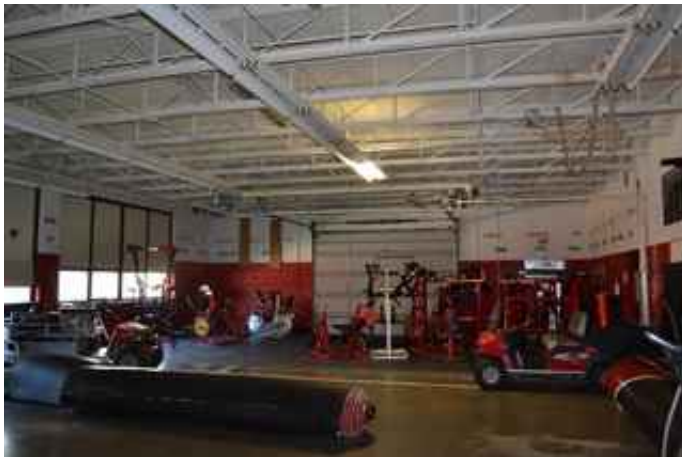
Tectum Deck

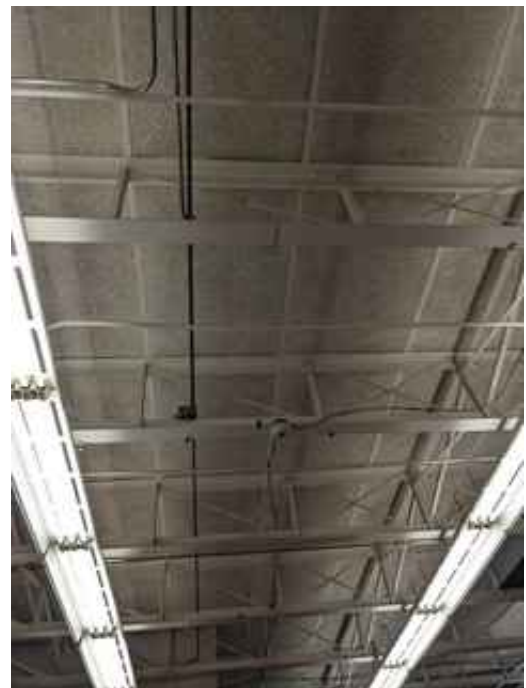
Tectum Deck

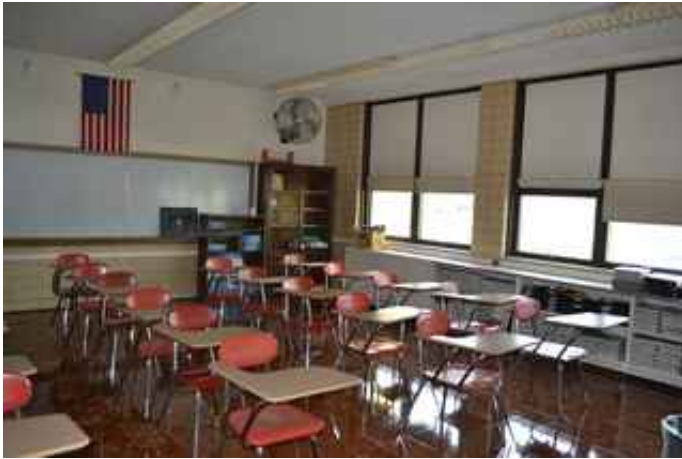
Description: The original building features traditionally partitioned classrooms, with VAT and VCT flooring, glazed block and gypsum walls, and dropped screw spline ceilings that are in poor condition. The 1962 addition classrooms have VCT flooring, CMU walls, and lay-in ceilings in poor condition. The 1964 and 1965 additions have classrooms with VAT and VCT flooring, CMU walls, and lay-in ACT ceilings in fair condition. The 1967 addition classrooms have VCT and carpet flooring, CMU and gypsum walls, and lay-in ACT ceilings in fair condition. Ceilings throughout were typically 9'-0" with a small interstitial clearance between ceiling and structure ranging from 11" to 1'-1". The typical classroom features built in storage for teacher materials. This casework is the original wood casework and it is in poor condition. Lockers for student storage are located in the corridors. These are recessed in the original building, but protrude into the corridor in the 1962 addition. The typical classroom features an adequate amount of markerboards or chalkboards. Tackboards are not consistently located in all of the classrooms in adequate amounts. Classroom doors are non-recessed wooden units without proper ADA hardware. The corridors throughout the whole building have terrazzo floors, brick or glazed block walls, and lay-in ceilings in fair condition. The large group restrooms in the original building, 1962, 1964, and 1965 additions feature terrazzo flooring and glazed block walls in fair condition. The restrooms ceilings are gypsum board and they are in fair condition. The toilet partitions are metal in poor condition. The gymnasium has wood flooring in poor condition for the playing court and is surrounded by terrazzo which is in good condition. The gymnasium has brick walls in fair condition, and exposed deck ceiling. There are fixed bleachers above a storage and locker room, as well as operable plastic bleachers, both in good condition. There is a divider curtain in fair condition. The gymnasium has no acoustical treatment on the walls or ceiling. The art room does have a kiln. The media center is not centrally located. It features carpet flooring, brick walls and lay-in ceilings. The media center finishes are in fair condition. There are two kitchens and cafeterias in the school building. The kitchen in the original building is a full kitchen with VAT flooring, glazed block walls, and a plaster ceiling that are in poor condition. The age of the kitchen equipment is not known. There are walk-in freezers or coolers provided in fair condition. The kitchen in the 1965 addition is a warming kitchen with VAT flooring, glazed block walls, and a plaster ceiling that are in poor condition. The age of the kitchen equipment is not known. There are no walk-in freezers or coolers. The cafeteria in the original building has VAT floors, with brick walls, and screw spine ceilings in poor condition. The cafeteria in the 1965 addition has VAT flooring, brick walls, and lay-in ceilings in poor condition. There is an auditorium in the building that was added as a part of the 1962 addition. The auditorium lobby has terrazzo floors, stone walls, and lay-in ceilings in fair condition. The auditorium itself has a one floor of seating on a sloped floor with concrete and carpet flooring. The walls are CMU and glazed block. The stage has VCT flooring with a wood-wrapped proscenium arch. The finishes of the auditorium are in fair condition but look dated.

Typical Classroom Finishes

Recommendations: Provide complete replacement of finishes in the original building due to poor conditions and due to the installation of systems outlined in this report (such as HVAC system, electrical, technology, etc). Provide for replacement of old toilet partitions and provide new accessories. Provide for replacement of the gymnasium floor. Provide for the replacement of all kitchen equipment. Provide for the addition of acoustical treatment to the gymnasium, band room, and cafeterias. Funding for replacement of interior doors is provided in Item O, including doors here noted as being in poor condition.

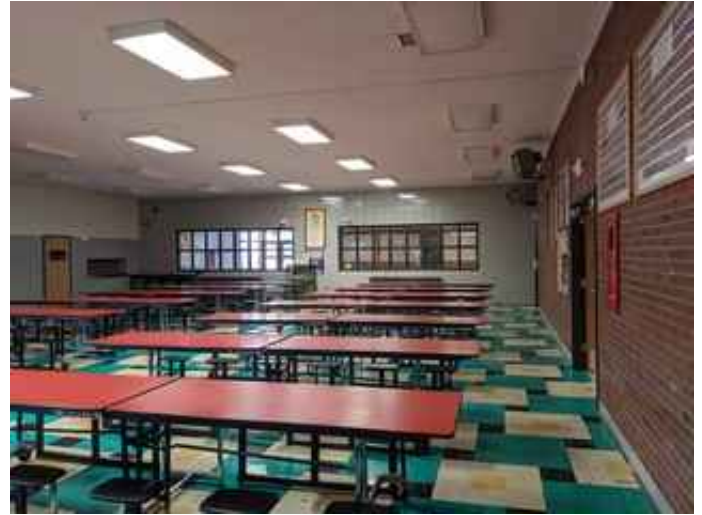
Cafeteria Finishes

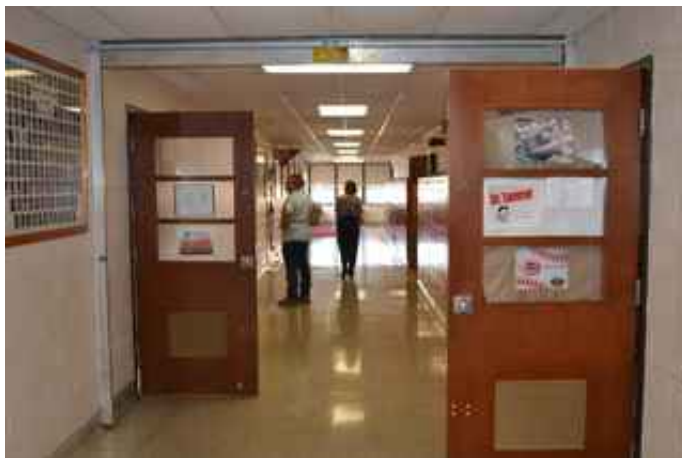
Door Swings in Hallway

Recommendations: Provide ADA-compliant signage, elevators, sinks, toilets, urinals, showers, electric water coolers (see Item E), toilet partitions, mirrors and toilet partition accessories as required. Provide ADA power assist operator at main entrance. Provide for lift at auditorium stage. Replace elevator in place. Replace old wood doors with new leafs equipped with ADA hardware. Provide for replacement of non-ADA compliant ramp. Parking issues are corrected in Item P.

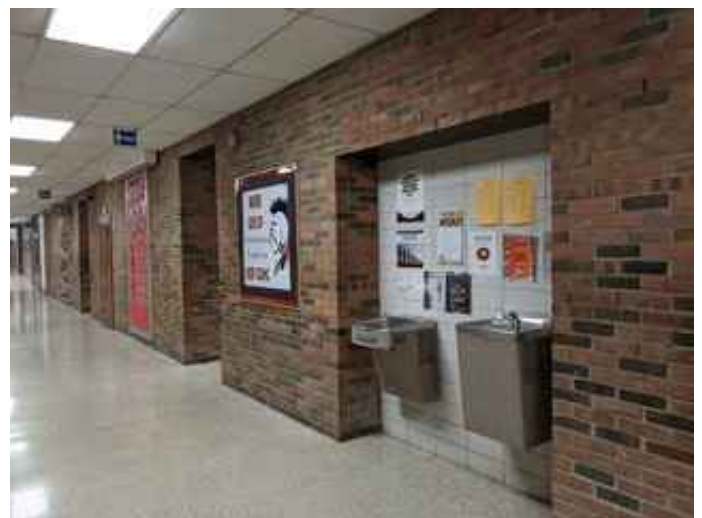
ADA Drinking Fountain without Bottle Filler

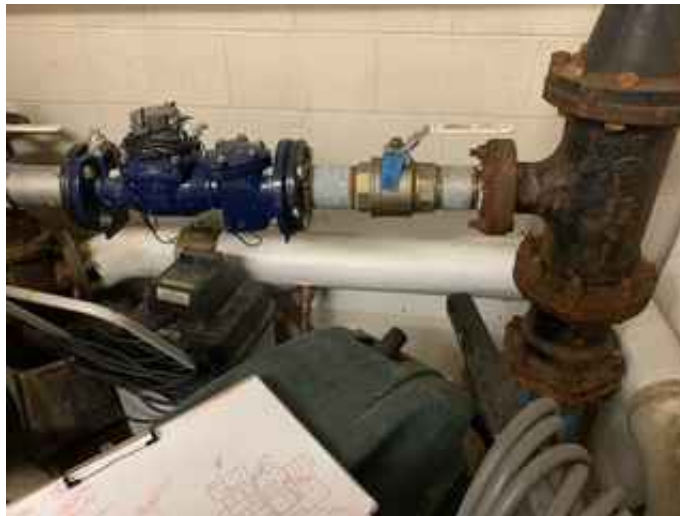
Description: The domestic water supply system is tied into the municipal system features 6" service and 3" water meter, is in fair condition. The District was not able to provide water supply flow test data. The facility is not equipped with an automated fire suppression system, and the existing water supply will not provide adequate support for a future system. The domestic water service is not equipped with a water booster pump and none is required. The system does not provide adequate pressure and capacity for the future needs of the school.

incoming water service

Recommendations: Provide a new city water supply line of adequate capacity to support the existing needs of the facility, as well as a future automated fire suppression system. Funding provided in Item U.

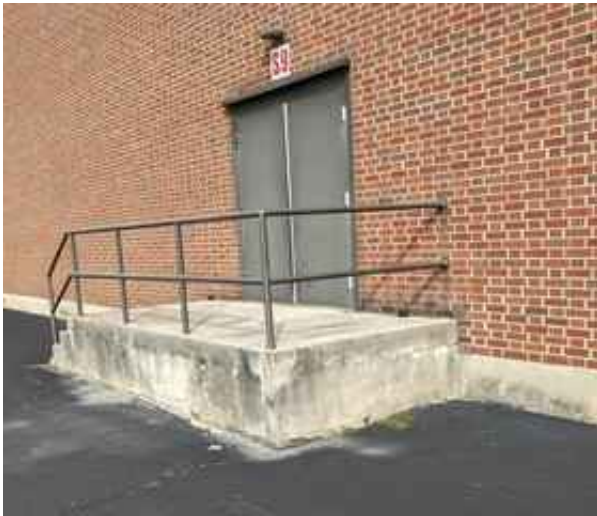
Description: Exterior doors in the building are aluminum and are in fair to poor condition. There are overhead doors that are steel and in fair condition.

Exterior Door

Recommendations: Provide for the replacement of all exterior doors.

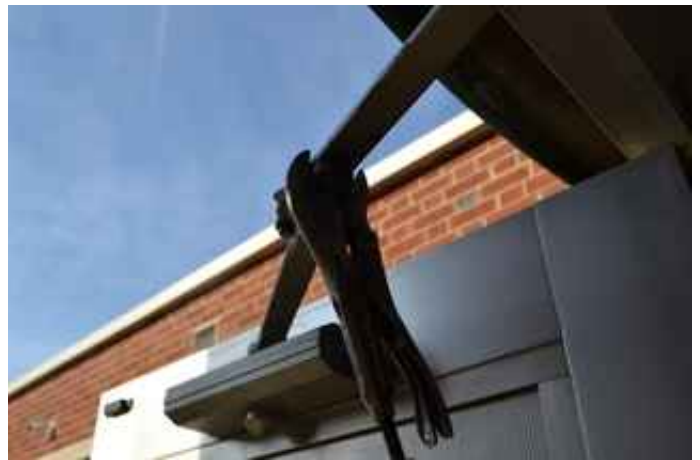
Exterior Door Hardware

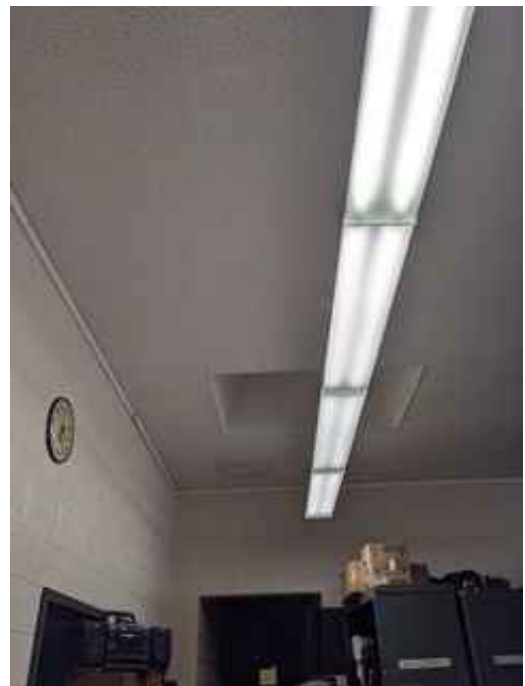
Description: The school was observed to contain asbestos. An AHERA report from 2002 has been provided, though it stated that all asbestos containing materials had been abated. Vinyl asbestos tile was observed in the school during the assessment. It is unclear the quantity and scope of existing hazardous materials.

Screw Spline Ceiling Tile

Recommendations: Provide for an Enhanced Environmental Report to be completed and budget adjustments to be made in order to replace abated materials.

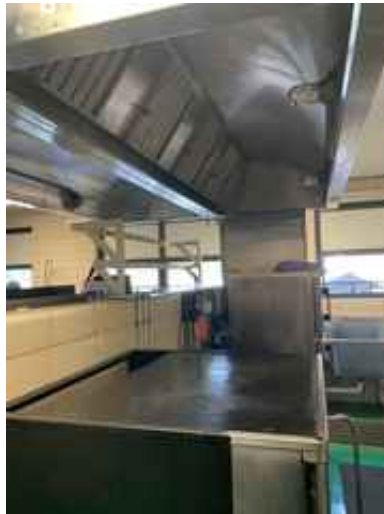
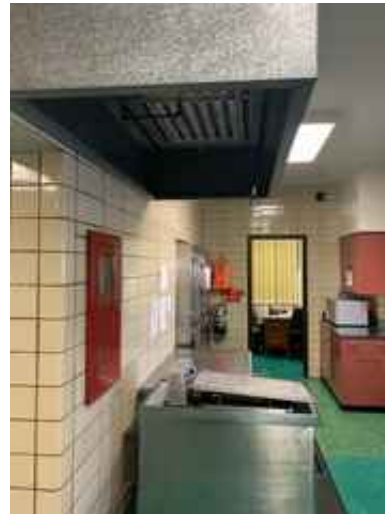
non conforming kitchen hood

Recommendations: Provide new automated fire suppression system to meet Ohio School Design Manual guidelines. Provide increased water service of a capacity sufficient to support the fire suppression system, funding included in fire suppression funding. Provide 300 linear feet of water line to support the new Fire Protection System (1954 addition). Provide 2 new kitchen hood systems, one for the east and west kitchens (provided under Item J). Provide appropriate enclosures for interior stairwells. Provide an emergency generator.

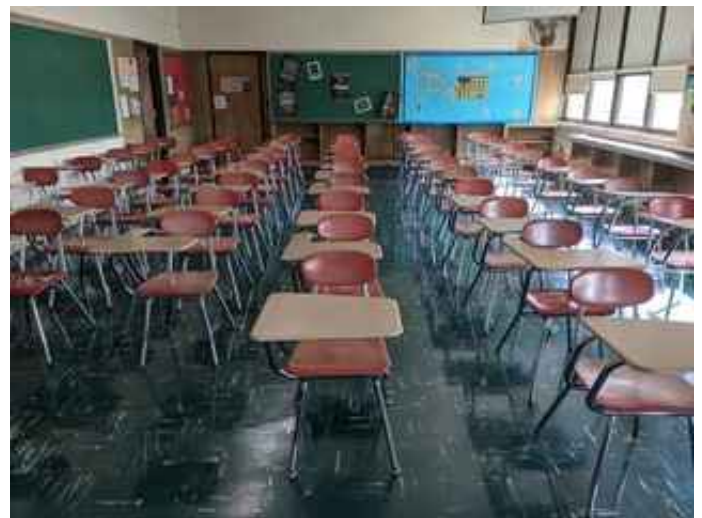
Description: The typical furniture is generally uniform but dated. It consists of student desks and chairs, teacher desks and chairs, desk-height file cabinets, reading tables/computer workstations and bookcases. The facility's furniture and loose equipment were evaluated in item 6.17 in the CEFPI section of this report, and on a scale of 1 to 10 the overall facility received a rating of 4 due to observed conditions, and due to the fact that it lacks some of the design manual required elements.

Dated Classroom Furniture

Recommendations: Provide for complete replacement of furnishings.

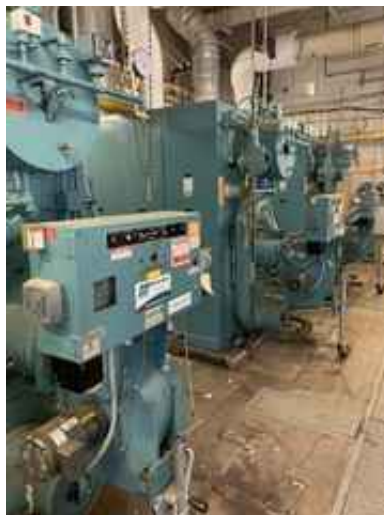
Steam Boilers

Recommendations: Provide new overall heating, ventilating, and air conditioning system to achieve compliance with Ohio Building Code and Ohio School Design Manual standards. Convert to a ducted system to facilitate efficient exchange of conditioned air. Replace steam heating with hot water. Provide architectural soffits to accommodate the installation of duct work

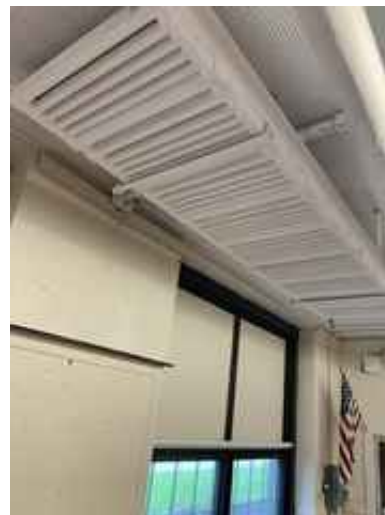
Steam Radiators

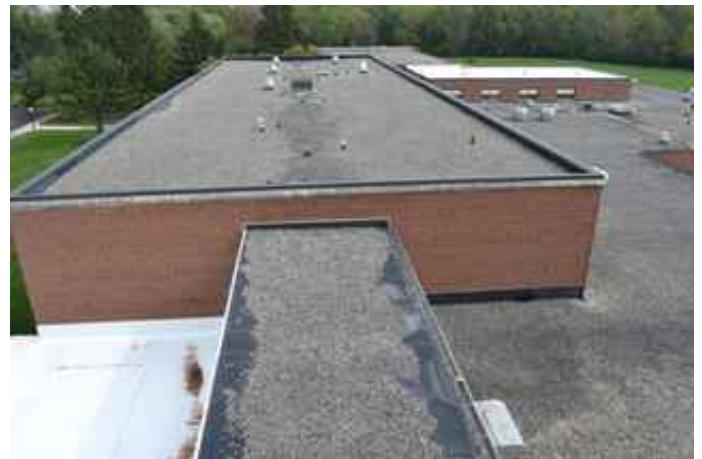
Ballasted Roofing

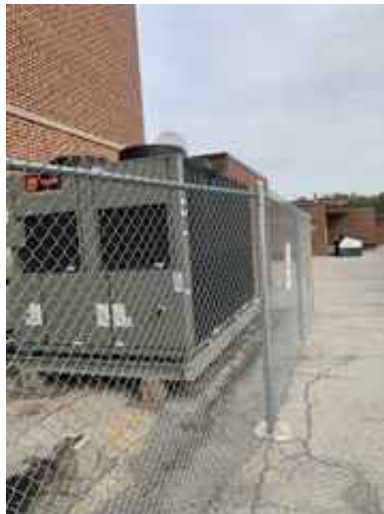
1973 outdoor chiller

Recommendations: Provide an air conditioning system to meet with Ohio Building Code and Ohio School Design Manual requirements. Pricing included in Item A. Add kiln ventilation. Add new dust collection system to wood shop. Add 8 general room exhaust fans in the art rooms, wood shop and science classrooms.

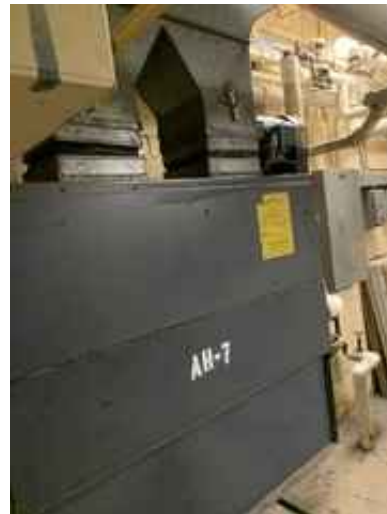
air handling unit

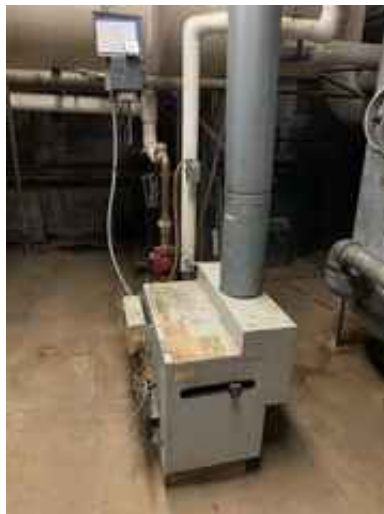
Description:	<p>The service entrance is located in the boiler house remote from the middle school and includes a 6" incoming line with a 3" meter and reduced pressure backflow preventor in fair condition. A water treatment system is not provided though none is needed. The domestic water supply piping in the overall facility except the 1973 addition is galvanized, is original to each addition, and is in poor condition. The facility is equipped with 1 gas water boiler that appears to be over 20 years old and in poor condition, with 1 separate 1000 gallon storage tank in fair condition. The school contains 7 Large Group Restrooms for boys, 7 Large Group Restrooms for girls, 2 Locker Room Restrooms for boys, 2 Locker Room Restrooms for girls, 1 Restrooms associated with specialty Classrooms, and 12 Restrooms for staff. Boys' Large Group Restrooms contain 0 ADA and 21 non-ADA floor mounted flush valve toilets, 3 wall mounted, flush valve toilets, 0 ADA and 5 non-ADA floor mounted flush valve urinals, 17 wall mounted, flush valve urinals, as well as 0 ADA and 13 non-ADA wall mounted lavatories. Girls' Large Group Restrooms contain 0 ADA and 29 non-ADA floor mounted flush valve toilets, as well as 0 ADA and 11 non-ADA wall mounted lavatories. Boys' Locker Room Restrooms contain 0 ADA and 2 non-ADA floor mounted flush valve toilets, 0 ADA and 1 non-ADA floor mounted flush valve urinals, 2 wall mounted flush valve urinals, 0 ADA and 2 non-ADA wall mounted lavatories, as well as 0 ADA and 15 non-ADA showers. Girls' Locker Room Restrooms contain 0 ADA and 3 non-ADA, floor mounted flush valve toilets, as well as 0 ADA and 0 non-ADA lavatories, as well as 0 ADA and 8 non-ADA showers. Staff Restrooms contain 0 ADA and 11 non-ADA floor mounted, flush valve toilets, 2 wall mounted flush valve toilets, 0 ADA and 2 non-ADA, floor mounted urinals, as well as 0 ADA and 13 non-ADA wall mounted lavatories. Condition of fixtures is fair. The facility is equipped with 0 ADA and 0 non-ADA drinking fountains, as well as 0 ADA and 16 non-ADA electric water coolers, 12 of the water coolers are in poor condition and 4 are newer and have the required bottle filler. Middle School Special Education Classroom is not equipped with sink mounted type drinking fountains. Special Education Classroom is not equipped with the required Restroom facilities. Kitchen is not equipped with the required Restroom and fixtures are in fair condition. Heath Clinic is not equipped with the required Restroom. Due to existing grade configuration, Kindergarten / Pre-K Classroom Restroom considerations are not relevant. Kitchen fixtures consist of 2 triple compartment sink, dishwasher, and disposal, which are in fair condition. The Kitchen is equipped with a satisfactory grease interceptor. The Kitchen is provided the required 140- degree hot water supply via a 150 gallon, gas fired, water heater, which appears to be over 20 years old and should be replaced. The school meets the OBC requirements for fixtures. Per OBC and OSDM requirements this facility should be equipped with 17 toilets, 17 urinals, 17 lavatories, 1 Classroom sink mounted drinking fountain, and 9 electric water coolers. Observations revealed that the school is currently equipped with 73 toilets, 28 urinals, 40 lavatories, 0 Classroom sinks mounted drinking fountains, and 16 electric water coolers. Custodial Closets are properly located and are adequately provided with required service sinks or floor drain sinks which are in fair condition. 4 Science Classrooms are not equipped with safety shower/eyewash. Wood shop does not have the required restroom or emergency shower/eyewash, and the wash fountain is in poor condition and should be replaced. Biology and Chemistry Classrooms are equipped with central type acid waste systems and neutralization tanks which are in fair condition. Adequate exterior wall hydrants are provided.</p>

Rating:	3 Needs Replacement
Recommendations:	<p>To facilitate the school's compliance with OBC and OFCC fixture requirements provide: 1 sink with bubbler drinking fountain - 1959 addition. 1 clinic restroom (1-WC and 1-LAV) - 1924 addition. 1 wood shop restroom (1-WC and 1-LAV) - 1924 addition. Due to the OSDM requirement of all low flow fixtures, all of the existing fixtures shall be removed/ replaced: 1924 Original Building 32 water closets 13 urinals 15 lavs 8 electric water coolers 1 wash fountain, 1938 Addition 1 water closet 1 lavatory, 1950 Addition 25 water closets 7 urinals 13 lavs 3 electric water coolers, 1957 Addition 12 water closets 6 urinals 8 lavs 1 electric water cooler, 1959 Addition 2 water closets 2 lavs, 1973 Addition 1 water closet 2 urinals 1 lav. Replace: 1 domestic water boiler (1924 addition), 1 kitchen domestic water heater (1973 addition). Replace galvanized water supply piping in the overall facility (except the 1973 addition) with copper piping. Replace sanitary waste piping in the overall facility (except the 1973 addition) due to age and condition. Provide the 4 Science Classrooms (1950 addition) with the required safety shower/eyewash stations. Provide the wood shops (1924 addition) with the required safety shower/eyewash station.</p>

domestic water boiler

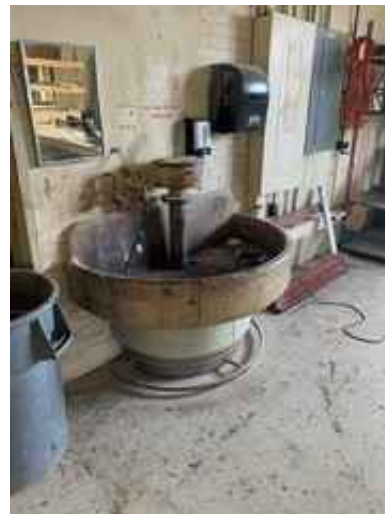
wash fountain

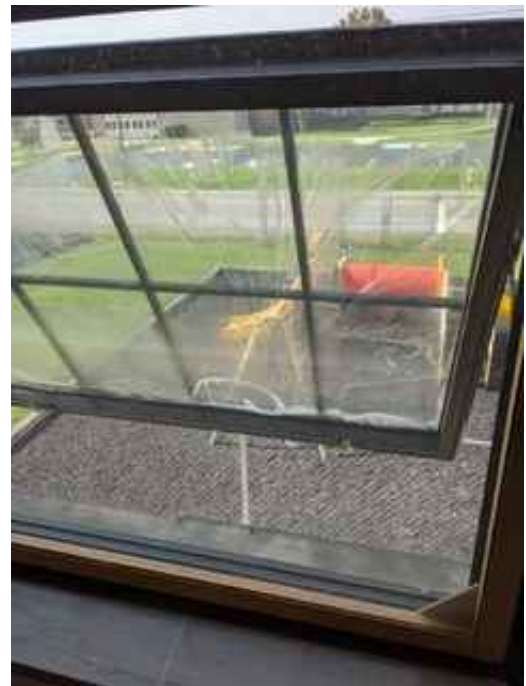
Description: The windows throughout the majority of the school facility are an aluminum frame insulated glazing type window system which is not original to the building and their replacement date is unknown. Windows do not have integral blinds but do have an e-coating that can be seen peeling off of many windows. Not all windows throughout the facility have bug screens. The window system hardware appears in fair condition. No glass block windows were observed in the school. There are no skylights in the building. There are no curtain wall window systems in the building. There is a storefront entrance at the 1973 addition that is single pane and should be replaced.

Rating: 3 Needs Replacement

Window with Peeling Coating

Recommendations: Provide a new window system throughout the building due peeling coating and lack of blinds and bug screens. New compliant window systems should be a double-glazed, thermally separated frame type with integral blinds. Replace storefront at the entrance.

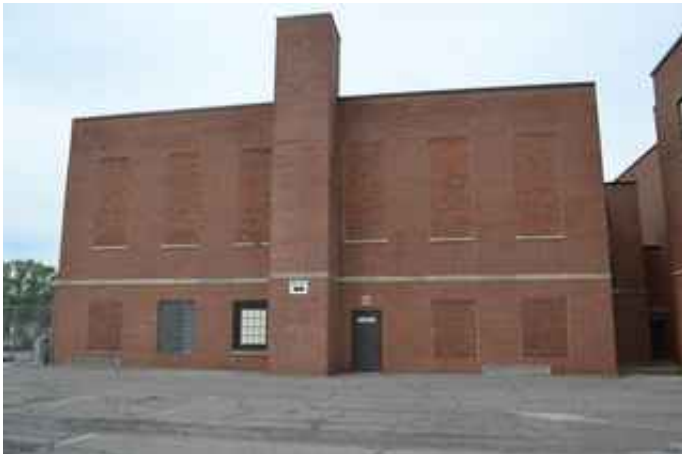
Description: The school is a brick veneer structure on load bearing masonry wall system which is in fair condition. This is consistent throughout the whole building and all additions. The exterior masonry does not have control joints. Brick veneer masonry walls are cavity walls. Exterior masonry does not appear to have been cleaned in recent years. Ongoing tuckpoint of the exterior structure is visible. No locations of mold were observed. Architectural exterior accent materials consist of brick banding and translucent wall panels which is aesthetically pleasing and generally in good condition. All classrooms have glazed block or plaster walls that are in fair condition. The window sills are stone throughout the building and are in fair condition. The exterior lintels are varying in condition from fair to poor. The school does have a loading dock in poor condition.

Original Building Masonry

Recommendations: Provide for exterior masonry cleaning and sealing as required. Provide for the replacement of the concrete loading dock.

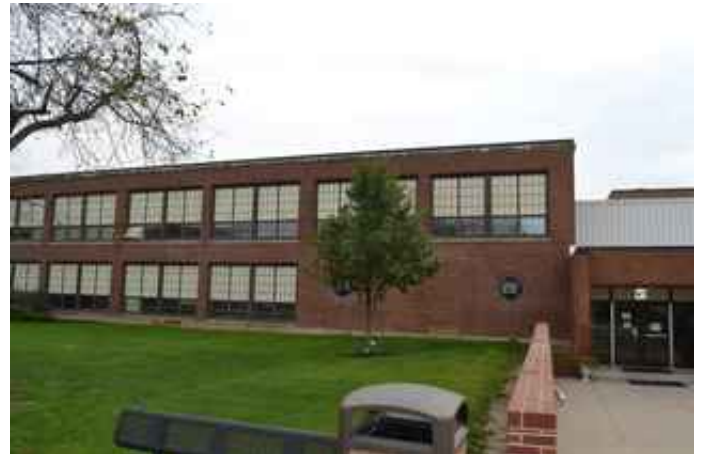
Stone Detailing Needing Cleaning

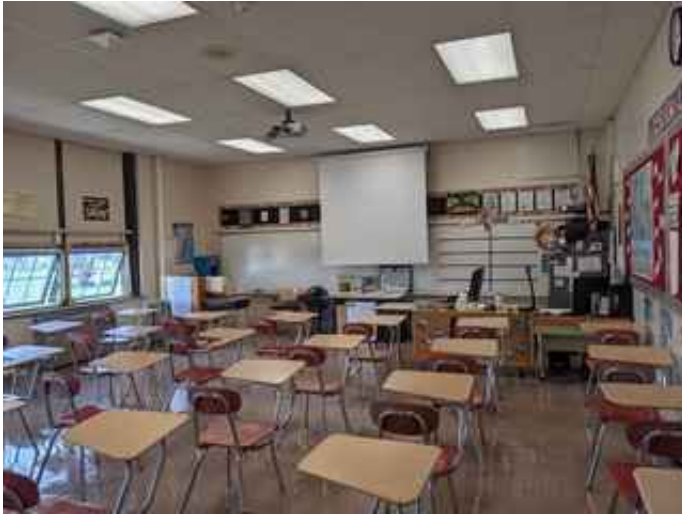
The original building and 1938 addition features conventionally partitioned classrooms, with VCT and carpet flooring, plaster walls, and screw-spline ceilings that are in poor condition. Typical classroom features built in storage for teacher materials. The casework is the original, old wood casework and it is in poor condition. Lockers are recessed in the corridor walls for student storage. The typical classroom features an adequate amount of white boards or chalkboards and tackboards. The interior classroom doors are recessed wood units in the original building and slightly recessed wood units in the 1938 addition. They are not equipped with appropriate ADA hardware but are equipped with tempered glass vision panels. The doors in the original building and 1938 addition are in poor condition. The 1950, 1957, and 1959 additions feature conventionally partitioned classrooms, with VAT and VCT flooring, glazed block walls, and lay-in ceilings that are in poor condition. Typical classroom features built in storage for teacher materials. The casework is the original, old wood casework and it is in poor condition. Lockers are located in the corridors for student storage, but are not recessed in the wall. The typical classroom features an adequate amount of white boards or chalkboards and tackboards. The interior classroom doors are non-recessed wood units. They are not all equipped with appropriate ADA hardware but are equipped with tempered glass vision panels. The doors are in poor condition. The corridors throughout the whole building have terrazzo flooring, plaster walls, and lay-in ceilings. The large group restrooms feature ceramic tile and terrazzo flooring and glazed block walls in poor condition. The restroom ceilings are lay-in and drywall ceilings and they are in poor condition. These finishes are consistent through all additions. The toilet partitions vary throughout the building and its additions. The partitions range from high density plastic, metal, and glazed block walls with wood doors. They have been replaced with high-density plastic as needed. The metal and glazed block wall partitions are in poor condition. The original gymnasium has wood floor in poor condition, painted brick walls in fair condition, and plaster ceiling. There are built-in stands above storage and adjacent rooms that are concrete and in fair condition. The gymnasium does not have a stage. There is a divider curtain that is in fair condition. There are acoustical wall panels that are in poor condition. The gymnasium in the 1950 addition has wood flooring in very poor condition, glazed block walls in fair condition, and a lay-in ceiling in poor condition. There is a stage that has been repurposed for a locker room with wood flooring in poor condition. There are no bleachers or divider curtain in this gymnasium. The art room, located in the 1938 addition, does have a kiln. The media center is centrally located and features VCT and carpet flooring, gypsum walls and lay-in ceilings. The media center finishes are in fair condition. The existing kitchen is a full kitchen with quarry tile flooring, glazed block walls, and a gypsum ceiling that are in poor condition. The age of the kitchen equipment is not known. There are walk-in freezers or coolers provided in fair condition.

3 Needs Replacement

Typical Classroom Finishes

Provide complete replacement of finishes and provide new casework due poor conditions and due to the installation of systems outlined in this report (such as HVAC system, electrical, technology, etc). Provide for replacement of old toilet partitions and provide new accessories. Provide for the replacement of the gymnasium flooring. Provide for the full replacement of kitchen equipment due to age and code compliance. Funding for replacement of interior doors is provided in Item O, including doors here noted as being in poor condition.

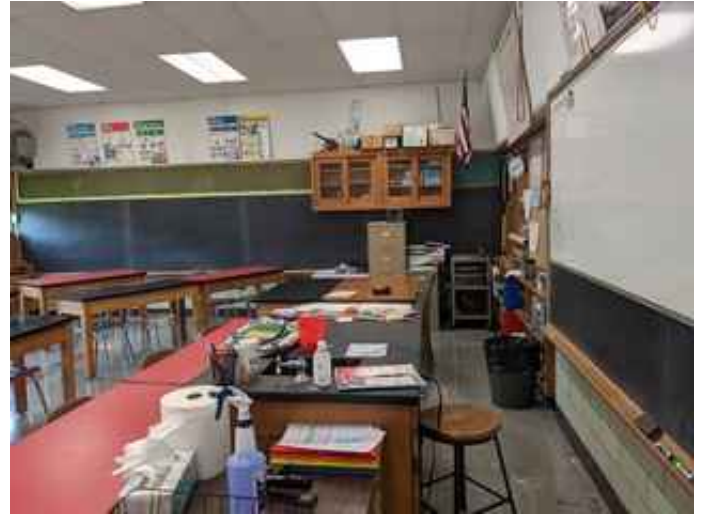
Science Classroom Finishes

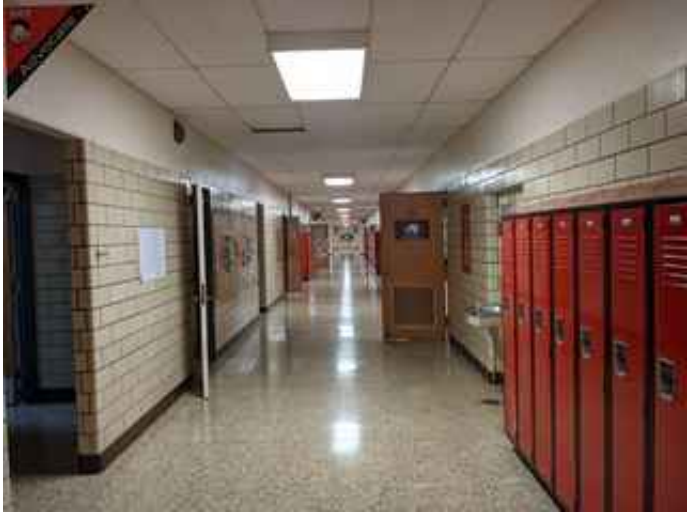
Rating: 3 Needs Replacement

Corridor Clearances

Recommendations: Provide ADA-compliant signage, new elevators, sinks, toilets, urinals, showers, electric water coolers (see Item E), toilet partitions, mirrors and toilet partition accessories as required. Provide an elevator for accessibility in the 1957 addition. Provide a lift for access to the locker room on the stage. Replace old wood doors with new leafs equipped with ADA hardware. Parking issues are corrected in Item P.

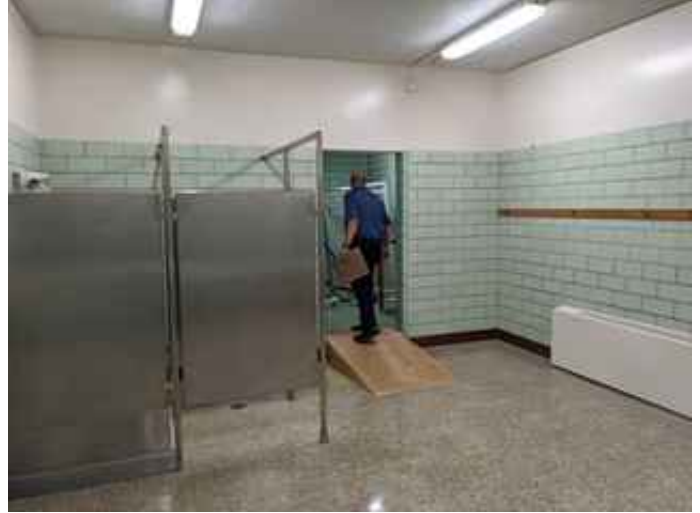
Ramp to Showers

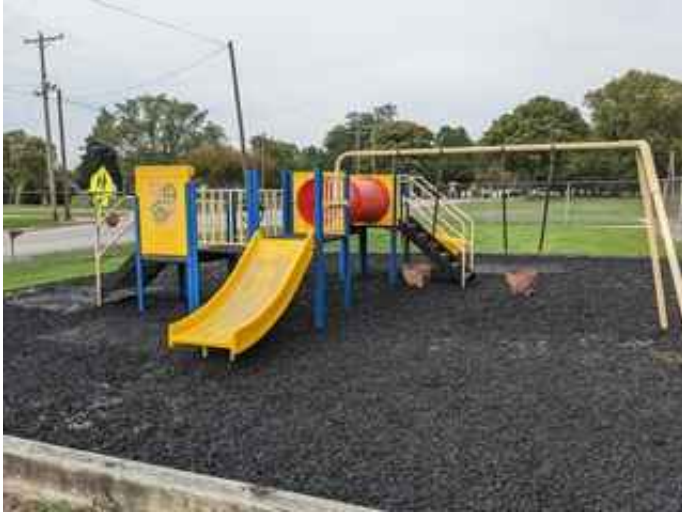
Description: The 31.36-acre flat site is located in a rural residential neighborhood and is provided with minimal tree and shrub type landscaping. The site houses the school building, three playgrounds, two baseball fields, an asphalt track, a boiler house, and the maintenance and bus garage. No areas of erosion were observed. No ponding was observed. The site is bordered by a moderately traveled street. There are three entrances onto the site which allows for some separation of bus and car traffic. There is a drop-off lane at the main entrance that is shared with visitor parking. Staff and visitor parking occur in two main parking asphalt lots that are in poor condition. Parking spaces appear to be adequately provided between the front lot and the back lot that is shared with the maintenance and bus garage. Two (2) ADA parking spaces are provided, though five (5) are required. Site and parking lot drainage design consists of sheet drainage and storm sewers. Sidewalks are generally properly sloped and located to provide a logical flow of pedestrian traffic, though there are areas that require replacement. The playground equipment is metal and high-density plastic and in fair condition. The playground is located on a wood mulch soft surface. Two of the playgrounds are fenced with chain-link fencing and the third playground is not fenced. There are no athletic facilities on the site aside from the practice track and baseball fields. The trash dumpsters are not provided with a concrete pad as per the OSDM requirements.

Rating: 3 Needs Replacement

Playground Equipment

Recommendations: Provide ADA parking spaces. Resurface all asphalt areas. Provide for concrete sidewalk replacement. Provide for reconstruction of the entrance steps at the 1973 addition and subsequent retaining walls and railings. Provide for replacement of old chain link fencing. Provide for new playground equipment. Provide new rubber or soft surface material for playgrounds. Provide for an enclosure and concrete pad for dumpsters.

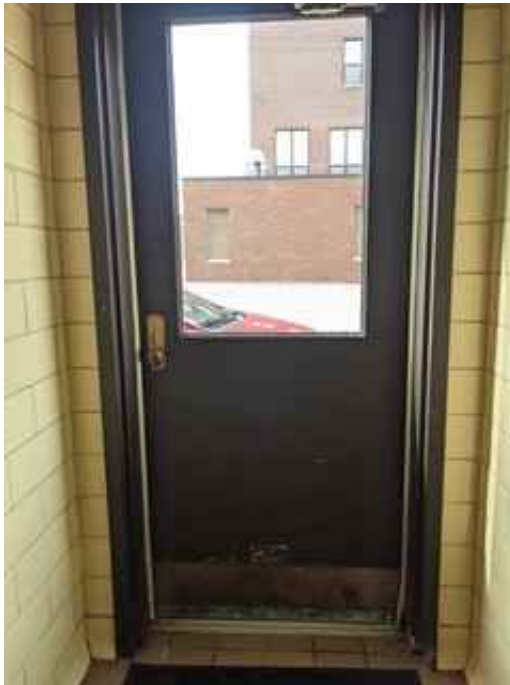
Description: Exterior doors are a mixture of aluminum and hollow metal and are in poor condition. There is a steel overhead door at the loading dock that is in poor condition.

Rating: 3 Needs Replacement

Exterior Door

Recommendations: Replace all exterior doors including the overhead door.

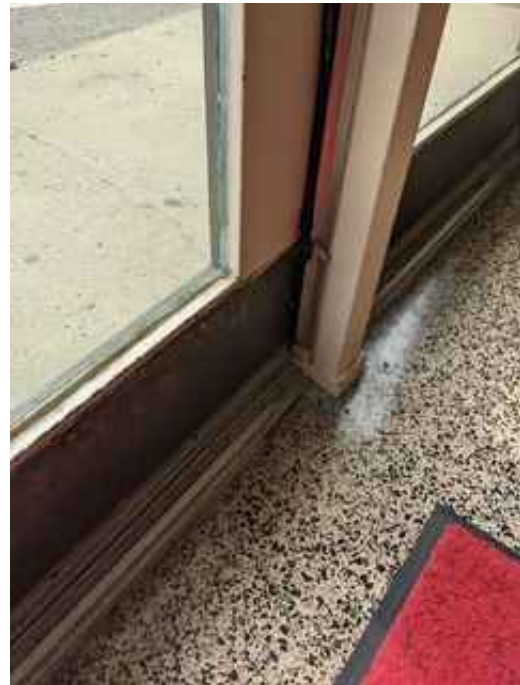
Exterior Door Threshold and Seals

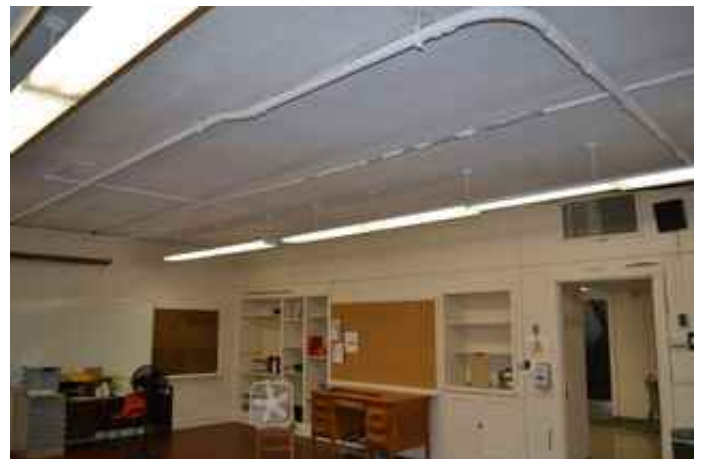
Description: The school was observed to contain asbestos. An AHERA report from 2002 has been provided, though it stated that all asbestos containing materials had been abated. Vinyl asbestos tile was observed in the school during the assessment. It is unclear the quantity and scope of existing hazardous materials.

Screw Spline Ceiling Tile

Recommendations: Provide for an Enhanced Environmental Report to be completed and budget adjustments to be made in order to replace abated materials.

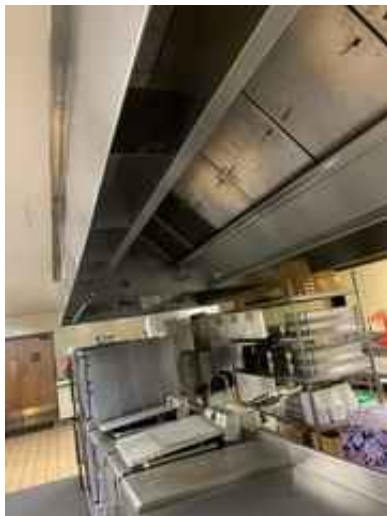
Description: The overall facility is not equipped with an automated fire suppression system. The Kitchen hood is in fair condition, is equipped with the required UL 300 compliant wet chemical fire suppression system. The facility is not currently equipped with an emergency generator. Exit corridors are situated such that dead-end corridors are not present. Fire extinguishers are provided throughout the facility. Rooms with a capacity greater than 50 occupants are equipped with adequate egress. Interior stairwells are not all appropriately enclosed with a rated enclosure.

Type 1 kitchen hood

Recommendations: Provide new automated fire suppression system to meet Ohio School Design Manual guidelines. Provide increased water service of a capacity sufficient to support the fire suppression system, funding included in fire suppression funding. Provide appropriate enclosures for interior stairwells. Provide for an emergency generator.

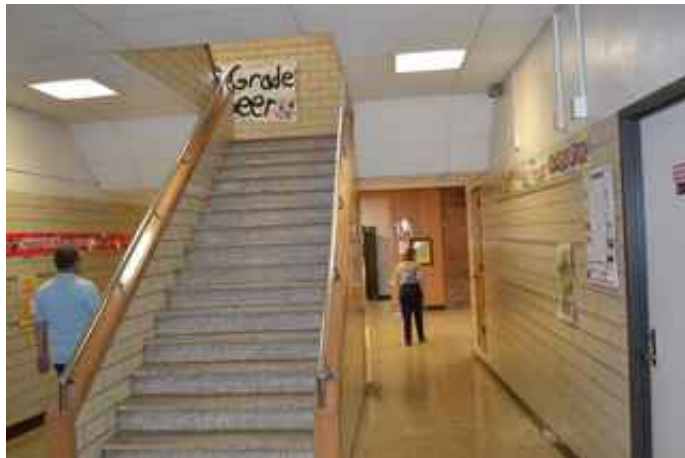
Rating: 2 Needs Repair

Unenclosed Stair

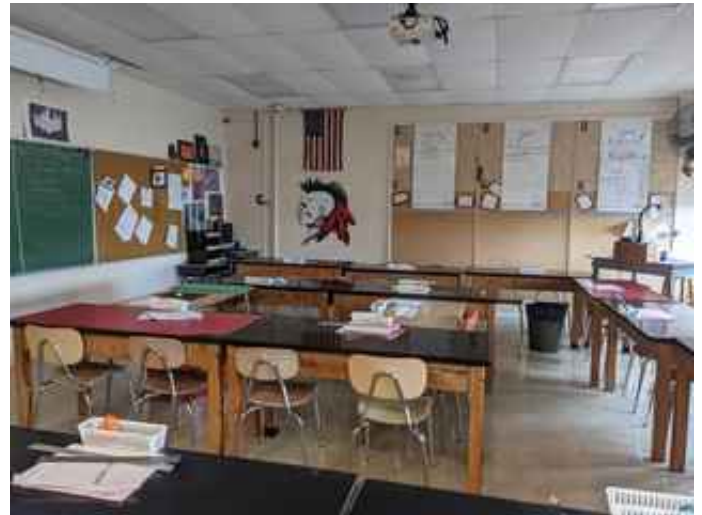
Description: The typical furniture generally matches within a classroom but all the furniture is dated. It consists of student desks and chairs, teacher desks and chairs, desk-height file cabinets, reading tables/computer workstations and bookcases. The facility's furniture and loose equipment were evaluated in item 6.17 in the CEFPI section of this report, and on a scale of 1 to 10 the overall facility received a rating of 4 due to observed conditions, and due to the fact that it lacks some of the design manual required elements.

Rating: 3 Needs Replacement

Mismatched and Dated Furniture

Recommendations: Provide for complete replacement of furnishings.

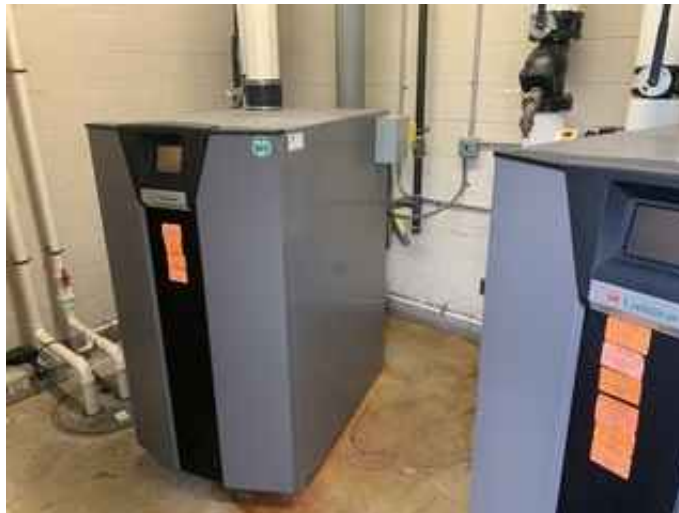
Description: The existing system for the overall facility is a gas fired, high efficiency, hydronic heating hot water boiler system installed in 2014, and is in good condition. The 2 high efficiency condensing boilers, manufactured by Lochinvar, were installed in 2014 and are in good condition. Heating water is distributed to terminal units consisting of cabinet heaters, unit heaters, fin tubes and rooftop multizone units. The terminal equipment was installed in 2014 and is in good condition. There are 4 rooftop units that have hot water heating coils and Dx Cooling coils. These units utilize hot water reheat coils to add the required heat to the spaces. The system does comply with the 15 CFM per person fresh air requirements of the Ohio Building Code mechanical code and Ohio School Design Manual. The electronic DDC type system temperature controls were installed in 2014 and are in good condition. The system does feature individual temperature controls in all spaces required by the OSDM. Central energy recovery units are located in the multizone units and are utilized to pre-condition ventilation air, are in good condition. The facility is equipped with a ceiling return air plenum and has return grilles in the ceiling of each space. The existing system is ducted, and the ductwork can be integrated into a possible future system due to arrangement, air volume, and routing of existing ductwork. The overall heating system is evaluated as being in safe and efficient working order, and long- term life expectancy of the existing system is anticipated. The structure is not equipped with central air conditioning. The site does not contain underground fuel tanks.

Hot water boilers

Recommendations: Existing conditions require no renovation or replacement at the present time.

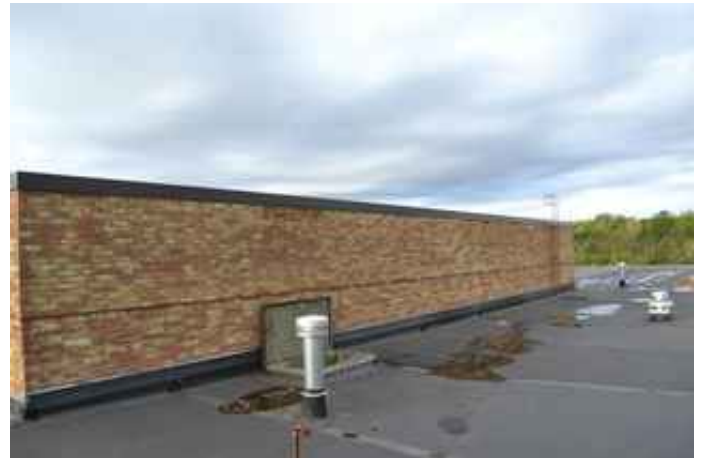
Roof Hatch and Access Ladder

Recommendations: The flat, EPDM roofs require replacement to meet Ohio School Design Manual guidelines for the age of the system and due to ponding conditions. Due to roof replacement, all roof drains should be replaced with drains and overflow drains with grates. Replace roof access ladder between high and low roof due to condition. Replace roof hatch due to roof system and insulation replacement.

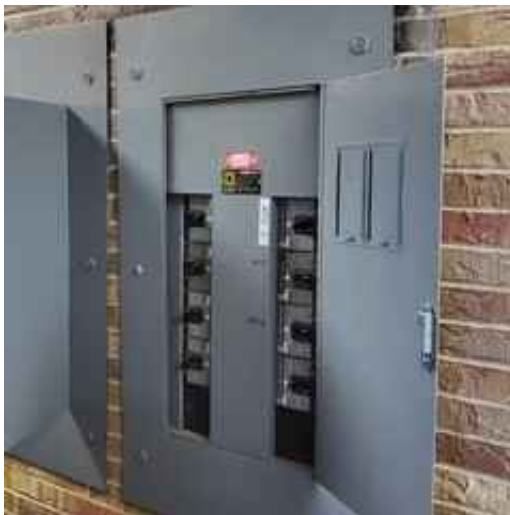
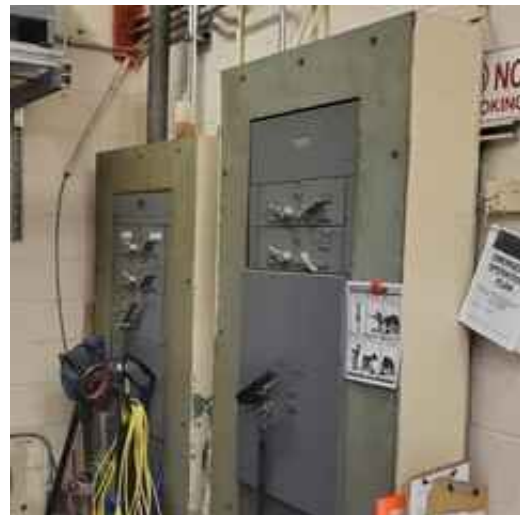
Description: The electrical system provided to the overall facility is a 600 Amp, 480/277, 3 phase 4 wire system installed in 1969, and is in poor condition. Power is provided to the school by a single utility owned, pad-mounted transformer located on the exterior, and in good condition. The panel system, installed in 1969, is in poor condition, and cannot be expanded to add additional capacity. The Classrooms are not equipped with adequate electrical outlets. The typical Classroom contains 4 general purpose outlets, 1 dedicated outlet for each Classroom computer, and 1 dedicated outlet(s) for each Classroom television. Some Classrooms are equipped with as many as 4 general purpose outlets, while others are equipped with as few as 2 general purpose outlets. There are some spaces that have no electrical outlets. The Corridors are not equipped with adequate electrical outlets for servicing. Adequate GFI protected exterior outlets are not provided around the perimeter of the building. The facility is not equipped with a emergency generator. Adequate lightning protection safeguards are not provided. Stage lighting power system including control panel, breakers, and dimmers is inadequately provided, in poor condition and does not meet OSDM requirements. The overall electrical system meets does not meet Ohio School Design Manual requirements in supporting the current needs of the school, and will be inadequate to meet the facility's future needs.

Rating: 3 Needs Replacement

Recommendations: The entire electrical system requires replacement to meet Ohio School Design Manual guidelines for overall capacity, Classroom capacity, due to condition and age, lack of OSDM-required features, to accommodate the addition of an air conditioning system.

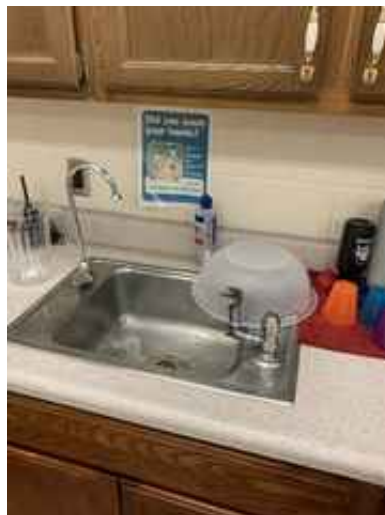
Classroom sink with drinking fountain

Recommendations: Due to age, condition, and OFCC requirements, and to meet the low flow requirements for all toilet room fixtures, remove and replace 23 toilets, 25 lavatories, 14 urinals, and 3 electric water coolers. Provide 2 new Special Education classroom (1-1969 addition, 1-1972 addition) restrooms that consist of 1 water closet and 1 lavatory for each. Provide kitchen restroom that consists of 1 water closet and 1 lavatory. Provide 11 classroom sinks with the required bubbler, provide 4 (1-1969 addition, 3- 1972 addition) classrooms with the required new sink and bubbler. Add 1 indoor grease trap 1969 addition). Replace the domestic water heater.

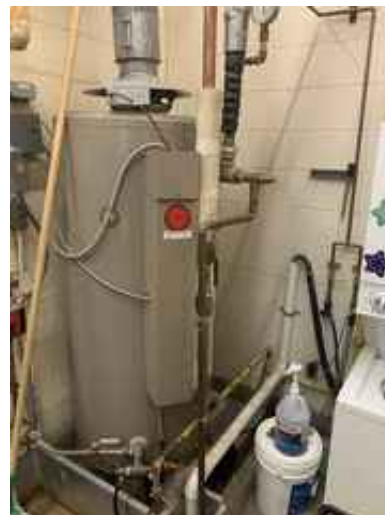
Domestic Water Heater

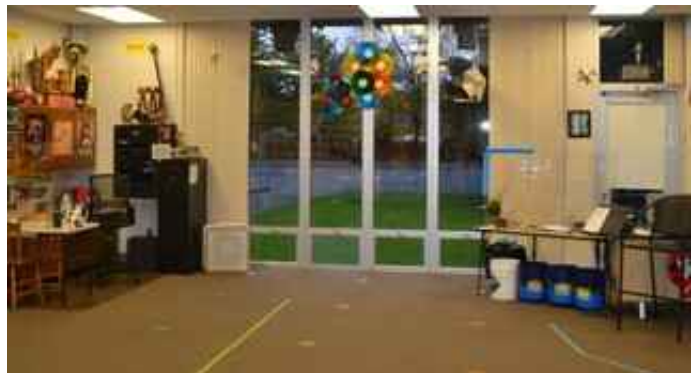
Description: The windows throughout the majority of the school facility are an aluminum frame single pane glazing type window system with surface mounted blinds and do not have insect screens. These windows are in poor condition. The window system hardware appears in fair condition. The windows are original to the building. No glass block windows were observed in the school. There are no skylights in the building. There is no curtainwall system in the school. The storefront system at the entrances are single pane and should be replaced.

Rating: 3 Needs Replacement

Existing Windows with Blinds

Recommendations: Provide a new window system in the original building due to these windows being a non-OSDM compliant window system. New compliant window systems should be a double-glazed, thermally separated frame type with integral blinds. Provide a new storefront system at the entrances.
