**BEFORE
THE OHIO SITING BOARD**

In the matter of the Application of Birch)	
Solar 1, LLC for a Certificate of)	
Environmental Compatibility and Public)	Case No. 20-1605-EL-BGN
Need to Construct a Solar-Powered Electric)	
Generation Facility in Allen and Auglaize)	
Counties, Ohio.)

TESTIMONY OF

May 11, 2022

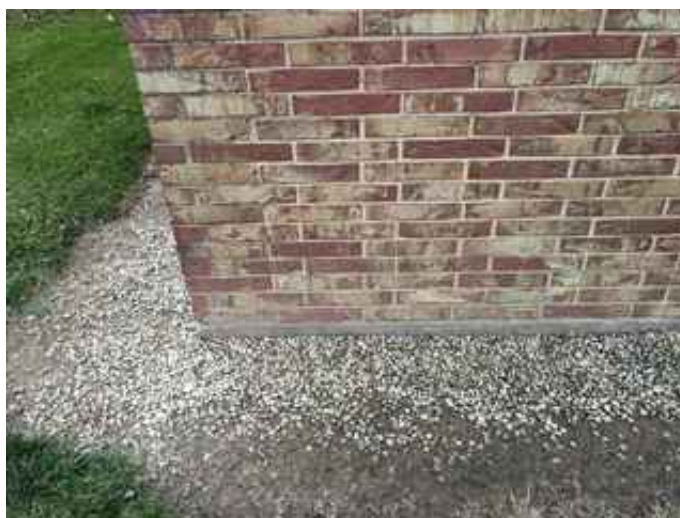
Description: The facility is equipped with concrete foundation walls on concrete footings that were observed to be generally in fair condition. No grading or site drainage deficiencies were noted around the perimeter of the structure that are contributing to or could contribute to foundation/wall structural deterioration.

Exterior Wall at Grade

Recommendations: No work is required at this time.

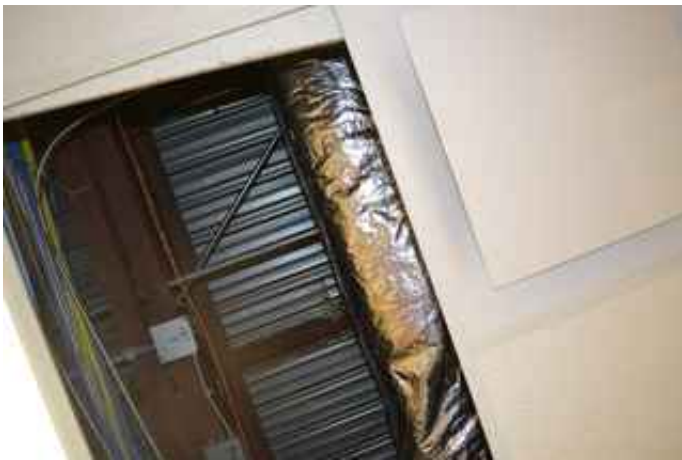
Description: The floor construction is a cast in place concrete type construction, and is in fair condition. There are crawlspaces for pipes throughout the school. The roof construction is metal trusses and steel joists. Exterior soffits are metal and are in fair condition.

Metal Deck and Steel Joists

Recommendations: Provide for exterior soffits to be repainted.

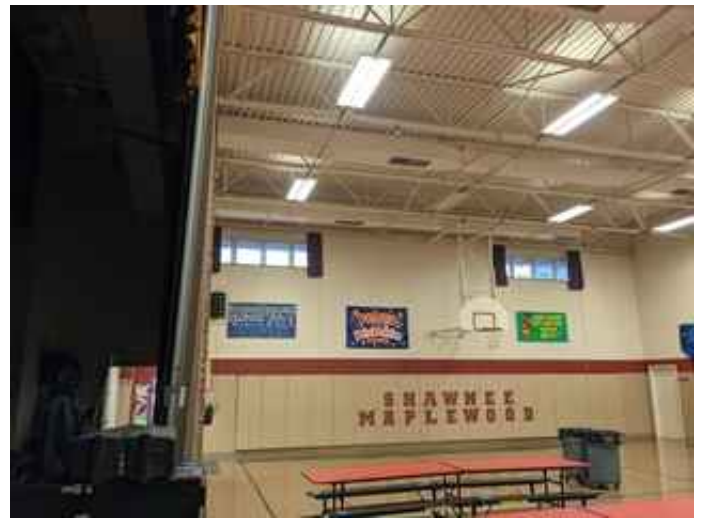
Painted Deck and Structure

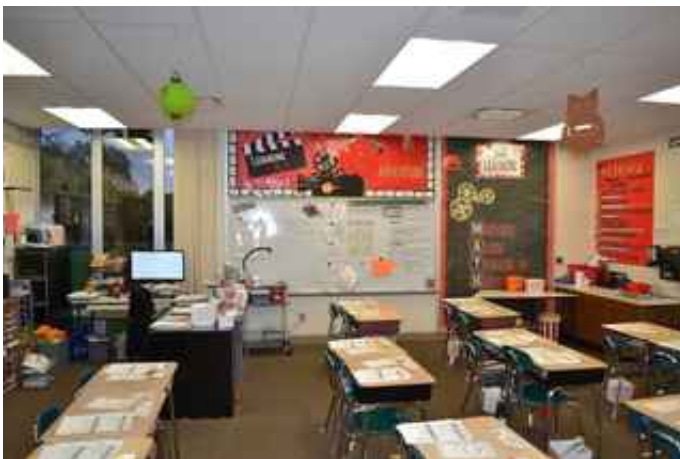
Typical Classroom Finishes

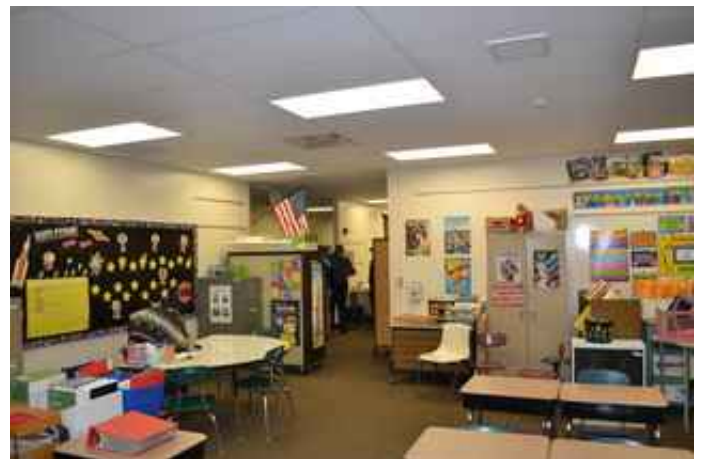
Un-Enclosed Classrooms

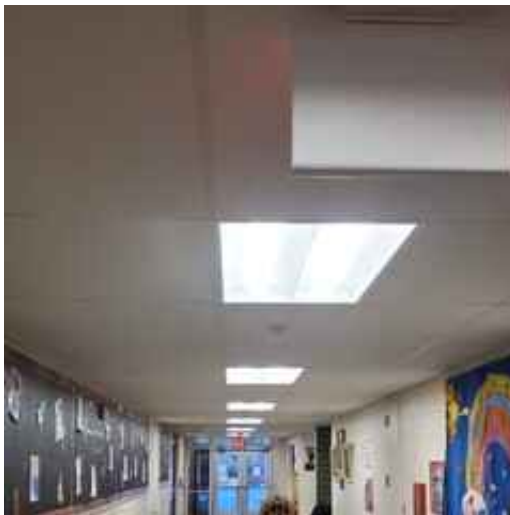
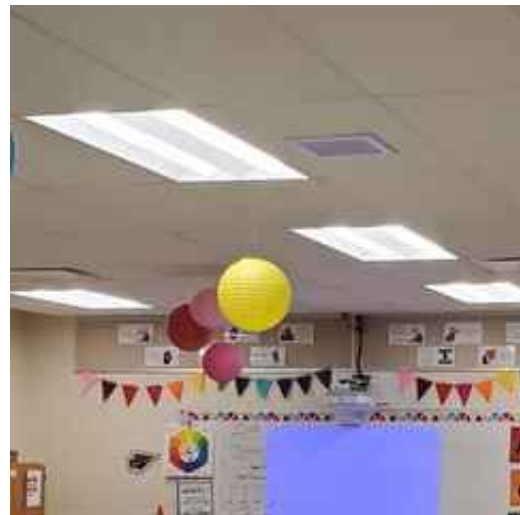
Rating: 3 Needs Replacement

Recommendations: Provide complete replacement of lighting system due to inadequate lighting levels, lack of multi-level switching and lack of automatic controls.

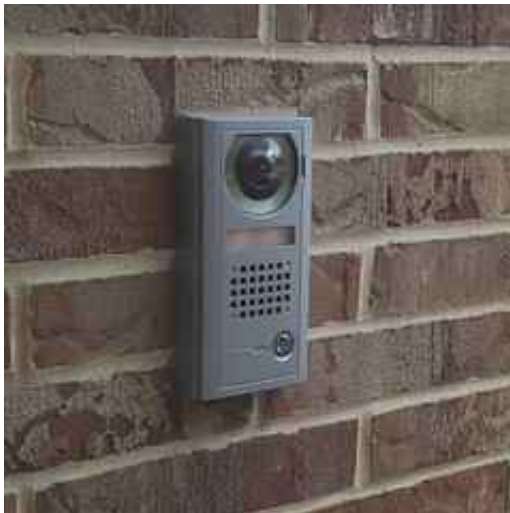
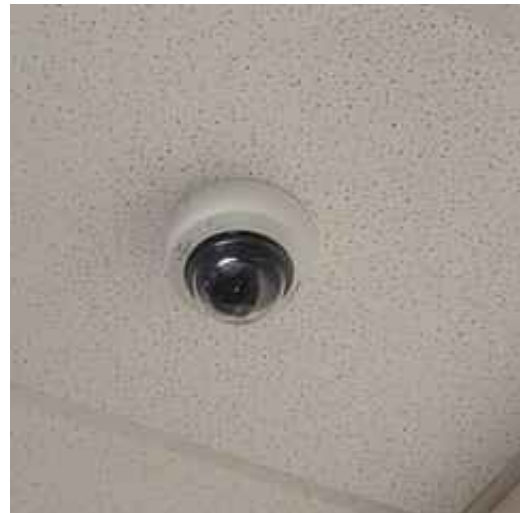
Rating: 2 Needs Repair

Recommendations: Provide partial security system upgrade, consisting of cameras and motion detectors, to meet Ohio School Design Manual guidelines. Provide complete replacement of exterior site lighting system to meet Ohio School Design Manual guidelines.

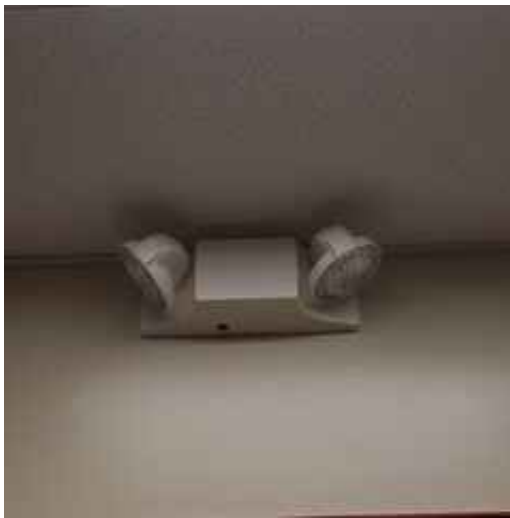
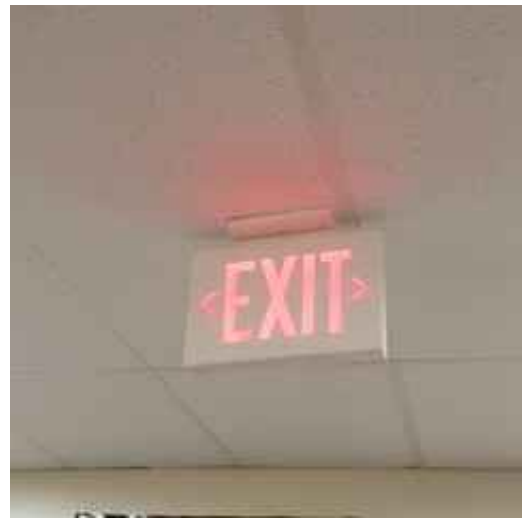
- Description:** The overall facility is equipped with an emergency egress lighting system consisting of plastic construction exit signs and the system is in good condition. The facility is equipped with emergency egress floodlighting, and the system is in good condition. The system is not provided with appropriate battery backup or emergency generator. (Refer to item U for specific emergency generator information) The system is not adequately provided throughout, and does not meet Ohio School Design Manual and Ohio Building Code requirements due to the lack of emergency generator.
- Rating:** 3 Needs Replacement
- Recommendations:** Provide complete replacement of new emergency / egress lighting system to meet Ohio School Design Manual and Ohio Building Code guidelines as part of work in items K/U.

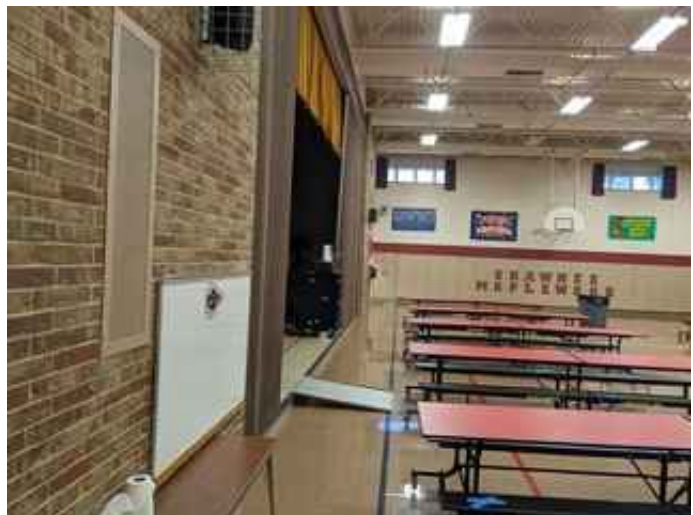
Stage Access Ramp

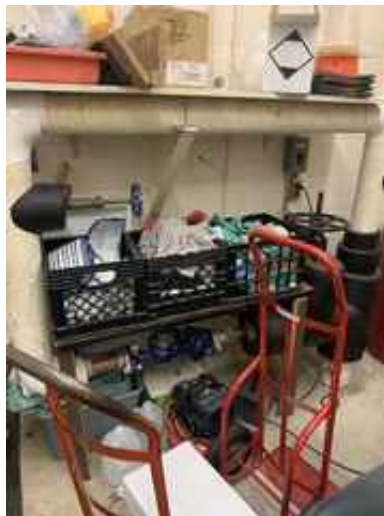
incoming water service

Recommendations: Existing conditions require no renovation or replacement at the present time. Water line will be replaced under Item U, life safety. Pressure and capacity issues addressing in Item U.

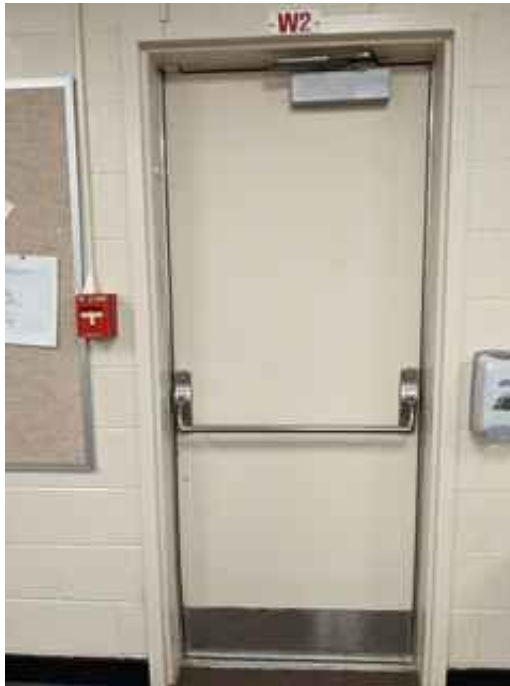
Exterior Door

Recommendations: Provide for the replacement of all exterior doors.

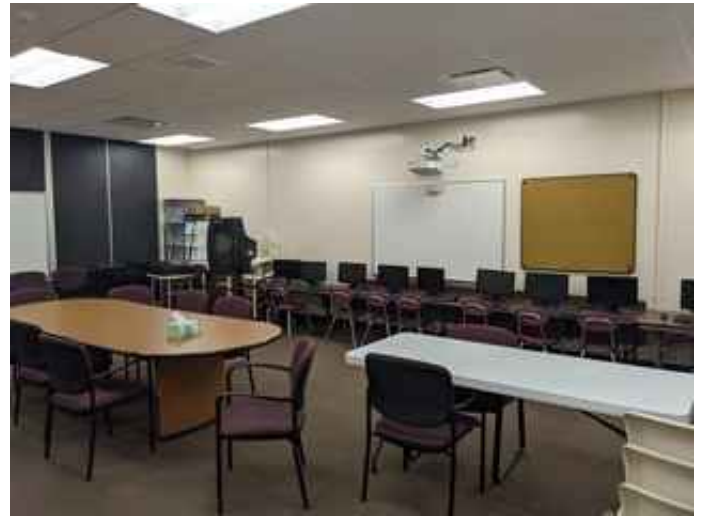
Dated Furniture

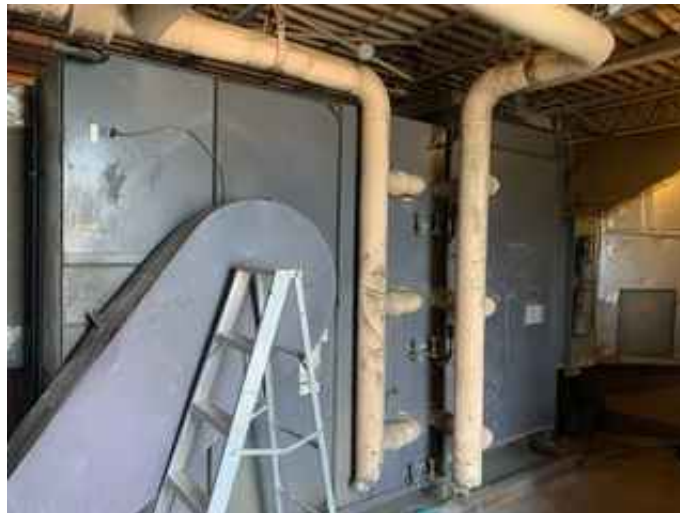
Original AHU

Recommendations: For the 1973 original facility, provide new overall heating, ventilating, and air conditioning system to achieve compliance with Ohio Building Code and Ohio School Design Manual standards. Install new hydronic boiler system to eliminate the electric heat throughout. This includes complete control upgrade. For the 2008 addition, provide pricing for upgrades to the heating hot water system. The AHU and ductwork will remain with upgrades to the VAV box reheat coils. The controls for the 2008 addition will be upgraded to electronic DDC.

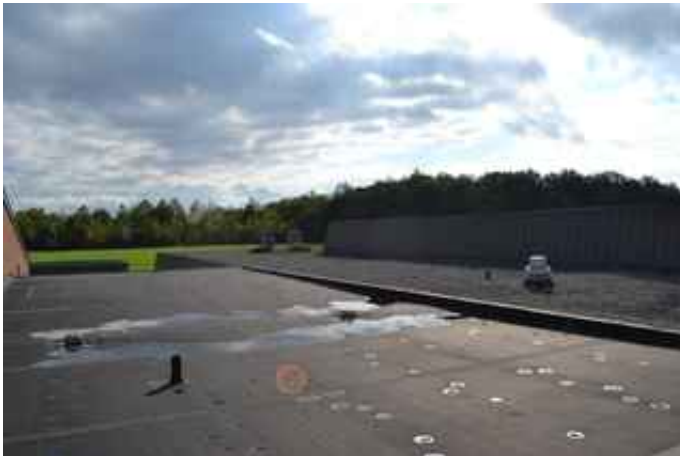
EPDM Roofing

Recommendations: The flat, EPDM roofs require replacement to meet Ohio School Design Manual guidelines for the age of the system and due to ponding conditions. With the replacement of these roofs, overflow drains are to be added. Replace roof hatch due to roofing and insulation replacement.

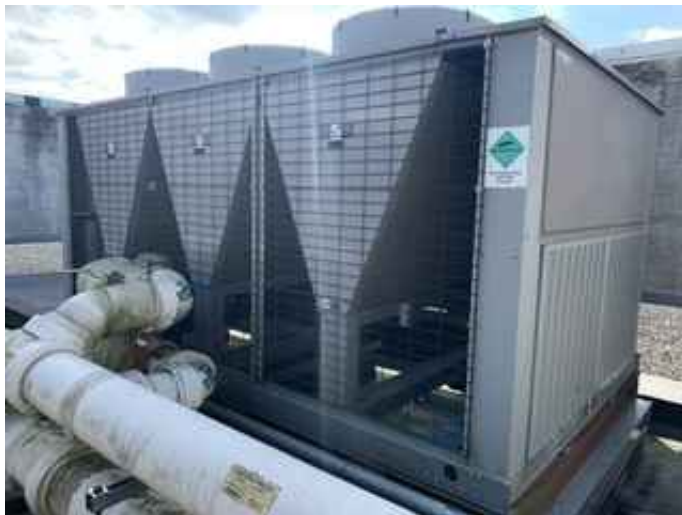
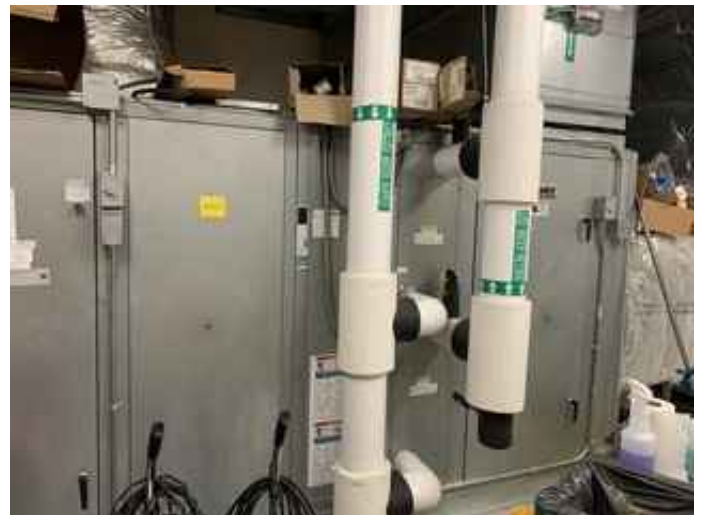
Description: The overall facility is not equipped with a central air conditioning system. The existing rooftop units utilize Dx Cooling on each of the 4 units. Although this is not an acceptable OSDM system, the units are in good shape and provide the needed controls thru the separate VAV boxes with hot water reheat coils. No window units were observed. The ventilation system in the overall facility consists of rooftop HVAC Units installed in 2014 and in good condition, providing fresh air to Classrooms, and to other miscellaneous spaces such as Gymnasiums, Student Dining, Media Center, etc. Relief air venting is provided by ceiling plenums. The rooftop units are ducted back through energy recovery units. The ventilation system does meet the Ohio Building Code 15 CFM per occupant fresh air requirement. The overall system is compliant with Ohio Building Code requirements. Dust collection systems are not required in this facility. The Art program is equipped with a kiln that is not ventilated. General building exhaust systems for restrooms, storage rooms and Custodial Closets are adequately placed, however the art room should have a general room exhaust fan.

Rating: 3 Needs Replacement

2008 Air Cooled Chiller

Recommendations: Add air conditioning to meet the requirements of the OMC and OSDM. Pricing included in Item A. Add general exhaust fan for Art Room.

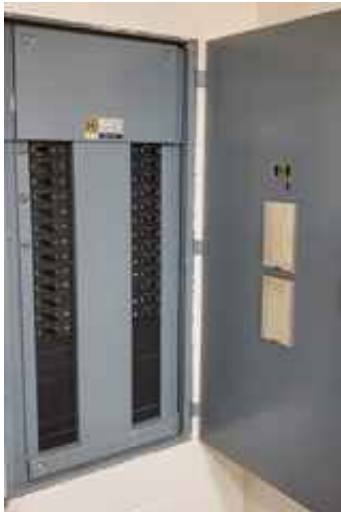
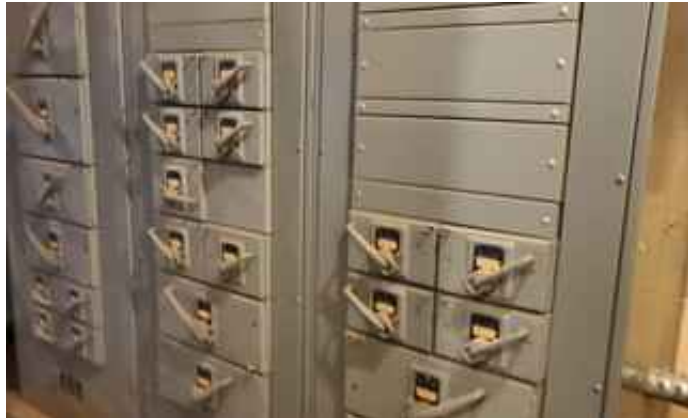
Description: The electrical system provided to the original facility is a 2000 Amp, 480/277, 3 phase 4 wire system installed in 1973, and is in poor condition. Power is provided to the school by a single utility owned, pad-mounted transformer located on the exterior, and in good condition. The panel system, installed in 1973, is in poor condition, and can cannot be expanded to add additional capacity. The Classrooms are not equipped with adequate electrical outlets. The typical Classroom contains 5 general purpose outlets, 1 dedicated outlet for each Classroom computer, and 1 dedicated outlet(s) for each Classroom television. Some Classrooms are equipped with as many as 4 general purpose outlets, while others are equipped with as few as 3 general purpose outlets. There are no spaces that have no electrical outlets. The Corridors are not equipped with adequate electrical outlets for servicing. Adequate GFI protected exterior outlets are not provided around the perimeter of the building. The facility is not equipped with a emergency generator. Adequate lightning protection safeguards are not provided. Stage lighting power system including control panel, breakers, and dimmers is inadequately provided, in poor condition and does not meet OSDM requirements. The overall electrical system does not meet Ohio School Design Manual requirements in supporting the current needs of the school, and will be inadequate to meet the facility's

Rating: 3 Needs Replacement

Recommendations: The entire electrical system requires replacement to meet Ohio School Design Manual guidelines for overall capacity, Classroom capacity, due to condition and age, lack of OSDM-required features, and to accommodate the addition of an air conditioning system.

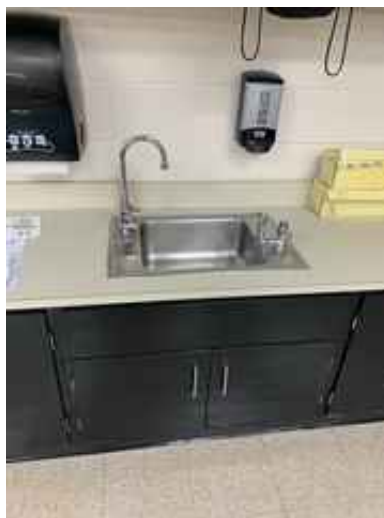
Description: The service entrance is not equipped with a reduced pressure backflow preventer. A water treatment system is not provided though none is needed. The domestic water supply piping in the overall facility is copper and is original to each addition, is in fair condition. The waste piping in the overall facility is cast iron, is original to each addition, and is in fair condition. The facility is equipped with a 199 MBH, gas water heater in fair condition, however due to it's age should be replaced. The school contains 2 Large Group Restrooms for boys, 2 Large Group Restrooms for girls, 0 Locker Room Restrooms for boys, 0 Locker Room Restrooms for girls, 0 Restrooms associated with specialty Classrooms, and 4 Restrooms for staff. Boys' Large Group Restrooms contain 0 ADA and 4 non-ADA wall mounted flush valve toilets, 0 ADA and 14 non-ADA wall mounted flush valve urinals, as well as 0 ADA and 9 non-ADA wall mounted lavatories. Girls' Large Group Restrooms contain 0 ADA and 12 non-ADA wall mounted flush valve toilets, as well as 0 ADA and 9 non-ADA wall mounted lavatories. Staff Restrooms contain 0 ADA and 4 non-ADA floor mounted flush valve toilets, 0 ADA and 0 non-ADA wall mounted urinals, as well as 0 ADA and 4 non-ADA wall mounted lavatories. Condition of fixtures is fair. The facility is equipped with 0 ADA and 0 non-ADA drinking fountains, as well as 0 ADA and 7 non-ADA electric water coolers, 4 are the required bottle filler and 3 should be replaced due to age and condition. The elementary school contains 24 classrooms that include 9 classroom sinks with bubbler fountains, 11 classrooms have sinks without bubblers and 4 classrooms have none. There are 3 Special Education Classrooms and only 1 is equipped with the required Restroom facilities and fixtures are in fair condition. Kitchen is not equipped with the required Restroom. Heath Clinic is not equipped with the required Restroom. Kitchen fixtures consist of 1 triple compartment sink, which is in fair condition. The Kitchen is not equipped with a grease interceptor. The school meets the OBC requirements for fixtures. Per OBC and OSDM requirements this facility should be equipped with 8 toilets, 8 urinals, 8 lavatories, 24 Classroom sink mounted drinking fountains, and 4 electric water coolers. Observations revealed that the school is currently equipped with 23 toilets, 14 urinals, 25 lavatories, 9 Classroom sink mounted drinking fountains, and 7 electric water coolers. ADA requirements are met for fixtures and drinking fountains (see Item O). Custodial Closets are properly located and are not adequately provided with required service sinks or floor drain sinks, which are in fair condition. Science Classroom, Lab utility sinks, gas connections, compressed air connections, and safety shower / eyewash are not provided, but are not required due to existing grade configuration. Due to existing grade configuration, no Biology or Chemistry Classroom acid waste systems are required. Adequate exterior wall hydrants are provided.

Rating: 3 Needs Replacement

Classroom sink with drinking fountain

Recommendations: Due to age, condition, and OSFC requirements, and to meet the low flow requirements for all toilet room fixtures, remove and replace 23 toilets, 25 lavatories, 14 urinals, and 3 electric water coolers. Provide 2 new Special Education classroom restrooms that consist of 1 water closet and 1 lavatory for each. Provide kitchen restroom that consists of 1 water closet and 1 lavatory. Provide 11 classroom sinks with the required bubbler, provide 4 classrooms with the required new sink and bubbler. Add 1 indoor grease trap. Add backflow preventer to incoming water service. Replace domestic water heater.

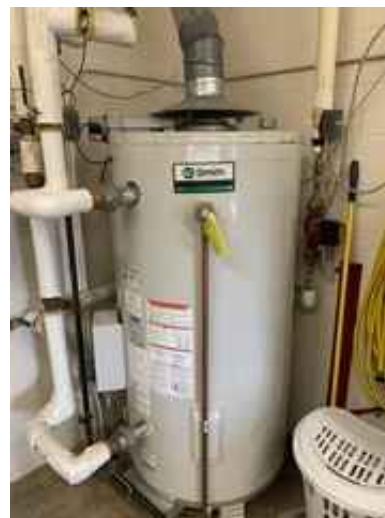
Domestic water heater

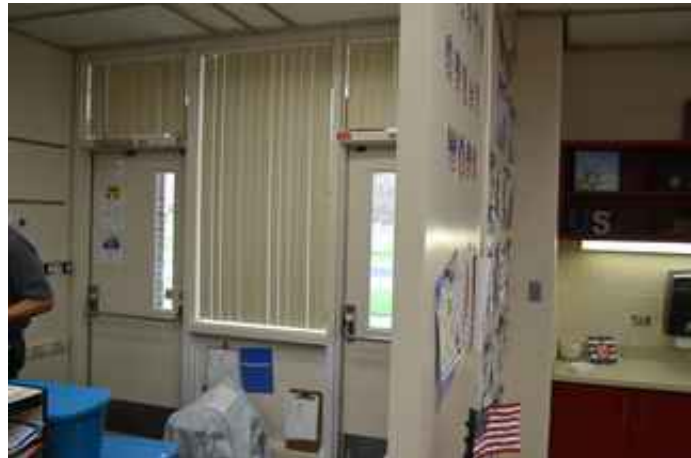
Description: The windows throughout the original 1973 building are an aluminum frame single pane glazing type window system with surface mounted blinds. The windows are operable but do not have insect screens. The window system hardware appears in fair condition. The windows are original to the building. The windows throughout the 2008 additional are aluminum frame insulated glazing system with surface mounted blinds. The windows are operable but do not have insect screens. No glass block windows were observed in the school. There are no skylights in the building. There are no curtain wall window systems in the facility, but there are storefront window systems at the entrances of both additions. The storefront system in the 2008 addition is in good condition. The storefront system at the entrance to the original 1973 building is single pane and should be replaced.

Rating: 3 Needs Replacement

Original Storefront Glazing

Recommendations: Provide a new window system in the original building due to these windows being a non-OSDM compliant window system. New compliant window systems should be a double-glazed, thermally separated frame type with integral blinds. Provide a new storefront window system at the entrances to the original building.

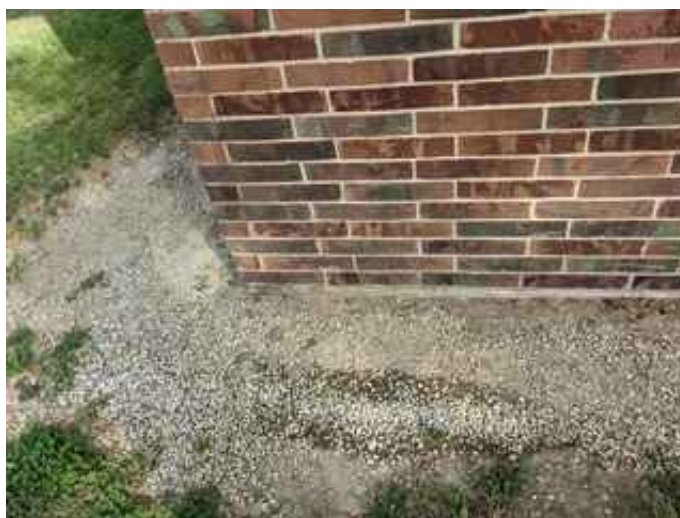
Description: The facility is equipped with concrete foundation walls on concrete footings that were observed to be generally in good condition. No grading or site drainage deficiencies were noted around the perimeter of the structure that are contributing to or could contribute to foundation/wall structural deterioration.

Exterior Wall at Grade

Recommendations: No work is required at this time.

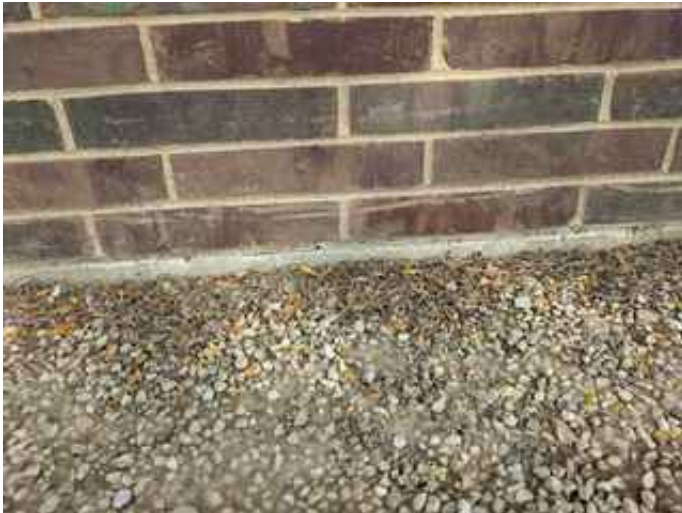
Description: The school is a brick veneer structures on load bearing masonry wall system which are in fair condition. The exterior masonry is provided with control joints in fair condition. Brick veneer masonry walls are cavity walls. Weep holes are present, though some are covered by the grade as they are located quite close to the foundation. Exterior masonry does not appear to have been cleaned or sealed in recent years but shows little evidence of mortar deterioration. No locations of mold were observed. Architectural exterior accent materials consist of burnished block banding on the 2008 addition and metal panels at exterior soffits on both the original building and addition which is aesthetically pleasing and generally in good condition. The classrooms have either CMU walls, gypsum walls, or demountable walls, which are generally in fair condition. The window sills are brick and marble and are in fair condition. The exterior lintels are in good condition in the school building. The school does not have a loading dock.

Rating: 2 Needs Repair

Weep Holes at Concrete

Recommendations: Provide for exterior masonry cleaning, sealing and caulking as required. Provide for exposure of weeps holes that are covered for better moisture control.

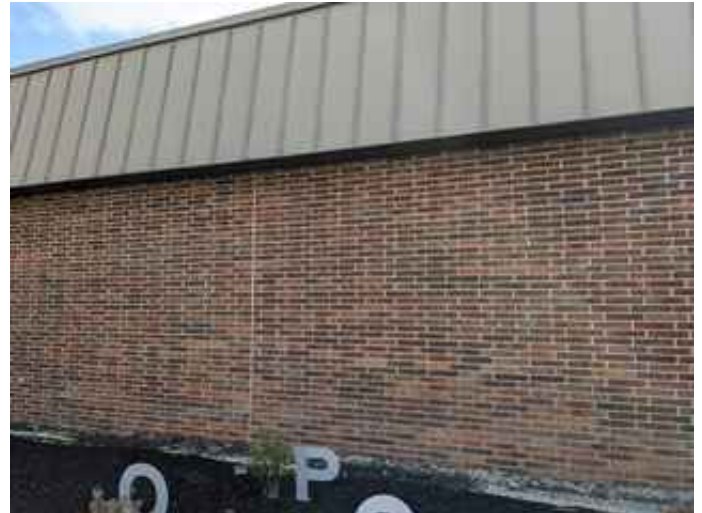
Exterior Masonry and Control Joint

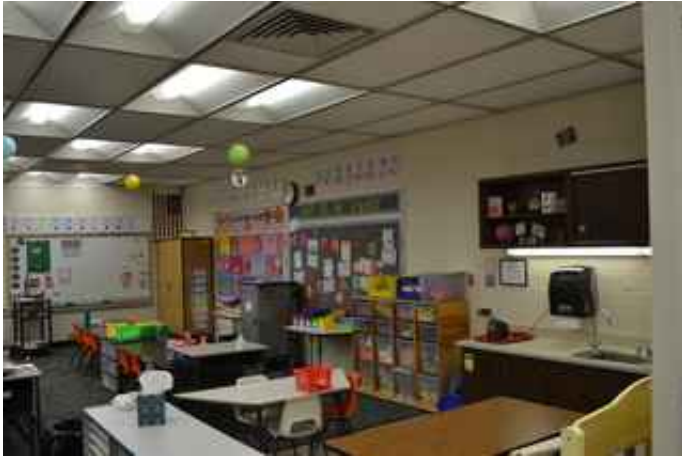
Description: The original school building features open concept classrooms, with carpet flooring, CMU and gypsum walls, and dropped 2' x 4' lay-in ceilings that are in fair condition. These classrooms have been sectioned off by gypsum walls that visually separate the rooms but do not separate sound or function. The typical classroom features a cloakroom with hooks for student storage, and minimal built-in storage for teacher materials. The built-in casework is wood and in poor condition. The typical classroom features more than an adequate amount of chalkboards that are the old wood, built-in the wall type and no tack boards are installed. The interior classroom doors are recessed wood units. They are not equipped with appropriate ADA hardware but do have tempered glass vision panels and all are in poor to fair condition. The 2008 addition features two kindergarten classrooms that are traditionally partitioned with a combination of carpet and VCT flooring, CMU walls, and 2' x 4' lay-in ceilings in good condition. These classrooms contain cubies for student storage and casework for teacher storage with is laminate and in good condition. There is an adequate amount of white boards and tack boards. The classrooms doors are recessed wood units with appropriate ADA hardware and tempered glass vision panels in good condition. The large group restrooms in the original building feature ceramic tile flooring and glazed block walls in fair condition. The restroom ceilings are drywall and they are in fair condition. The toilet partitions are both high density plastic in good condition and metal in poor condition. The large group restrooms in the 2008 addition feature VCT flooring and CMU walls in good condition. The restrooms ceilings are lay-in ceilings and they are in good condition. The toilet partitions are high-density plastic in good condition. The original gymnasium is used as the cafeteria. It has wood floor in fair condition, CMU walls with paint in good condition, and a lay-in ceiling. There are no bleachers in this gymnasium. The gymnasium does not feature a stage, and there is no divider curtain. The gymnasium in the 2008 addition is the primary gymnasium. It features wood floors in good condition, CMU walls, and an exposed metal deck ceiling in good condition. The gymnasium has high density plastic bleachers in good condition and a divider curtain in good condition. This gymnasium also does not feature a stage. The original building contains dedicated art and music rooms. The art room does have a kiln in fair condition. The media center is centrally located and features carpet flooring, CMU and demountable walls and a lay-in ceiling. The media center finishes are in fair condition. The existing kitchen is a warming kitchen only with VCT flooring, CMU walls, and gypsum ceilings that are in poor condition. The age of the kitchen equipment is not known. There are no walk-in freezers or coolers provided.

Rating: 3 Needs Replacement

Typical Classroom Finishes

Recommendations: Provide complete replacement of finishes in the entire building due to poor conditions and due to the installation of systems outlined in this report (such as HVAC system, electrical, technology, etc). Provide for replacement of old toilet partitions and provide new accessories. Provide for replacement of demountable walls with gypsum board walls. Funding for replacement of interior doors is provided in Item O, including doors here noted as being in poor condition.

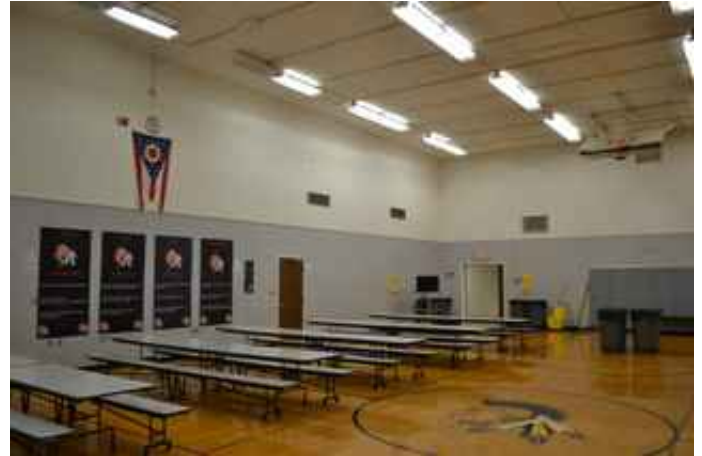
Cafeteria Finishes

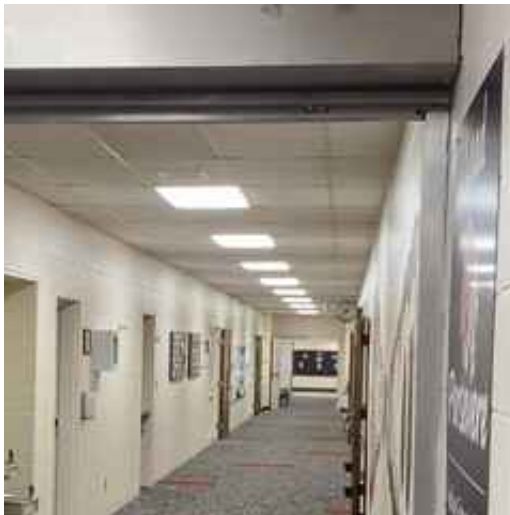
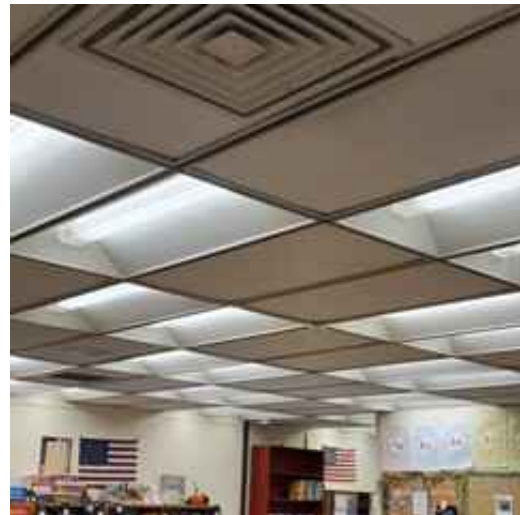
Description: The typical Classrooms in the overall facility are equipped with T8 2x4 lay-in fixtures with single level switching. Classroom fixtures are in fair condition, providing an average illumination of 60 FC, thus meeting the 50 FC recommended by the OSDM. The typical Corridors in the overall facility are equipped with T8 2x4 lay-in fluorescent fixtures with single level switching. Corridor fixtures are in good condition, providing an average illumination of 28 FC, thus complying with the 20 FC recommended by the OSDM. The Primary Gymnasium/Cafeteria spaces are equipped with T8 2x4 suspended type lighting, in fair condition, providing an average illumination of 40 FC, which is less than the 50 FC recommended by the OSDM. The Media Center is equipped with T8 2x4 lay-in fluorescent fixture type lighting in good condition, providing an average illumination of 60 FC, thus complying with the 50 FC recommended by the OSDM. The Kitchen spaces are equipped with 2x4 recessed T8 fluorescent fixture type lighting with single level switching. Kitchen fixtures are in fair condition, providing an average illumination of 50 FC, which is less than the 75-80 FC recommended by the OSDM. The Service Areas in the overall facility yare equipped with 1x4 suspended T8 fluorescent fixture type lighting in fair condition. The typical administrative spaces in the overall facility are equipped with 2x4 lay-in T8 fluorescent fixture type lighting in fair condition, providing adequate illumination based on OSDM requirements. The overall lighting systems of the facility are not fully compliant with Ohio School Design Manual requirements due to inadequate lighting levels, lack of multi-level switching and lack of automatic controls.

Rating: 3 Needs Replacement

Recommendations: Provide complete replacement of lighting system due to inadequate lighting levels, lack of multi-level switching and lack of automatic controls.

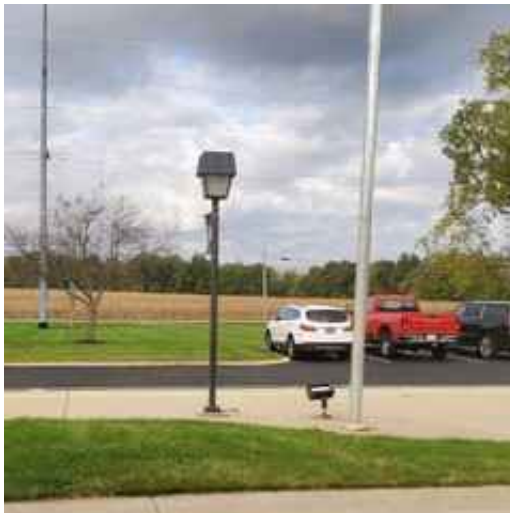
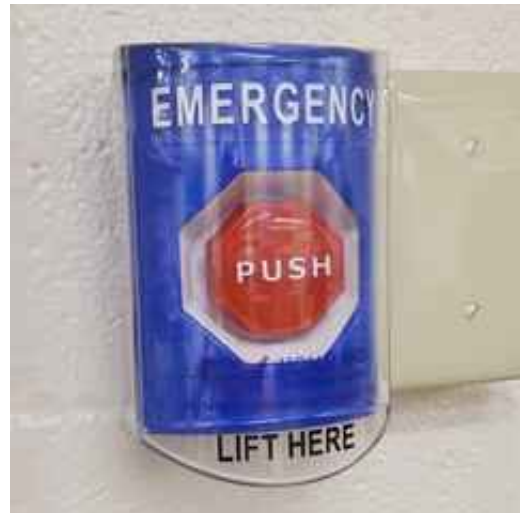
Description: The overall facility contains a Honeywell motion detector, CCTV, door contact type security system in good condition. Motion detectors are inadequately provided in main entries, central gathering areas, offices, main Corridors, and spaces where 6 or more computers are located. Exterior doors are equipped with door contacts. An automatic visitor control system is not provided. Compliant color CCTV cameras are provided at main entry areas, parking lots, central gathering areas, and main Corridors. CCTV is monitored in Administrative Area computer based hard disk recording device. A compliant computer controlled access control system integrating alarms and video signals, with appropriate UPS backup, is provided. The system is equipped with card. The security system is not adequately provided throughout, and the system is not fully compliant with Ohio School Design Manual guidelines. There are no playground fencing issues requiring attention. The exterior site lighting system is equipped with building mounted LED entry lights in good. Pedestrian, Parking and bus pick-up / drop off areas are illuminated by pole mounted HID / metal halide fixtures in poor condition. The exterior site lighting system provides adequate inadequate illumination due to insufficient fixture capacity.

Rating: 2 Needs Repair

Recommendations: Provide partial security system upgrade, consisting of cameras and motion detectors, to meet Ohio School Design Manual guidelines. Provide complete replacement of exterior site lighting system to meet Ohio School Design Manual guidelines.

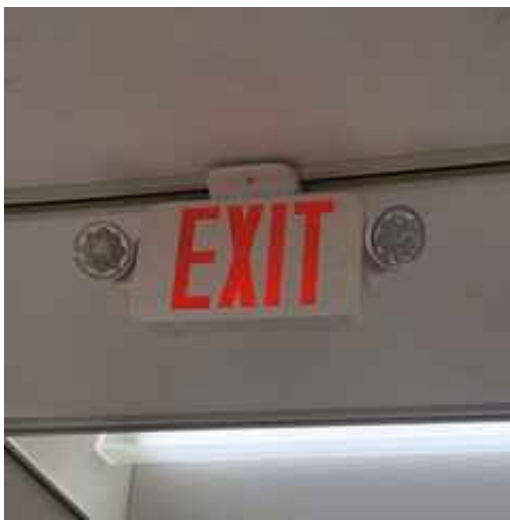
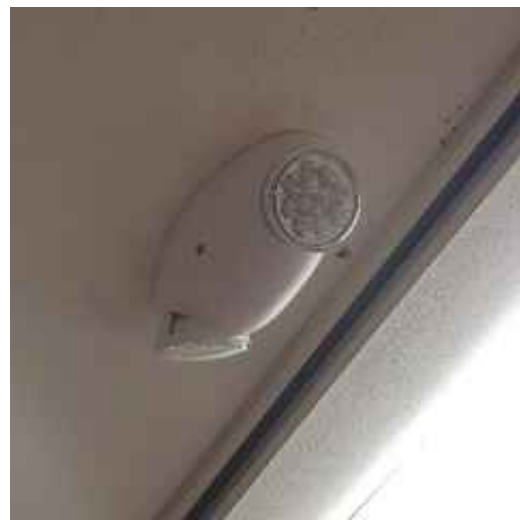
Description: The overall facility is equipped with an emergency egress lighting system consisting of plastic construction exit signs and the system is in good condition. The facility is equipped with emergency egress floodlighting, and the system is in good condition. The system is not provided with appropriate battery backup or emergency generator. (Refer to item U for specific emergency generator information) The system is not adequately provided throughout, and does not meet Ohio School Design Manual and Ohio Building Code requirements due to the lack of emergency generator.

Rating: 3 Needs Replacement

Recommendations: Provide complete replacement of new emergency / egress lighting system to meet Ohio School Design Manual and Ohio Building Code guidelines as part of work in items K/U.

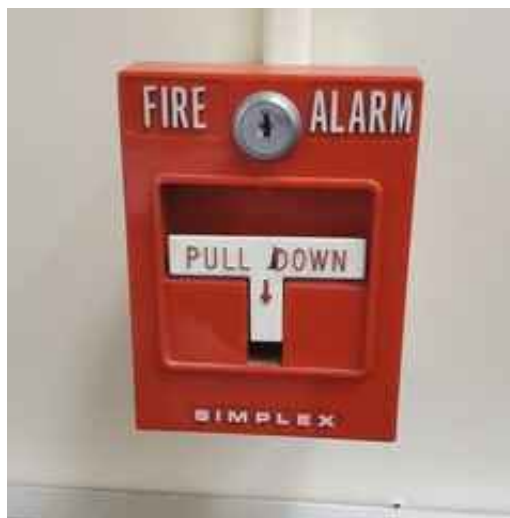
Description: The overall facility is equipped with a Simplex zone type fire alarm system, updated in the last 15 year and in fair condition, consisting of manual pull stations, bells, horn and strobe indicating devices. The system is automatic and is monitored by a third party. The system is equipped with sufficient audible horns, strobe indicating devices, flow switches, tamper switches. The system is not equipped with sufficient smoke detectors and heat sensors. The system thus will support future fire suppression systems. The system is not adequately provided throughout, and does have additional zone capabilities. The system is not fully compliant with Ohio Building Code, NFPA, and Ohio School Design Manual requirements.

Rating: 3 Needs Replacement

Recommendations: Provide complete replacement of fire alarm system to meet OBC, NFPA, and Ohio School Design Manual guidelines due to the age, lack of smoke/heat detectors, and mismatch of equipment.

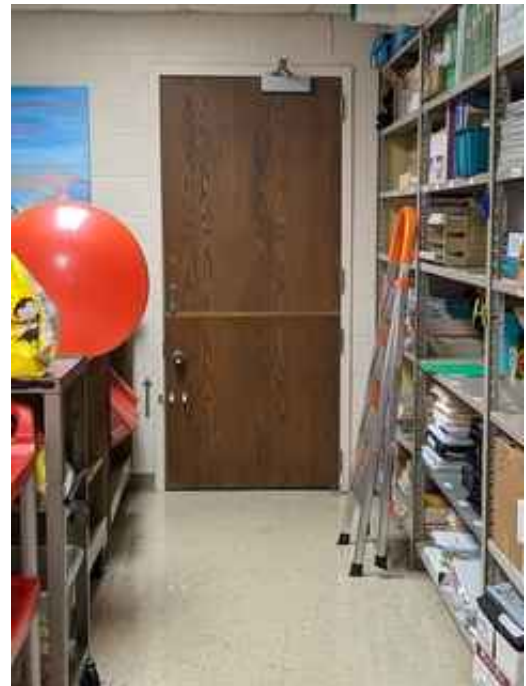
Rating: 3 Needs Replacement

Non-Compliant Door Hardware

Recommendations: Provide ADA-compliant signage, sinks, toilets, urinals, electric water coolers (see Item E), toilet partitions, mirrors and toilet partition accessories as required. Replace all wood doors in the original building with new leafs equipped with ADA hardware. Provide main entrance with an ADA power-assist operator. Parking issues are corrected in Item P.

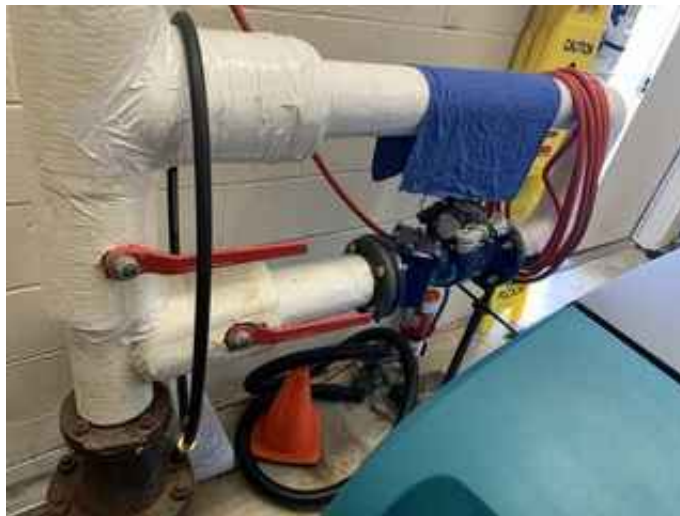
incoming water service

Description: The domestic water supply system is tied into the municipal system, well type, features 2" service and 2" water meter, and is in fair condition. The district was not able to provide water supply flow test data, well logs. The existing domestic water service appears to meet the facility's current needs. The facility is not equipped with an automated fire suppression system, and the existing water supply will not provide adequate support for a future system. The domestic water service is not equipped with a water booster pump, and none is required. The system does not provide adequate pressure and capacity for the future needs of the school.

Recommendations: Add backflow preventer (pricing included in Item E Plumbing). Pressure and capacity addressed in Item U.

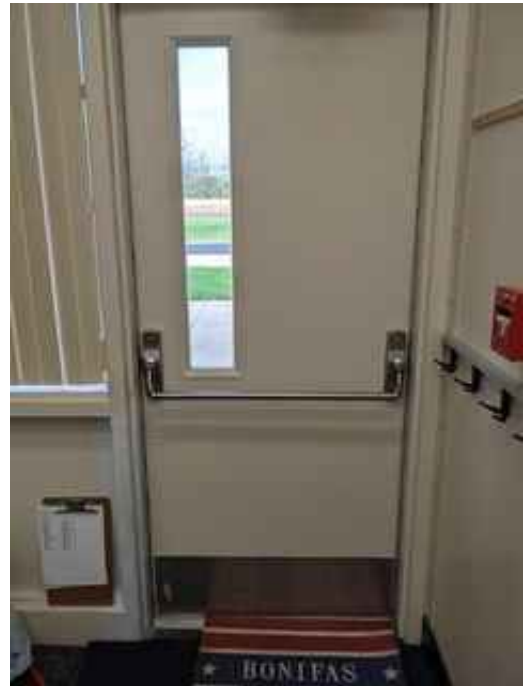
Exterior Door in Original Building

Description: The typical exterior doors in the original building are hollow metal and are in fair condition. The typical exterior doors in the 2008 addition are FRP and are in good condition. There is no exterior overhead door in this building.
