Re: Case No 07-723-EL-UNC

MICHAEL L. HOFMANN

Subject: Evaluation of Failed Turbine Blades from Zimmer Station  
Metallurgy File #3791

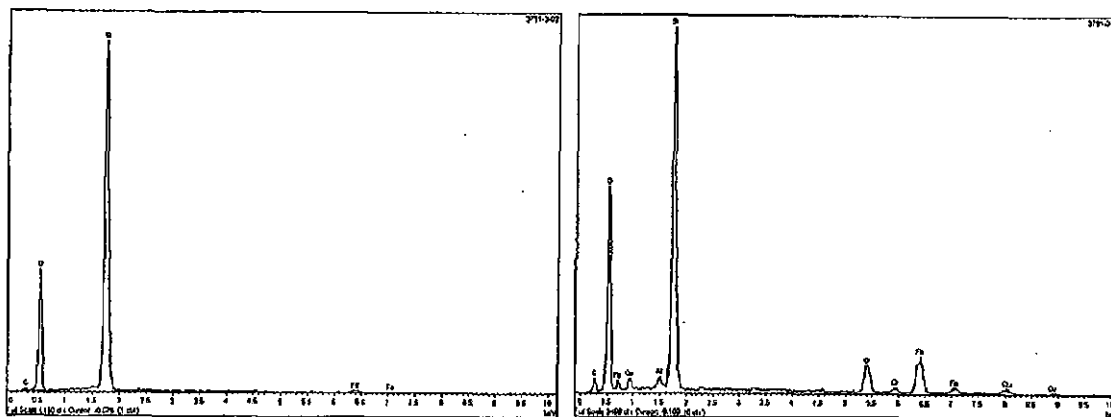
As noted above, the L-2 blades had an adherent brown deposit on the convex surface. Some of the material was scraped from the surface and examined by energy dispersive spectroscopy (EDS) to determine if any specific corrosive species could be detected (Figures 17 and 18). The bulk of the deposit consists of a silicon compound. No elements were detected that might commonly be associated with silicon as a silicate, therefore, it appears that the bulk of the deposit is silica. Several other elements such as copper, aluminum and nickel were also detected in the deposit. Nickel and aluminum were not uniformly dispersed among the particles examined but copper appeared in almost every spectrum. No chlorides or sulfur compounds were detected in any of the deposits. One analysis by Nalco (below) confirmed the presence of these elements.

**Figure: 17** Deposit particles scraped from the surface of one of the LPA L-2 blades. Lighter areas indicate the presence of heavier elements such as copper, iron, chromium and nickel.

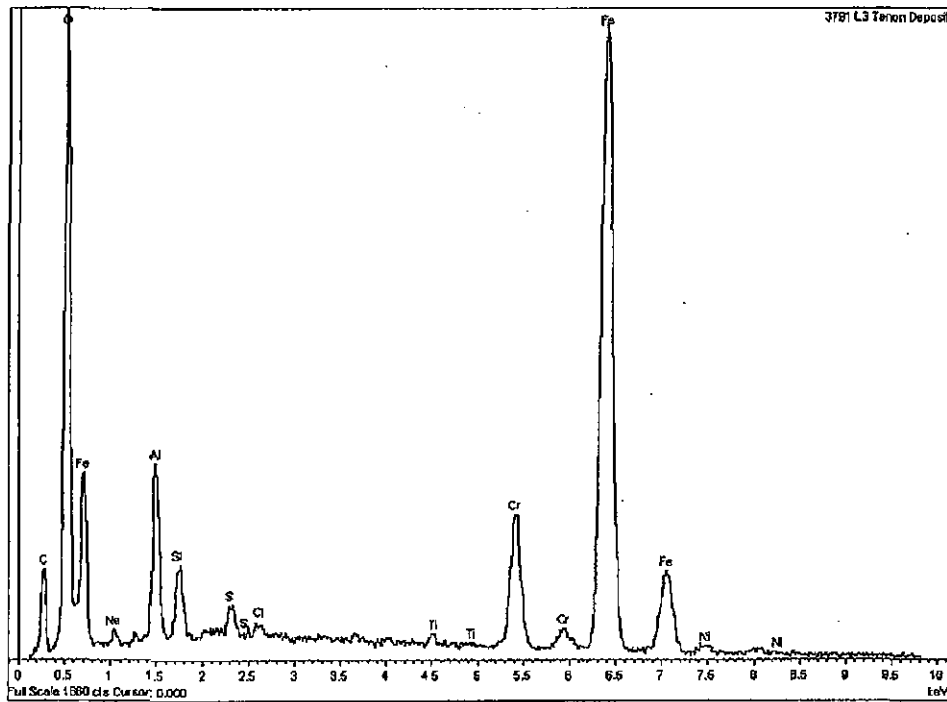
**Figure: 18** EDS spectra of particles at left and bottom of Figure 13. Composition variation is typical from particle to particle.

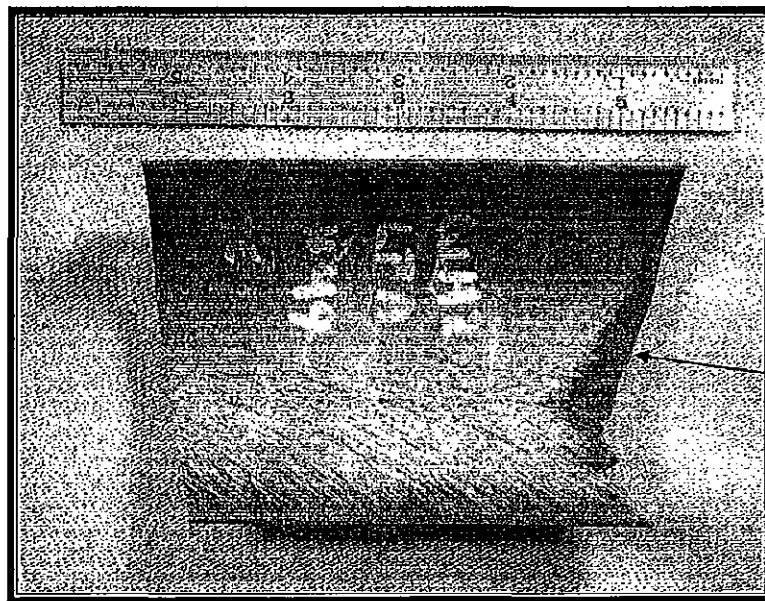
The LP-A L-2R fractured blades #49 and #175 and LP-B L-2R fractured blades #103 and #141 in the as received condition are shown in Figures 1 – 8. All the blades were covered with a reddish brown deposit on the convex side. The fracture surface of the blades was covered by oxide deposits.

Figure 1: As received LP-A L-2 #49 blade concave side.

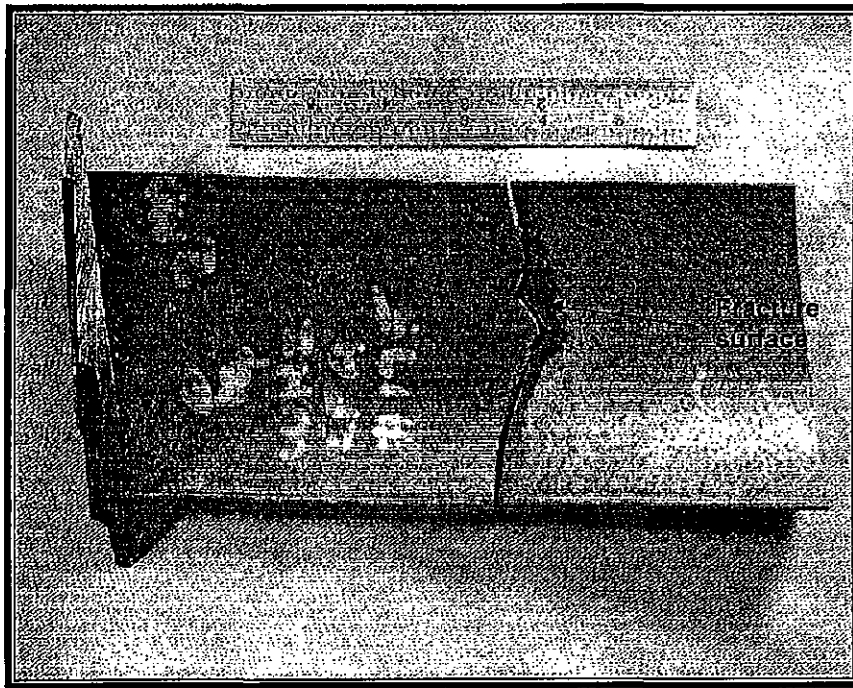
Figure 3: As received LP-A L-2 #175 blade concave side

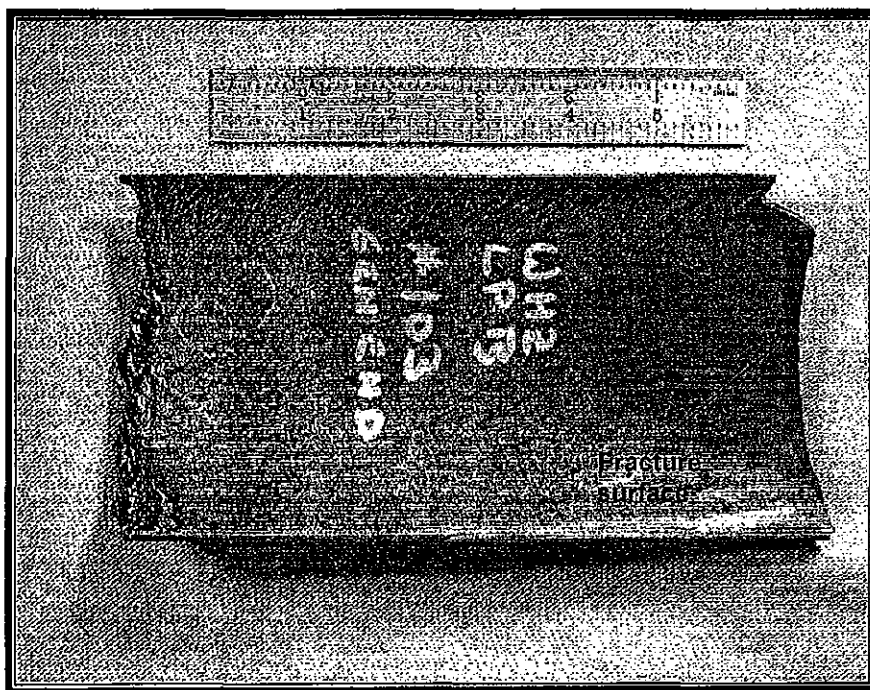
Figure 5: As received LP-B L-2 #103 blade concave side

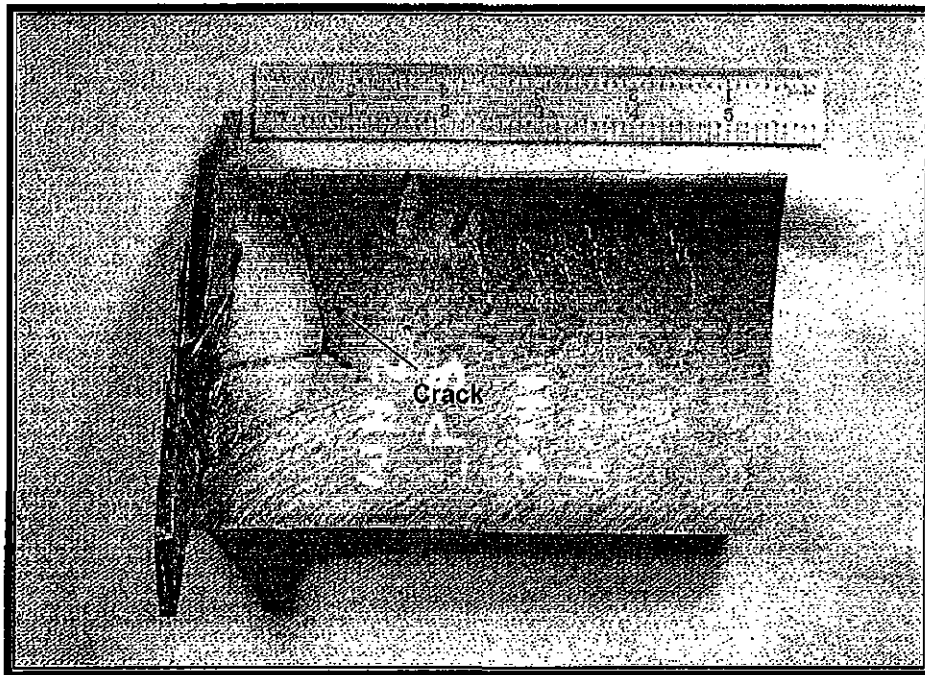
Figure 7: As received LP-B L-2 #141 blade concave side

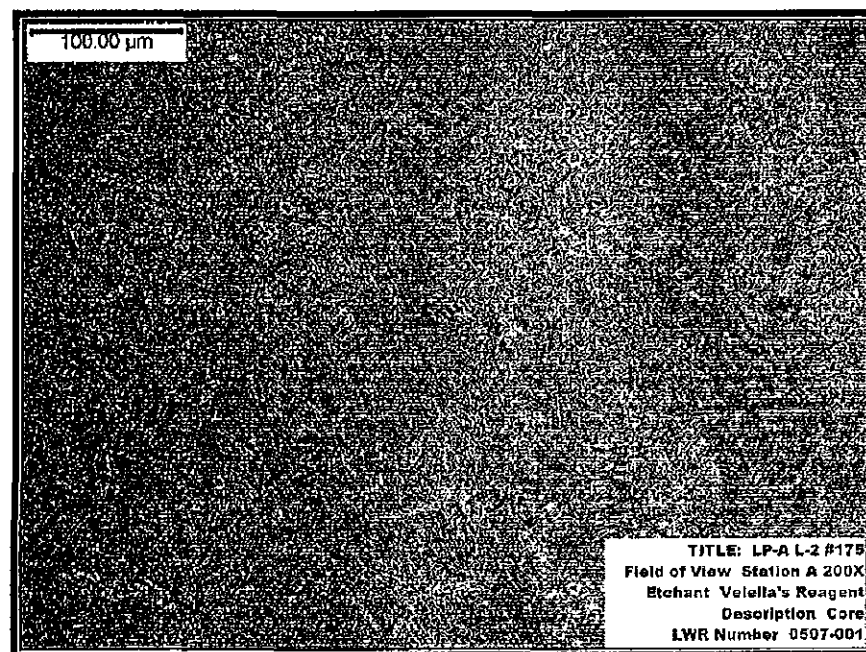
Figure 19: Photomicrograph of the core of LP-A L-2R #175 blade. The microstructure consists of tempered martensite and delta ferrite (<5%).

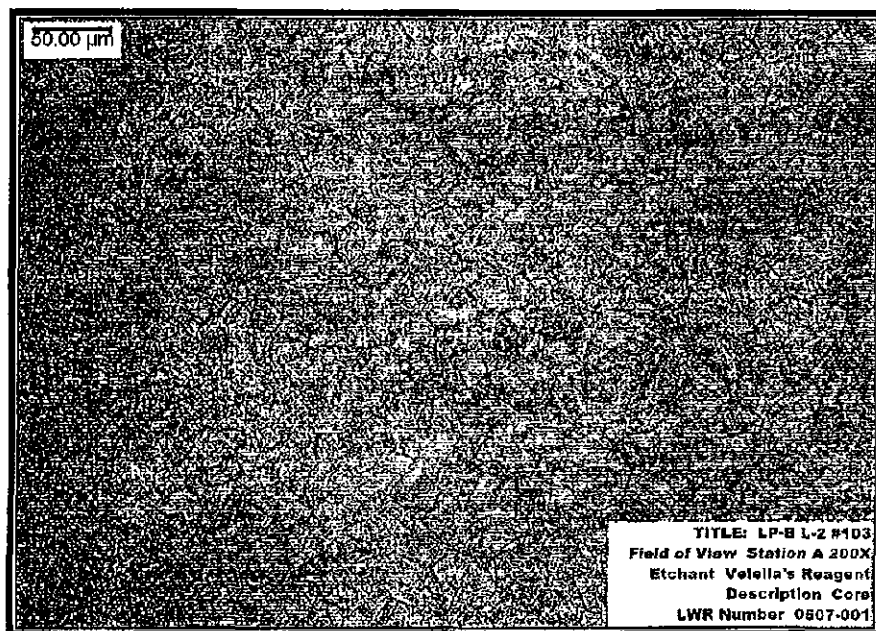
Figure 20: Photomicrograph of the core of LP-B L-2R #103 blade. The microstructure consists of tempered martensite and delta ferrite (<5%).

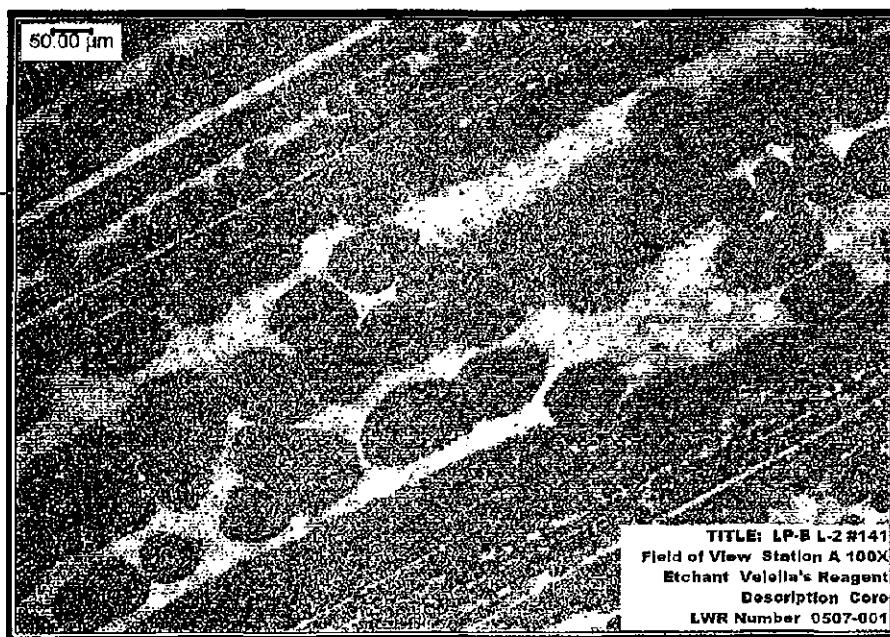
Figure 21: Photomicrograph of the core of LP-B L-2R #141 blade. The microstructure consists of tempered martensite and delta ferrite (~15%).
