BEFORE THE OHIO POWER SITING BOARD

**In the Matter of the Application
of Champaign Wind LLC for a
Certificate to Install Electricity
Generating Wind Turbines in
Champaign County**

**MEMORANDUM OF INTERVENORS UNION NEIGHBORS UNITED, INC.,
JULIE JOHNSON, AND ROBERT AND DIANE McCONNELL IN OPPOSITION
TO THE MOTIONS OF EDP RENEWABLES NORTH AMERICA LLC,
GAMESA WIND US, LLC, INVENERGY LLC, AND CHAMPAIGN WIND
LLC TO QUASH THE BOARD’S SUBPOENAS DUCES TECUM**

RE: April 24, 2012 Turbine Failure at Timber Road II Wind Farm ("Timber Road II")

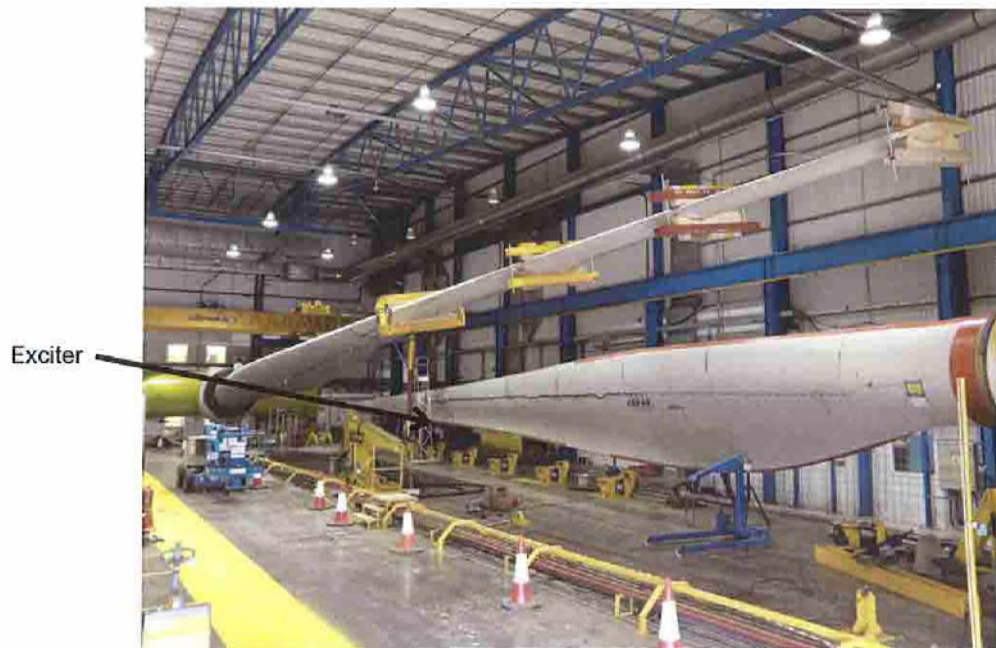
The test method used complies with the relevant IEC TS 61400-23 standards and was performed at elevated loads. A series of sensors (strain gauges and acoustic emission sensors) were mounted on the blade to detect potential damage. During the test period, the blade was also scanned with ultrasound to detect and confirm any damage in the blade. For more information on the acoustic sensors used, please see that section later on in this report.

All of the blades tested in this report were produced at the Vestas blade factory in Lem, Denmark.
