BEFORE THE OHIO POWER SITING BOARD

In the Matter of the Application of )  
Champaign Wind LLC, for a Certificate )  
to Construct a Wind-Powered Electric ) Case No. 12-0160-EL-BGN  
Generating Facility in Champaign )  
County, Ohio )

EXHIBITS L TO Z OF THE AMENDED DIRECT WRITTEN TESTIMONY OF  
WILLIAM PALMER, FILED ON BEHALF OF INTERVENORS UNION NEIGHBORS  
UNITED, INC., DIANE AND ROBERT McCONNELL, AND JULIA F. JOHNSON

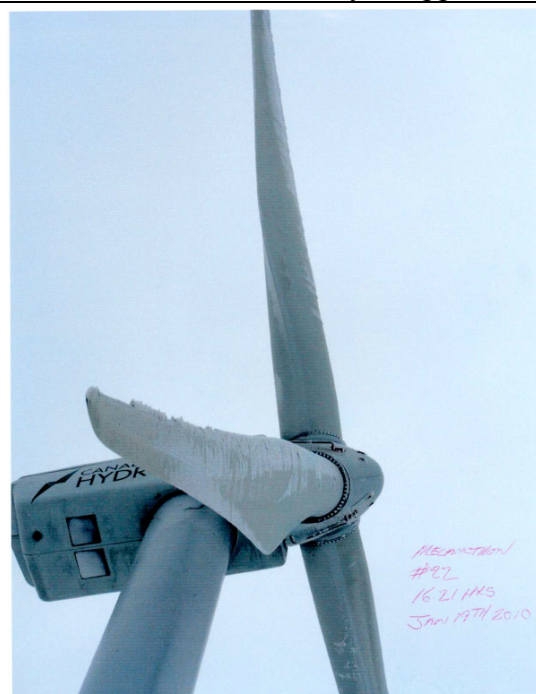
Note Some Ice Has Already Dropped

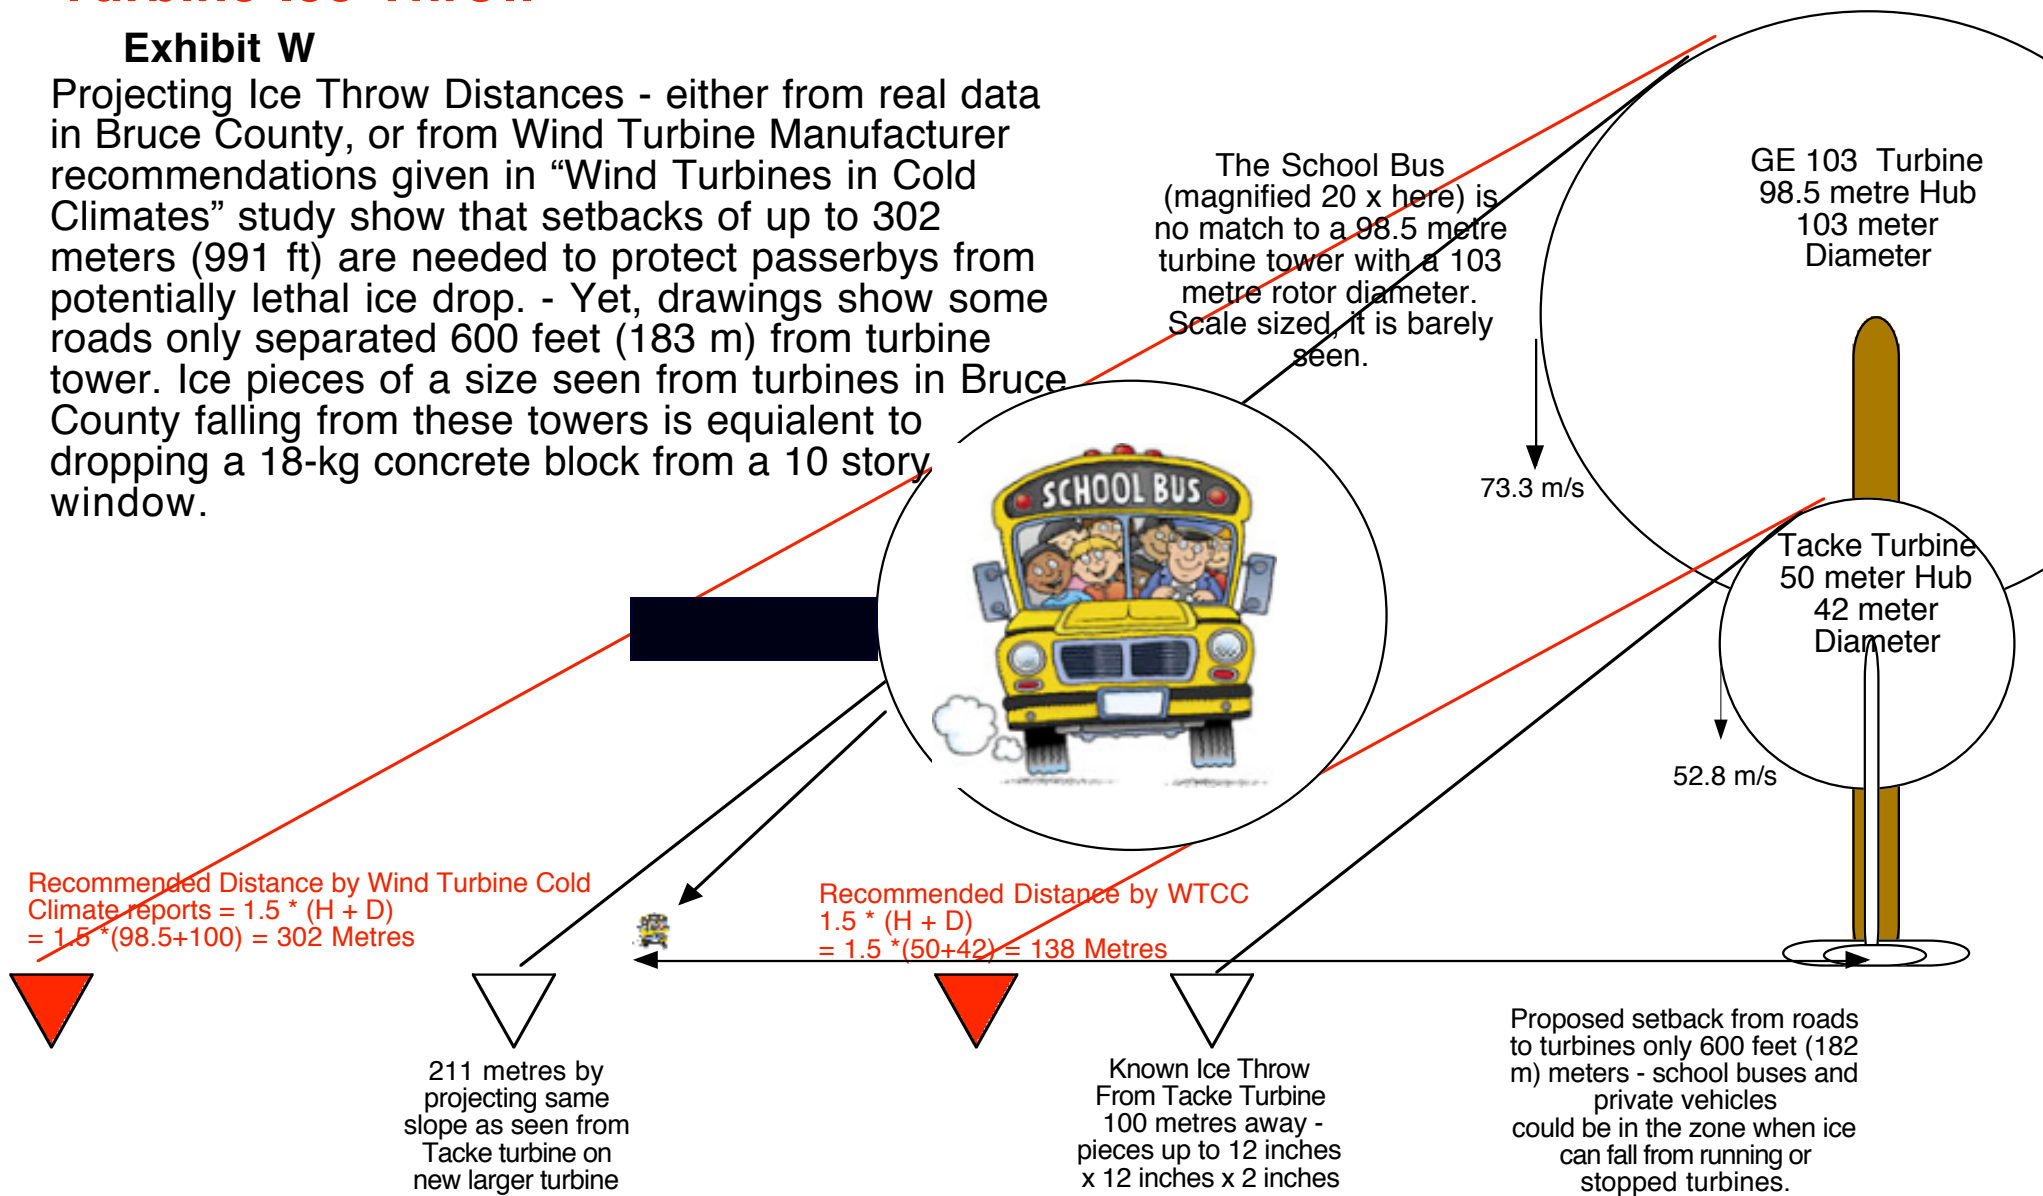
## Exhibit W

Projecting Ice Throw Distances - either from real data in Bruce County, or from Wind Turbine Manufacturer recommendations given in "Wind Turbines in Cold Climates" study show that setbacks of up to 302 meters (991 ft) are needed to protect passerbys from potentially lethal ice drop. - Yet, drawings show some roads only separated 600 feet (183 m) from turbine tower. Ice pieces of a size seen from turbines in Bruce County falling from these towers is equalent to dropping a 18-kg concrete block from a 10 story window.

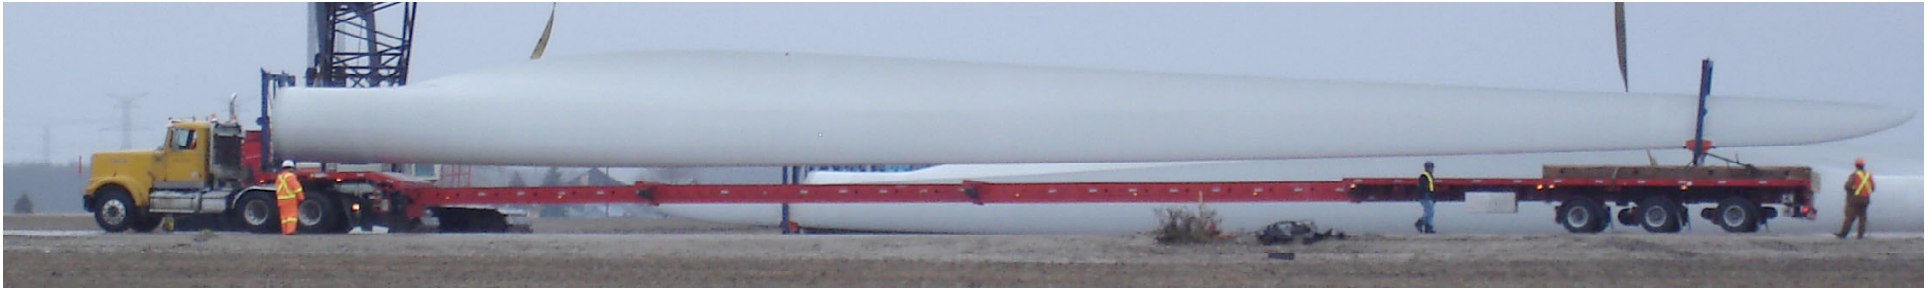
### Exhibit X: Wind Turbine Blade Failures

When considering wind turbine blade failures, it is important to understand the size of these devices that are nominally well up in the air, where they look small. This photo is a blade for a Vestas V-82 turbine, with an 82-metre rotor diameter. The turbines suggested for Buckeye II will have 24% larger blades with their 100-metre rotor diameter. Comparing the blade to the size of the men with it helps to understand the threat that even a small part of the turbine blade poses to human health if it falls.

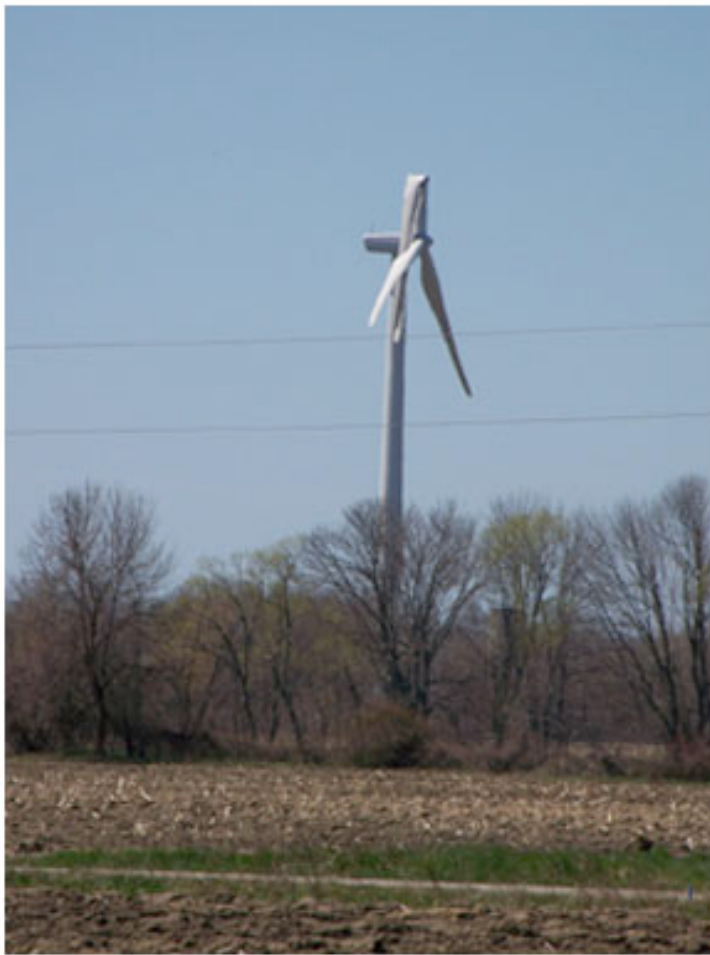
"Mike Crawley, president and CEO of AIM PowerGen, said the wind turbine performed just as it was designed to do when hit." "The blade took a direct hit from lightening and buckled, but did not separate from the rest of the turbine."

Looking at the pictures from  
A Channel News  
Monday April 30, 2007

Does "the blade" mean only the exterior coating, and not include any of the heavy structural material inside the gel-coat?
