**Vinton Solar Energy LLC  
Case No. 17-774-EL-BGN**

**Application Part 3 of 5**

- **Exhibit A Solar Modules - CONFIDENTIAL (filed under seal)**
- **Exhibit B Solar Inverters - CONFIDENTIAL (filed under seal)**
- **Exhibit C Road Survey Report May**
- **Exhibit D TRC Site Characterization Report June 2017**
- **Exhibit E TRC Vinton Raptor Nest Survey June 2017**

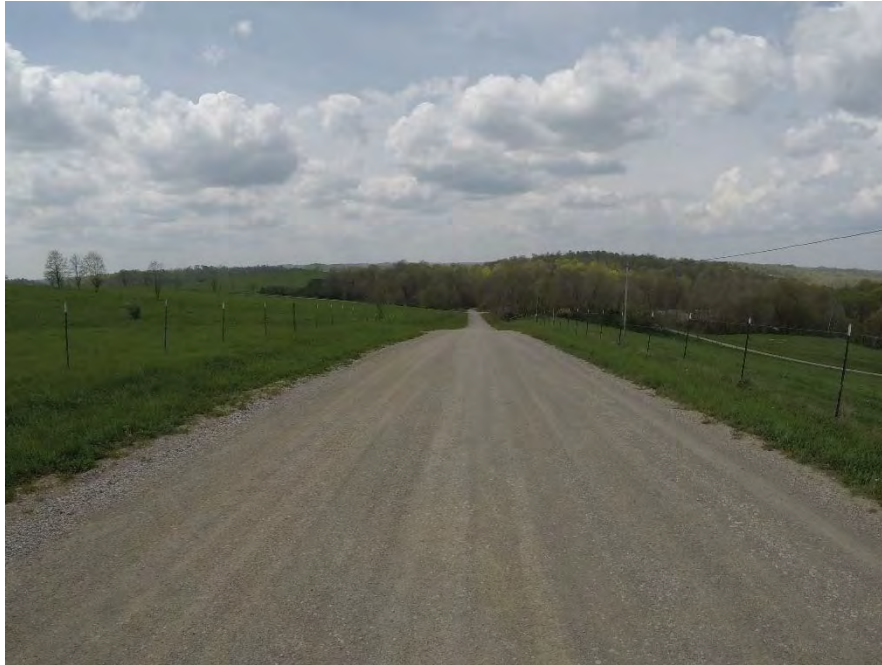
**Figure 4-3**      **Infirmary Rd at STA 73+00 (west)**

**Section 3** from 44+00 to 153+00 has no asphalt. Gravel roads are not subject to pavement assessment. Gravel section seems in good shape with some washout areas and rutting along the edges. Ride is constant without any mayor bumps. There is a weight limit of 23 Tons for a bridge located east of the project site.

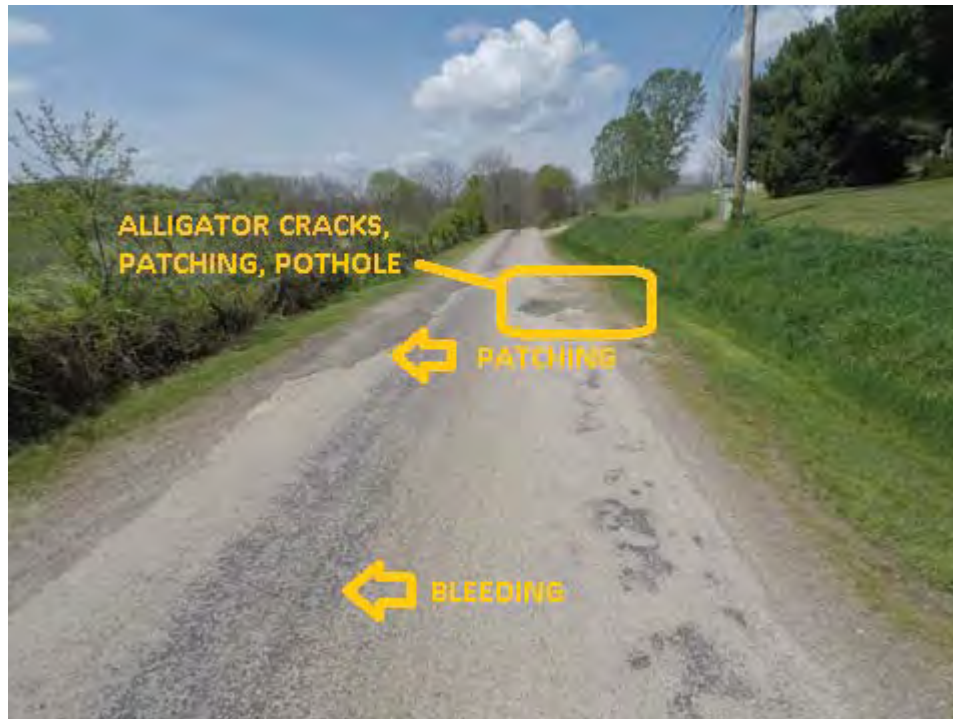
**Figure 4-5      Infirmary Rd at STA 157+00 (west)**

**Section 4** from 153+00 to 161+00 was observed generally very poor condition. The pavement has several patches, bumps and sags, alligator cracking and rutting. The ride quality for this section is poor. Driving at posted speeds presents vehicle vibration and some areas that require slight reduction in speed due to bumps and dips.
