# **Columbia Gas of Ohio - Zanesville Regulator Failure**

# Low Pressure MAOP Excursion – May 9, 2019

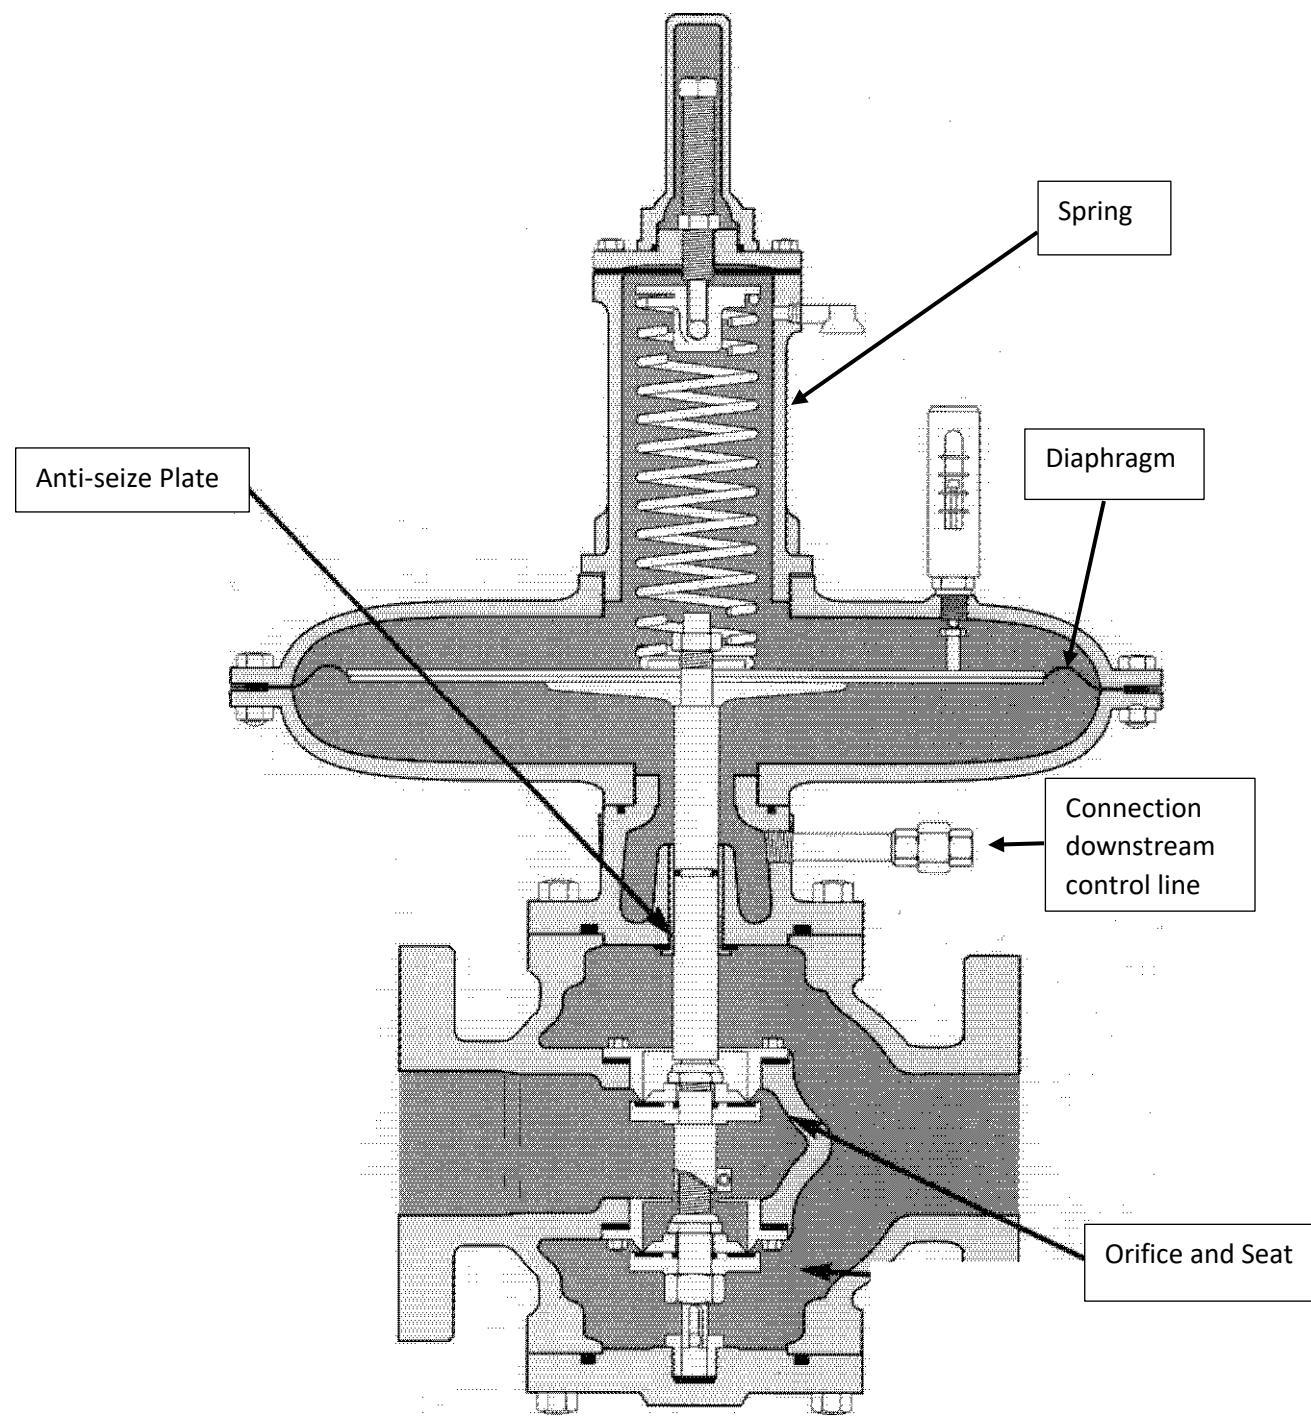
# Below is a side view diagram of a Rockwell 441S Regulator:

The M&R tech forgot to open the monitor control line valve (#5) and the control line valve (#6), which trapped the natural gas between the closed control line valves and the bottom part of the diaphragm of the regulators. This trapped downstream pressure is what causes the diaphragm not to move from the existing spring tension and applied a constant gas flow and pressure. This created a false sensing pressure for the monitor and control regulators, which caused the MAOP Excursion (refer to VIII – Written Statements).
