Case number: 18-0091-EL-BGN

Document Description: Incident Report - pages 2, 5, 6, 8, and 9

On September 3, 2020 at approximately 22:36 hours local time, a Vestas V150 4.2MW wind turbine at Paulding Wind Farm IV ("Timber Road IV") in Paulding County experienced a blade failure. Damaged blade debris has fallen to the crane pad and within an approximate 90-meter radius around the turbine.

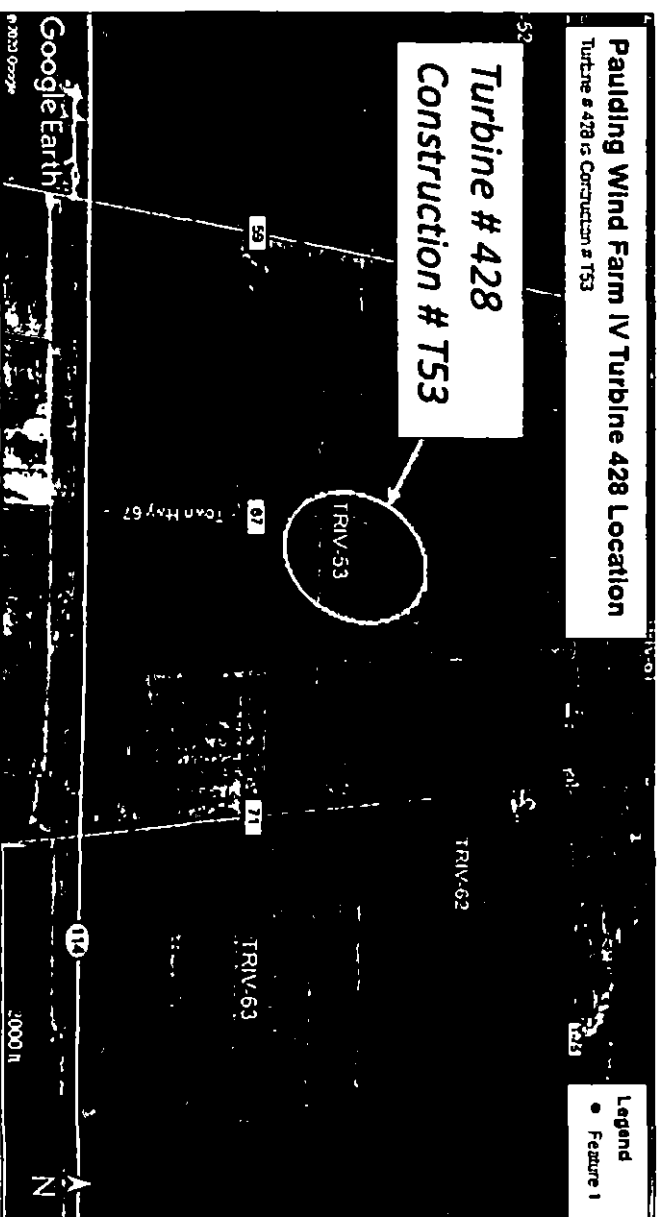
The Timber Road IV operations team mobilized to the turbine at 06:45 to ensure no additional hazards were present. After initial visual inspection of the turbine and surroundings, the operations team implemented actions to secure the area around the turbine. Those actions included notifying landowners and closing access roads leading to the affected turbine 428.
