CASE NUMBER: 08-935-EL-SSO

DESCRIPTION OF DOCUMENT: Direct  
Testimony of D. Cleaver

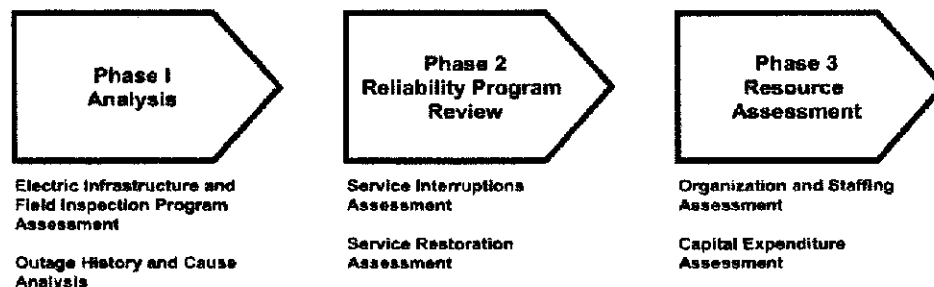
**Figure 1-1**  
**UMS Group's 3-Phased Diagnostic Process**

Figure 1-1 below characterizes the nature of our three-phased assessment approach.

#### **Phase 1: Infrastructure and Outage History and Cause Analyses**

During this initial phase, UMS Group conducted a selected sampling across CEI's 2 substation areas and 9 distribution line districts to verify the accuracy of CEI's system condition records, visually assess the physical condition of a sample of the system assets, and determine the effectiveness of and adherence to the Company's established Field Inspection policies and practices. The details of this analysis are presented in Section 2.0 of this report.

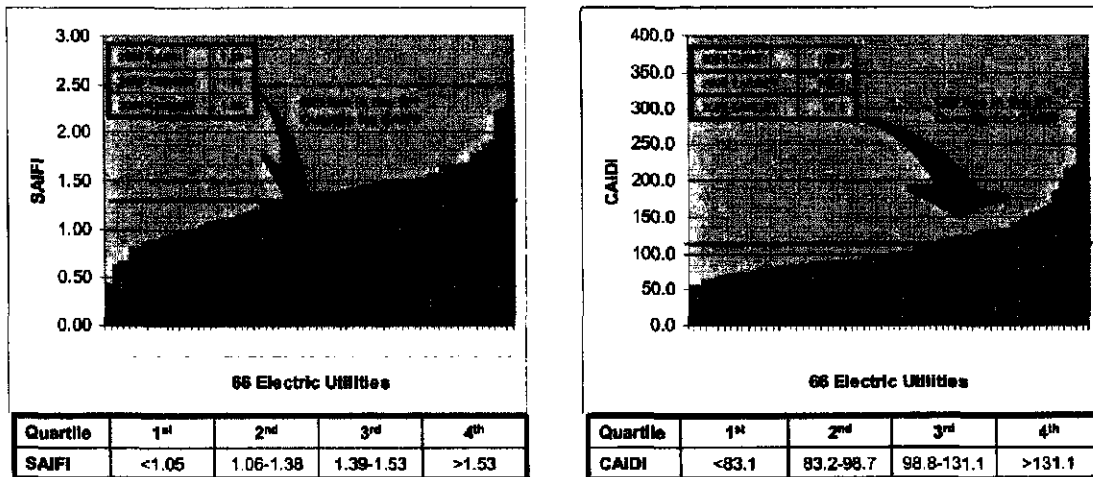
**Figure 1-2  
Industry Context for CEI's SAIFI and CAIDI Targets**

This assessment defines the actions (and their rationale) necessary for the Company to meet the targeted levels of reliability performance (specifically, SAIFI of 1.0 and CAIDI of 95.0) by 2009. From an industry-wide perspective, the challenge confronting the Company is that of striving to meet "top-quartile" performance in SAIFI and "second quartile" performance in CAIDI. Figure 1-2 below characterizes the Company's targets in the context of general industry patterns.

With respect to the targets themselves, as Figure 1-2 illustrates, they are appropriately aggressive in that top-quartile SAIFI performance and second quartile CAIDI performance are by no means unreasonable goals to establish, particularly over the long run. Our belief is that in the case of the CEI they would represent outstanding performance (for the reasons specified above), particularly when compared with the targets established for the other Ohio utilities and similar systems (in terms of overhead/underground mix, age, condition, etc.)

Special Note – The data shown in Figure 1-2 above originates from an updated database and does not precisely match the information reported to PUCO. The variance between this presentation and prior report is approximately 1 minute for CAIDI/SAIDI and less than 0.1 for SAIFI.

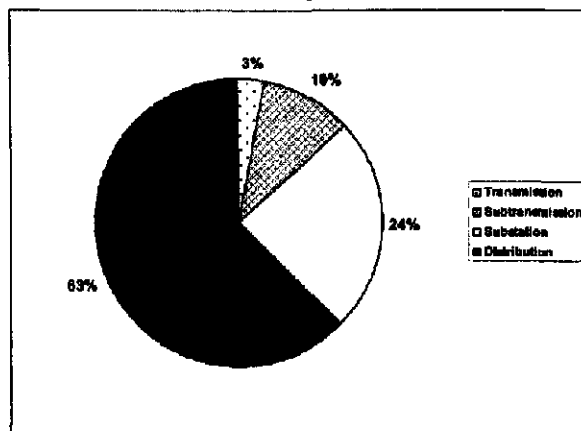
**Figure 1-4**  
**2006 SAIFI Stage of Delivery**

We initially looked at contributors to SAIFI (Figure 1-4) by Stage of Delivery (Transmission, Subtransmission, Substation and Distribution), where Distribution refers to the feeders. Obviously, the greatest opportunity for improvement is in the feeders (over 60 percent of the customer interruptions are attributed to feeders). That is not to say that improvement is not warranted in the areas of Subtransmission and Substations. But, the number of customer interruptions in these stages of delivery has been reduced, and the measures already taken should be sufficient to provide continued improvement.

In reviewing the implications of the Stage of Delivery analysis (Figure 1-4), the following key points are summarized:

- The primary focus on this assessment should be on Distribution (it contributes 0.76 to SAIFI or 63 percent of the customer interruptions)
- Substation SAIFI, contributing 0.29 to SAIFI or 24 percent of the customer interruptions, requires parallel focus. However, the Feeder Breaker and Relay replacements and Animal Protection already being implemented across CEI should be sufficient to maintain steady improvement.
- Subtransmission SAIFI (contributing 0.12 to SAIFI or 10 percent of the customer interruptions) improved significantly between 2005 and 2006 (a 72.4 percent reduction in customer interruptions due to improved operability of the switches on the subtransmission system).
- Transmission SAIFI is negligible (not covered in this assessment).

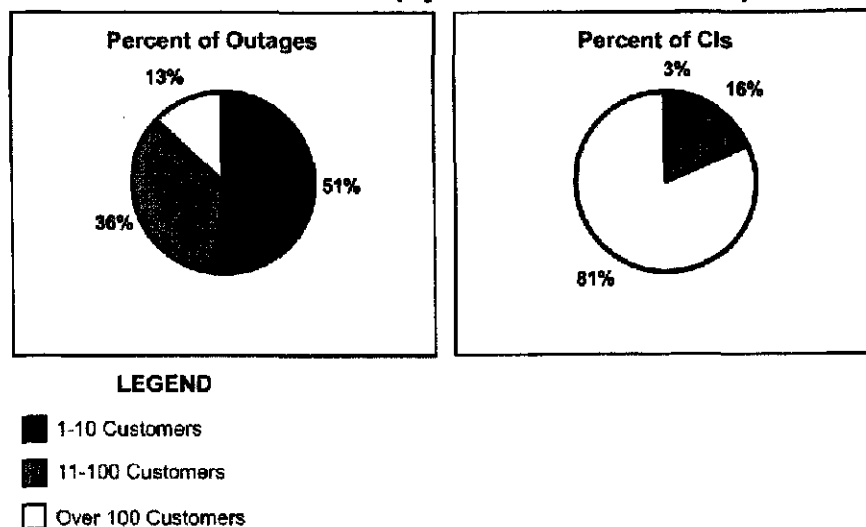
**Figure 1-5**  
**Distribution SAIFI (By Number of Customers)**

Within distribution (feeders), we then reviewed the distribution outages across the number of customers served. Figure 1-5 below illustrates that a relatively small percentage of outages (13 percent) had an appreciative effect on the numbers that drive SAIFI (customer interruptions). Therefore, any strategies and tactics aimed at reducing customer interruptions need to reflect the fact that 87 percent of the distribution outages accounted for only 19 percent of the customer interruptions (this is also indicative of effective fusing previously implemented by the Company).

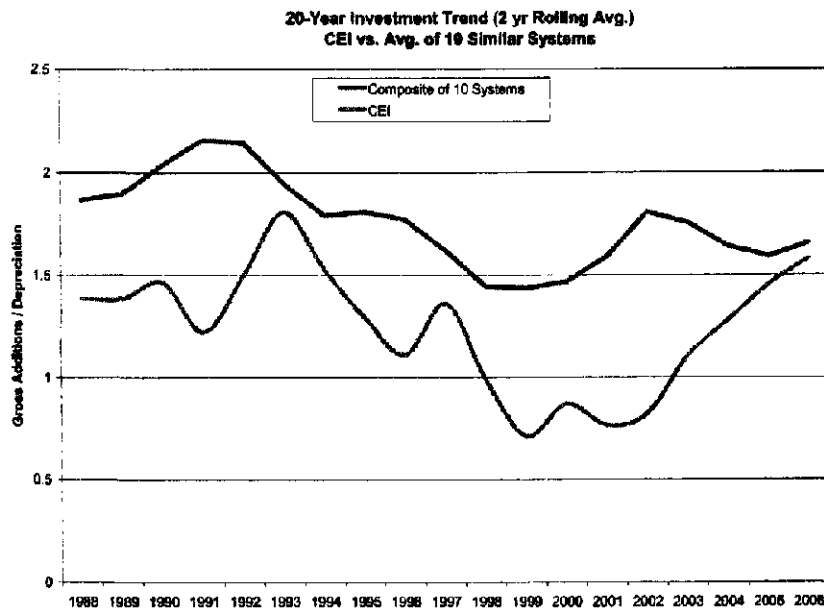
**Figure 1-8  
CEI Capital Spending vs. Similar Systems (1988-2006)**

Figure 1-8 presents a nearly 20-year trend of the ratio of *Gross Distribution Plant Additions / Depreciation* for CEI and for a composite of 10 U.S. electric utilities. The utilities in our reference composite measure were selected from similarly sized, Eastern U.S., urban/suburban systems. As discussed in Section 8.0, we selected this ratio as the most appropriate way to make relative comparisons of capital expenditures because it provides a practical and generally stable *relative* measure of investment levels among systems; moreover, it offers an indicator (albeit imprecise) of "reinvestment" in the system. To "dampen" the effect of extraordinary single year events (e.g. an extraordinary event or year), we prepared this data in a 2-year rolling average approach:

The implications of this comparative analysis are as follows:

- The Company's capital spending pattern over time has been consistent with the industry trends, albeit always at a *lower than average* level of spending for *all* years of this review.

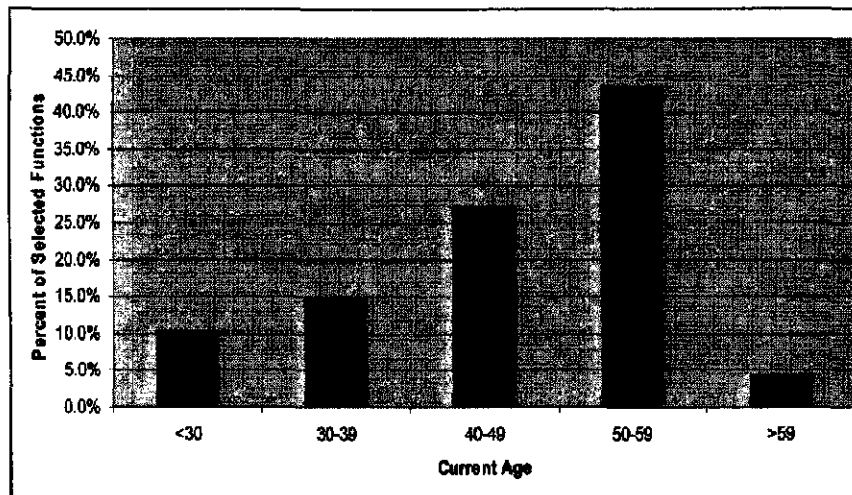
**Figure 1-10**  
**CEI Employees by Age and Function**

Figure 1-10 below presents the age profile of the staff within each of the functions shown in the above table (Figure 1-9). Over 48 percent (308 employees) are 50 years of age (or older) and are likely to retire within the next 10 years. The current policy of maintaining a one-for-one hiring policy with respect to managing attrition is certainly valid when doing "like for like" replacements in terms of experience, knowledge, and leadership acumen. The reality is that the Company is replacing the more seasoned individuals with "entry level" hires. Though the PSI program provides an outstanding foundation for a new hire, it does not replace the 3-5 year apprenticeship period necessary to become fully productive in the field, let alone the value provided by someone with over 20 years of field experience.

Related to the issue of an aging workforce is the fact that over 55 percent (38 of 68) of the current Leadership and Management staff in these targeted areas is also likely to retire within this same 10-year time period. The pipeline for future Leaders and Managers is typically composed of the Non-Managers (included in Figure 1-10) that currently range in age from 30-39); this pipeline is clearly constrained.

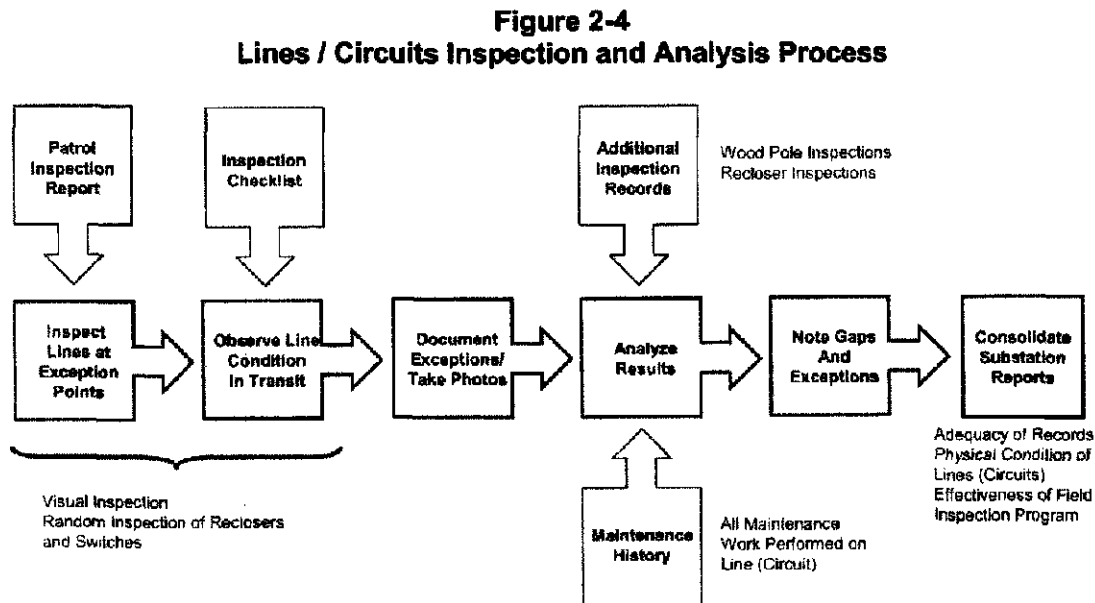
UMS Group conducted an overall visual inspection of the lines/circuits with a random inspection of reclosers and switches. Figure 2-4 below provides a description of this process where the most recent patrol inspection report was used in conjunction with the UMS Group inspection checklist to identify, document, and photograph

exceptions. These results were then compared with the various company inspection reports (Wood Pole and Reclosers) and Maintenance Records to assess the completeness and accuracy of the Company's records.

Figure 2-4 below summarizes the inspection and analysis process.

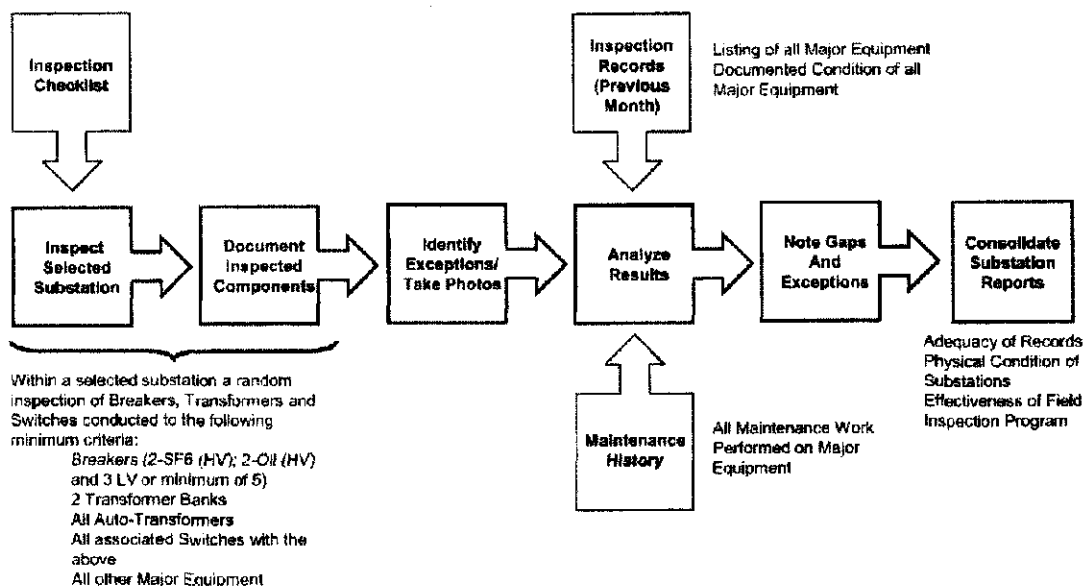
**Figure 2-5  
Substation Inspection and Analysis Process**

Figure 2-5 below outlines the process that we followed in assessing the adequacy of records, the physical condition of the substations, and the effectiveness of the Field Inspection Program (discussed further in Section 5.0). As with the Lines/Circuits Inspections, all noted exceptions were documented (photographs were taken) and compared with the Company's existing inspection and maintenance history. In so doing, exceptions were noted, compared with the inspection records (to verify that they had been previously identified), and correlated to the maintenance records (to gain insights into the Company's follow-up activities that result when discrepancies are identified).

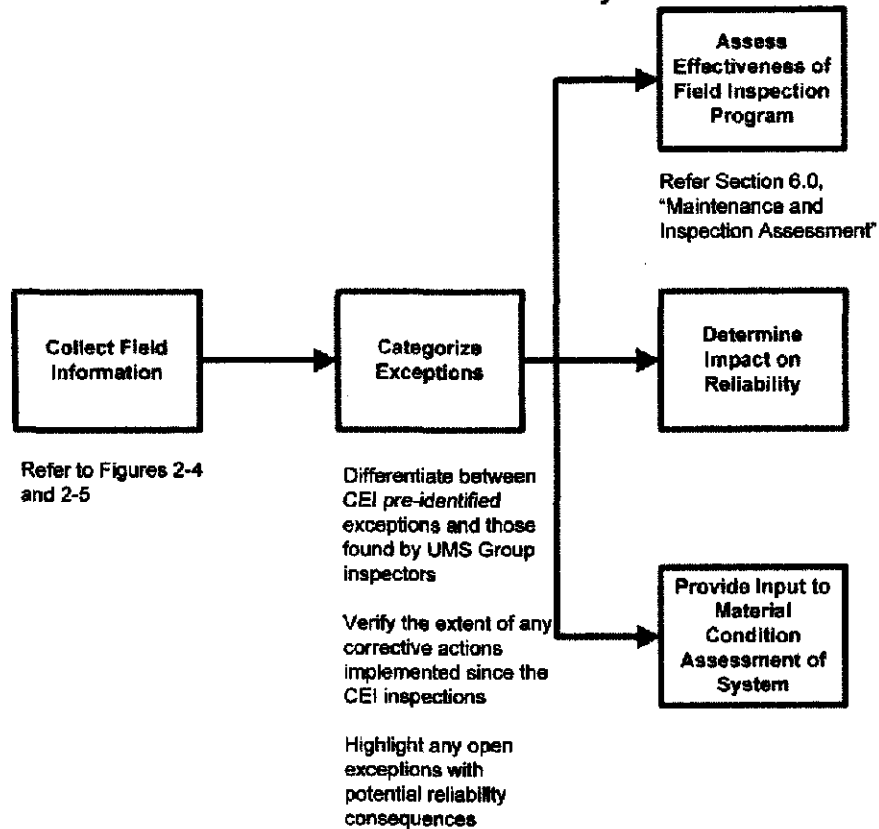
**Figure 2-6  
Condition Records Review and Analysis Process**

Figure 2-6 below provides a high level view of the process we followed to accomplish this charter. Its objective was to translate raw field inspection data into information and then develop a number of insights and conclusions.

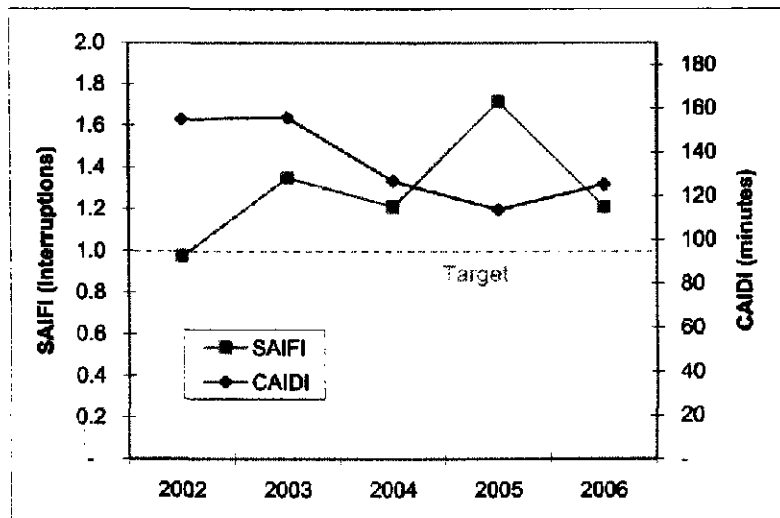
**Figure 3-2  
Five Year Trend in Key Reliability Measures**

The non-storm SAIFI and CAIDI data from Figure 3-1 above is shown graphically in Figure 3-2 below. When this presentation is compared with the 2006 Interim Goals and 2009 Target, it is obvious that CEI needs to both eliminate interruptions (SAIFI) and improve restoration (CAIDI).

From Figure 3-2, except for an anomaly in 2005 when SAIFI spiked to 1.71, CAIDI steadily improved through the period to 2005 (it has since leveled out) and SAIFI has been fairly constant (ranging between 1.21 and 1.35 since 2003). While the leveling off is encouraging, the Company clearly needs to improve to reach the 2009 targets as outlined in Figure 3-3 below:

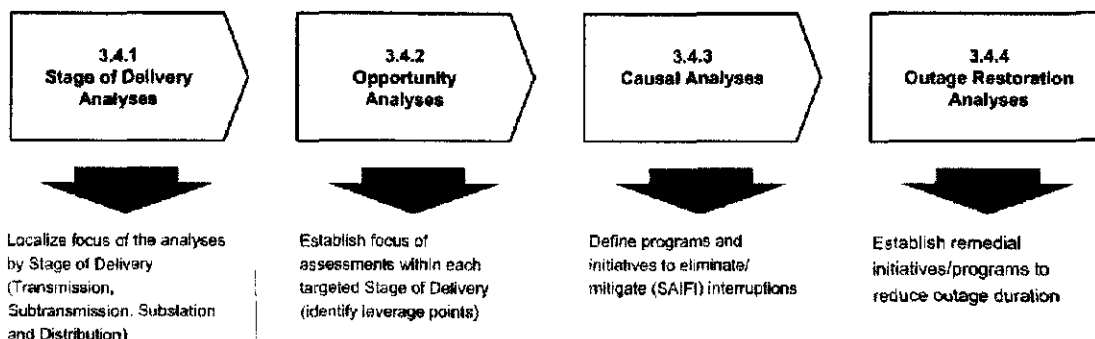
**Figure 3-5  
Reliability Analysis Framework**

Having established an overall perspective of CEI's performance relative to the reliability targets in the previous section, the next phase of this assessment involves defining the focus of the analysis (framing the reliability issues). Figure 3-5 below outlines the analysis approach that we have followed to further focus our work.

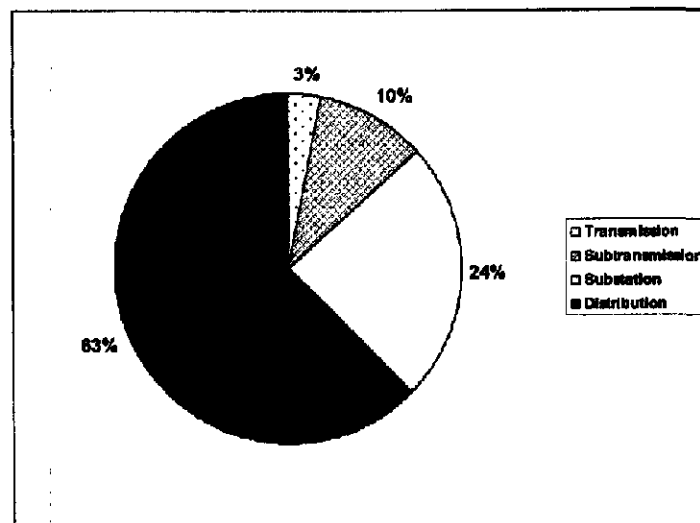
**Figure 3-7**  
**2006 SAIFI by Stage of Delivery**

It is evident from the data above that through 2005 CEI had reliability challenges across all dimensions of distribution (subtransmission, substation and distribution circuits/lines). Moreover, recent Company efforts (most notably proactive thermal imaging, installation of SCADA controlled sectionalizers, improving the operability of the switches on subtransmission, replacing feeder breakers and relays, and improving animal protection on substations) have yielded sufficient improvement to allow us to focus primarily on Distribution (with respect to identifying additional improvement opportunities). Figure 3-7 below further illustrates that point.

Therefore, the remainder of this analysis will **focus on distribution (feeders)**, noting that the initiatives already implemented for the Subtransmission and Substation stage of delivery need to continue.
