Re: Groundwater Hydrogeological and Geotechnical Desktop Document Review Summary Report for the Proposed Willowbrook Solar Farm Project Located in Highland County, Ohio; ORR005.0002.

Hull & Associates, Inc. (Hull) is pleased to provide Open Road Renewables, LLC (Client) with this Desktop Document Review of readily available geologic, hydrogeologic, and geotechnical information that was reviewed for the proposed Willowbrook Solar Farm Project located in Highland County and Brown County, Ohio (Project). The Client is pursuing the development of a solar powered electric generation facility that includes construction of associated infrastructure.

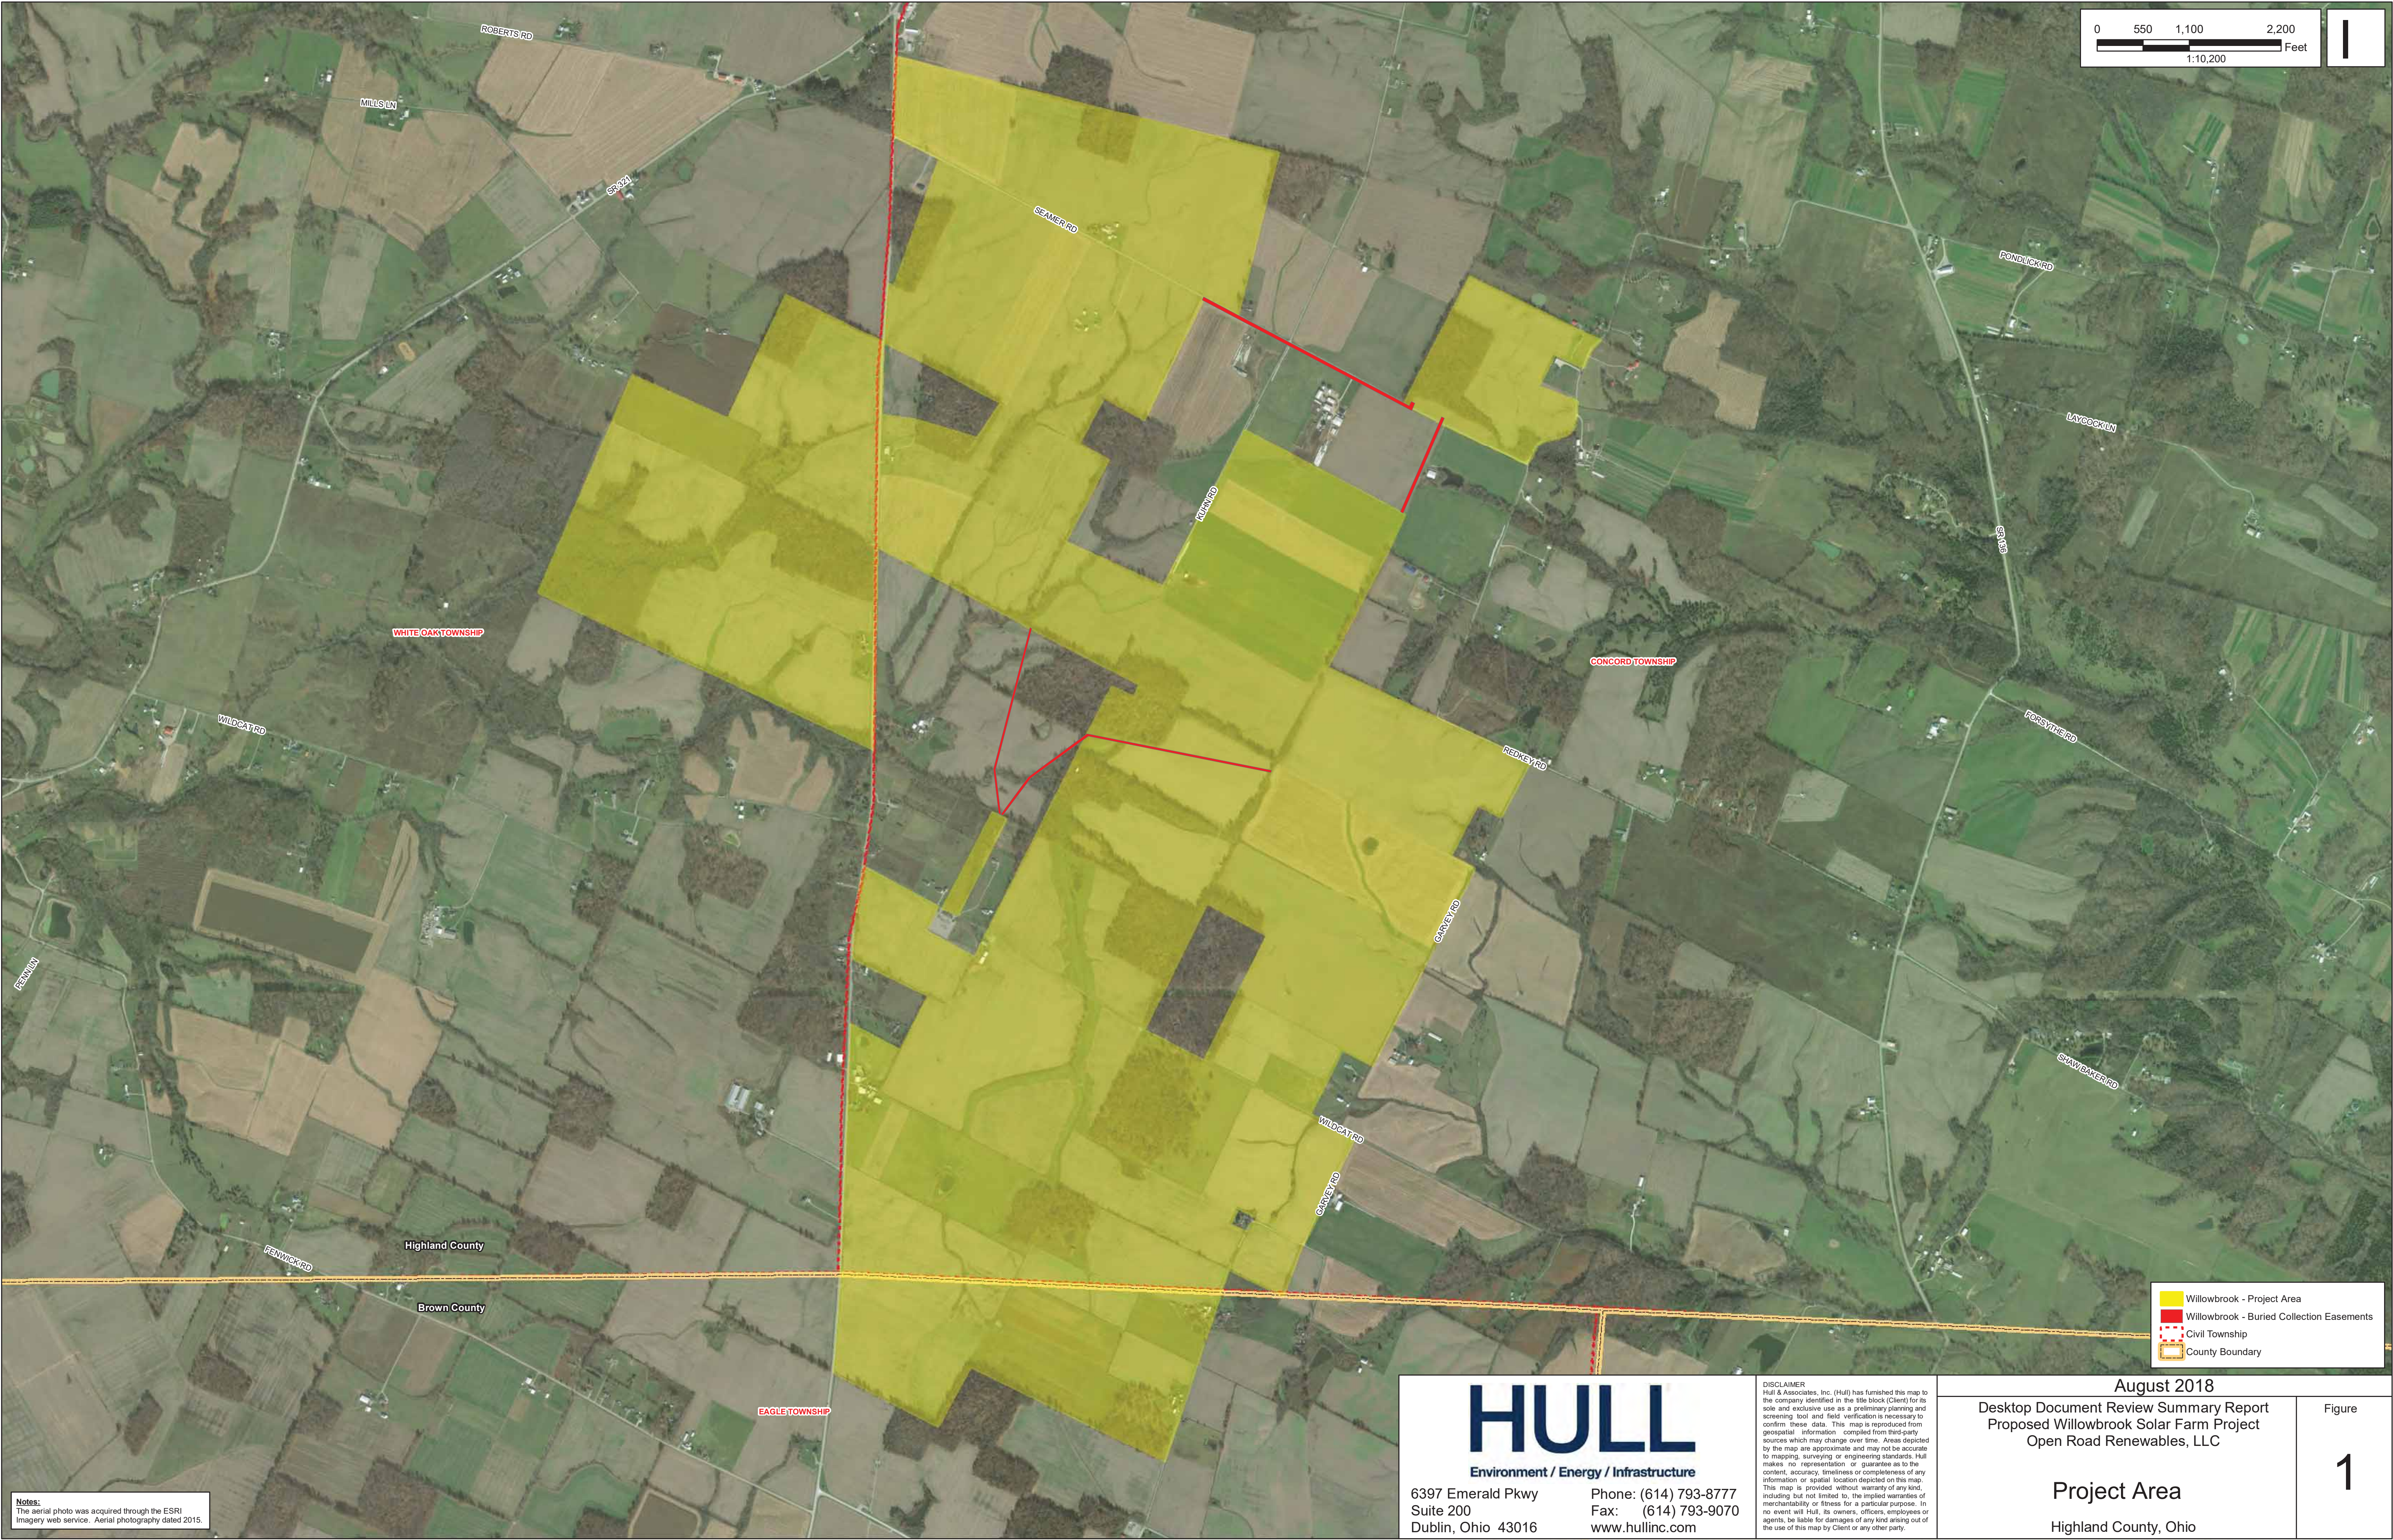
The proposed Project Area consists of approximately 2,034 acres located in Concord, White Oak and Eagle Townships and Highland and Brown Counties, Ohio. The currently proposed Project Area is shown on Figure 1 and subsequent figures discussed below.

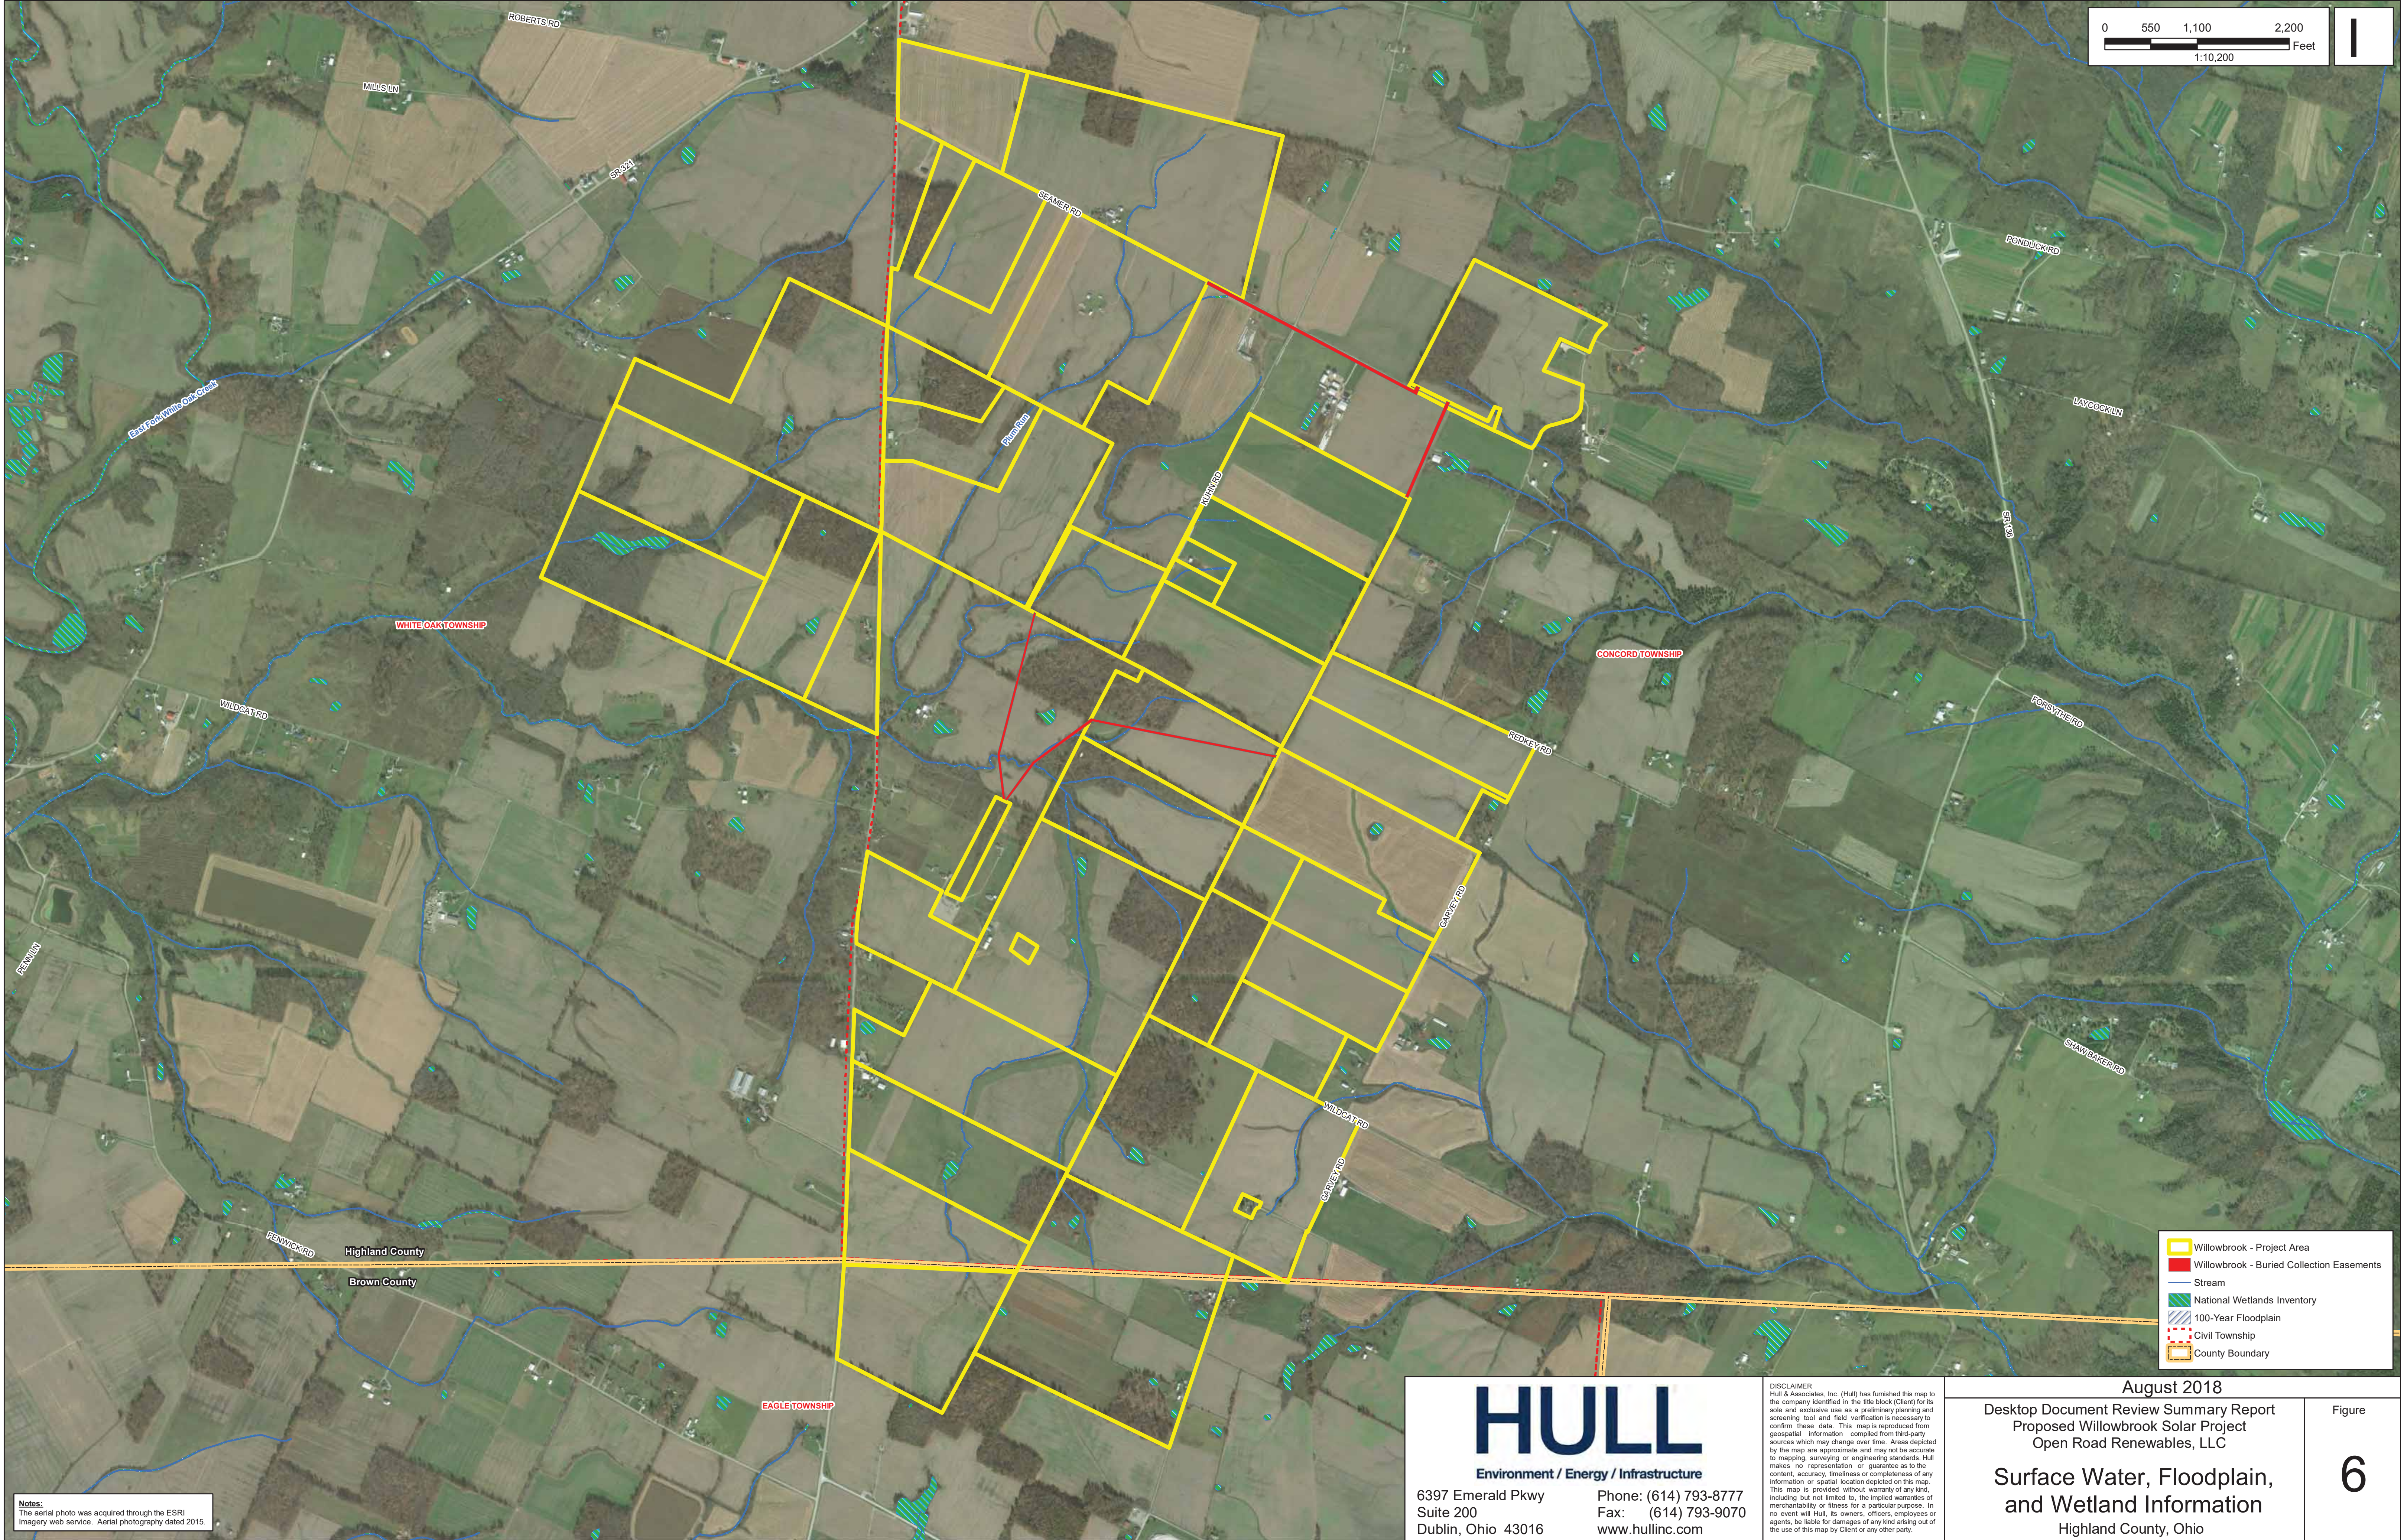
Figure 6 was prepared using information obtained from the ODNr and FEMA and shows that there are no 100-year floodplains located inside the Project Area or in the surrounding areas. Several small wetlands and streams registered with the National Wetlands Inventory are located in the western and southeastern portions of the Project Area.

Surface Water, Floodplain,
and Wetland Information
Highland County, Ohio

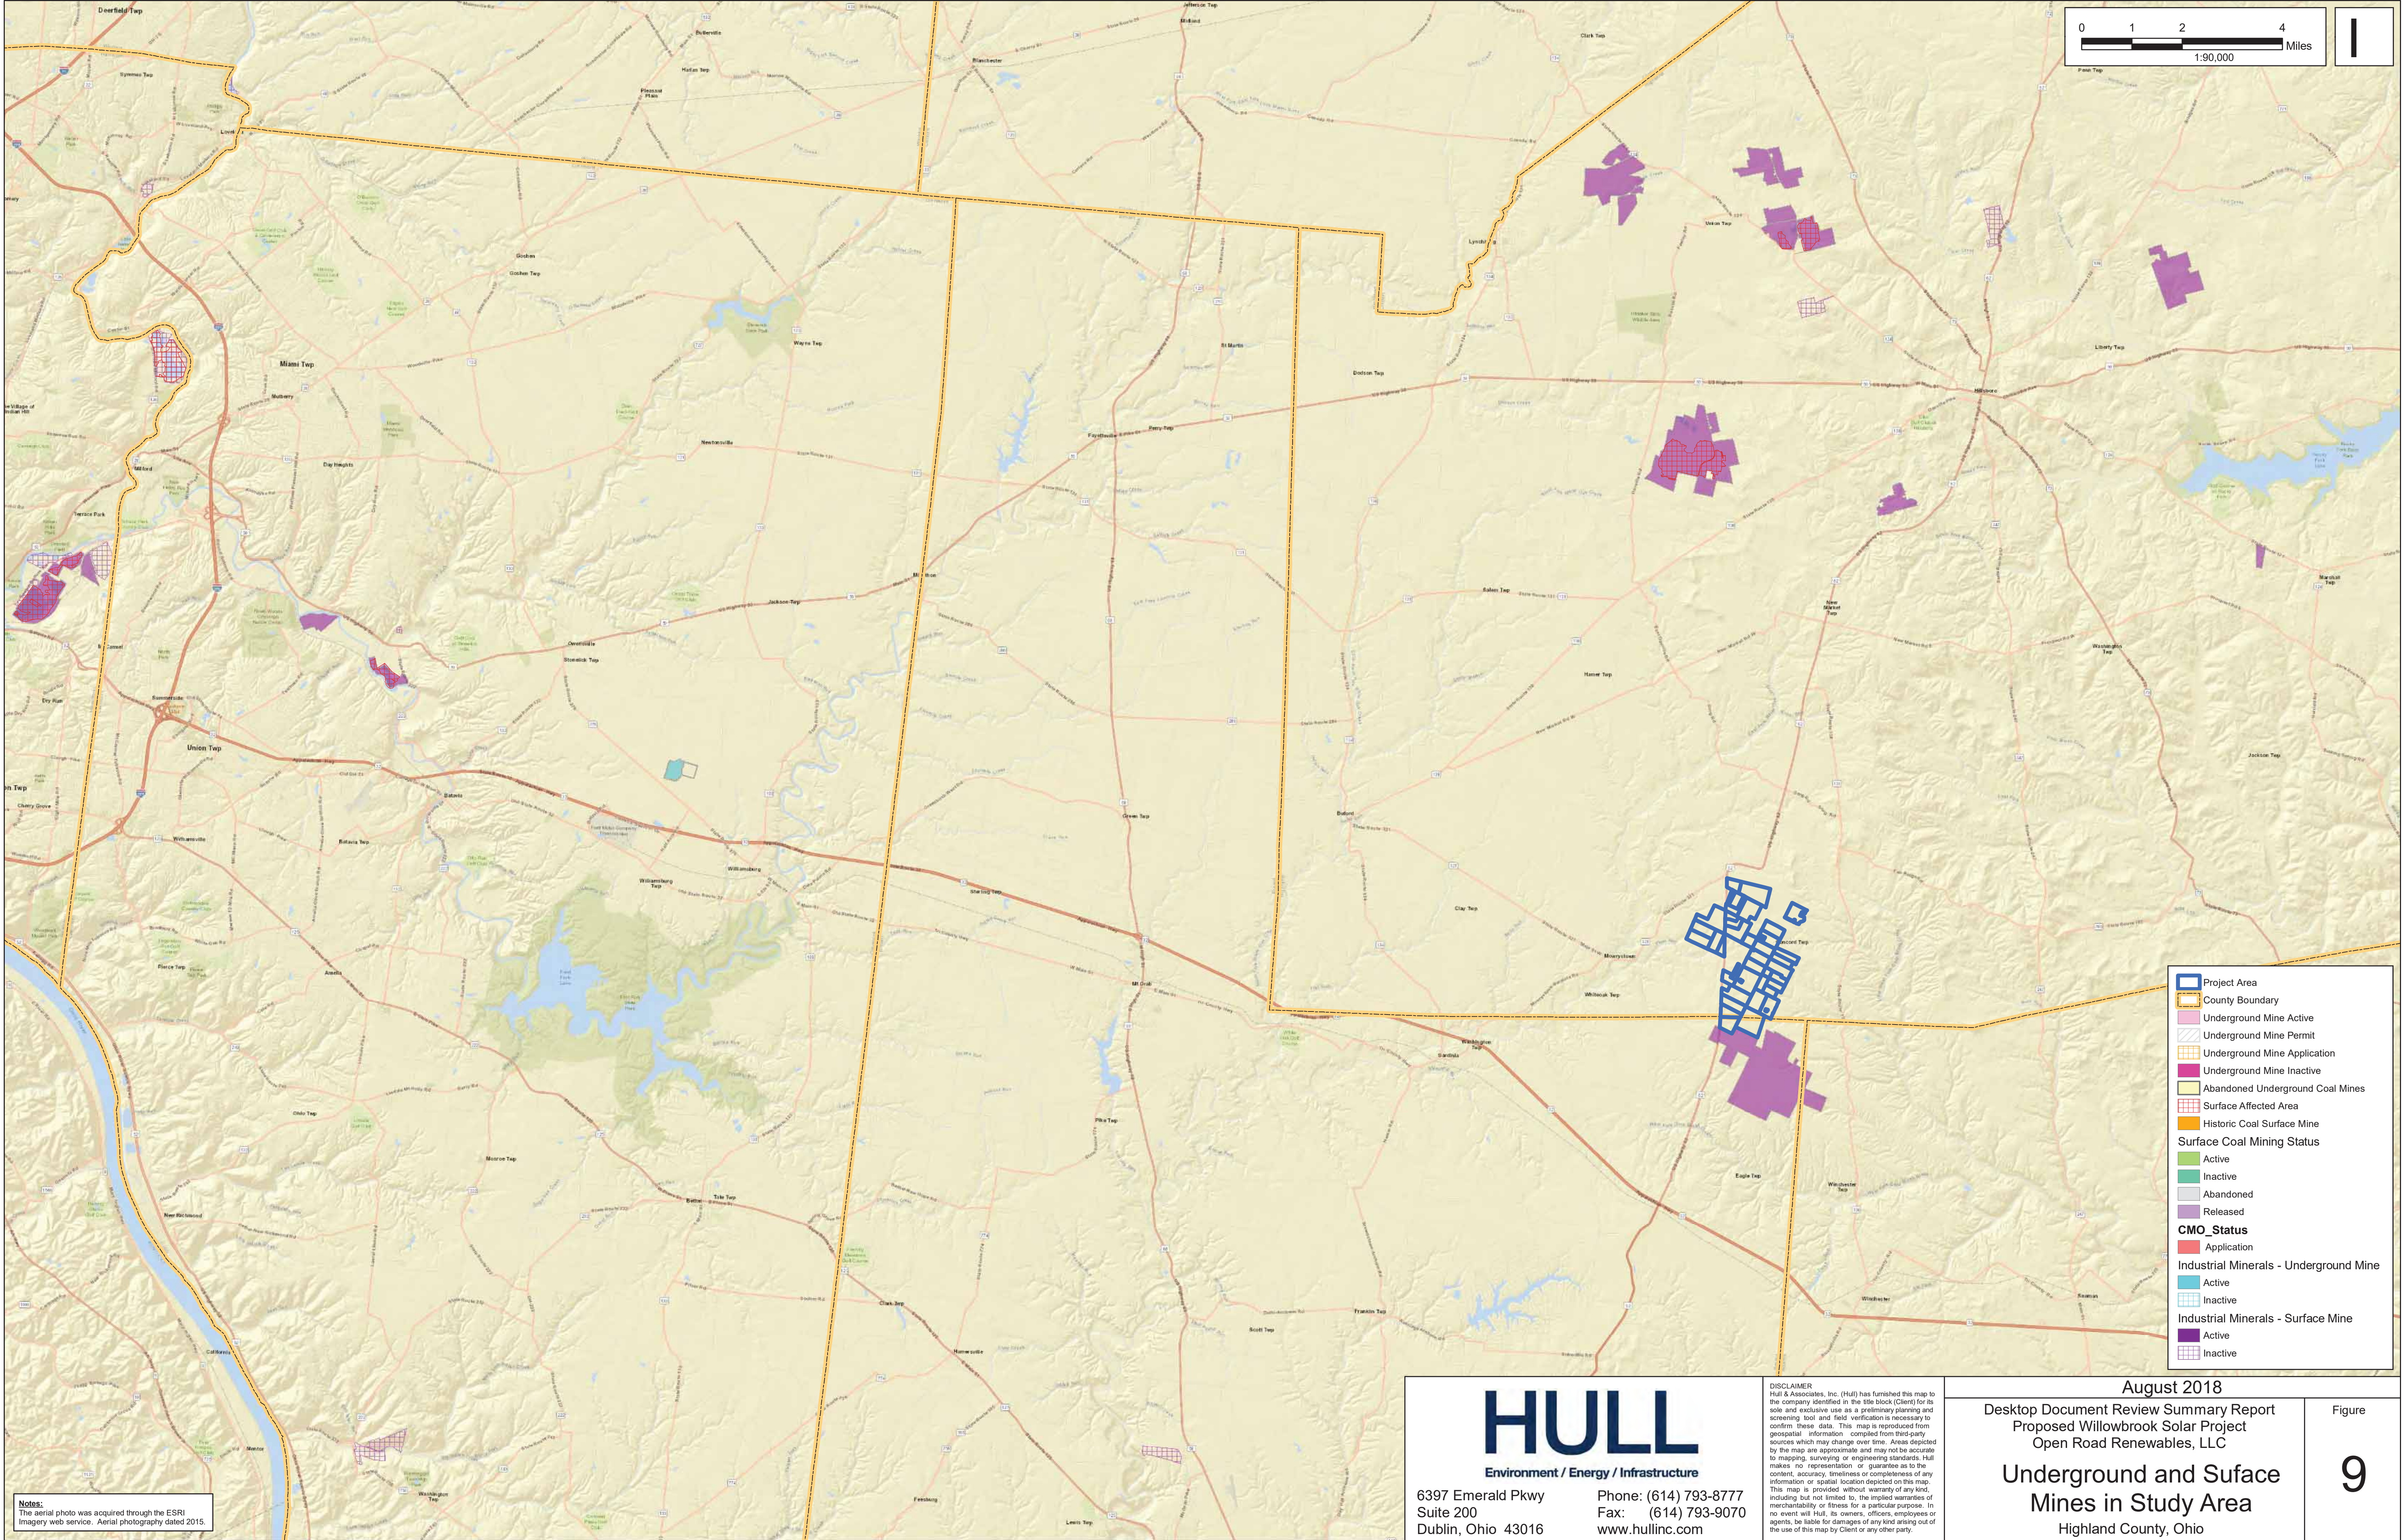
August 2018
Desktop Document Review Summary Report
Proposed Willowbrook Solar Project
Open Road Renewables, LLC
Soil Types
Highland County, Ohio

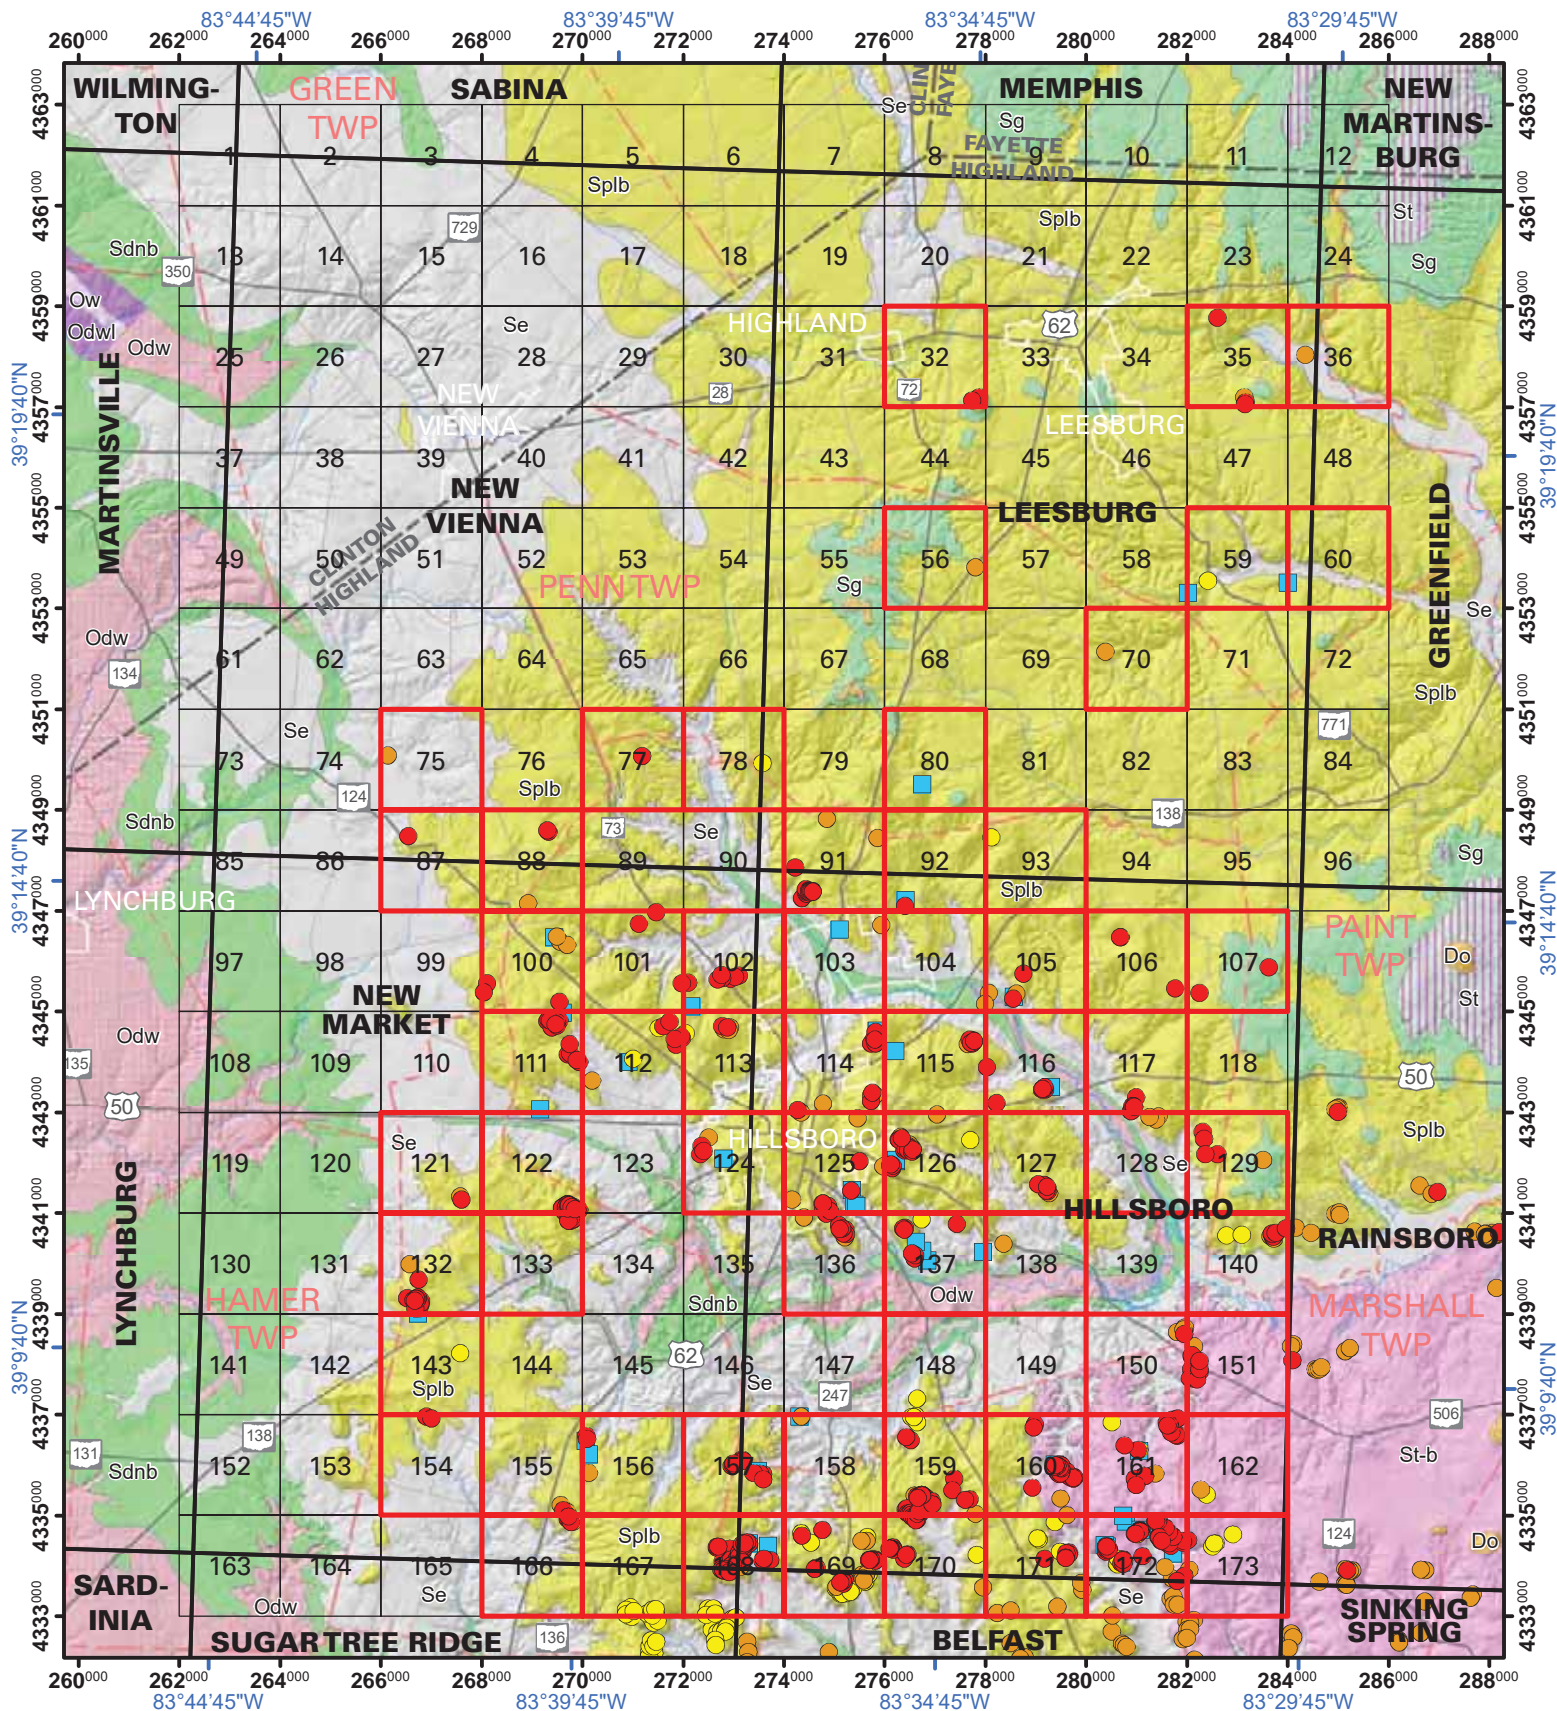
- Do Ohio and Olenangy Sh undivided
- St Tymochtee Dol
- Sg Greenfield Dol
- Splb Peebles Dol, Lilley Fm, Bisher Fm undivided
- St-b Tymochtee, Greenfield, & Peebles Dol, Lilley Fm, Bisher Fm undivided

- Se Estill Sh
- Sdnb Dayton Ls, Noland Fm, Brassfield Fm undivided
- Odwl Drakes, Whitewater, & Liberty Fm undivided
- Odw Drakes Fm & Waynesville Fm undivided
- Ow Waynesville Fm

The next overlay map is the Bedrock Geology map (p. 6). This map shows that the karst features are forming primarily by dissolution of Silurian-age rocks, namely the Peebles, Lilley, and Bisher Dolomites. In the Hillsboro region, most well-developed karst is expressed as steep-walled, cone-shaped depressions with active sinking and an active sink throat where water drains. It should be noted that according to this map, there are sinks on shale, which indicates that either the shale is very thin and the sinks are forming through it, or the bedrock map needs to be refined. There are also springs located on shale; this is to be expected since water percolating down through vuggy limestone is impeded by shale and moves horizontally until it reaches the land surface.

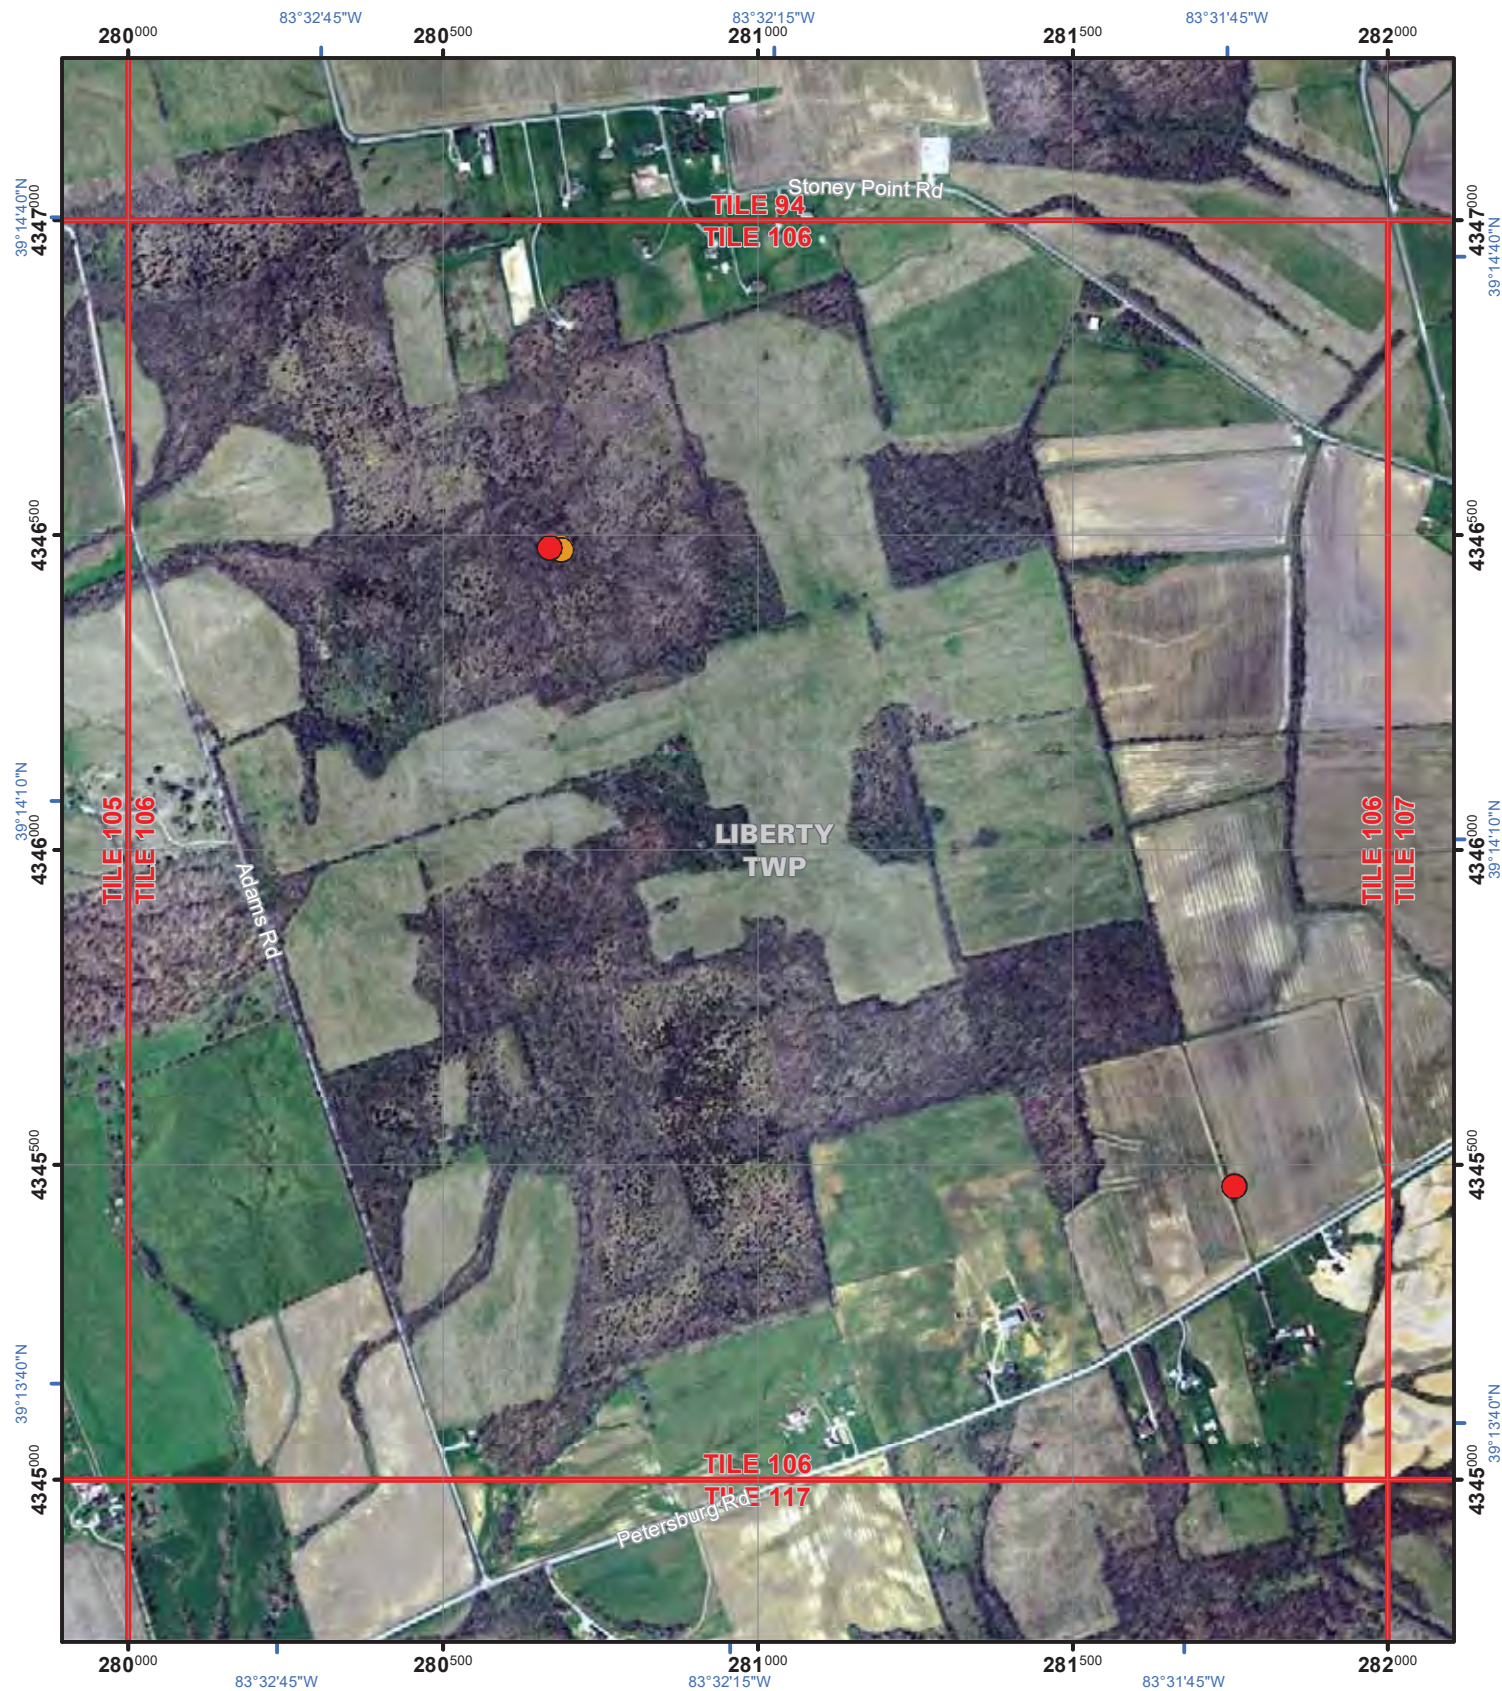
DEPRESSION
Depth in feet

- Yellow circles represent areas with suspect characteristics, such as a subtle LiDAR depression, a location where access to the property could not be gained, or where there was not enough time to field check the point.
- Blue squares represent springs, where water was found flowing from the subsurface.
