In the Matter of the Complaint of Citizens)	
Against Clear Cutting, <i>et al.</i> ,)	
)	
Complainants,)	
v.)	Case No. 17-2344-EL-CSS
)	
Duke Energy Ohio, Inc.,)	
)	
Respondent.)

DIRECT TESTIMONY OF

KEVIN MCLOUGHLIN

Transmission Facility Outages During the Northeast Snowstorm of October 29–30, 2011

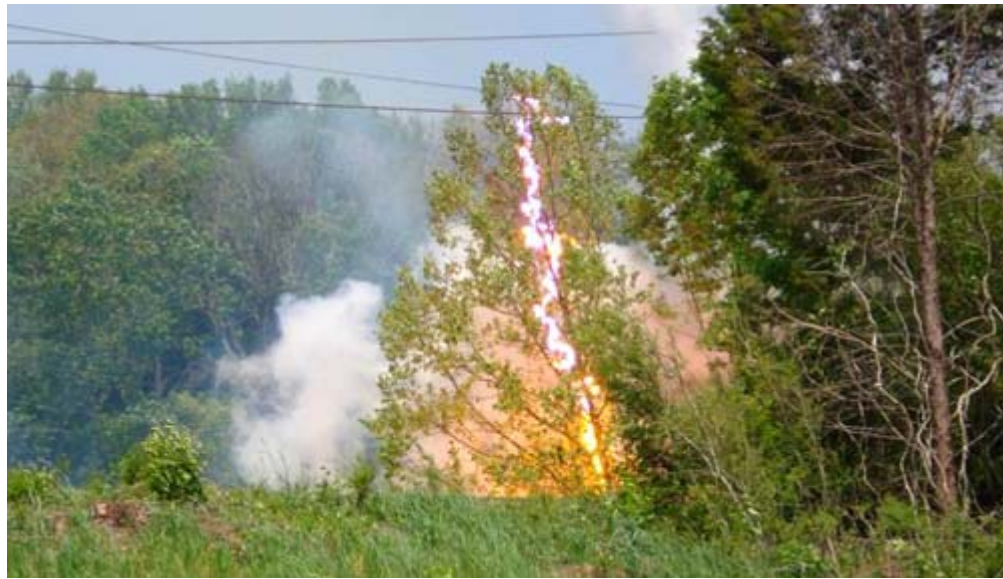
1 the potential for material damage and bodily injury. The photograph below
2 depicts such a flashover event whereby a line to ground fault is occurring via a
3 tree. Note that the energy being discharged is substantial and anybody in the
4 vicinity of such a flashover could be severely injured or killed.

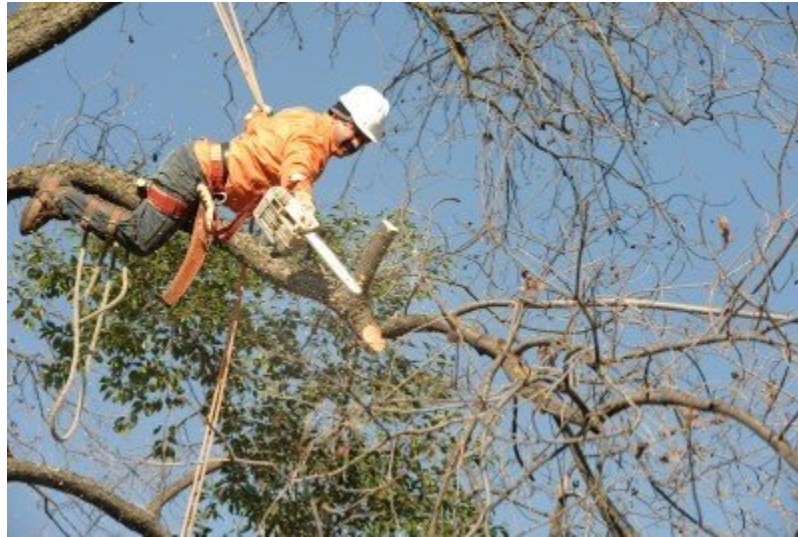
1 The next photograph shows the risks assumed by vegetation management
2 specialists when working on trees in close proximity to electric lines.

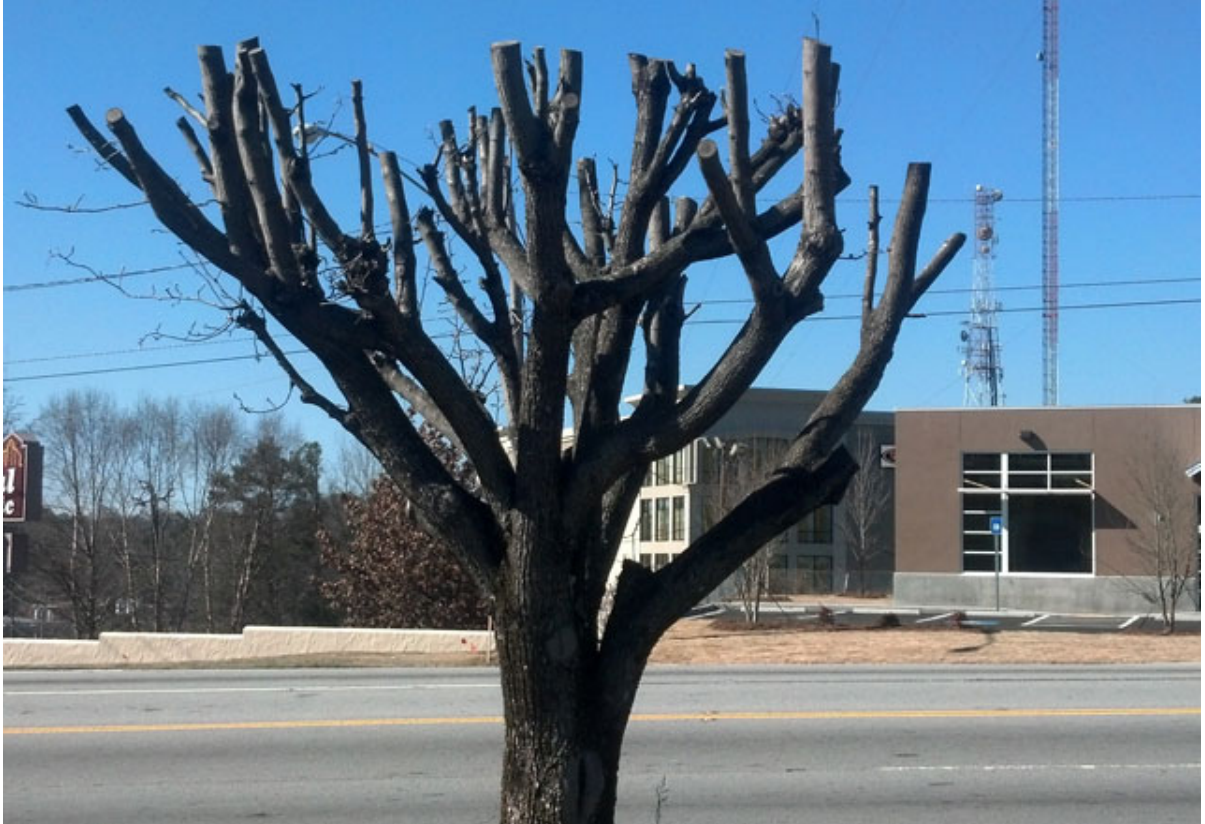
3 Additionally, a tree growing directly under the lines must be routinely and
4 frequently “topped” in a manner that most often results in a very deformed
5 appearance with numerous branches relentlessly growing up (sprouting) toward
6 the conductors. This topping effort is often euphemistically characterized as a
7 “crown reduction” endeavor by arborists. The shape of the tree crown after many
8 such “crown reductions” will tend to promote the growth of numerous vertical
9 stems which then expands the distance over which a flashover from the line will
10 be able to travel making a line to ground fault more inevitable. The photograph
11 below depicts one such tree that has been “topped” on more than one occasion.

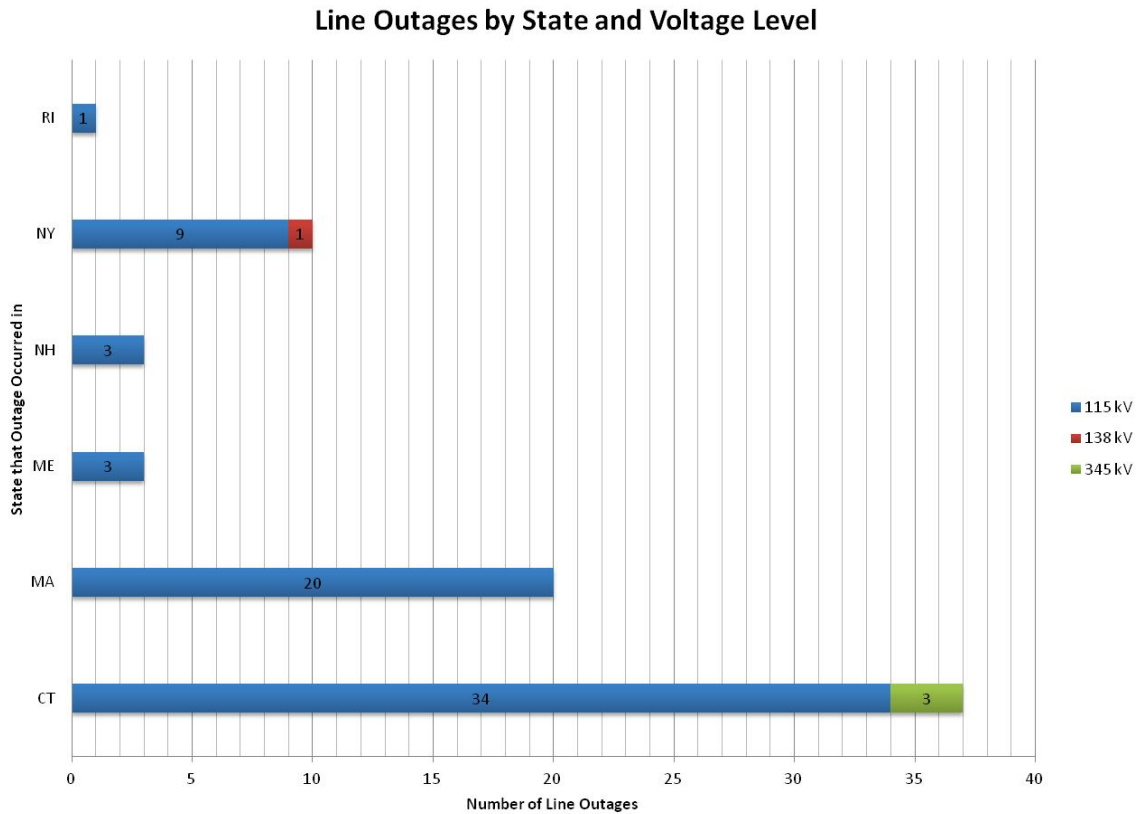
Figure 6: Transmission Line Outages by State and Voltage Level

A half-dozen states — Connecticut, Maine, Massachusetts, New Hampshire, New York, and Rhode Island — and ten utilities experienced transmission outages on lines they own, or co-own and maintain. Half of those outages occurred in just one state, Connecticut.⁵⁶ The chart below shows the number of outages by state.

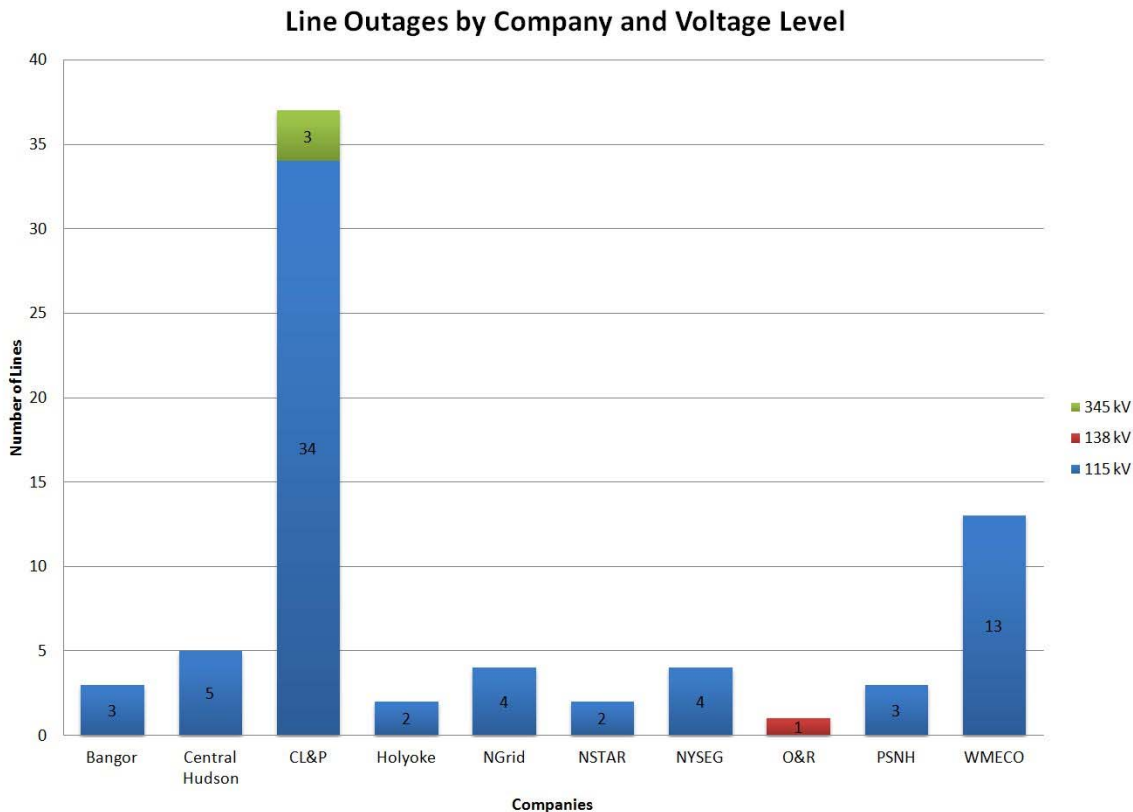
Figure 8: Line Outages by Company and Voltage Level⁵⁸

The service territories of CL&P and Western Massachusetts Electric Company (WMECO), two subsidiaries of Northeast Utilities (NU), largely cover this area. As shown in the chart below, these two companies had the most transmission line outages. A third NU subsidiary, Public Service of New Hampshire (PSNH), had an additional three transmission line outages. Overall, outages of facilities owned — or co-owned, operated, and maintained — by NU subsidiaries⁵⁷ accounted for fifty-four of the October storm’s seventy-four transmission line outages (approximately 74%).

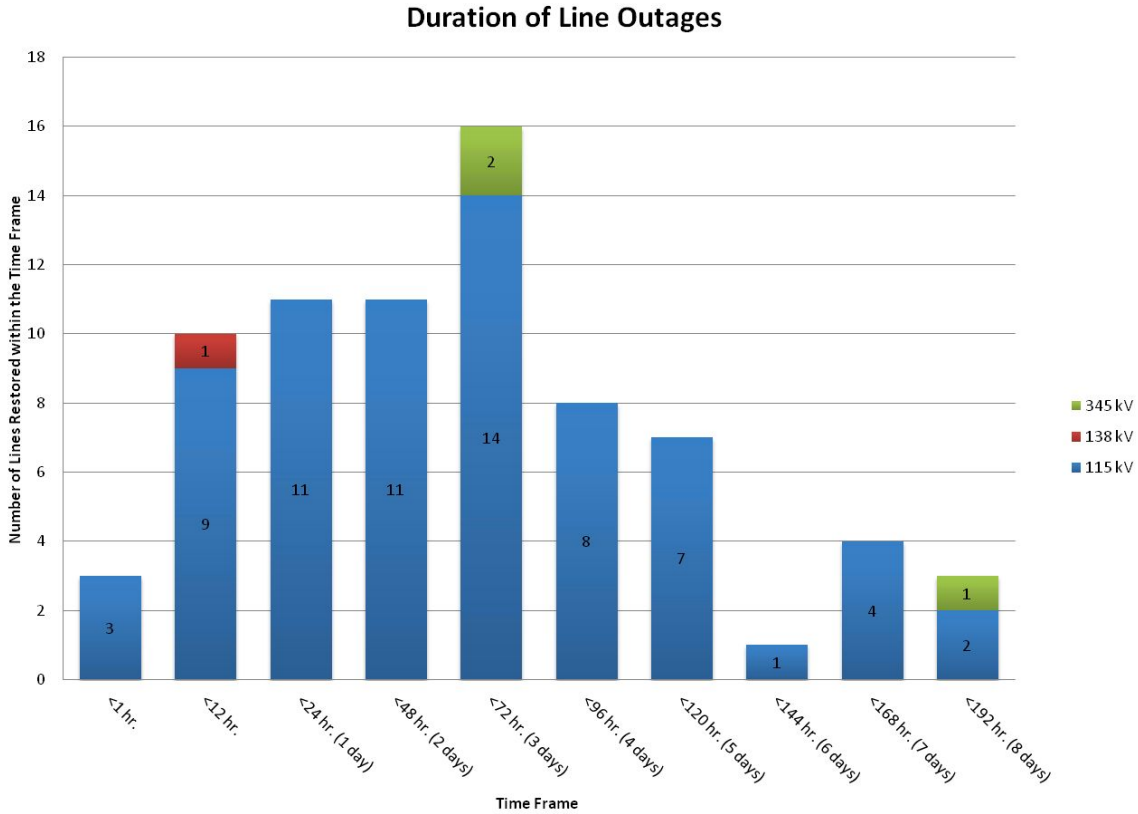
Figure 10: Duration of Transmission Line Outages

While most transmission facilities were restored relatively quickly, four were out of service for nearly a week, and an additional three remained out of service between seven and eight days. However, none of these seven transmission line outages resulted in customer outages or were, at that time, necessary for BPS stability. The following chart illustrates the duration of transmission line outages.

Utilities faced several physical obstacles in restoring the seven transmission lines that were out of service for six to eight days. Each of these lines or its supporting structures had significant structural damage that required rebuilding. For example, on five of these seven lines, falling trees snapped insulators, cross-arms, and various support structures. In addition, the site of the damage to the 345 kV line that was out of service for nearly eight days was particularly difficult to access. Again, no retail customers were without service due to these seven line outages.

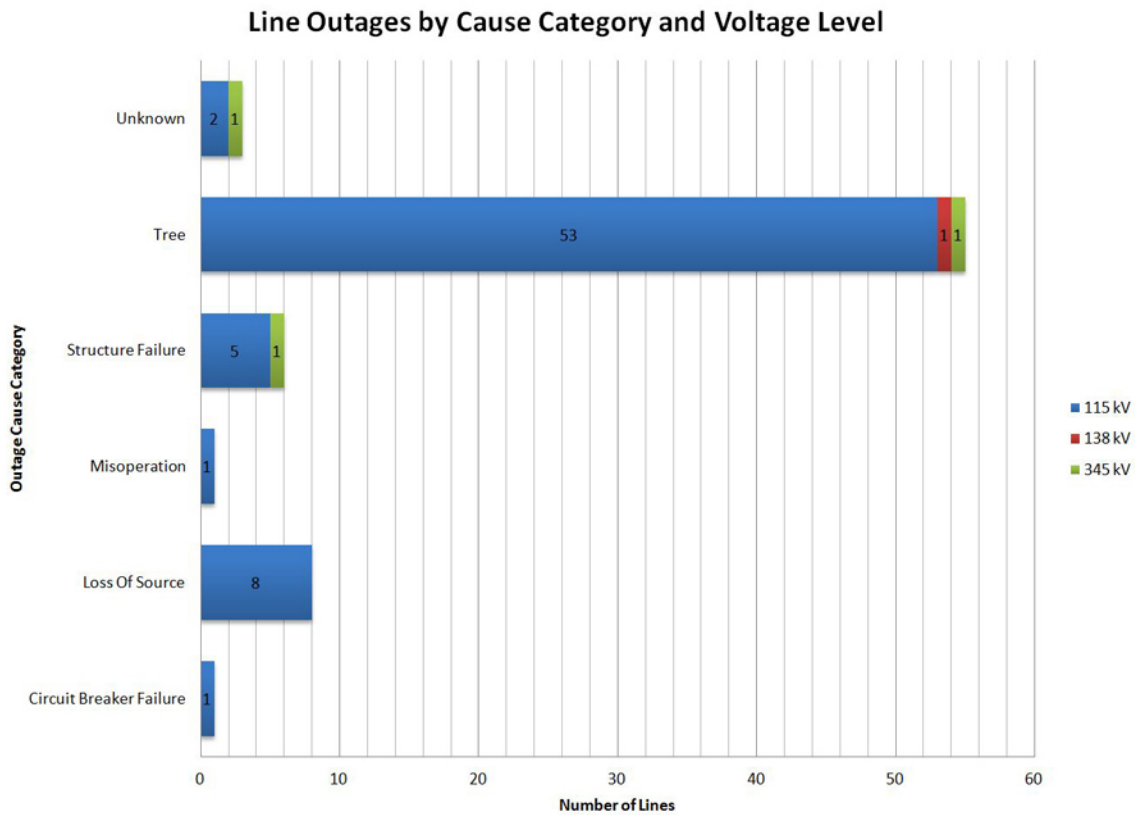
Figure 11: Line Outages by Cause Category and Voltage Level

As could be expected from a major snowstorm, the vast majority of transmission line outages during the October event were caused by tree contact or the accumulation of ice and heavy, wet snow on transmission conductors.⁶⁰ Other causes included losses of source⁶¹ and relay misoperation.
