**Re: Letter of Notification of Compliance for 6011 Greenwich  
Windpark, LLC, Case No. 13-990-EL-BGN**

In compliance with Condition No. 16 of the Board's Order, attached is a copy of the updated Shadow Flicker Report for Greenwich. This report considers the slight change in the project area layout, and updates the Shadow Flicker Report filed as Exhibit P to Greenwich's Application. The findings of the updated report do not differ from the previously filed Shadow Flicker Report (Exhibit P), which found:

Windlab Systems Pty Ltd carried out an assessment of the shadow flicker durations for houses surrounding the proposed Greenwich Wind Farm. On behalf of the Applicant, Windlab Systems Pty Ltd (Windlab) has prepared this report in satisfaction of the requirements set forth in Section 4906-17-08(A)(6) of the Ohio Administrative Code (OAC).

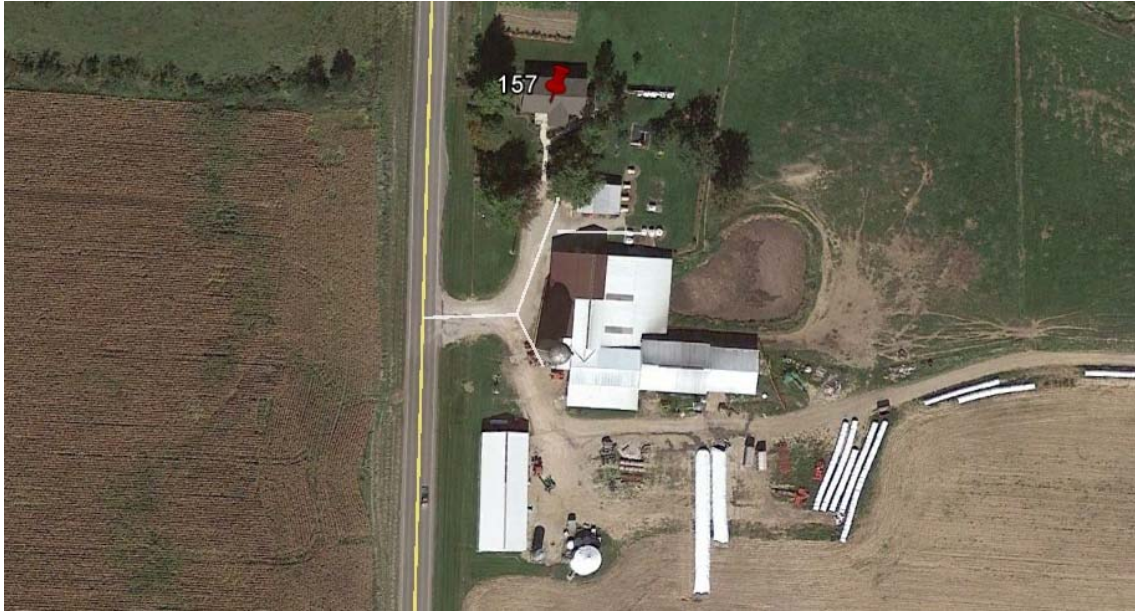
**Figure 4-2: Proximity of trees and buildings surrounding house 157 that potentially provide shielding from the shadow flicker of nearby turbines.**

- Trees surrounding the house and buildings located to the south would likely provide vegetative and structural screening from a number of turbine locations, see Figure 4-2 & Figure 4-3 below; and

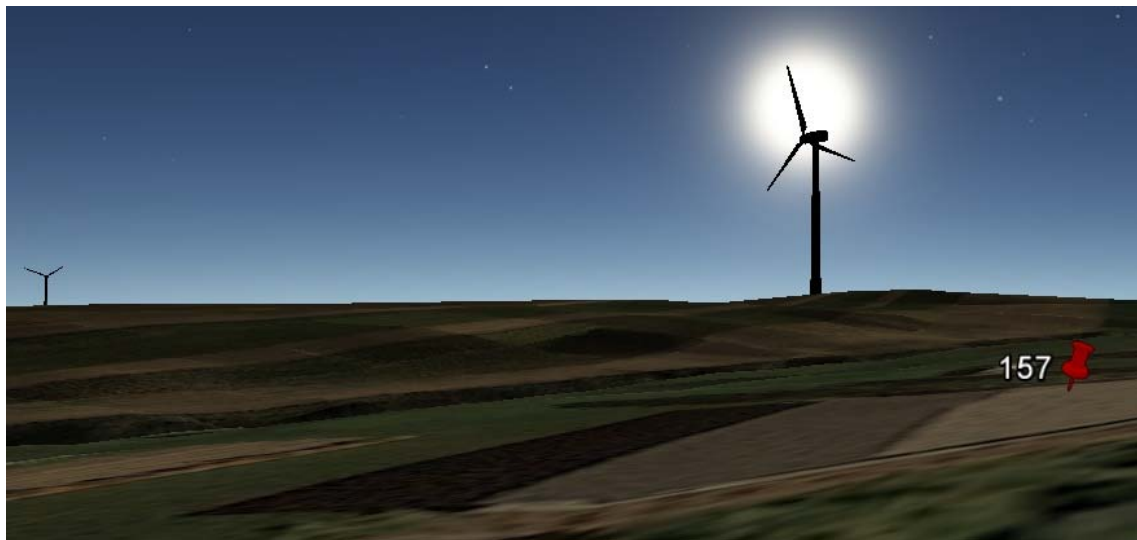
Figure 4-6: WTG 12 relative to house 157 on the morning of July 25.

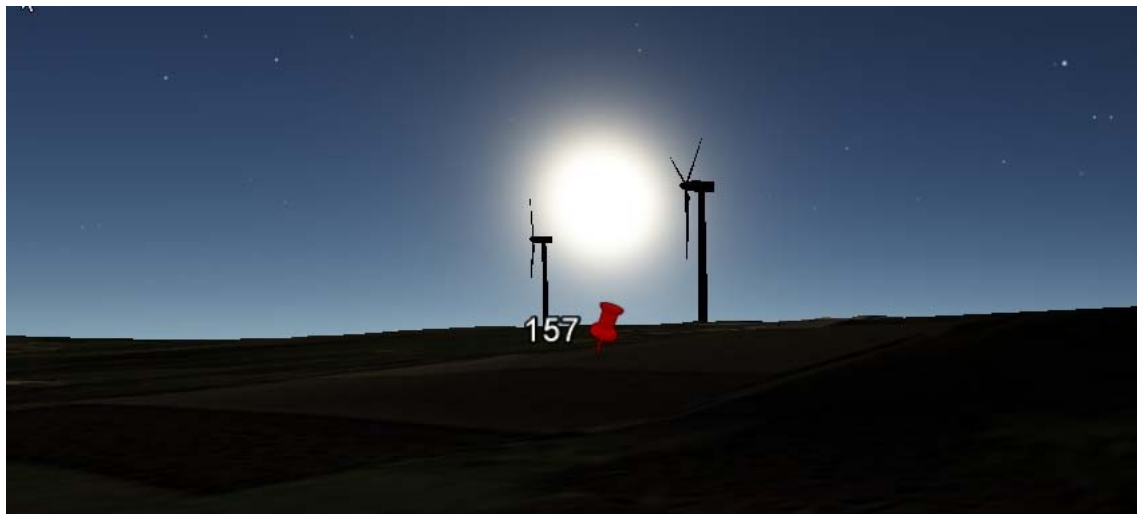
Figure 4-7: WTG 11 and 13 relative to house 157 on the morning of Dec 21.

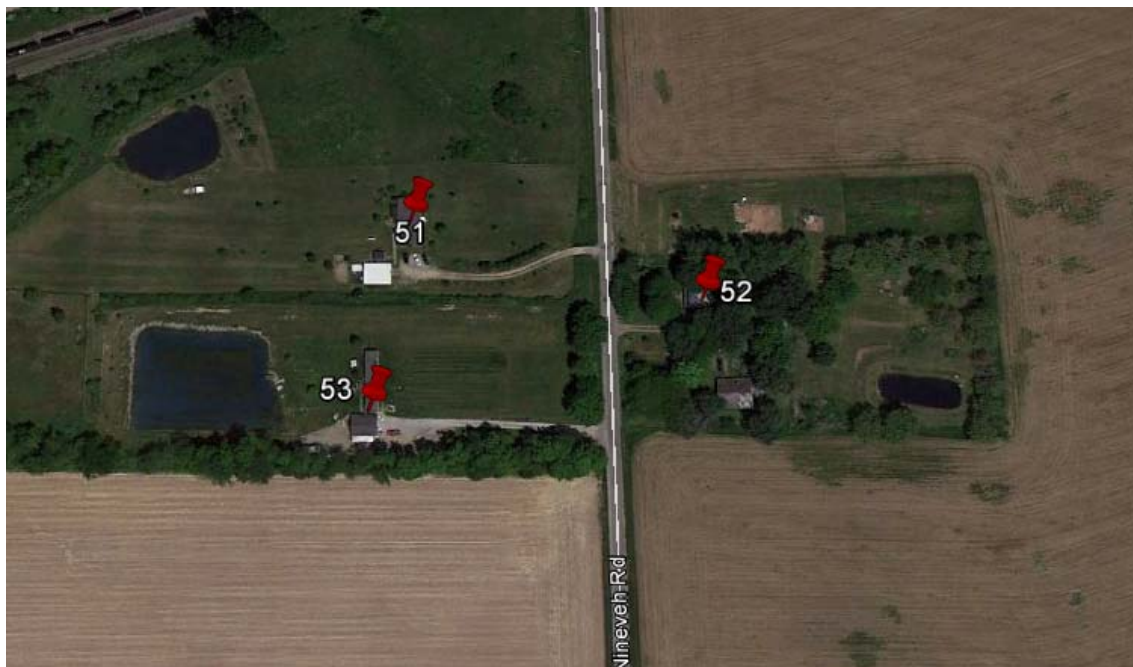
**Figure 4-9: Proximity of trees and buildings surrounding house 53 that potentially provide shielding from the shadow flicker of nearby turbines.**

- Some double counting of shadow flicker due to the two turbines at a bearing of ~235 degrees (WTG 19 and 21) on/or around the December Solstice;
- A number of trees, tree lines, and dense woodlands (approx 50ft high) surrounding the house to the east and south would likely provide vegetative screening from the turbine locations at the bearings of 89 and 235 degrees, see Figures 4-9 & 4-10 below; and
- The location of windows and doors in the house was not considered in the analysis.

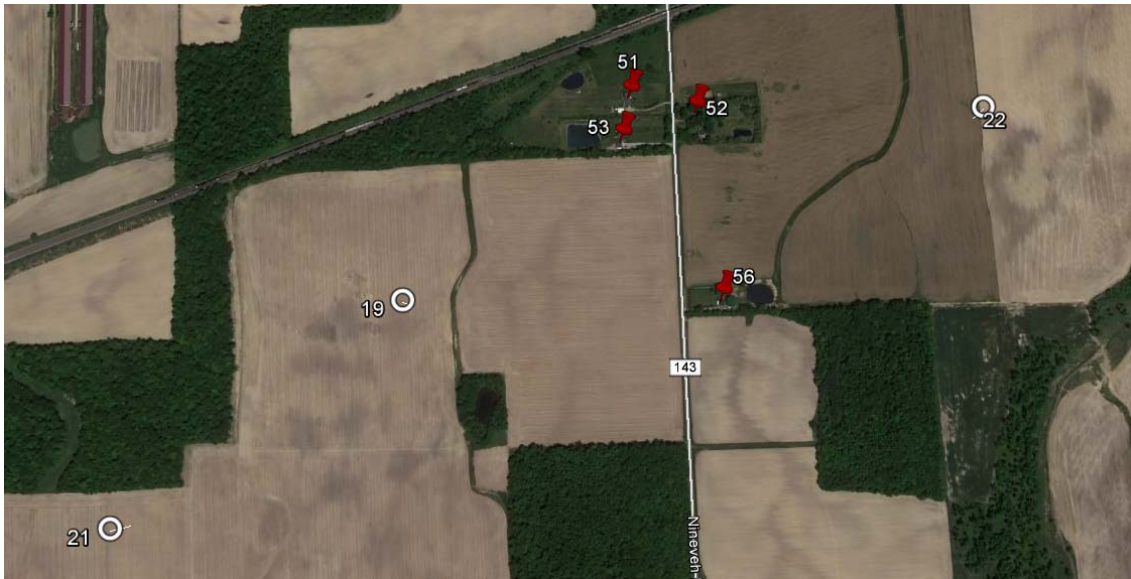
**Figure 4-11: Relative location of turbines 19, 21 & 22 which are modeled to potentially cause shadow flicker at house 53.**

House 53 is predicted to experience 42.6 hours of shadow flicker throughout the year, the worst day being the 16<sup>th</sup> of January where the house is subjected to a total of 20 minutes of shadow flicker. The shadow flicker is a result of turbine numbers 19, 21 and 22 at approximately 234, 235 and 89 degrees respectively from the house location. Actual shadow flicker experienced at this location is expected to be less than modeled, due to a number of factors:

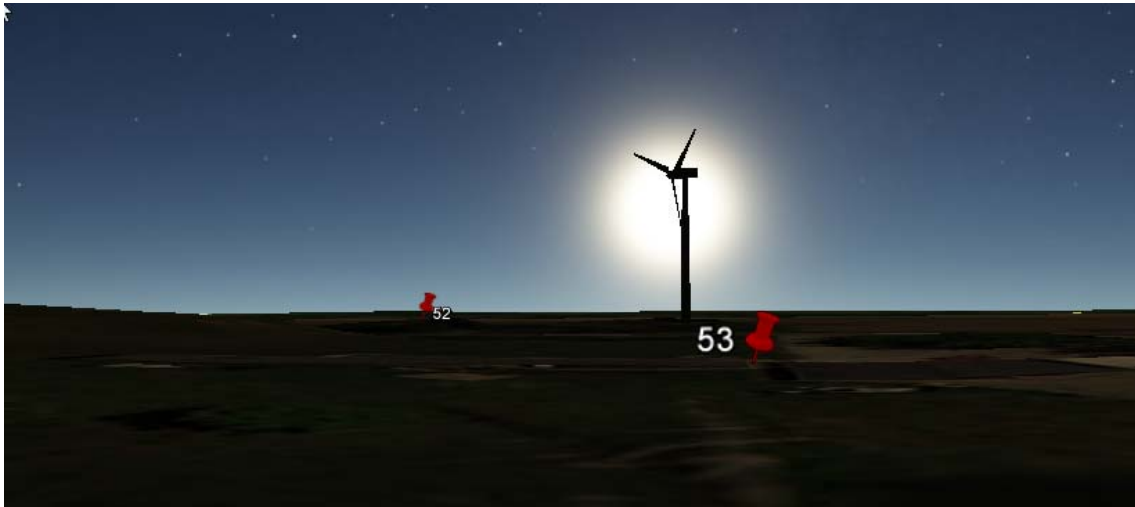
Figure 4-12: WTG 22 relative to house 53 on the morning of September 10.

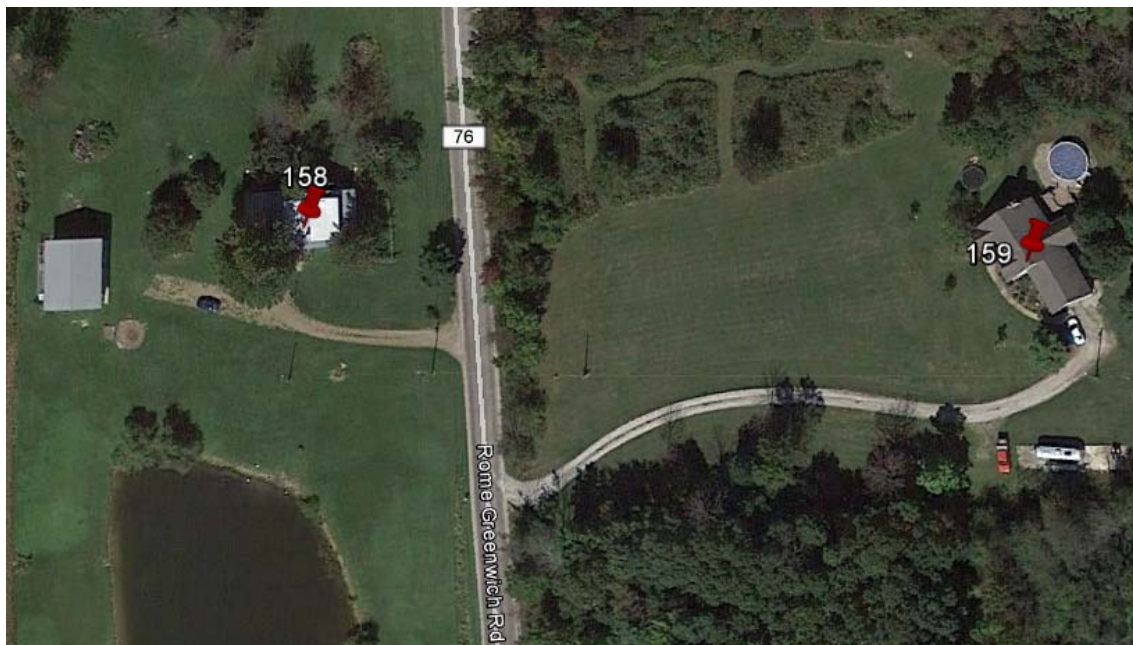
**Figure 4-15: Surrounding trees and buildings would potentially provide shielding for house 158 from the shadow flicker of nearby turbines.**

- There is dense woodland approximately 50ft in height surrounding the eastern and western side of the house that may potentially screen the shadow flicker from turbines 1, 6 and 10, see Figure 4-15 & 16 below; and
- The location of windows and doors in the house was not considered in the analysis.

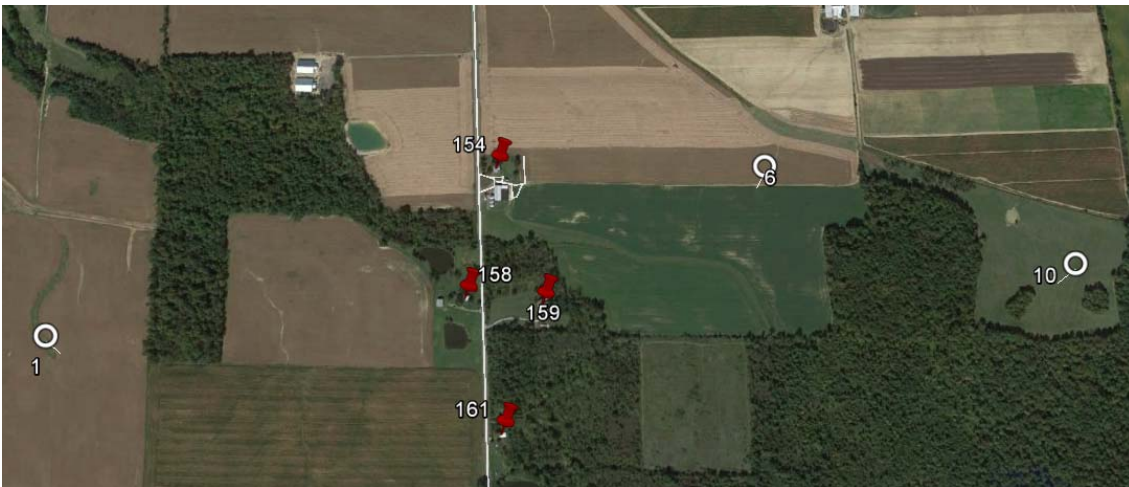
**Figure 4-17: Relative location of turbines 1, 6 & 10 which are modeled to potentially cause shadow flicker at house 158.**

House 158 is predicted to experience 41.4 hours of shadow flicker throughout the year, the worst day being the 14<sup>th</sup> of July where the house is subjected to a total of 23 minutes of shadow flicker. The shadow flicker is a result of turbine numbers 1, 6 and 10 at approximately 263, 69 and 89 degrees respectively from the house location. Two other turbines are within 1,170m; however, they do not cause any shadow flicker. Actual shadow flicker experienced at this location is expected to be less than modeled, due to a number of factors:

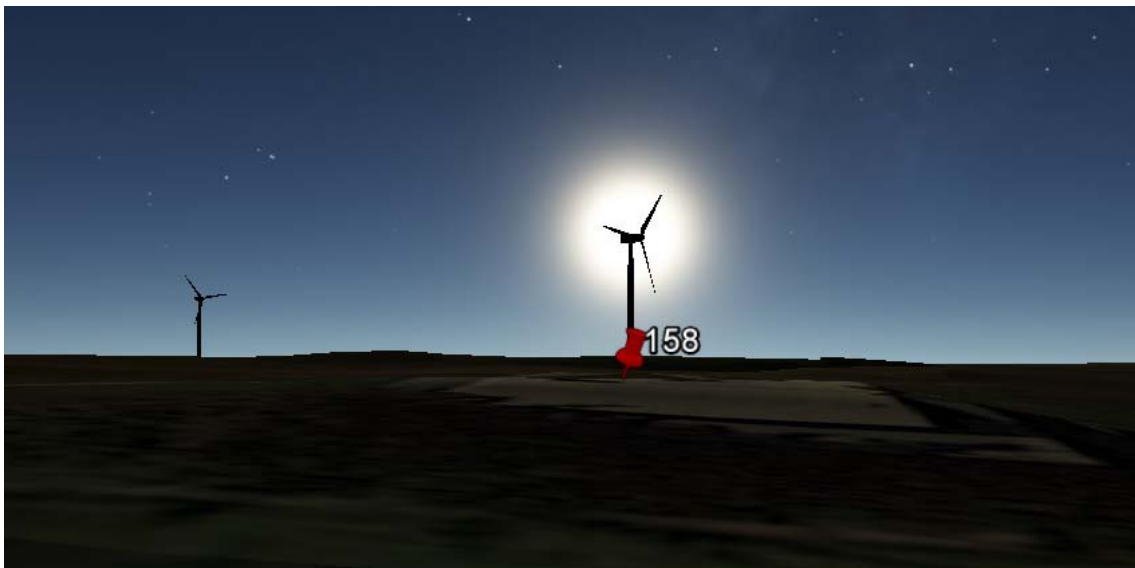
**Figure 4-19: WTG 1 relative to house 158 during the late afternoon of March 15.**

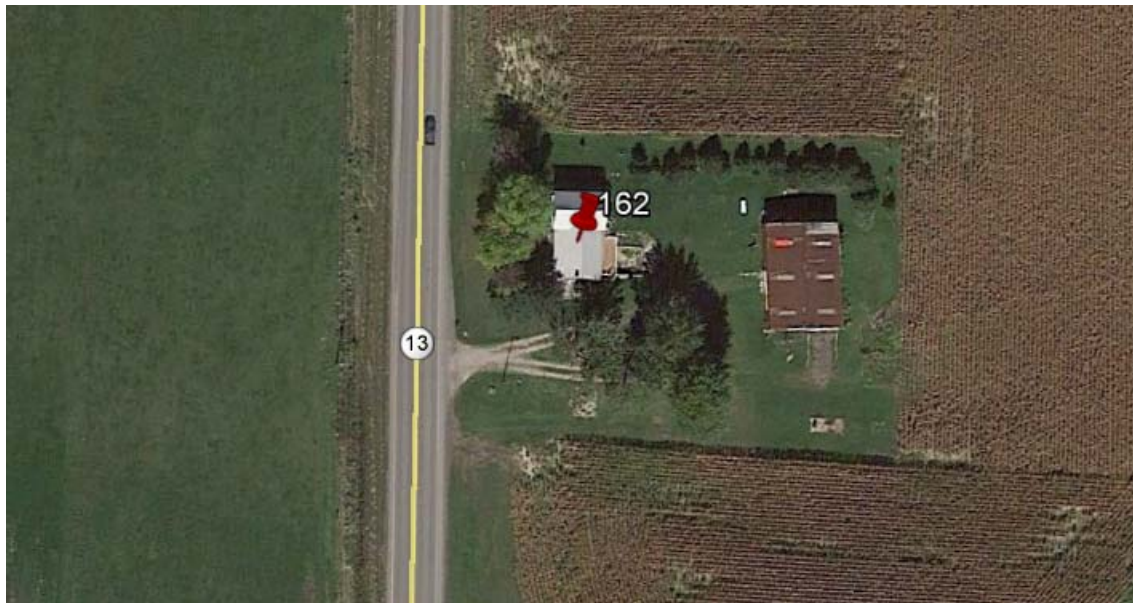
**Figure 4-21: Proximity of trees, and the barn to the east of house 162 that may provide shielding from the shadow flicker of nearby turbines.**

- Trees immediately surrounding the house may provide some vegetative screening;
- A building/barn located 25m east of the house may provide structural screening from the flickering from turbines 11 & 13, see Figure 4-21 & 22 below; and
- The location of windows and doors in the house was not considered in the analysis.

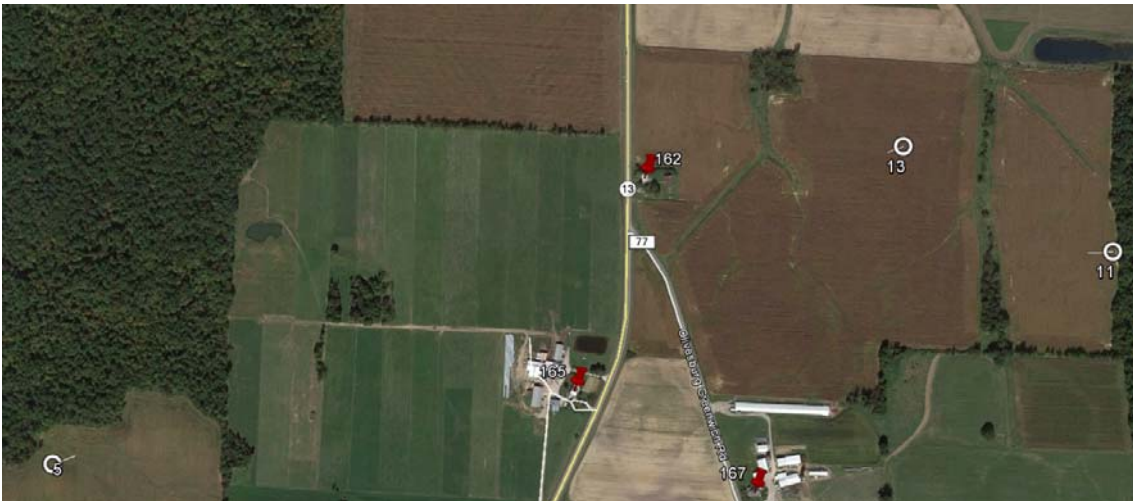
**Figure 4-23: Relative location of turbines 5, 11 and 13 which are modeled to potentially cause shadow flicker at house 162.**

House 162 is predicted to experience 41 hours of shadow flicker throughout the year, the worst day being the 19<sup>th</sup> of August where the house is subjected to a total of 29 minutes of shadow flicker. The shadow flicker is a result of turbine numbers 5, 11 and 13 at approximately 242, 98 and 83 degrees respectively from the house location. Two other turbines are within 1,170m; however they will not cause any shadow flicker. Actual shadow flicker experienced at this location is expected to be less than modeled, due to a number of factors:

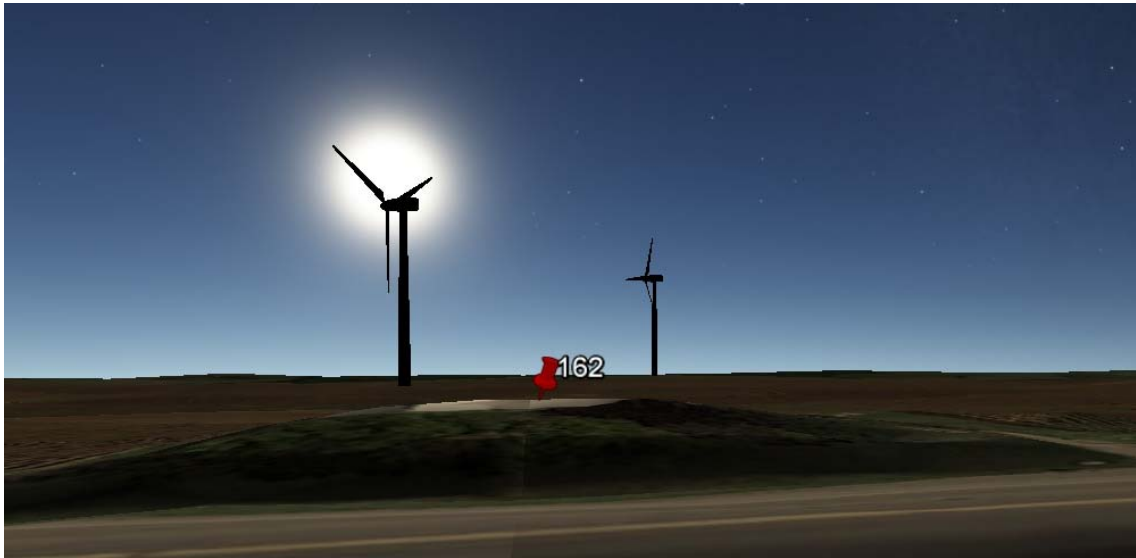
**Figure 4-24: WTG 13 relative to house 162 during the morning of August 19. WTG 11 is also visible on the right.**

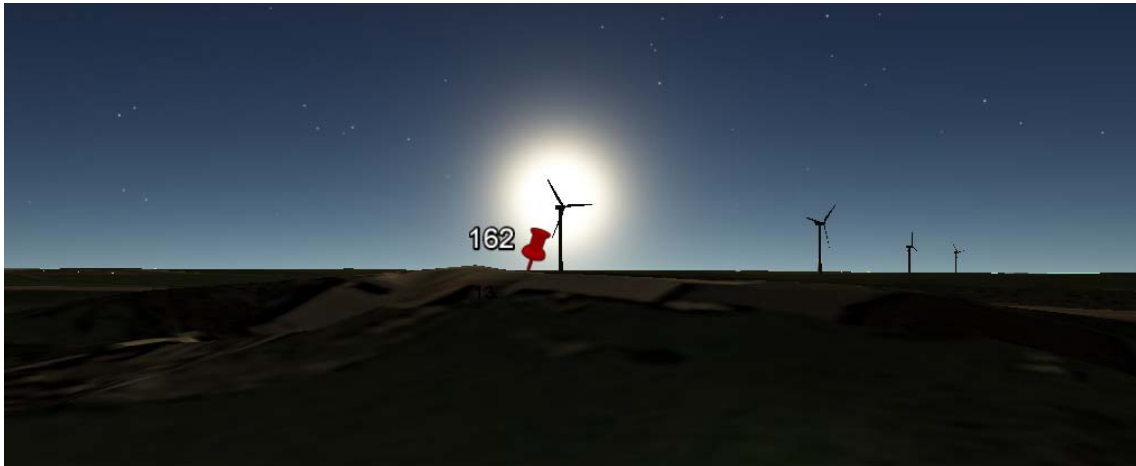
**Figure 4-25: WTG 5 relative to house 162 during the evening of November 13. Other turbines visible in this image are further than 1170m away, and therefore would not subject house 162 to shadow flicker.**

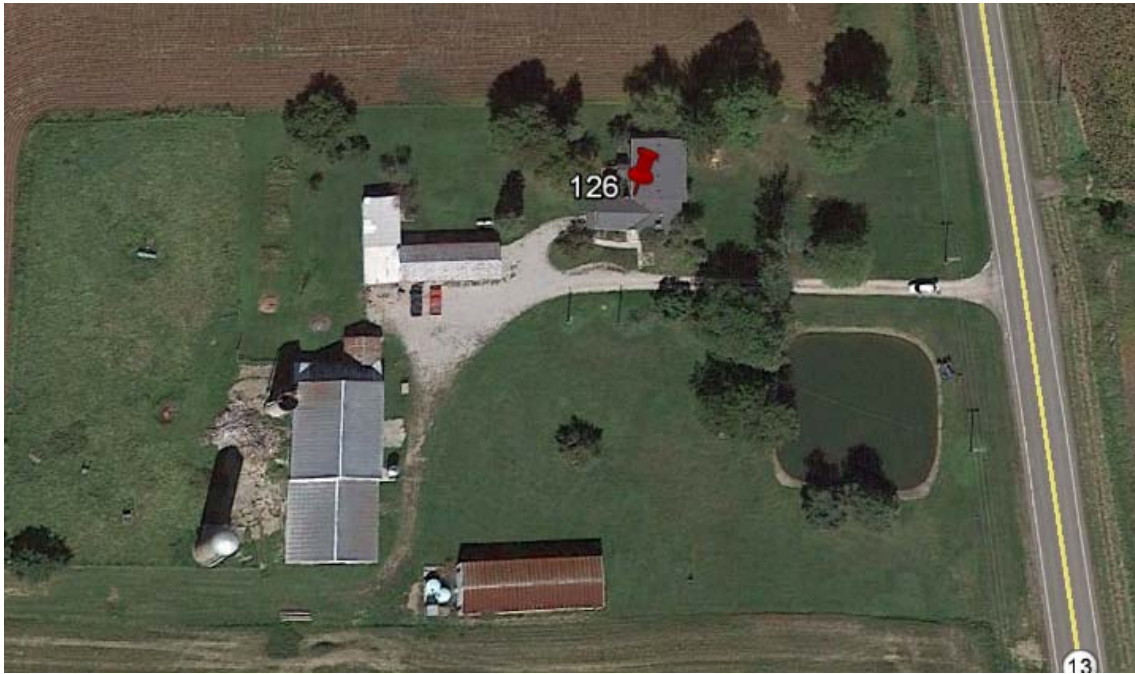
**Figure 4-27: Proximity of trees and buildings surrounding house 126 that potentially provide shielding from the shadow flicker of nearby turbines.**

- A number of trees and buildings surrounding the house would likely provide vegetative and structural screening from turbines 7, 9 & 15, see Figure 4-27 & 28 below; and
- The location of windows and doors in the house was not considered in the analysis.

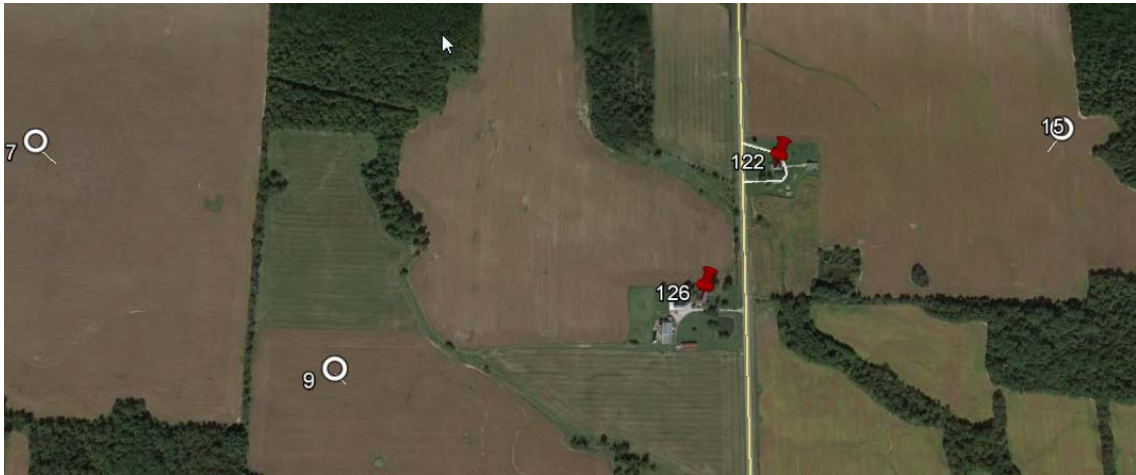
**Figure 4-29: Location of WTGs 7, 9 & 15 which are modeled to potentially cause shadow flicker at house 126.**

House 126 is predicted to experience 34.7 hours of shadow flicker throughout the year, the worst day being the 22<sup>nd</sup> of June where the house is subjected to a total of 20 minutes of shadow flicker. The majority of the shadow flicker is a result of turbine number 15, at approximately 65 degrees from the house location, and from turbine 9 at an angle of approximately 255 degrees. A small amount of flicker may result from turbine 7 at a bearing of 281 degrees. Actual shadow flicker experienced at this location is expected to be less than modeled, due to a number of factors:

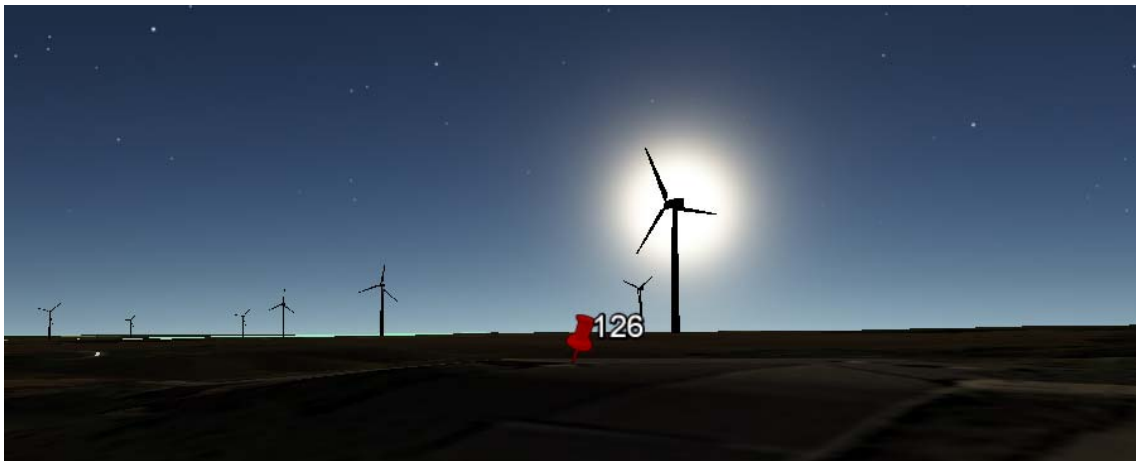
**Figure 4-30: WTG 15 on the morning of June 22 relative to house 126. Note that turbines in the background are further than 1170m and therefore would not subject house 126 to shadow flicker.**

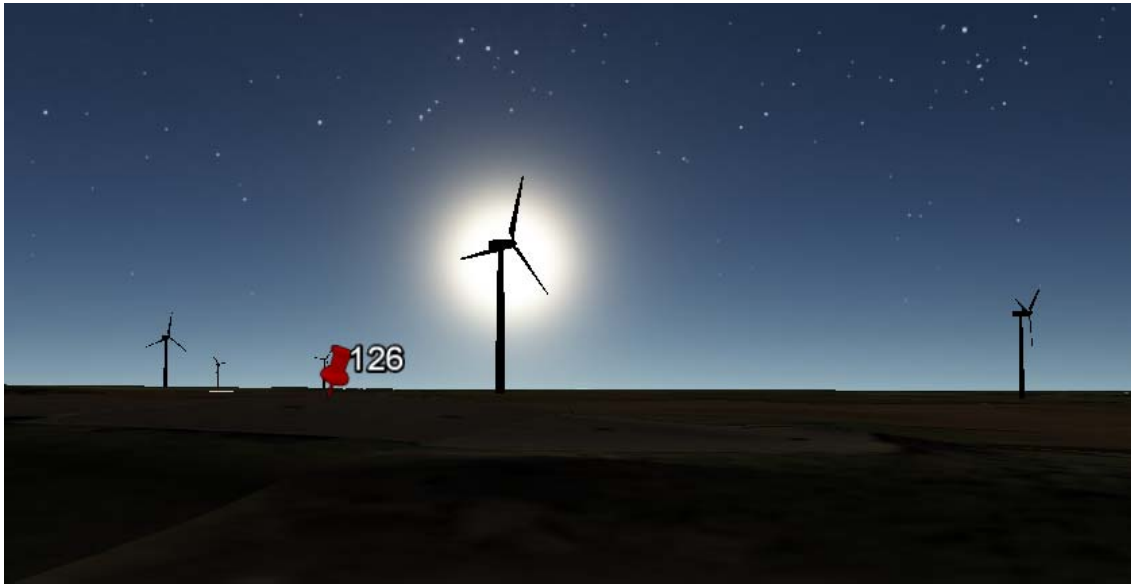
**Figure 4-31: WTG 9 on the evening of Oct 12 relative to house 126. WTG 7 is also visible on the far right. Note that the other turbines in the background are further than 1170m and would therefore not subject house 126 to shadow flicker.**

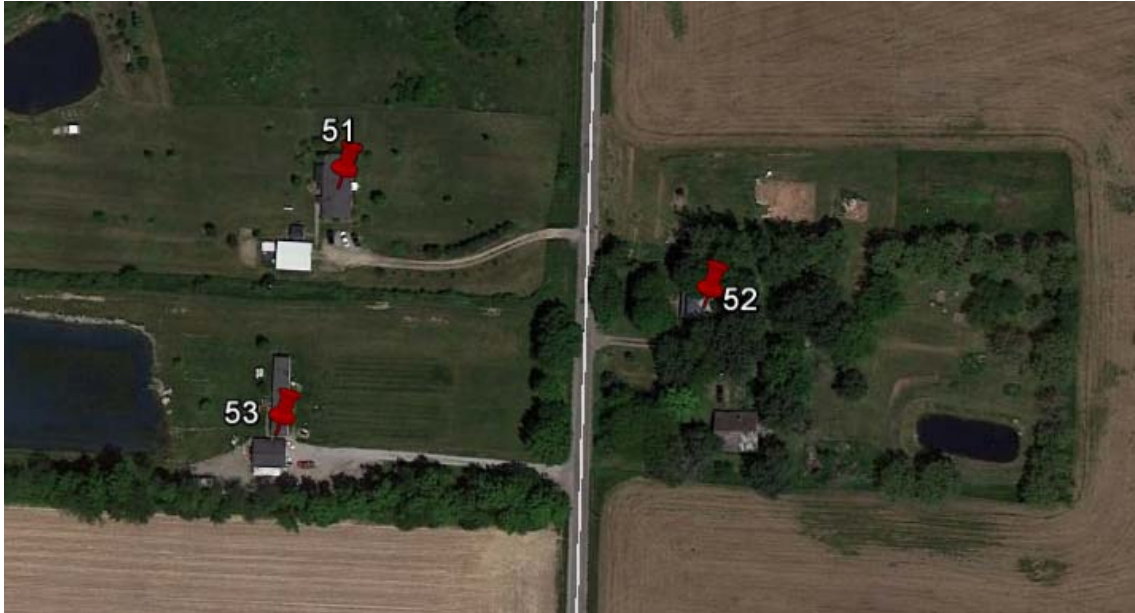
**Figure 4-33: Proximity of trees and buildings surrounding house 52 that may provide shielding from the shadow flicker of nearby turbines.**

- A number of trees and woodlands (approx 50ft high) surrounding the house would likely provide vegetative screening from turbine locations at the bearings of 94 and ~238 degrees, see Figure 4-32 & 33 below; and
- The location of windows and doors in the house was not considered in the analysis.

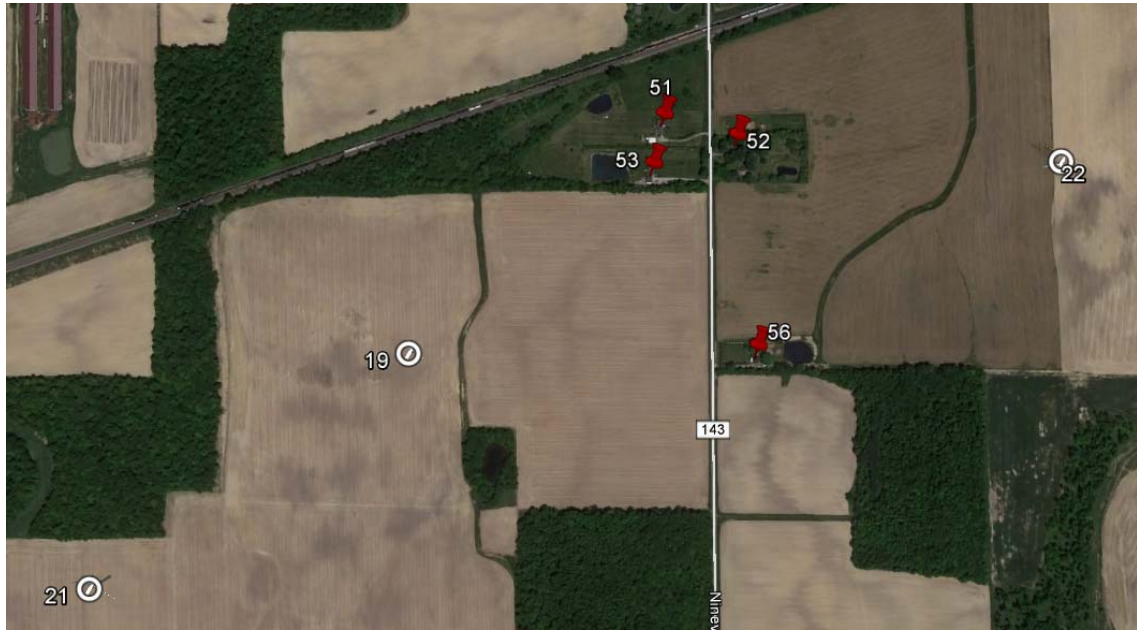
**Figure 4-35: Relative location of WTGs 19, 21 & 22 which are modeled to potentially cause shadow flicker at house 52.**

House 52 is predicted to experience 34 hours of shadow flicker throughout the year, the worst day being the 15<sup>th</sup> of September where the house is subjected to a total of 22 minutes of shadow flicker. The shadow flicker is a result of turbine numbers 19, 21 and 22 at approximately 238, 237 and 94 degrees respectively from the house location. Actual shadow flicker experienced at this location is expected to be less than modeled, due to a number of factors:

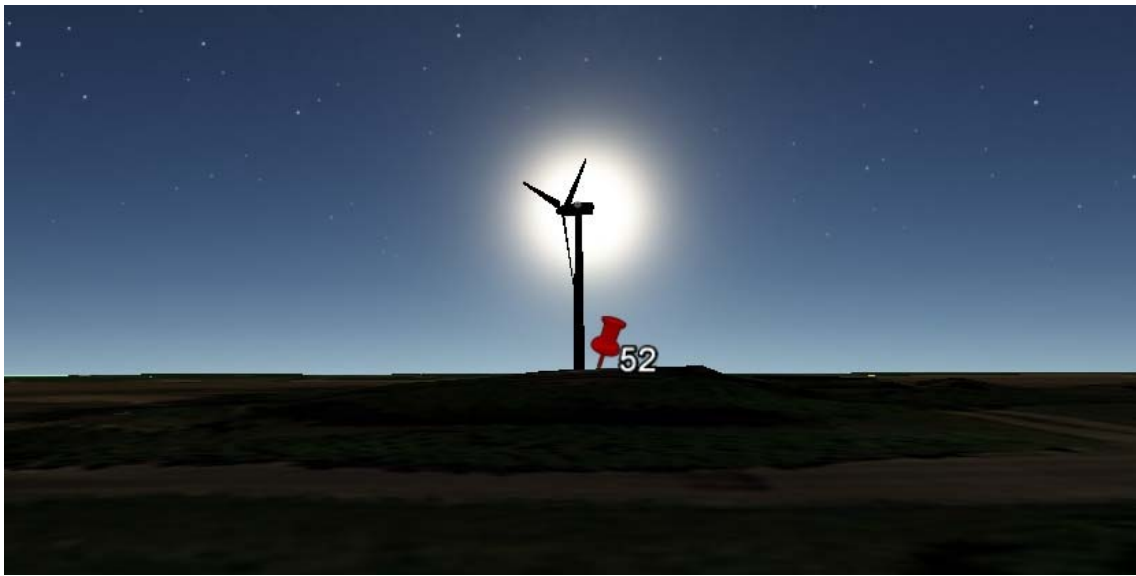
**Figure 4-36: WTG 22 relative to house 52 on the morning of September 15. Significant woodlands located between house 52 and WTG 22 would likely screen much of the shadow flicker.**

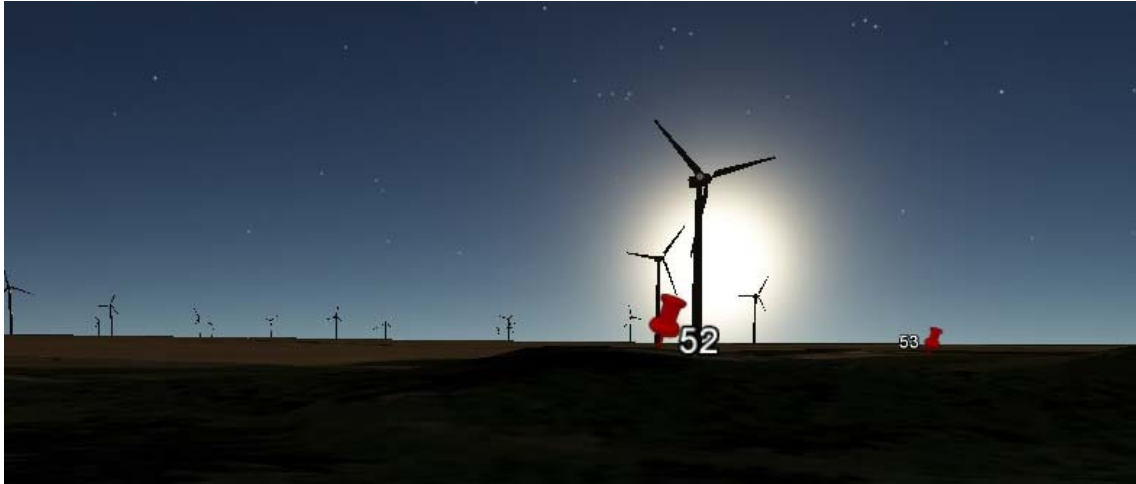
**Figure 4-37: WTGs 19 and 21 relative to house 52 during the evening of January 16. Woodlands located between the house and turbine that would likely screen much of the shadow flicker. Note that other turbines visible in this image are located further than 1,170 m away and therefore would not subject house 52 to shadow flicker.**

- Some double counting of the shadow flicker due to the two turbines located at a bearing ~238 degrees (WTG 19 and 21);

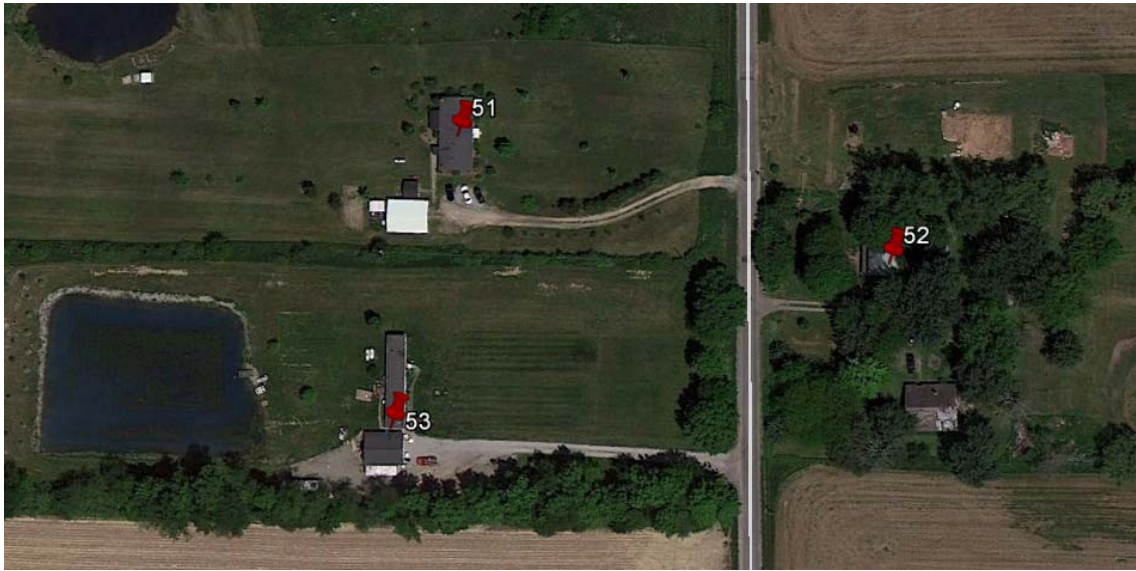
**Figure 4-39: Proximity of trees and buildings surrounding house 51 that potentially provide shielding from the shadow flicker of nearby turbines.**

- Some double counting of the shadow flicker due to the two turbines located at a bearing of ~230 degrees (WTG 19 and 21);
- A shed and a number of trees and dense woodlands (approx 50ft high) to the southwest of the house would likely provide vegetative screening from the turbine locations at the bearings of ~230 degrees, see Figure 4-38 & 39 below; and
- The location of windows and doors in the house was not considered in the analysis.

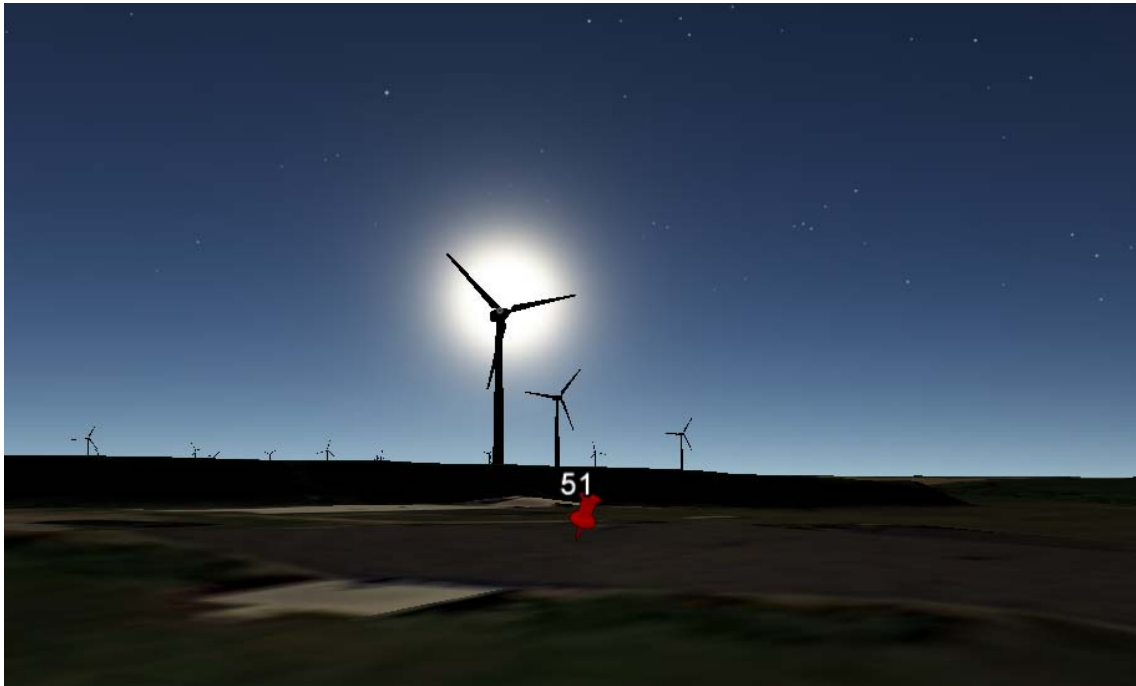
Figure 4-42: WTG 22 relative to house 51 in the morning of September 21.
