With reference to Case No. 15-1714-RR-UNC -- the Petition of Ohi-Rail Corp. to Close to Vehicular Traffic the W. Plain Street Grade Crossing (DOT No. 503425E), Located in the Village of Minerva, Ohio, Carroll County, Ohi-Rail Corporation submits the attached Expert Testimony.

## EXPERT TESTIMONY

Case No. 15-1714-RR-UNC -- the Petition of Ohi-Rail Corp. to Close to Vehicular Traffic the W. Plain Street Grade Crossing (DOT No. 503425E), Located in the Village of Minerva, Ohio, Carroll County.

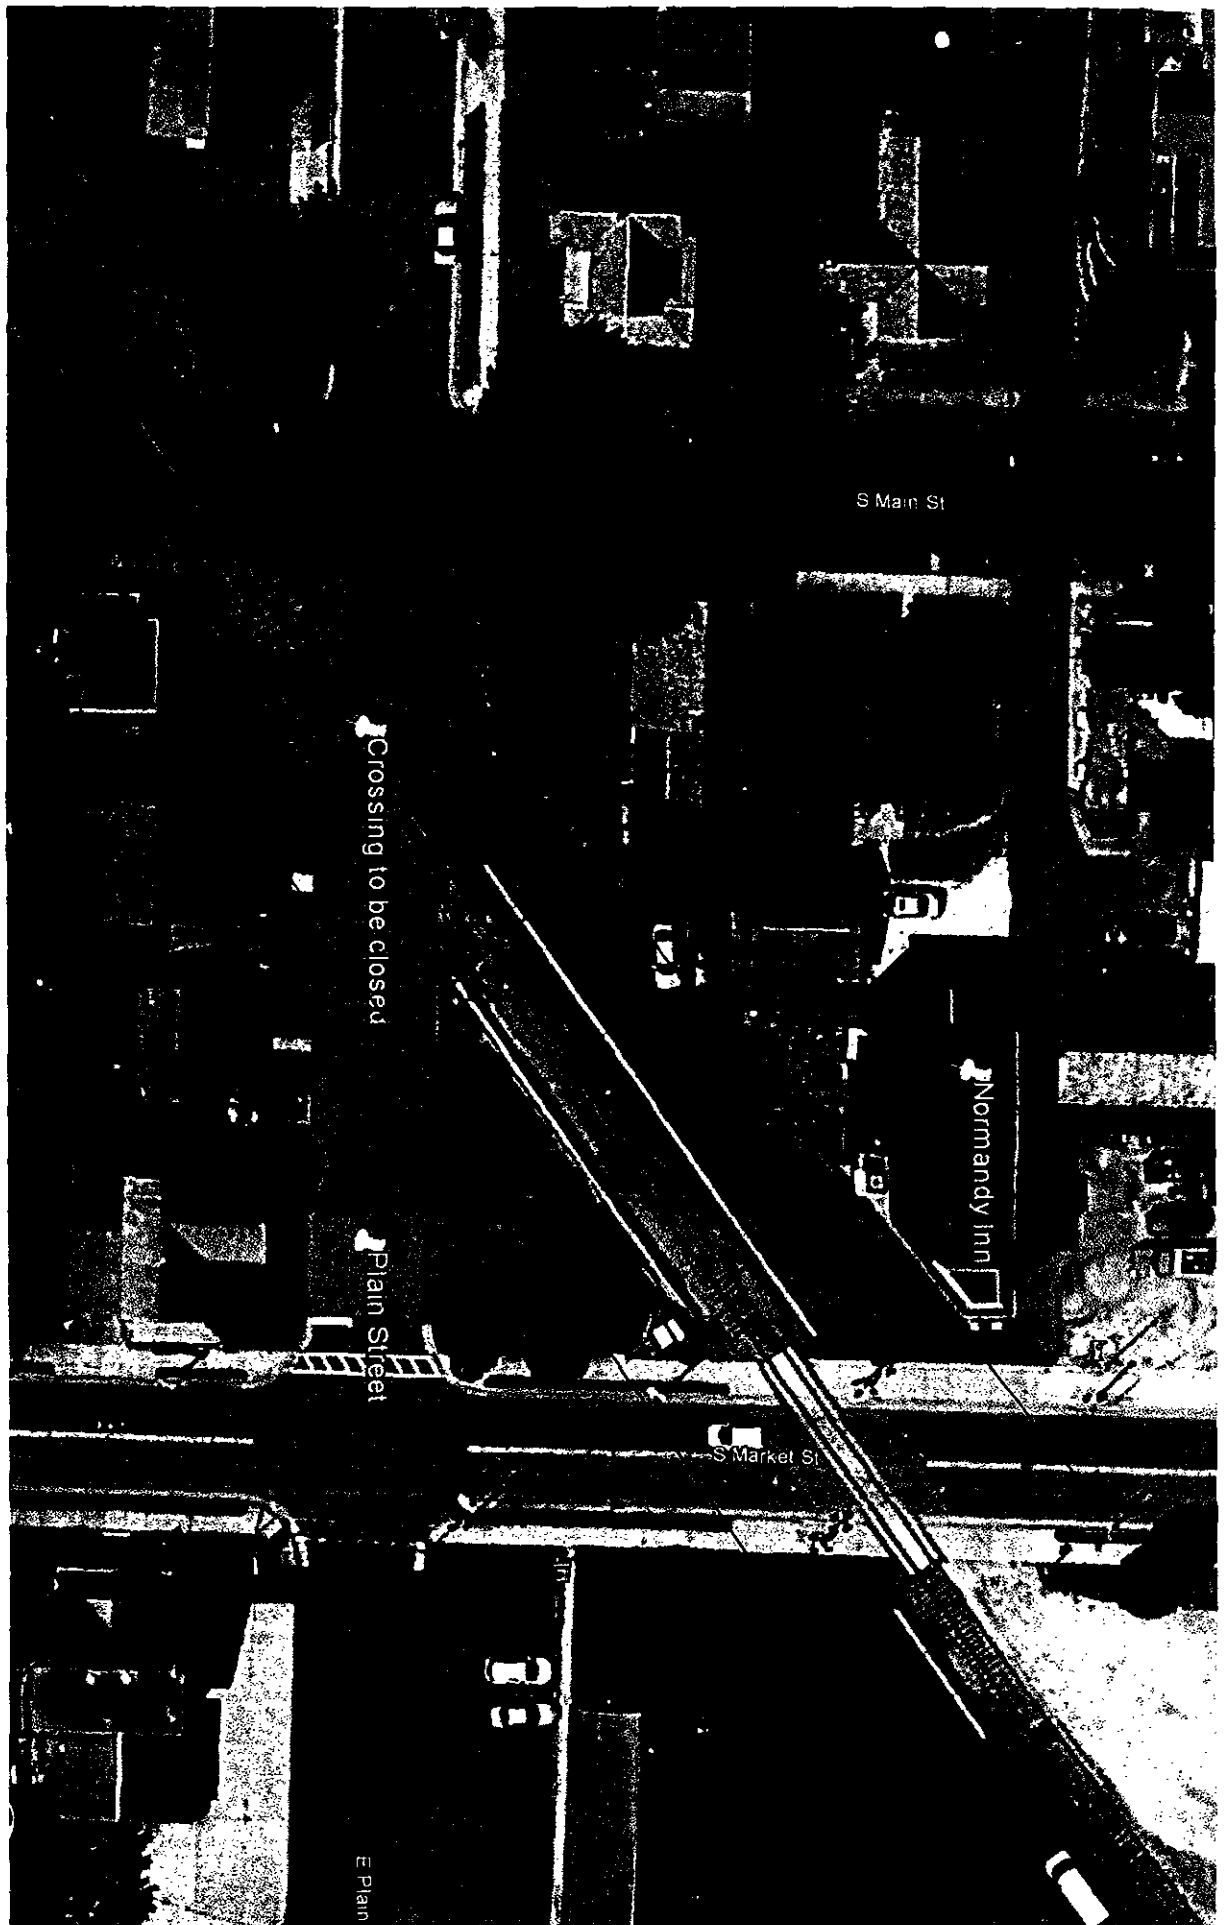
#### **Attachment**

We have attached an overhead photograph of the referenced area. The red lines indicate the Ohi-Rail property lines.
