**Re: East Ohio Gas Company d/b/a Dominion Energy Ohio PIR 567,  
Case No. 19-0135-GA-BNR**

## PIR 567 Cuyahoga River

### Inadvertent Return Contingency and Response Plan

## PIR 567 Directional Drill Overview

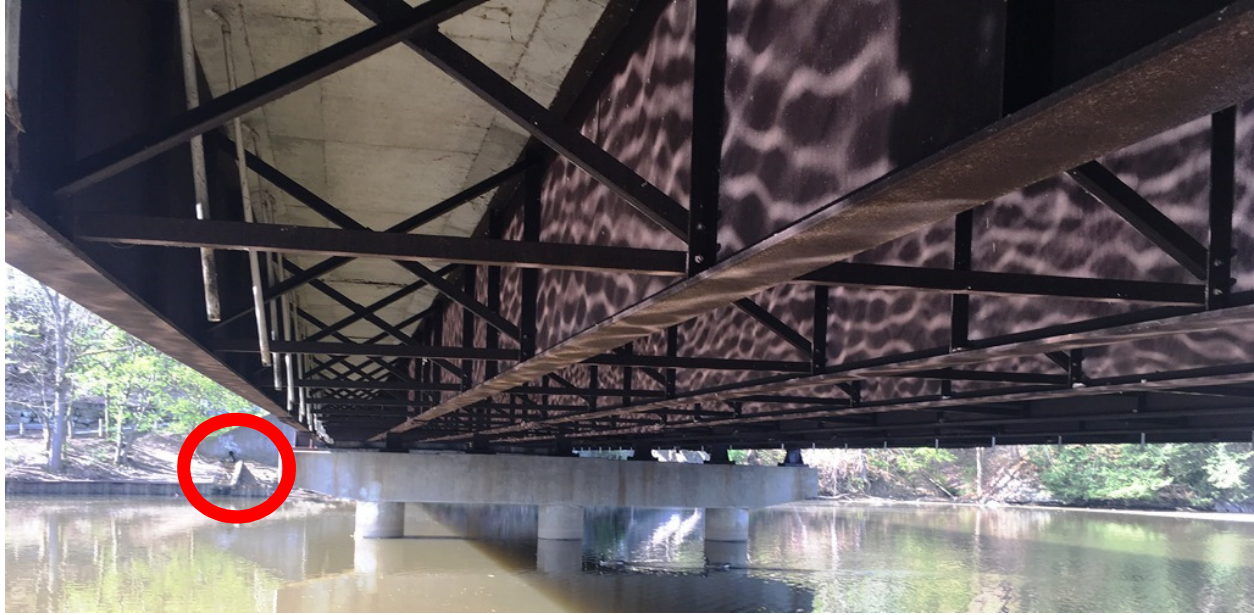
## Location 1

The SE side of the bridge has a 12" storm drain outfall dumping down a concrete spillway into the river. Based on this being in direct alignment with the bore path in the location where we will have the highest pressures based on the design, we identified this as our primary risk. To mitigate the potential of a return migrating into the storm drain and releasing into the river, the outfall will be routed into a plastic lined concrete washout container (or similar) to be monitored and to provide initial containment if there is a release. If fluids are detected the reservoir will be pumped over to a nearby parking area where a dewatering and containment area will be established to prevent bore fluids from going into the river. A frac-tank with secondary containment will be staged at the nearby parking area for additional fluid containment and storage.

Additionally the South side of the river bank will be lined with filter sock beneath the bridge to prevent any potential IR in the bank from running into the river. Several small sections (approximately 4'-5' long) of filter sock will be staged at this location in addition to the preinstalled section to allow for quick installation as needed if an IR occurs. A turbidity curtain will be preinstalled as depicted to isolate potential bore fluid release in the shallow area of the bank. These can be repositioned as needed should an IR occur.

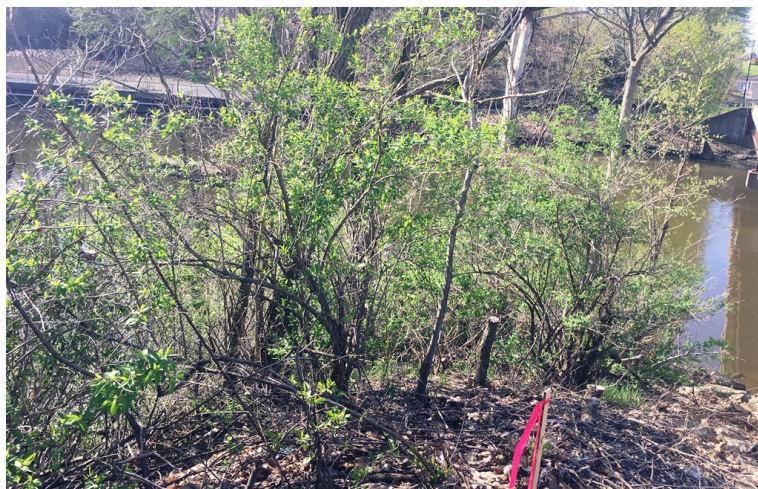
## Location 2

The NE bank is extremely steep and inaccessible (safely) from the land side. The bore path will be running beneath the bank with the pipe angling up towards the receiving pit. Concern here is of a return exiting the bank and running into the water before we can respond. A turbidity curtain will be pre-installed to isolate the area and prevent any potential IR fluid from being carried downstream.

Additionally the North side of the river bank will be lined with filter sock beneath the bridge to prevent any potential IR in the bank from running into the river. Several small sections (approximately 4'-5' long) of filter sock will be staged at this location in addition to the preinstalled section to allow for quick installation as needed if an IR occurs.

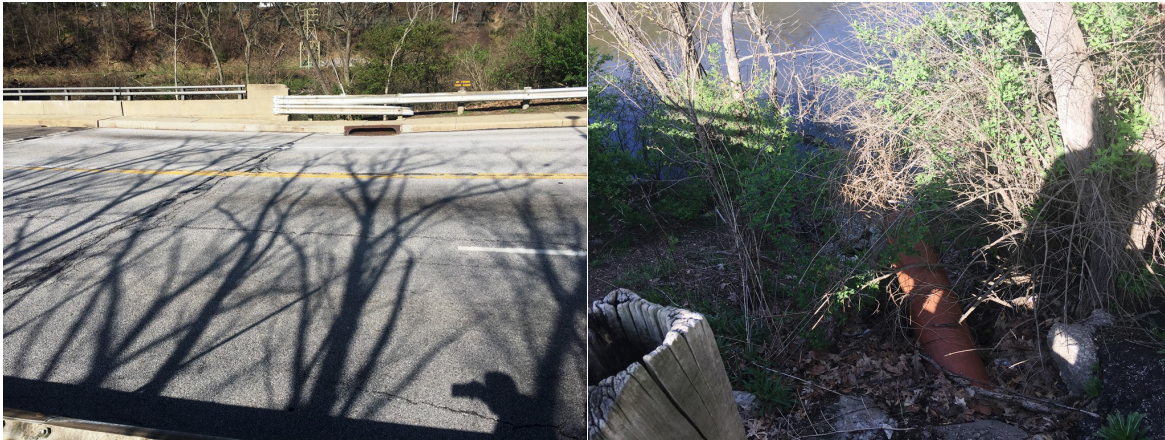
### **Location 3**

There is a 12" clay tile outfall on the NW bank of the river coming from the bridge. The area is steep and rocky with difficult access on foot. The 12" storm drain will be plugged using a plumber's plug at the bridge to prevent any returns from migrating into the SD and releasing into the river.

The NW bank is extremely steep and inaccessible (safely) from the land side. Concern here is of a return exiting the bank and running into the water before we can respond. A turbidity curtain will be pre-installed to isolate the area and prevent any potential IR fluid from being carried downstream.

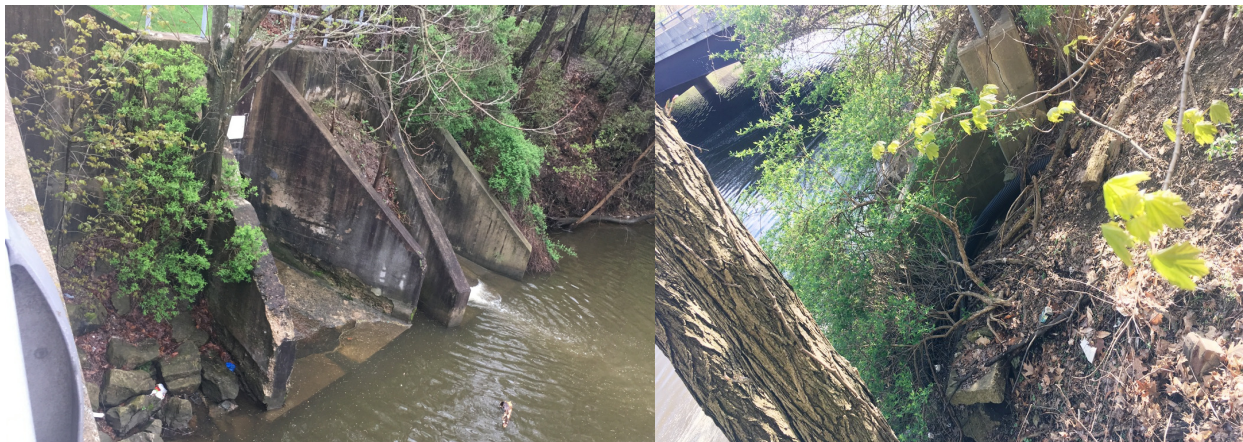
### **Location 4**

The SW side of the bridge has a storm drain and two CSO's releasing into the river. The area is steep and not safely accessible by foot. A turbidity curtain will be pre-installed to isolate the area and prevent any potential IR fluid from being carried downstream.

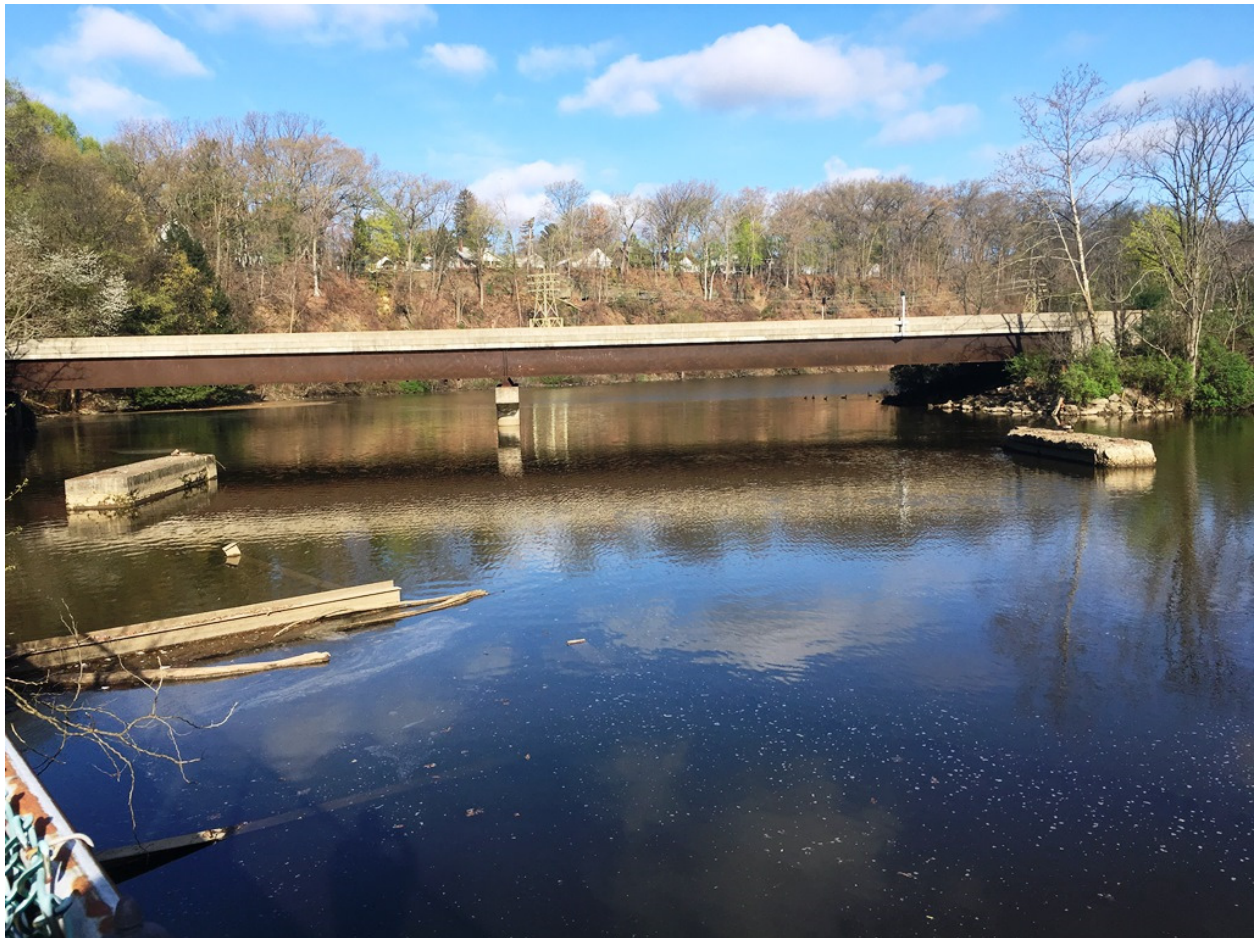
## IR within the River

The biggest concern is an IR within the river itself towards the center where isolation devices cannot be pre-staged. DEO Environmental has been in contact with Ohio EPA to coordinate potential response efforts if such an event should occur. During drill operations DEO personnel and 3<sup>rd</sup> party environmental inspectors will be monitoring the river from the banks and bridge itself for any returns into the river. The West side of the bridge has a sidewalk which can be used for these efforts, and the travel lane on the East side will be closed for the duration of the project allowing safe travel for employees and inspectors as they monitor the river. A vac truck will be staged and ready on the bridge along with various materials and equipment should an IR occur.

Per recommendation from Ohio EPA, a pre-fabricated, watertight wooden containment device or floatable boom/water bags will be on site to isolate and contain any drilling mud. A motorized boat large enough to support clean up and response will be on site and available if needed (ODNR has been notified of the use of a motorized boat on the river). Should an IR occur our environmental inspectors will monitor turbidity with sediment sticks and DEO will communicate with Ohio EPA throughout any response.
