Case No(s). 20-0417-EL-BGN

Summary: Application - 17 of 40 (Exhibit L – Part 3 of 3 - Water Resources Delineation Report) electronically filed by Christine M.T. Pirik on behalf of Grover Hill Wind, LLC

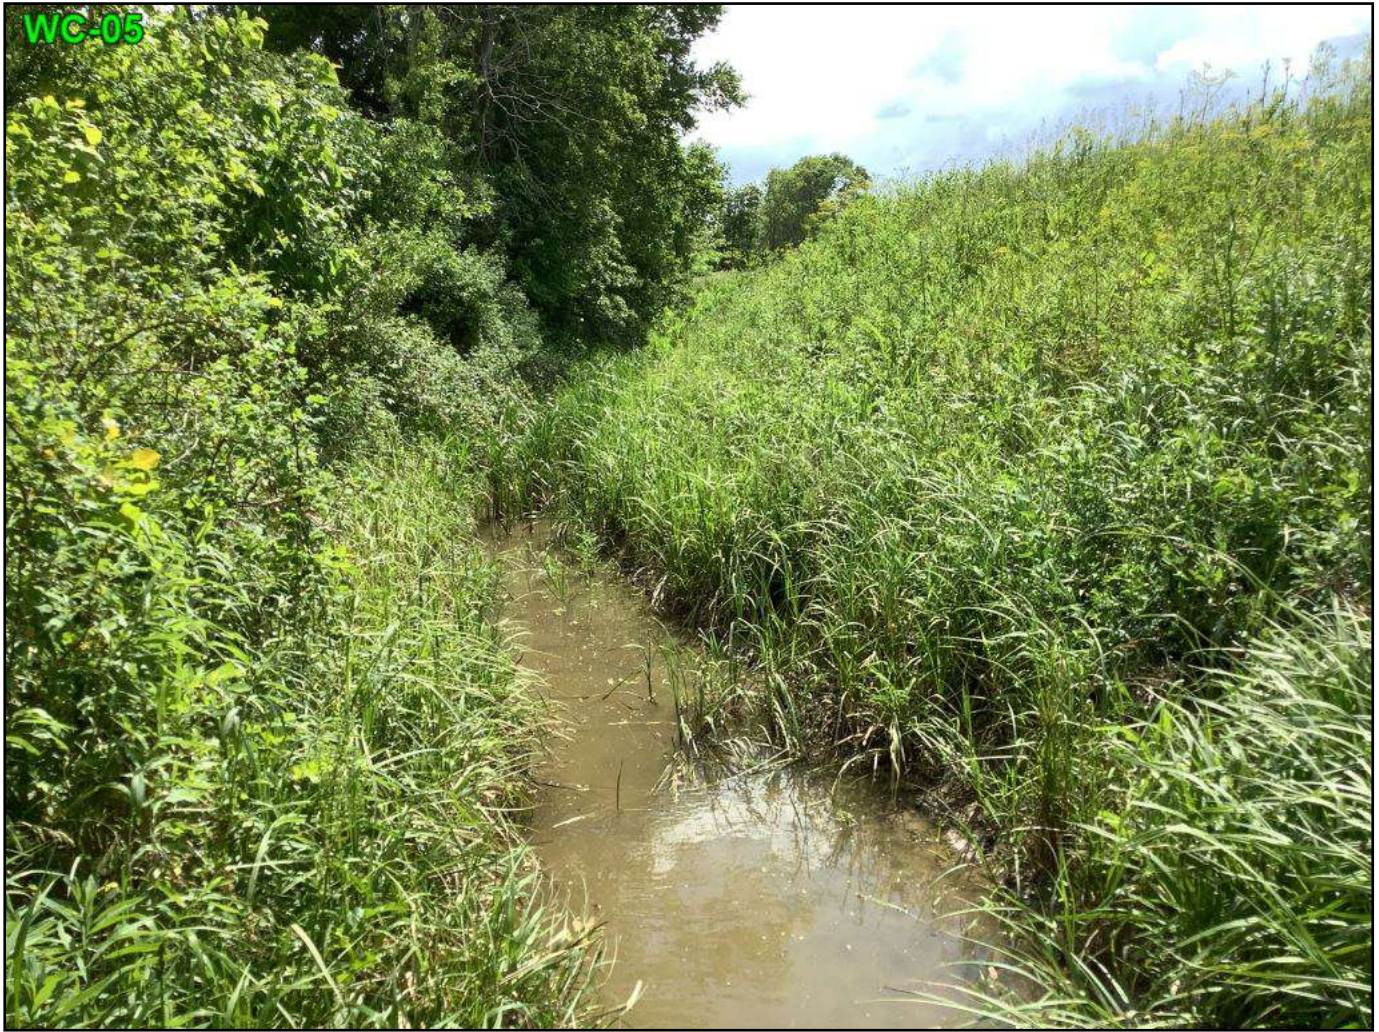
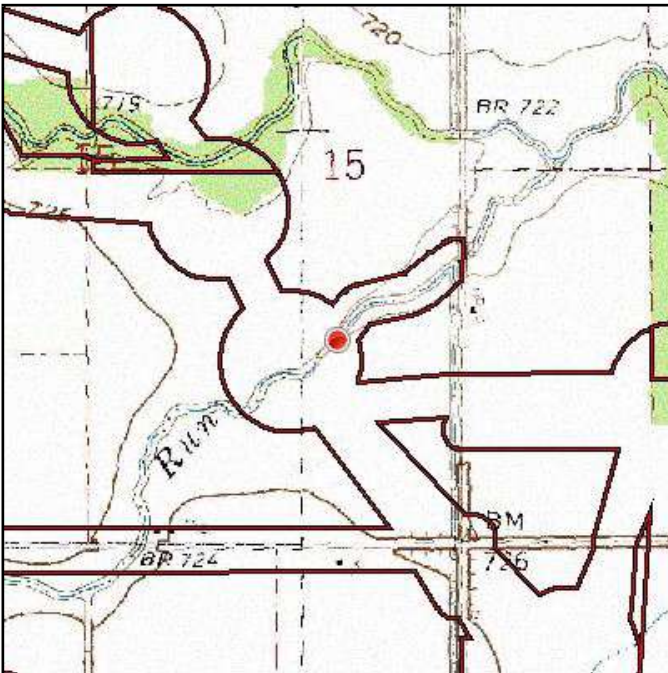
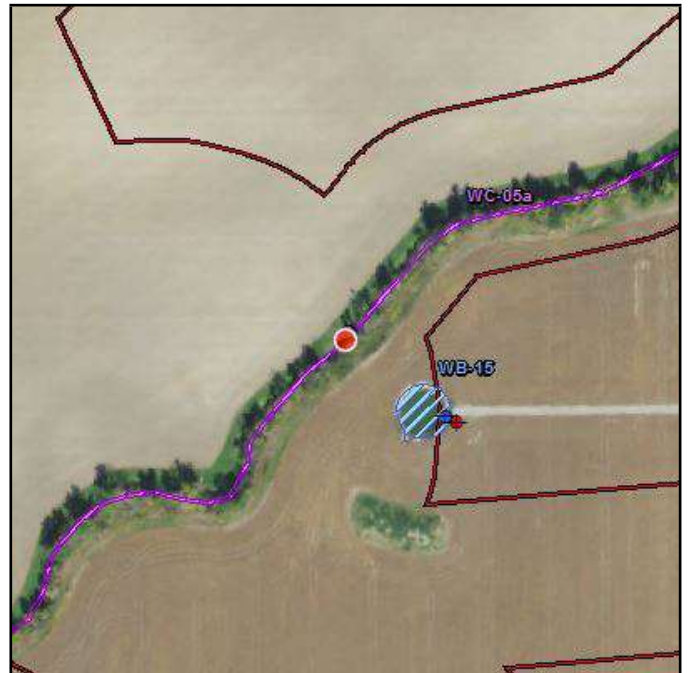
WC-05

| Attributes | |
| Defined Bed and Bank | Yes |
| Flow Characteristics | Intermittent |
| Water Width at Crossing (ft) | 2 |
| Top of Bank Width (ft) | 13 |
| OHWM Width (ft) | 6 |

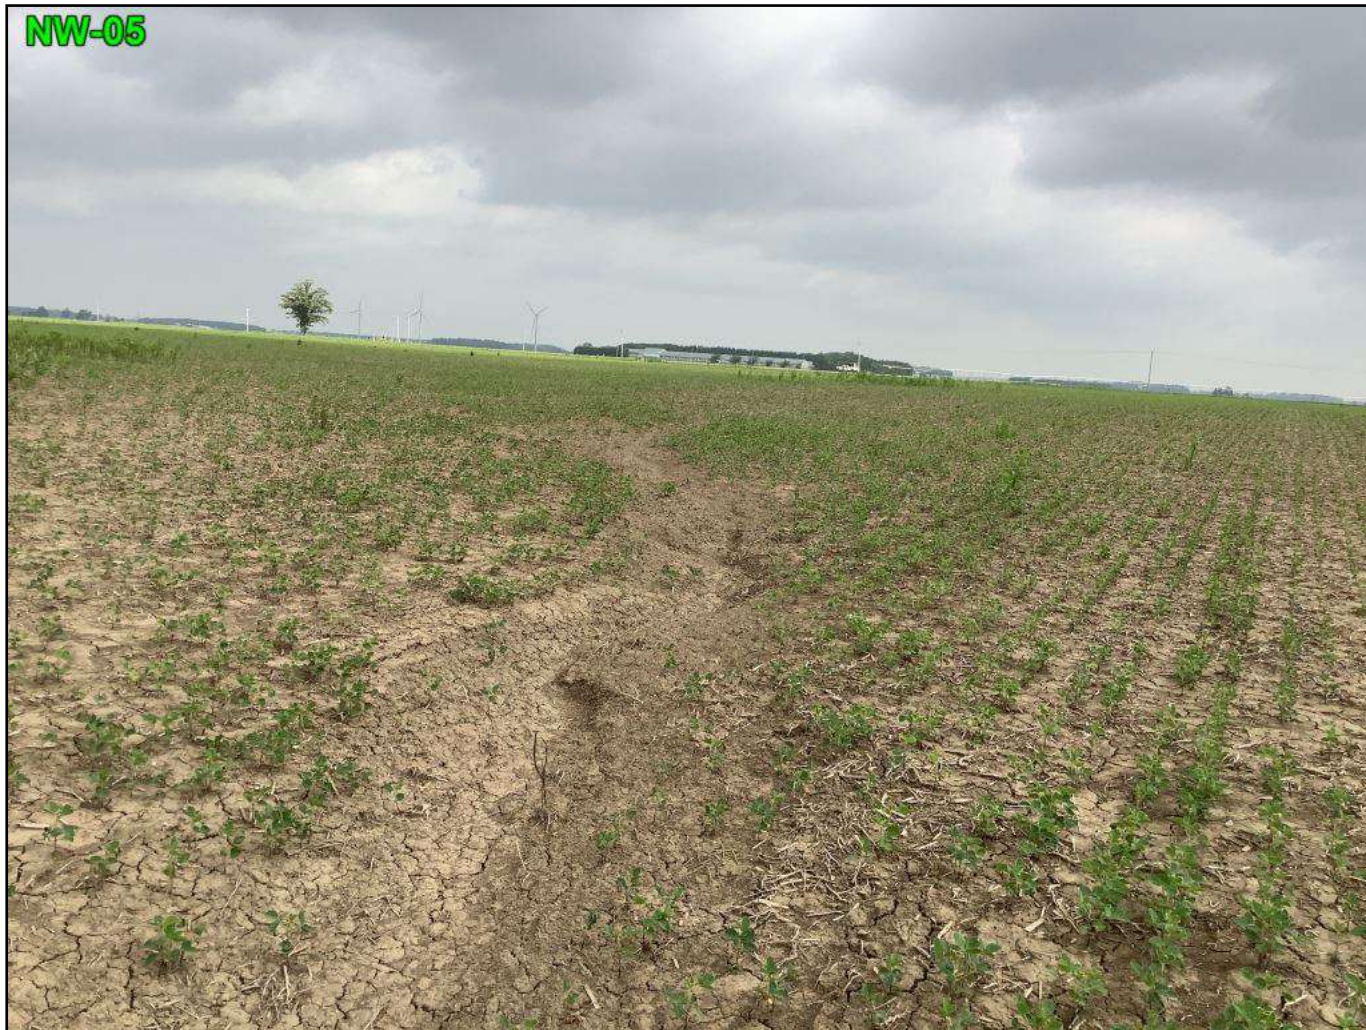
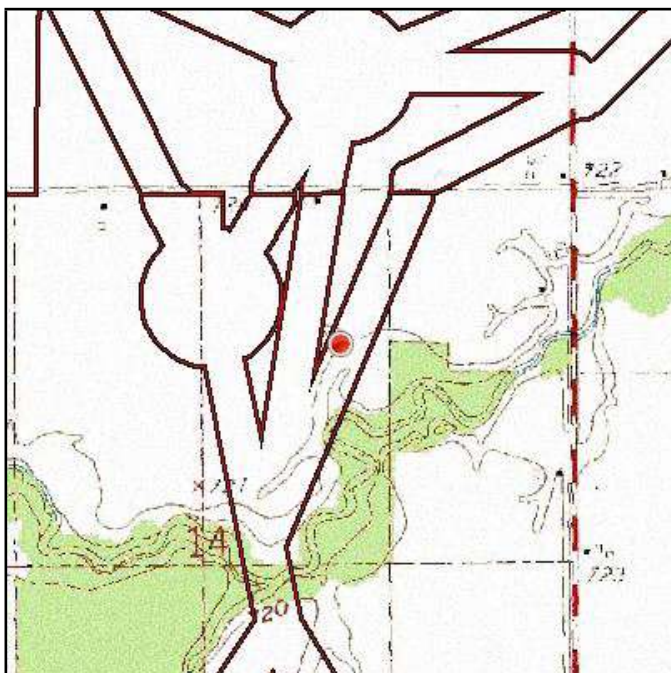
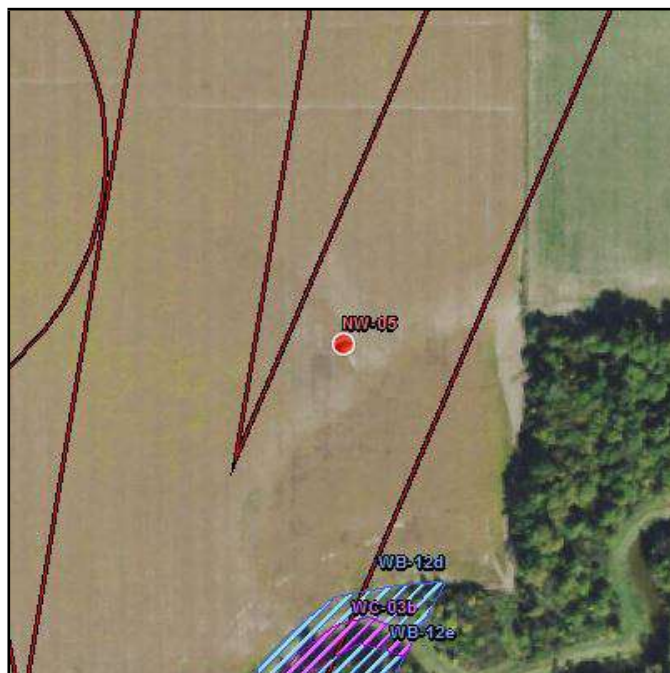
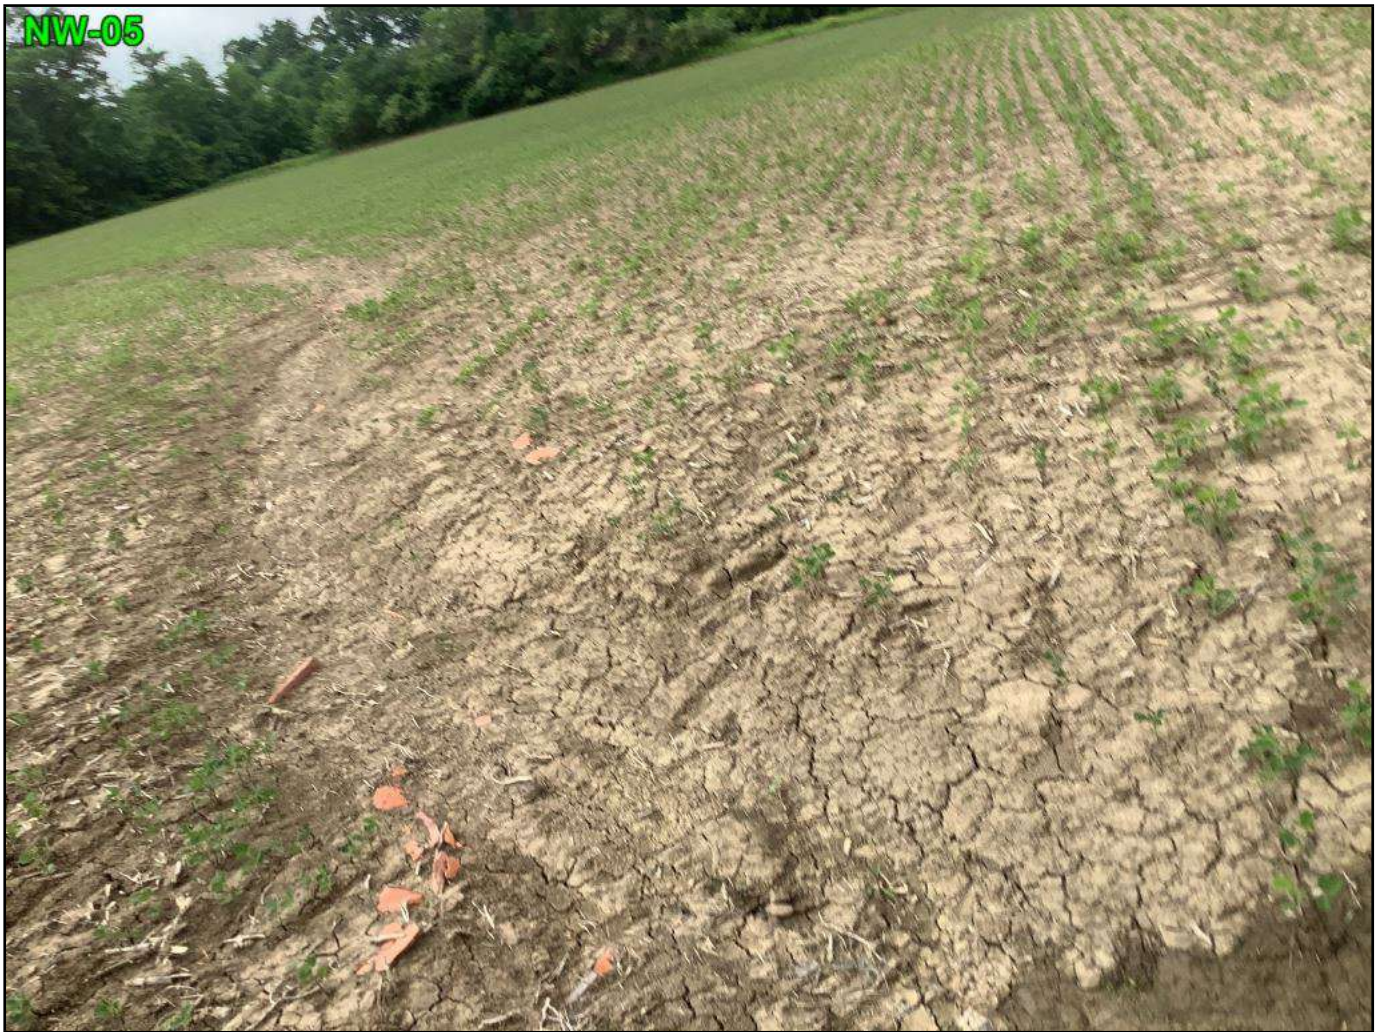
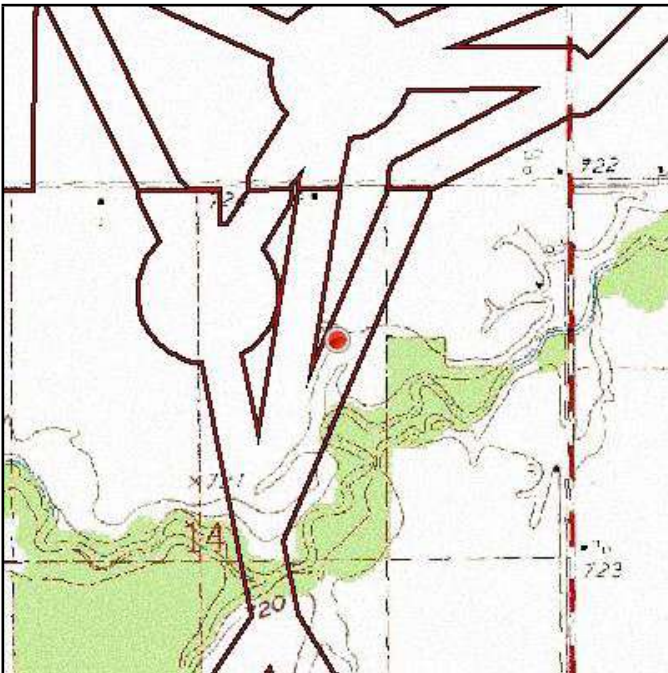
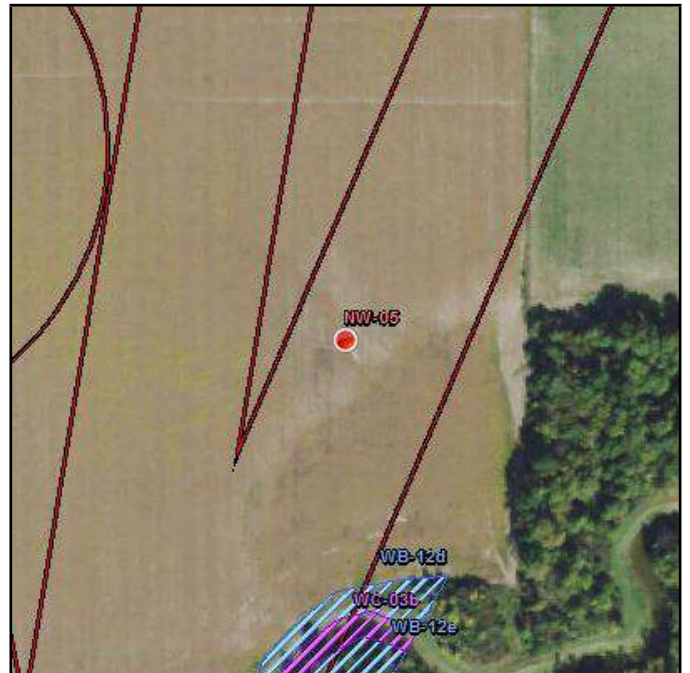
NW-05

| Attributes | |
| Defined Bed and Bank | No |
| Waters of the US | No |
| Mapped on NHD | Yes |
| Mapped on NWI | No |
| Flow Characteristics | No Evidence of Flow |
| Direction of Flow (Direction Downstream) | No Discernable Direction |
| Water Width at Crossing (ft) | No Water Noted |
| Water Depth at Crossing (ft) | No Water Noted |
| Top of Bank Width (ft) | N/A, No Defined Bank |
| Left Bank Height (ft) (Looking Downstream) | N/A, No Defined Bank |
| Right Bank Height (ft) (Looking Downstream) | N/A, No Defined Bank |
| OHWM Width (ft) | N/A, No OHWM Noted |
| OHWM Height (ft from substrate) | N/A, No OHWM Noted |
| Evidence of Scour or Erosion | No |
| OHWM Criteria | None Noted |
| Pools, Riffles, Runs Present? | None Noted |
| Substrate | Vegetated |

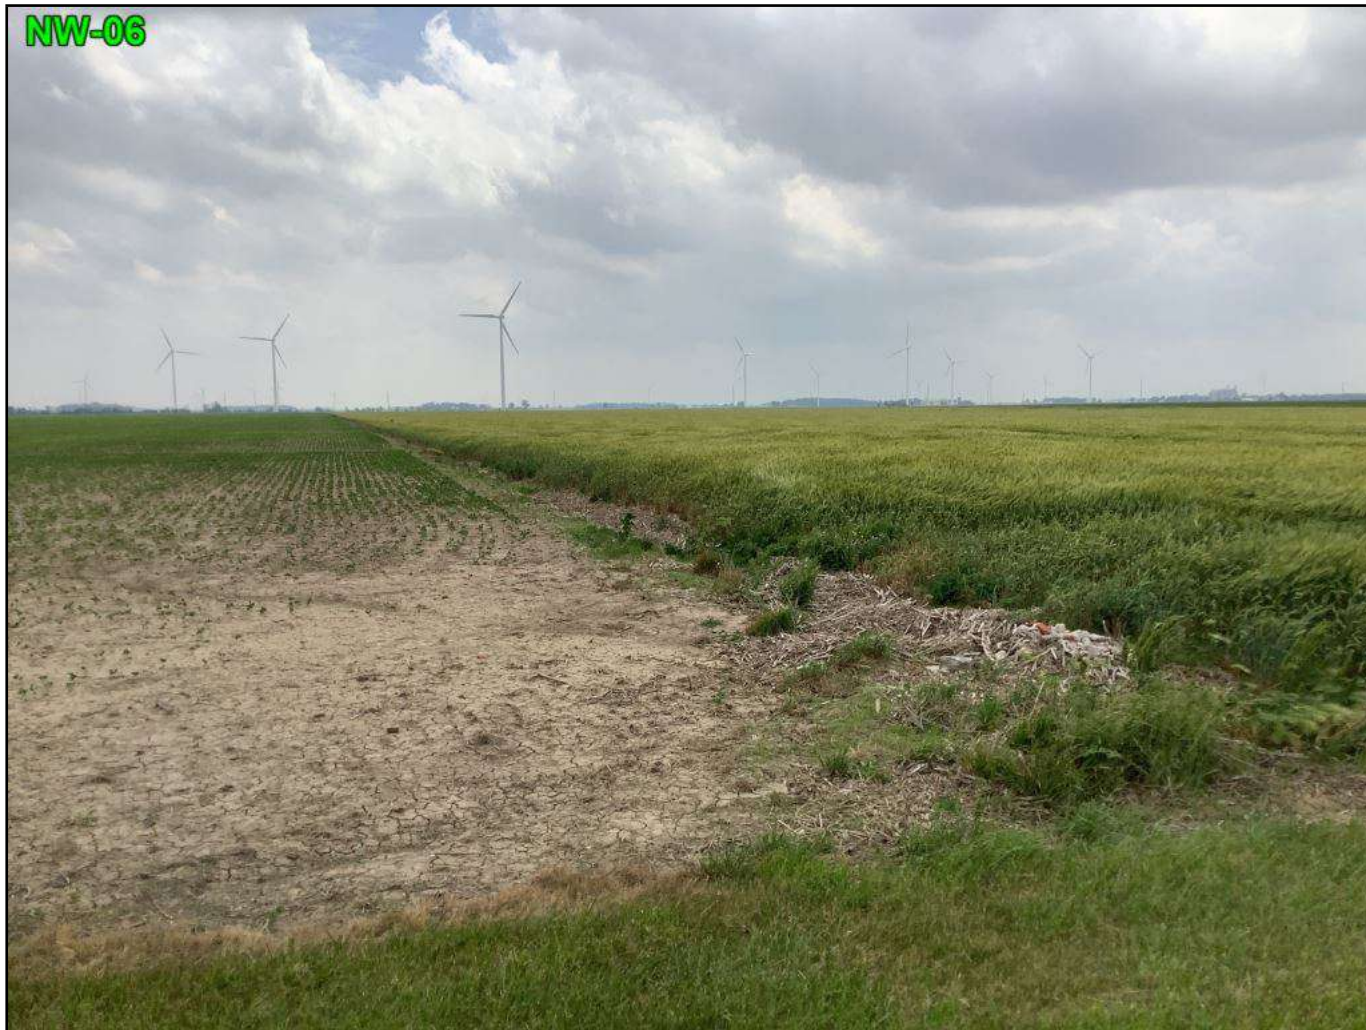
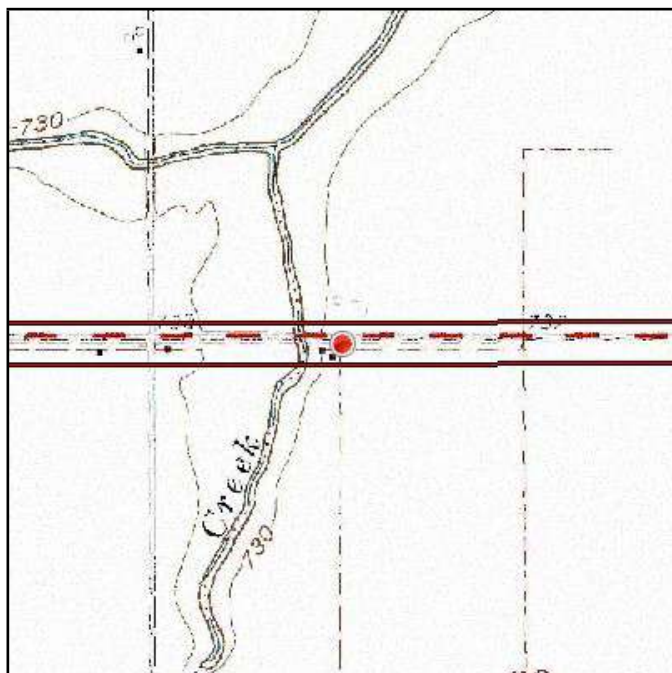
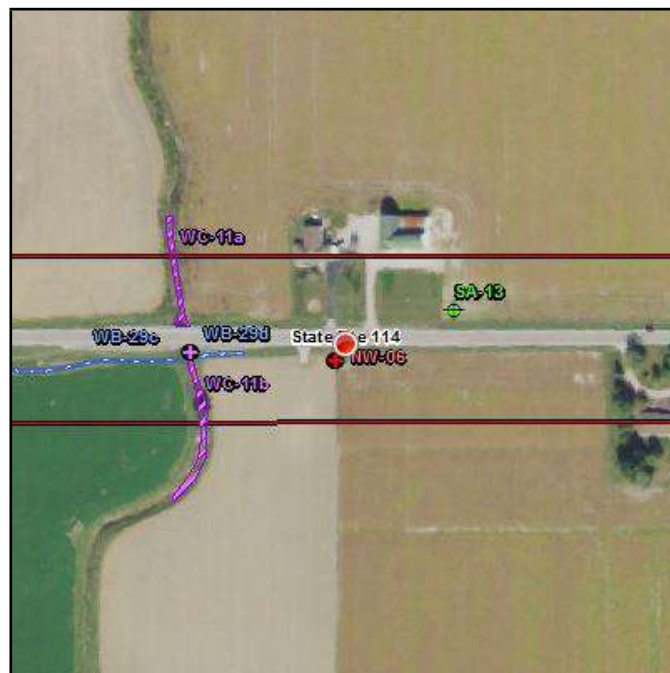
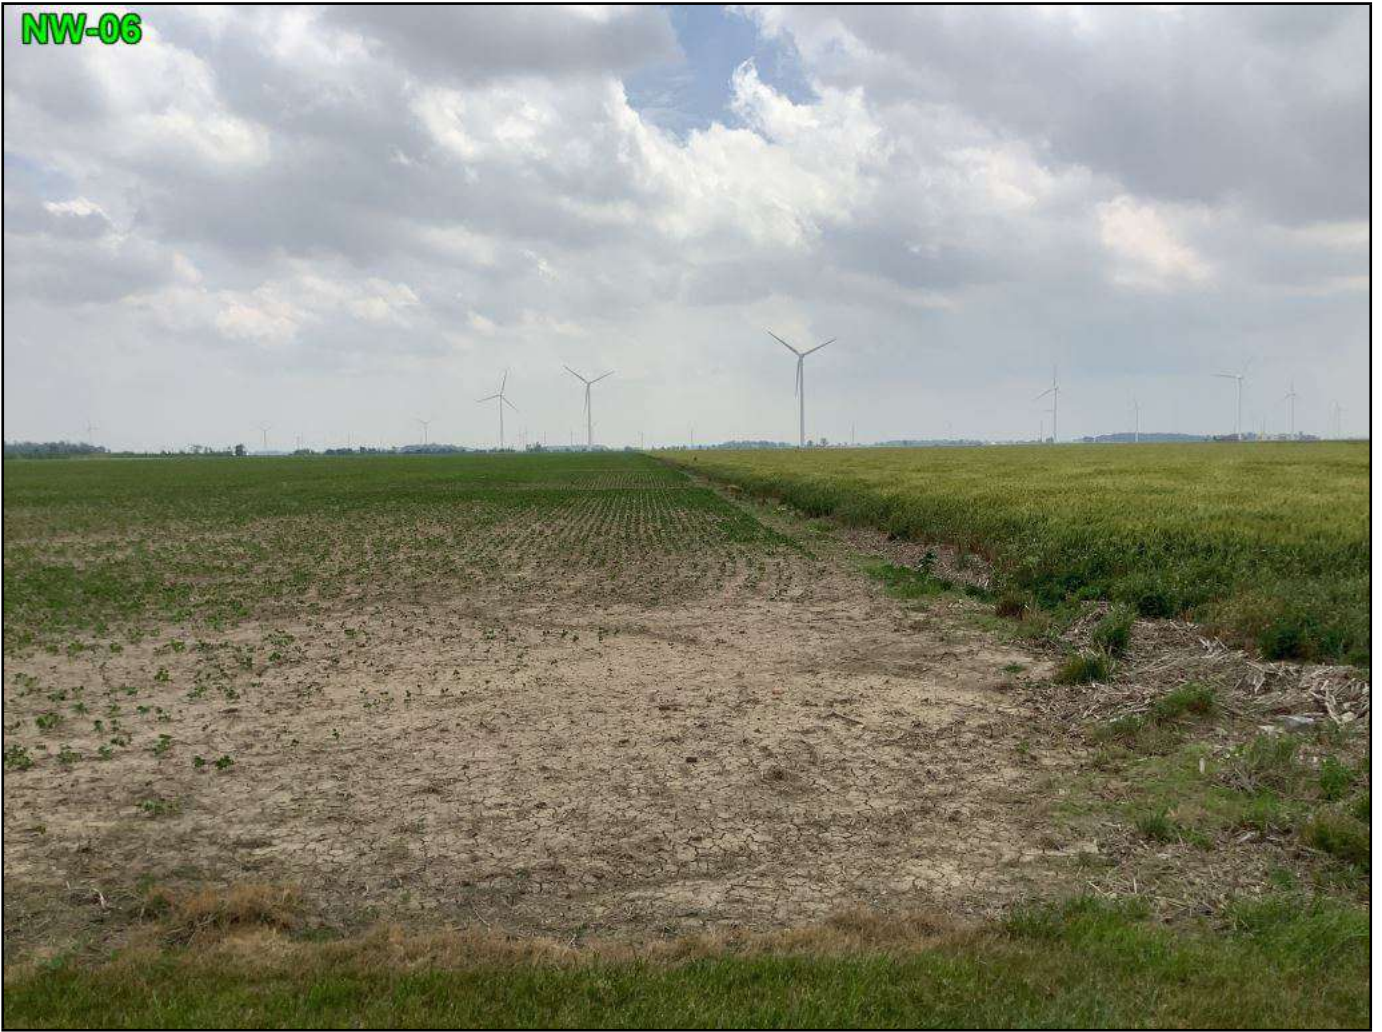
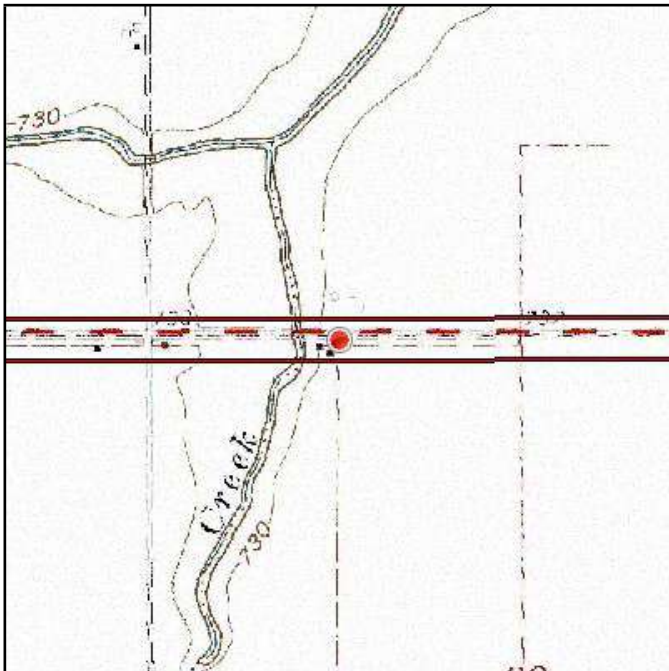
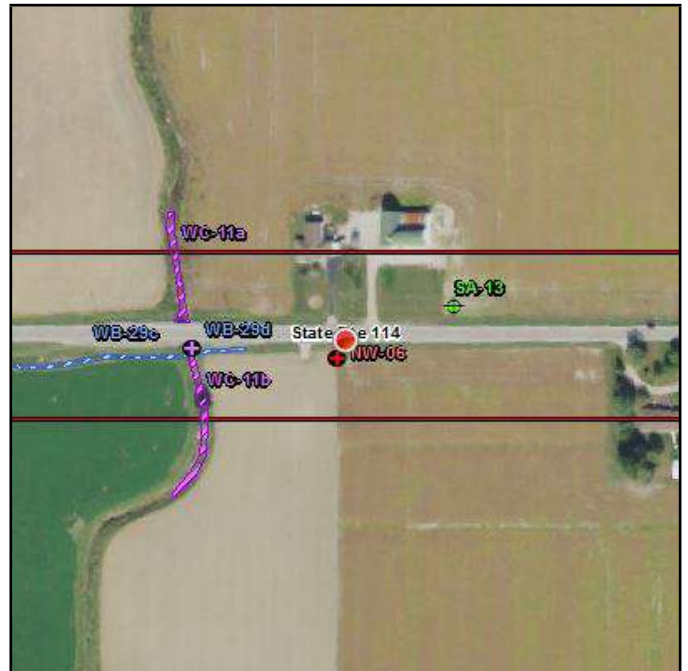
NW-06

| Attributes | |
| Defined Bed and Bank | No |
| Waters of the US | No |
| Mapped on NHD | Yes |
| Mapped on NWI | No |
| Water Width at Crossing (ft) | No Water Noted |
| Water Depth at Crossing (ft) | No Water Noted |
| OHWM Width (ft) | N/A, No OHWM Noted |
| OHWM Height (ft from substrate) | N/A, No OHWM Noted |
| OHWM Criteria | None Noted |
| Pools, Riffles, Runs Present? | None Noted |
| Substrate | Vegetated |

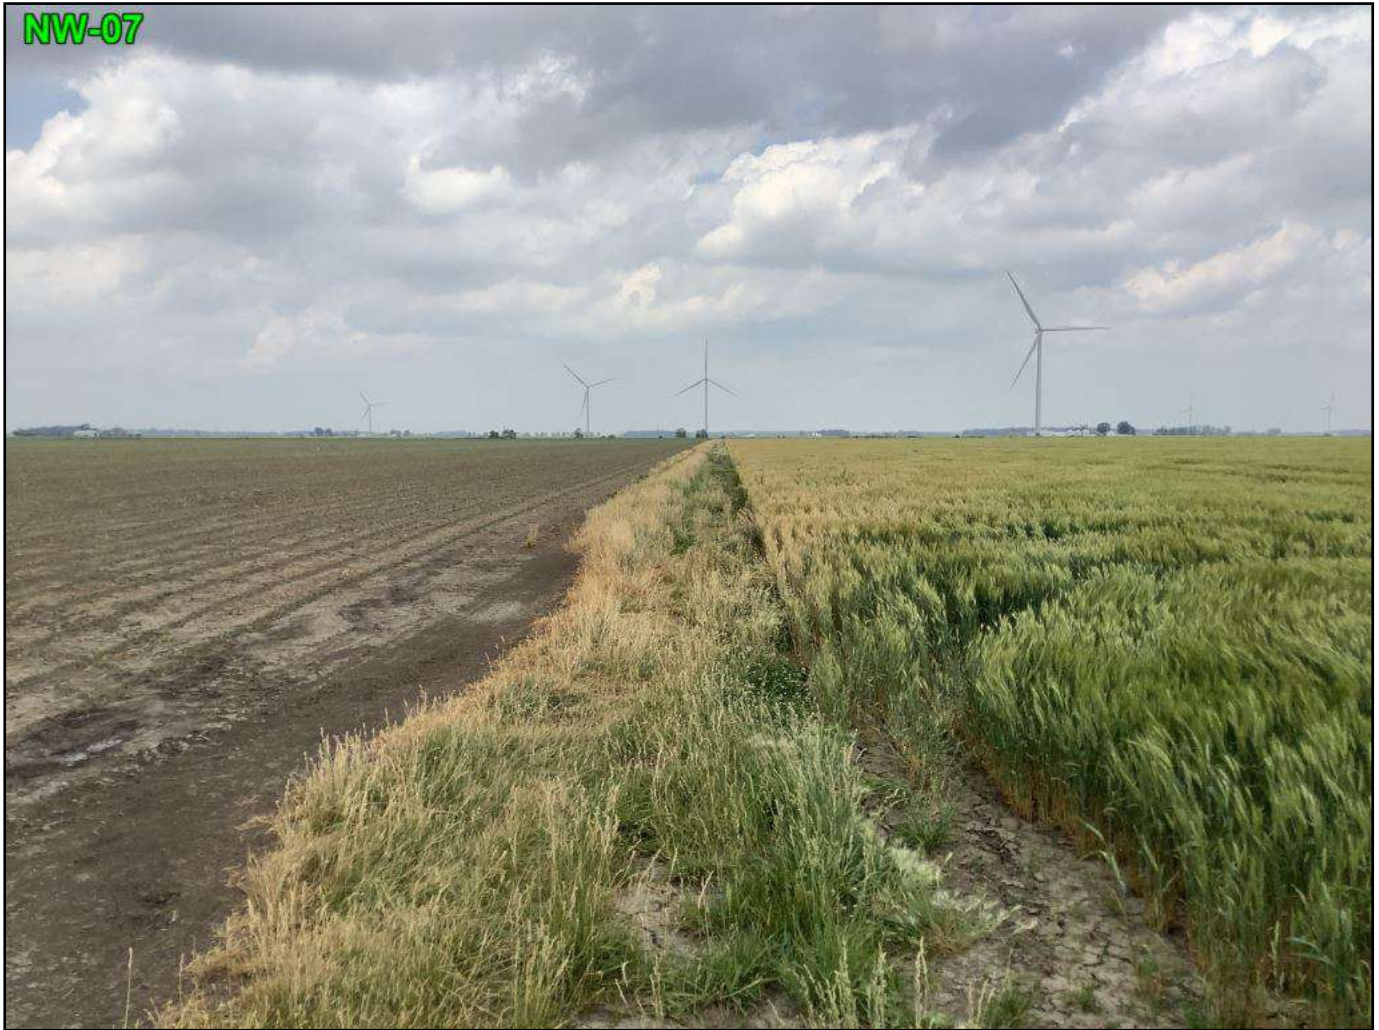
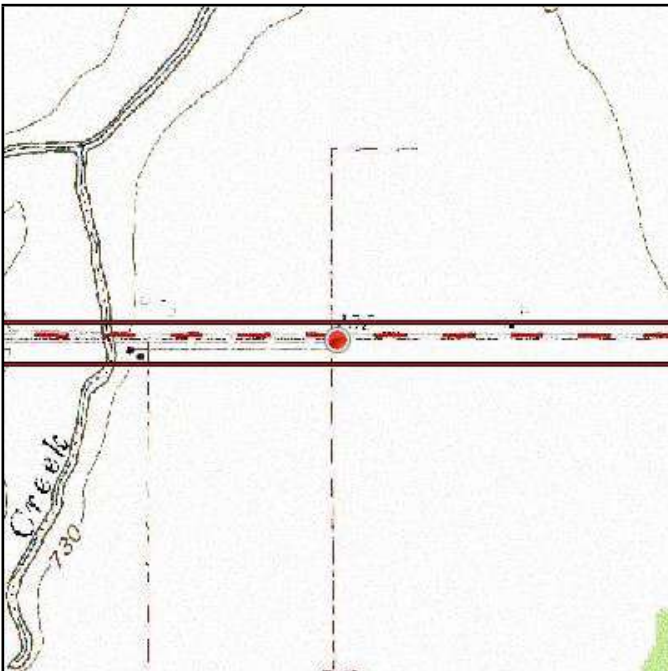
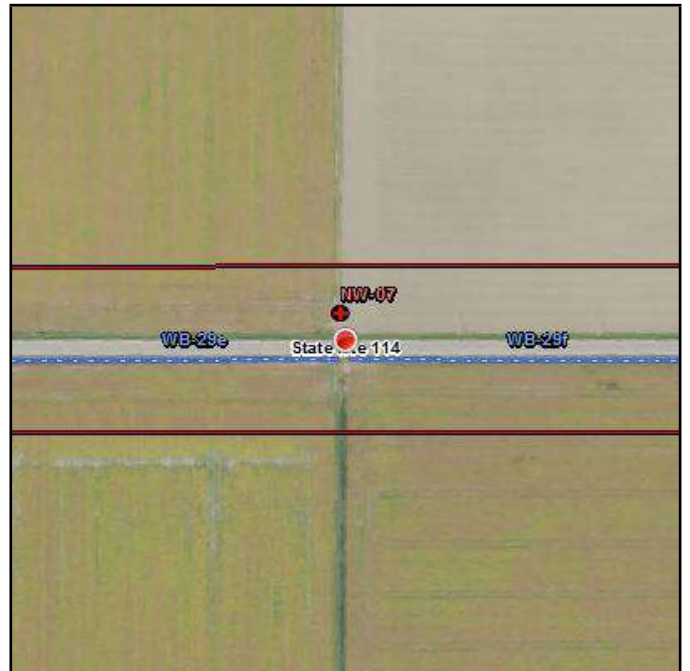
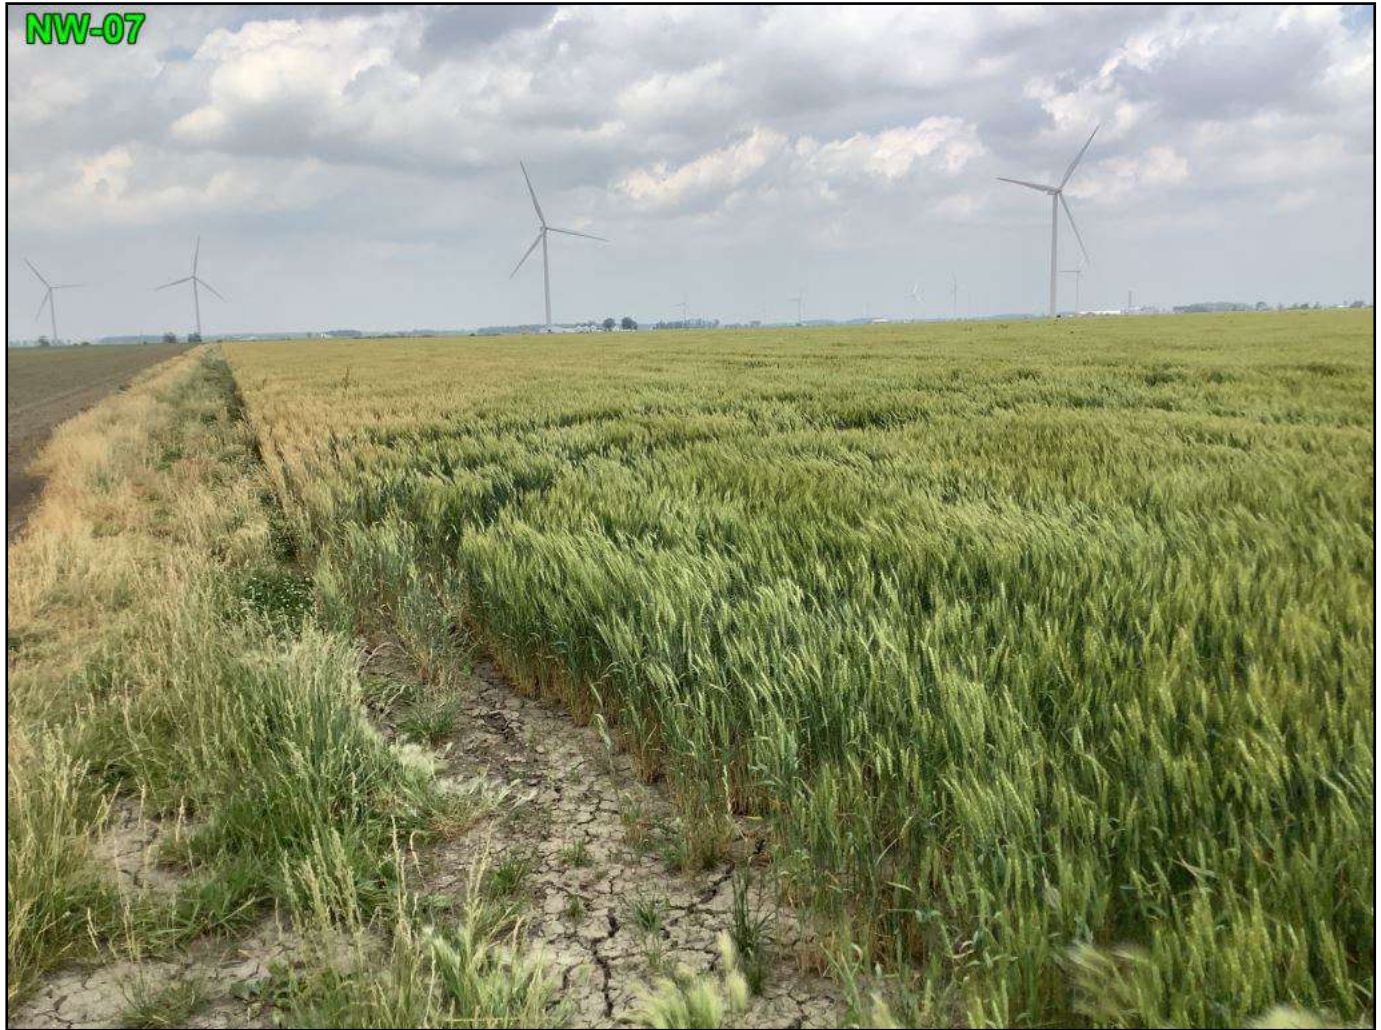
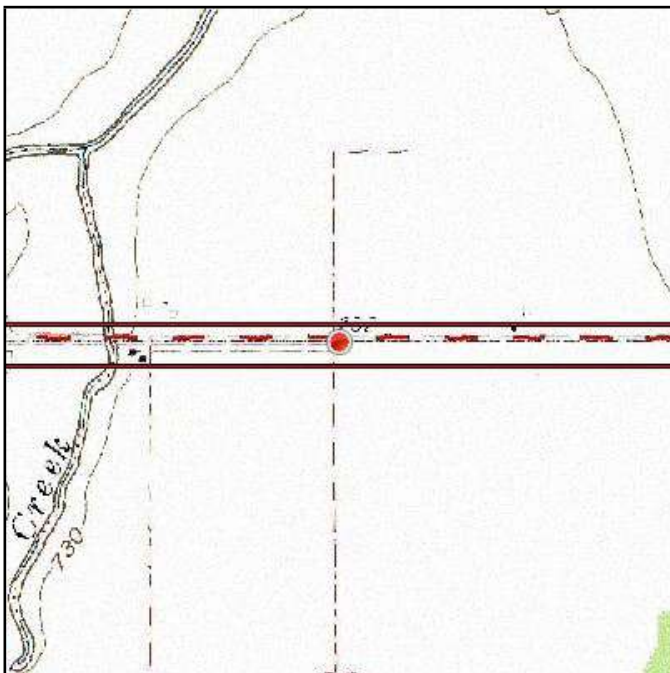
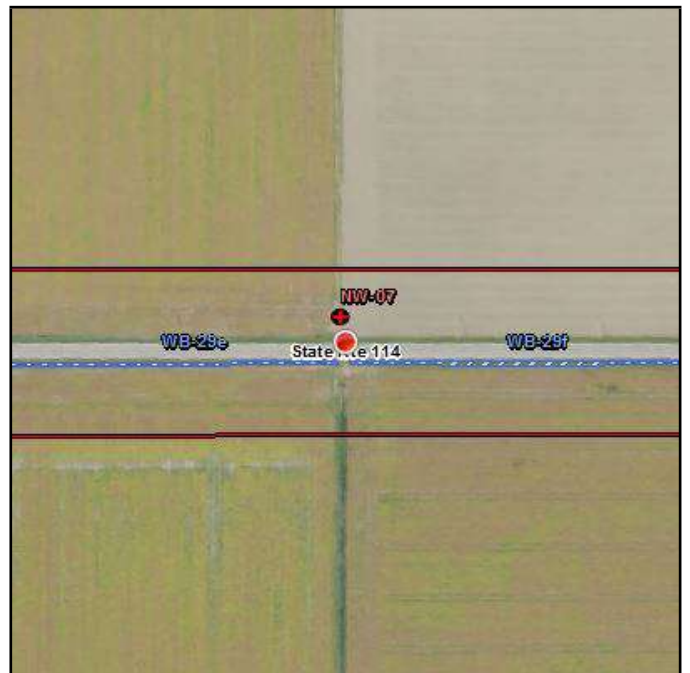
NW-07

| Attributes | |
| Defined Bed and Bank | No |
| Water Width at Crossing (ft) | No Water Noted |
| Water Depth at Crossing (ft) | No Water Noted |
| OHWM Width (ft) | N/A, No OHWM Noted |
| OHWM Height (ft from substrate) | N/A, No OHWM Noted |
| OHWM Criteria | None Noted |
| Pools, Riffles, Runs Present? | None Noted |
| Substrate | Vegetated |

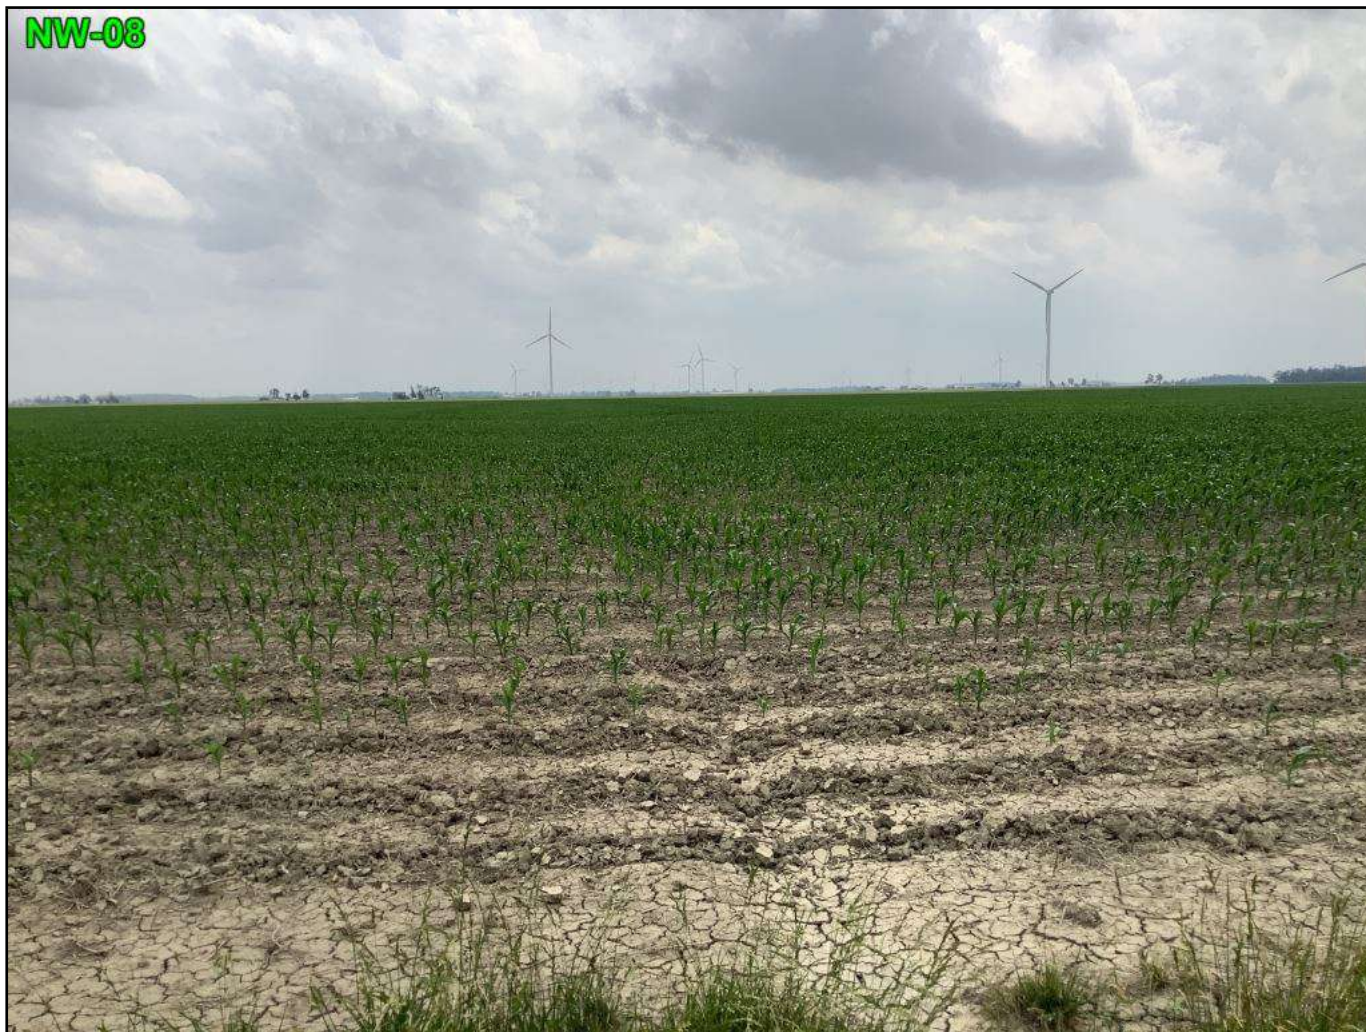
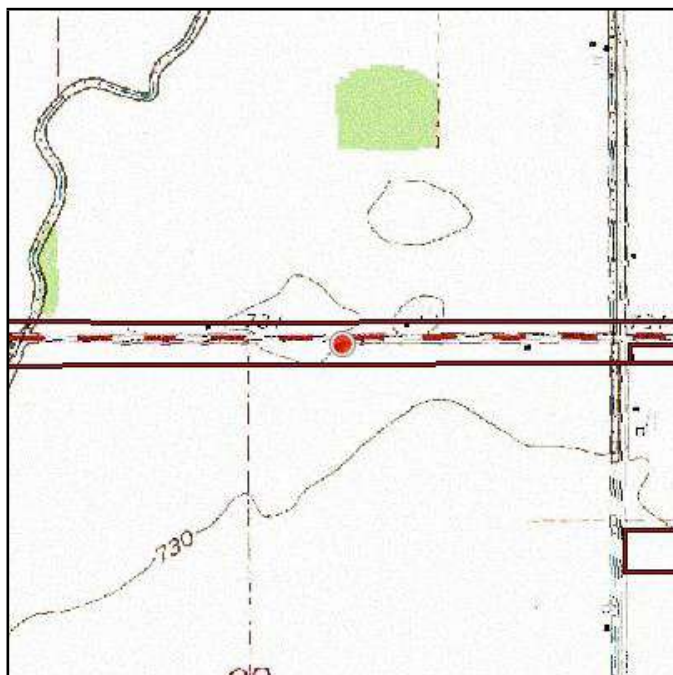
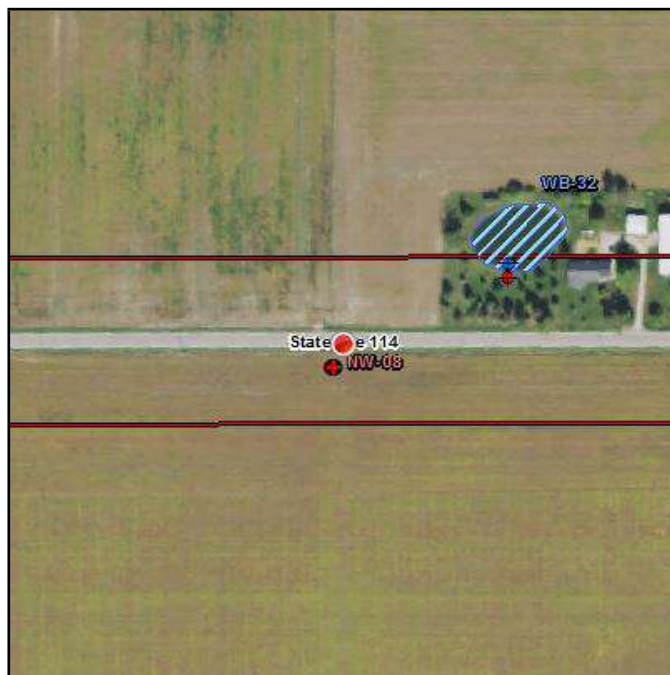
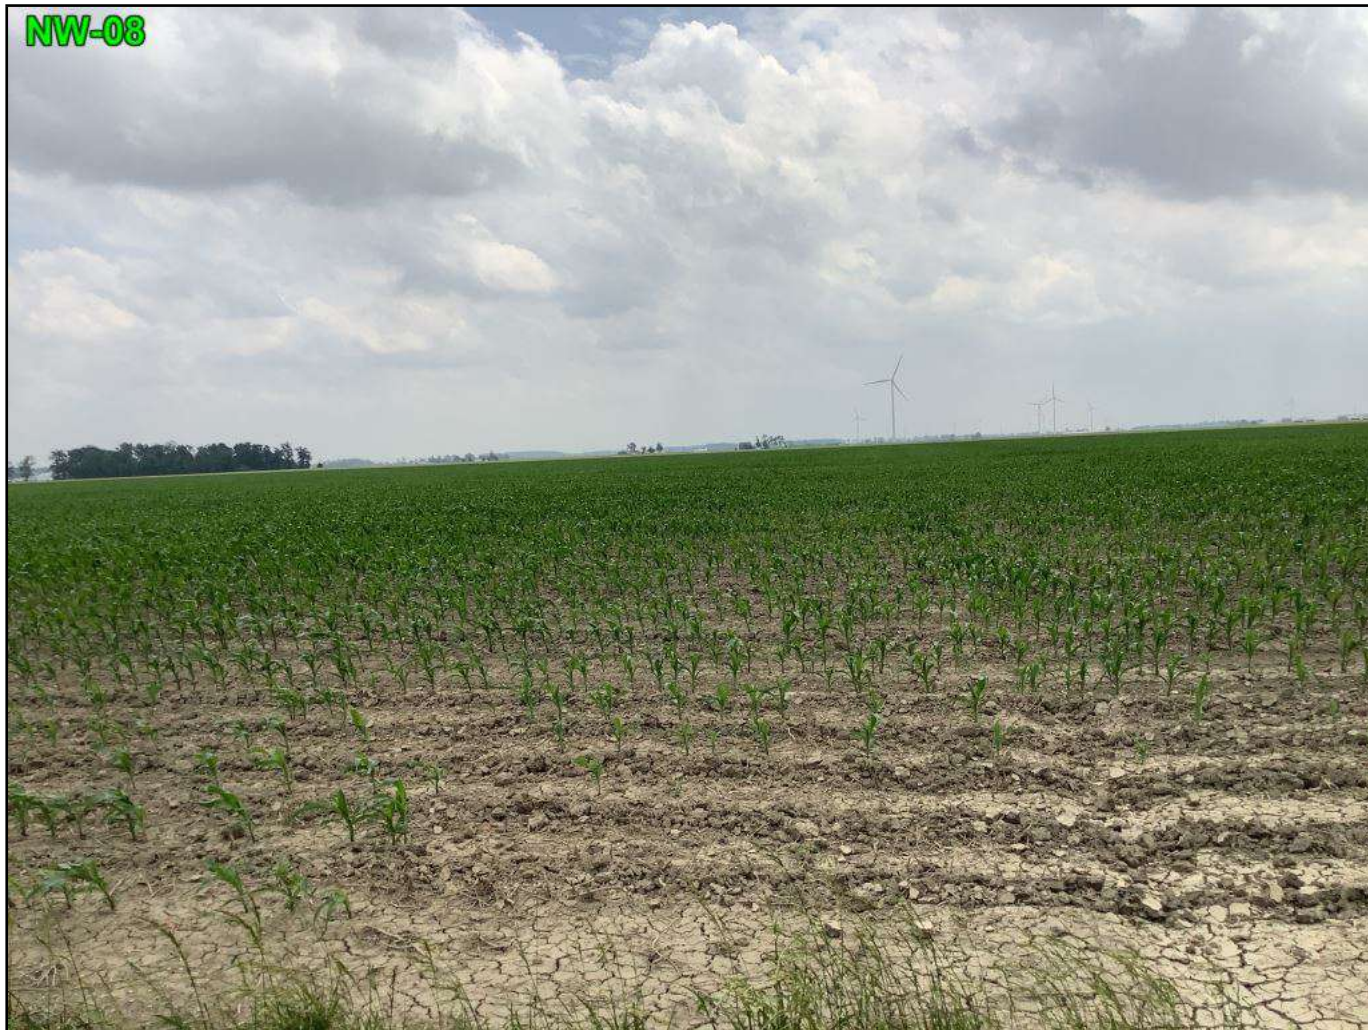
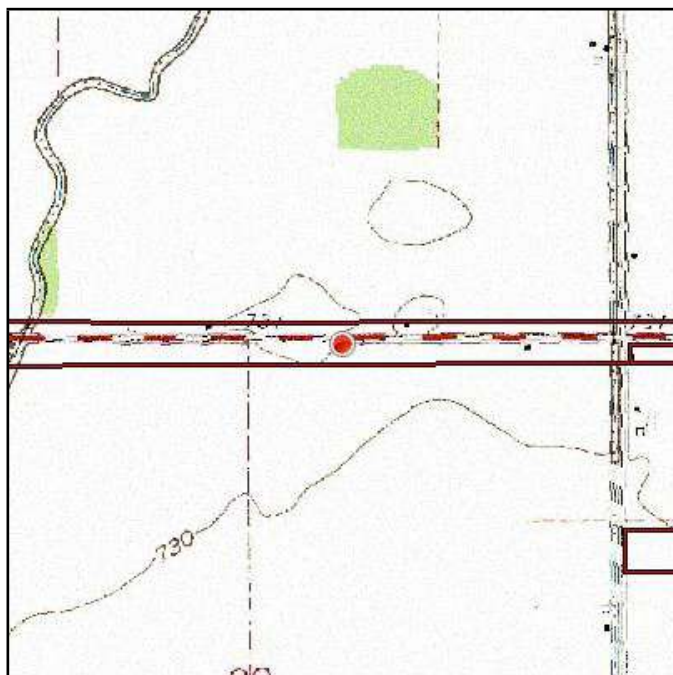
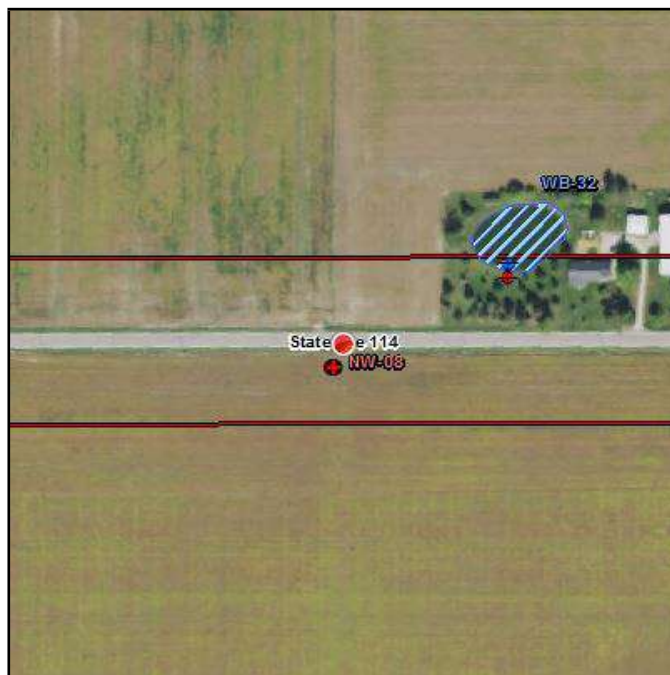
NW-08

| Attributes | |
| Defined Bed and Bank | No |
| Water Width at Crossing (ft) | No Water Noted |
| Water Depth at Crossing (ft) | No Water Noted |
| OHWM Width (ft) | N/A, No OHWM Noted |
| OHWM Height (ft from substrate) | N/A, No OHWM Noted |
| OHWM Criteria | None Noted |
| Pools, Riffles, Runs Present? | None Noted |
| Substrate | Vegetated |
