Case No(s). 20-0417-EL-BGN

Summary: Application - 17 of 40 (Exhibit L – Part 3 of 3 - Water Resources Delineation Report) electronically filed by Christine M.T. Pirik on behalf of Grover Hill Wind, LLC

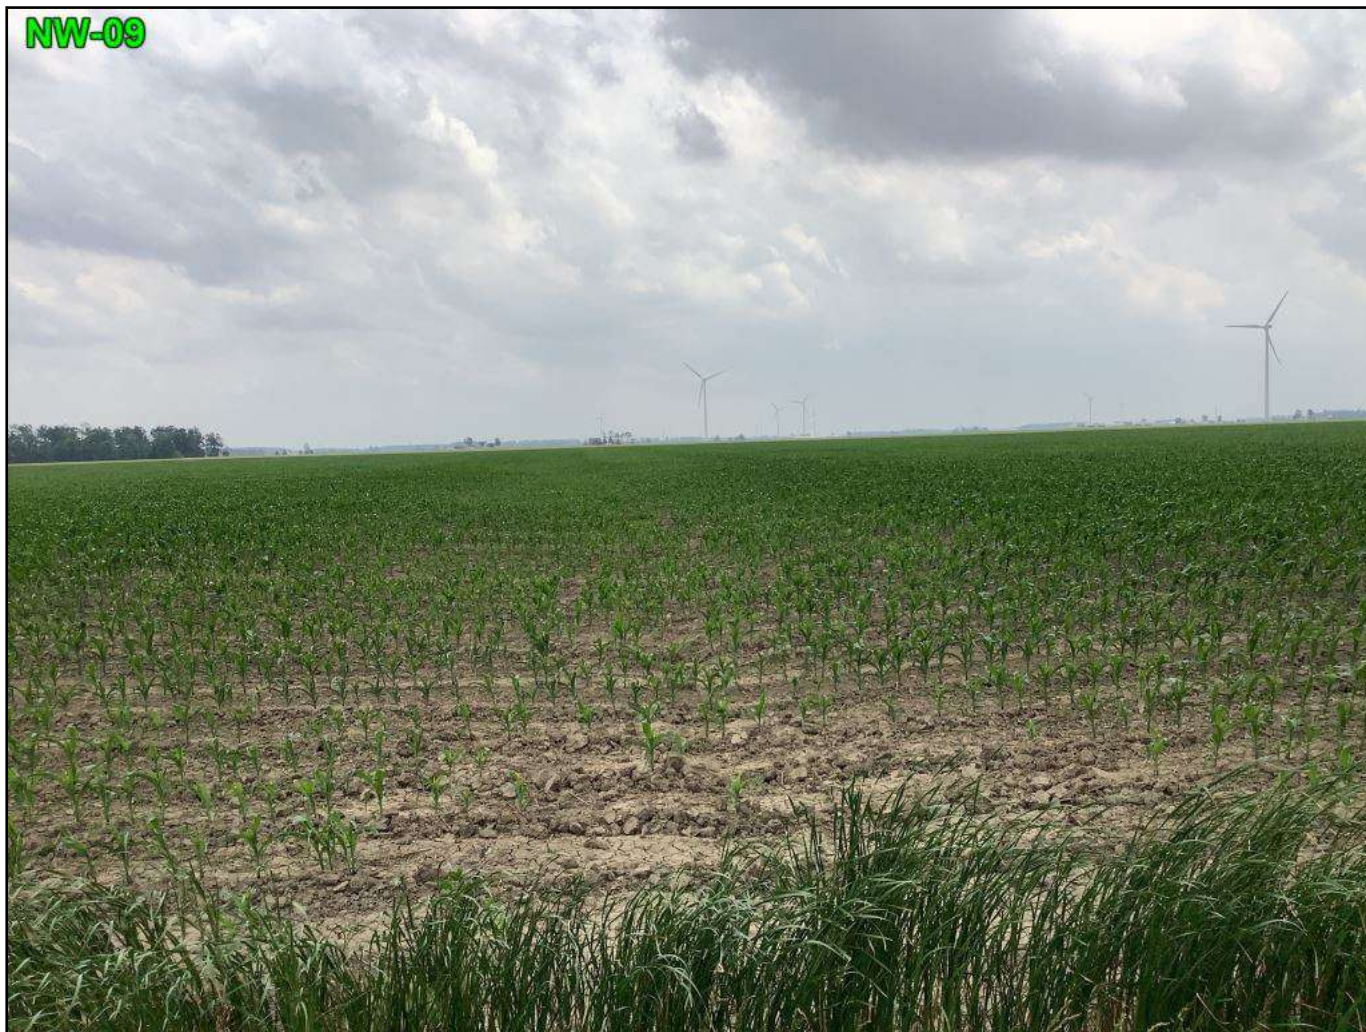
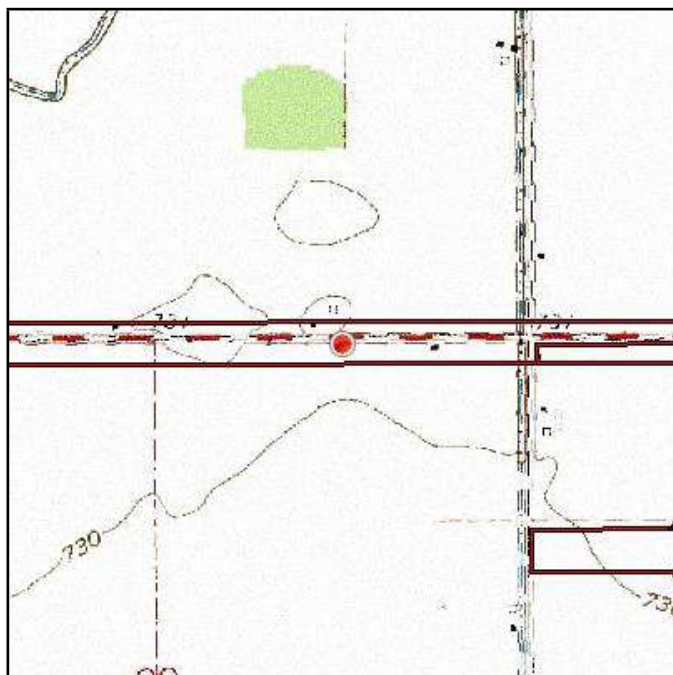
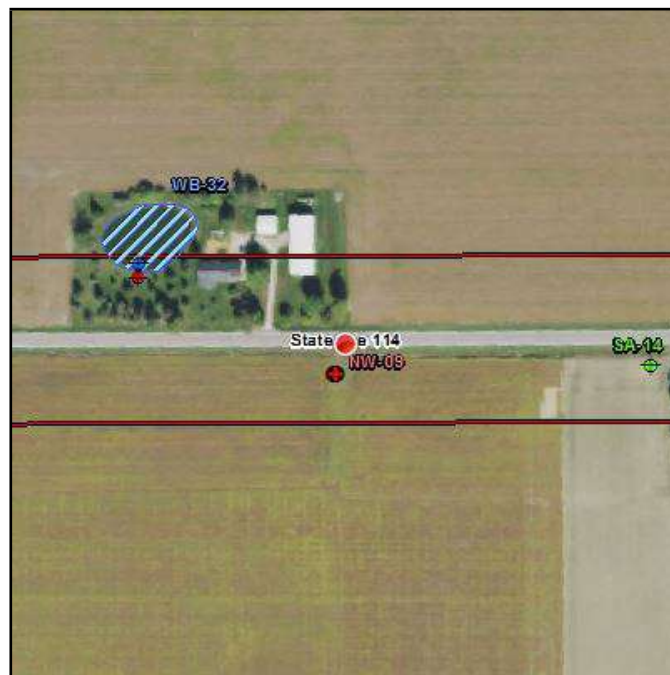
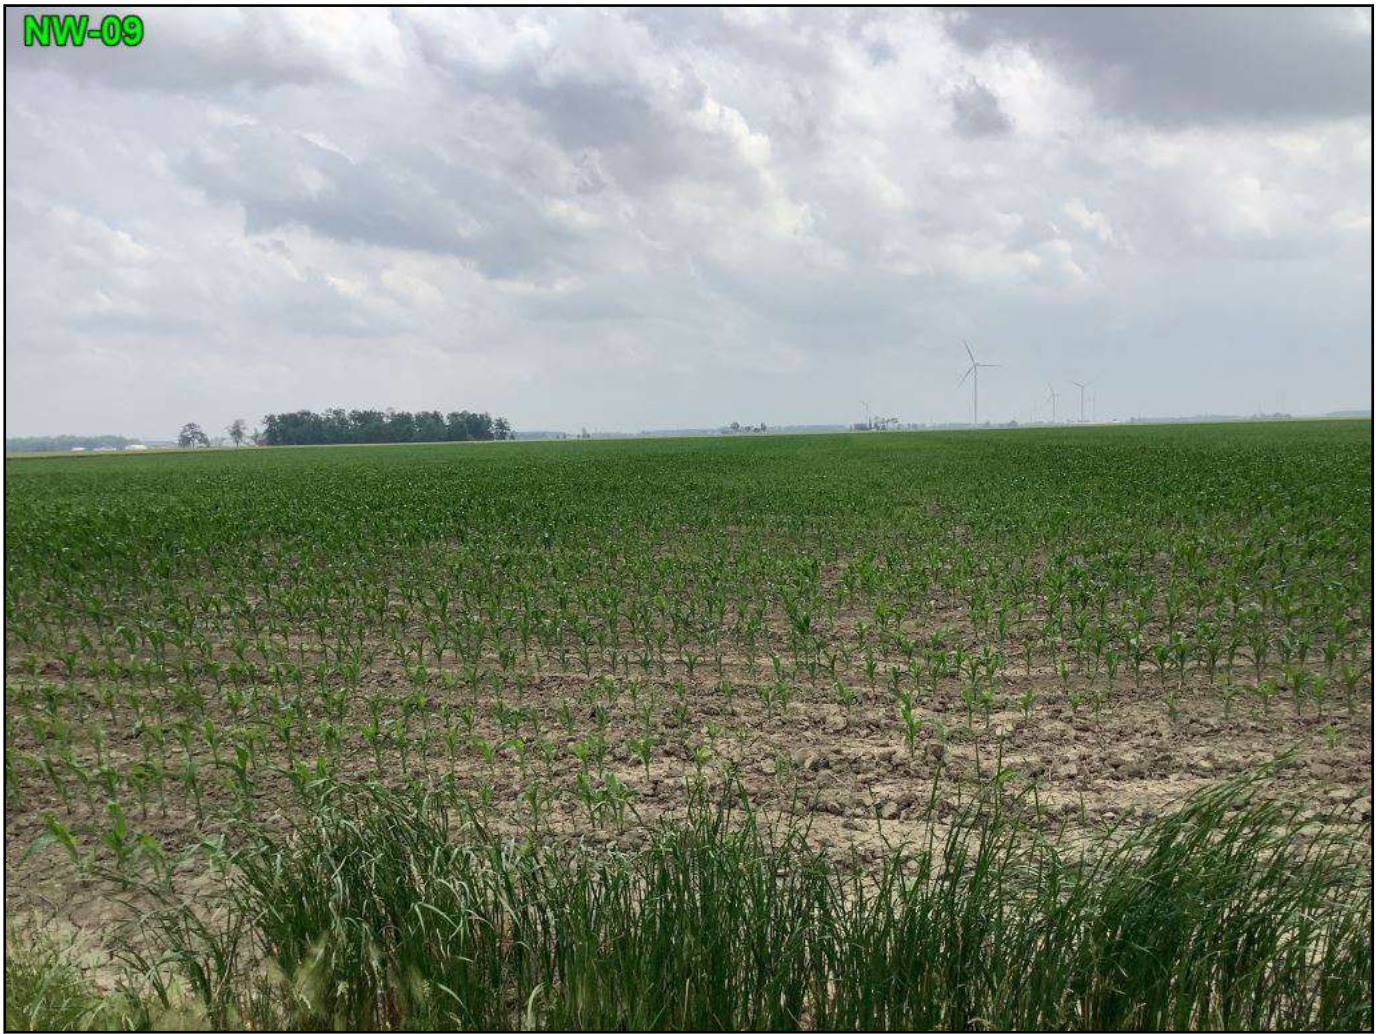
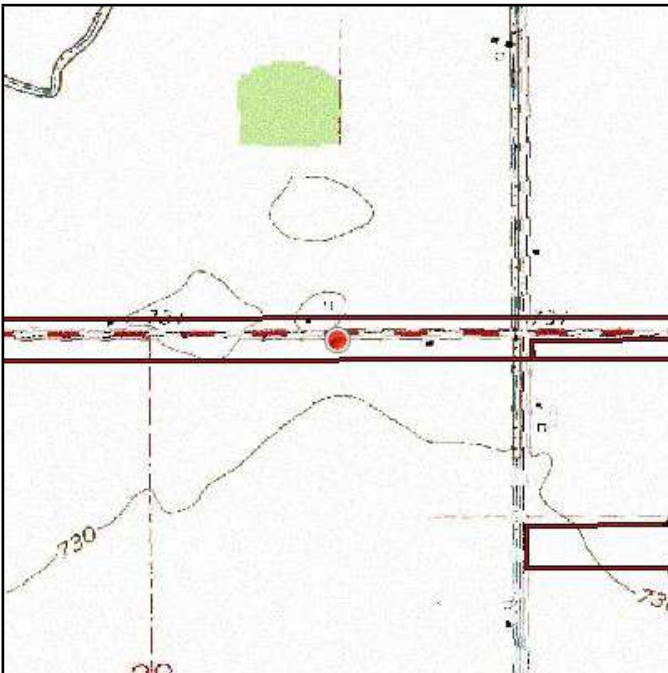
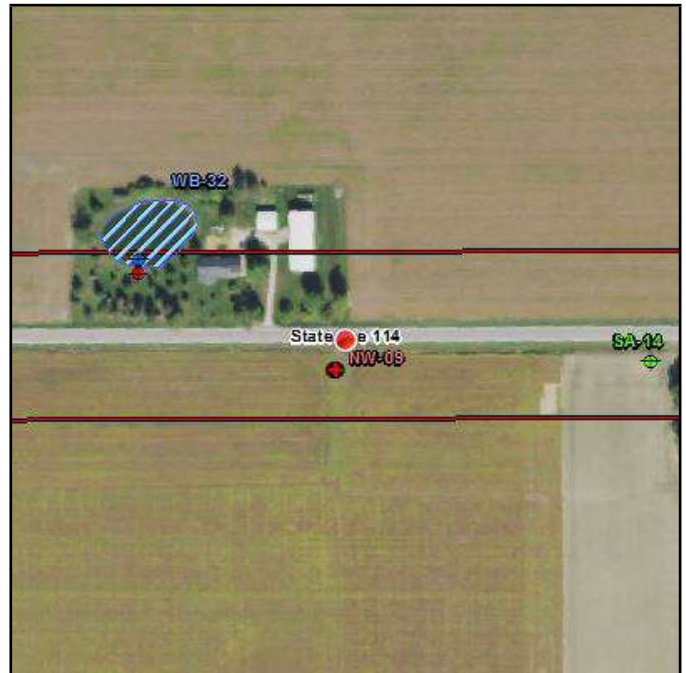
NW-09

| Attributes | |
| Defined Bed and Bank | No |
| Water Width at Crossing (ft) | No Water Noted |
| Water Depth at Crossing (ft) | No Water Noted |
| OHWM Width (ft) | N/A, No OHWM Noted |
| OHWM Height (ft from substrate) | N/A, No OHWM Noted |
| OHWM Criteria | None Noted |
| Pools, Riffles, Runs Present? | None Noted |
