**Case No(s). 20-0417-EL-BGN**

Summary: Application - 17 of 40 (Exhibit L – Part 3 of 3 - Water Resources Delineation Report) electronically filed by Christine M.T. Pirik on behalf of Grover Hill Wind, LLC

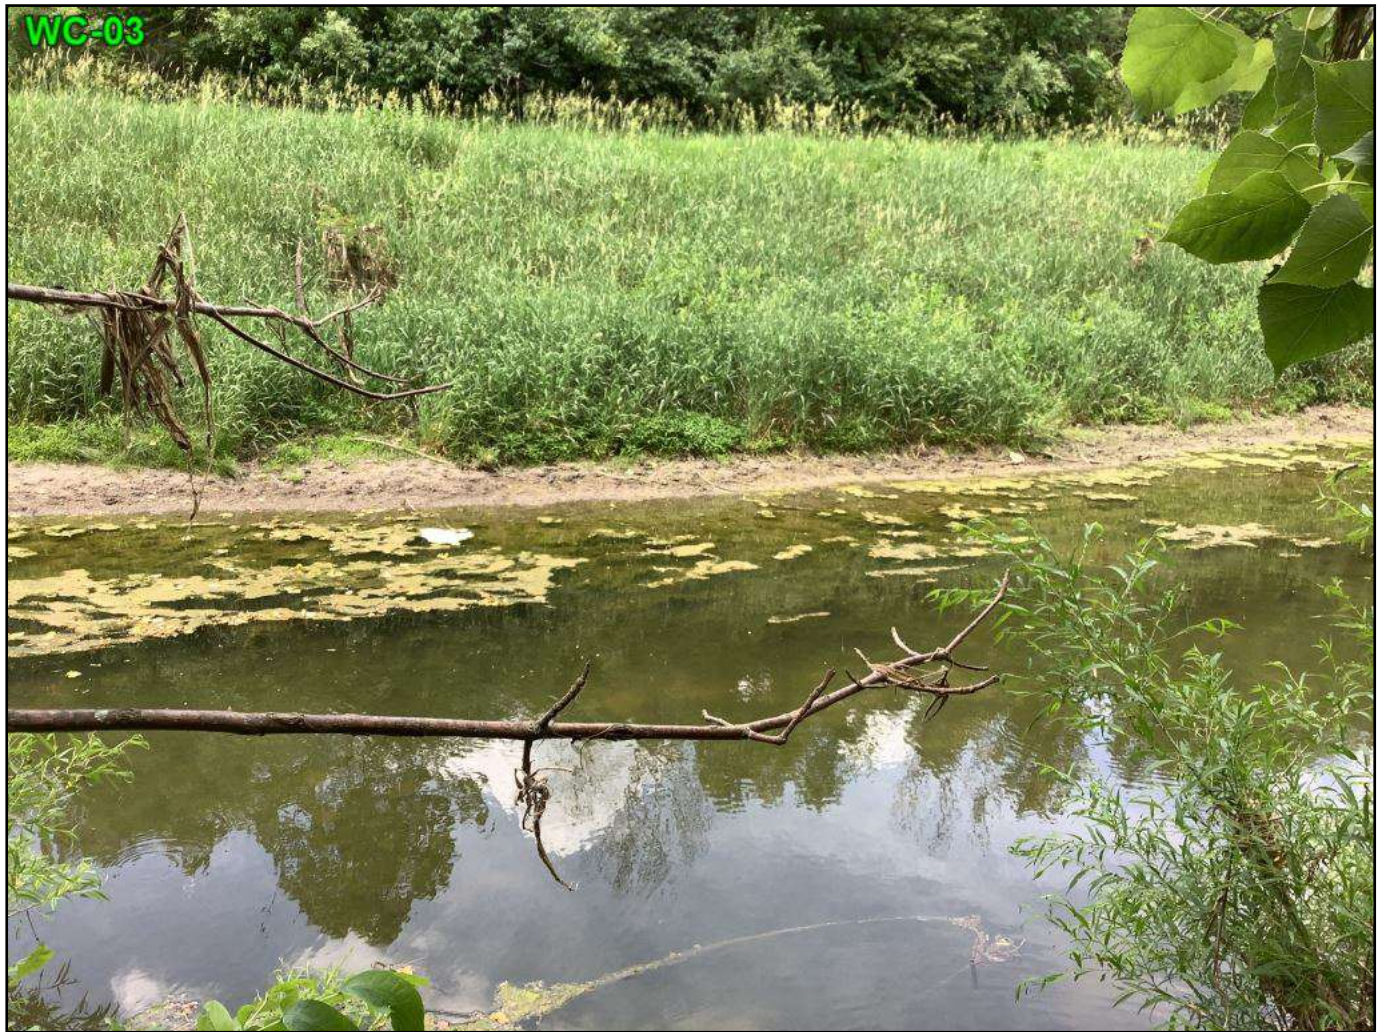
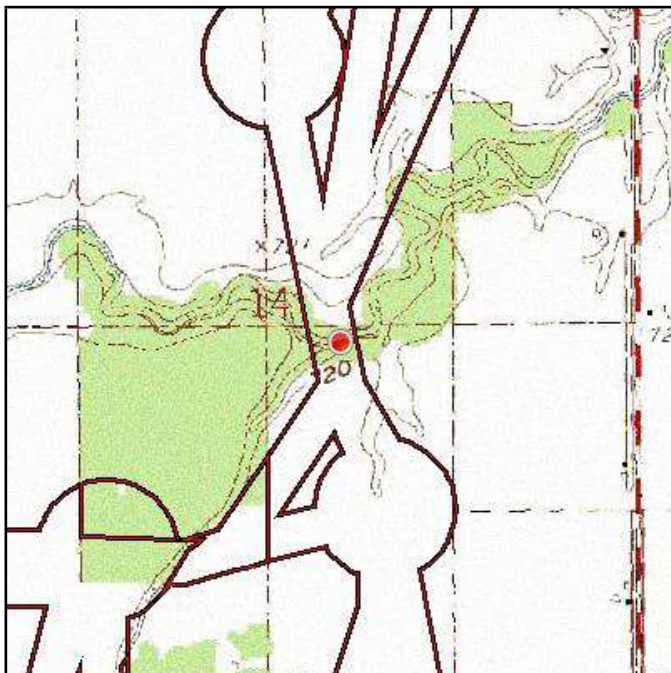
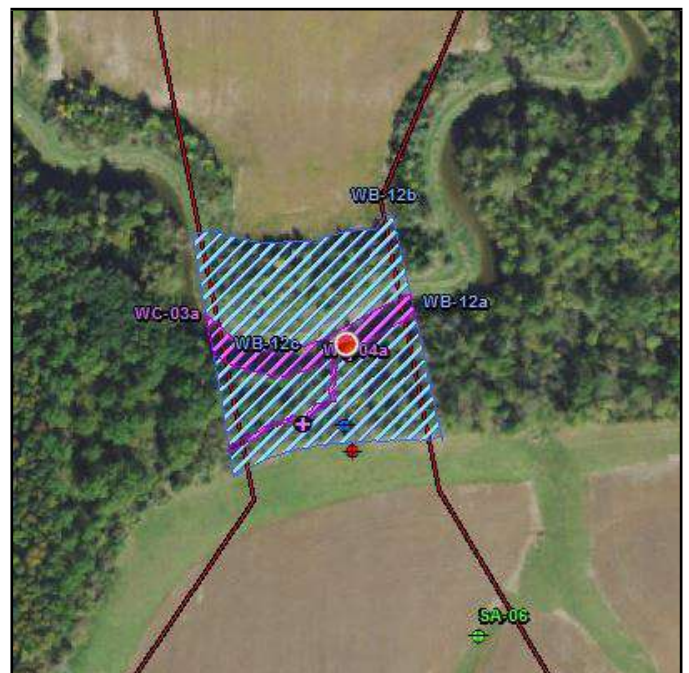
Attributes	
Defined Bed and Bank	Yes
Waters of the US	Yes
Mapped on NHD	Yes
Mapped on NWI	No
Investigator	MCV
Flow Characteristics	Perennial
Direction of Flow (Direction Downstream)	E
Water Width at Crossing (ft)	20
Water Depth at Crossing (ft)	2
Top of Bank Width (ft)	25
Left Bank Height (ft) (Looking Downstream)	12
Right Bank Height (ft) (Looking Downstream)	10
OHWM Width (ft)	20
OHWM Height (ft from substrate)	6
Evidence of Scour or Erosion	No
OHWM Criteria	Clear, Natural Line Impressed on Bank
Pools, Riffles, Runs Present?	Pools and Runs
Substrate	Sand

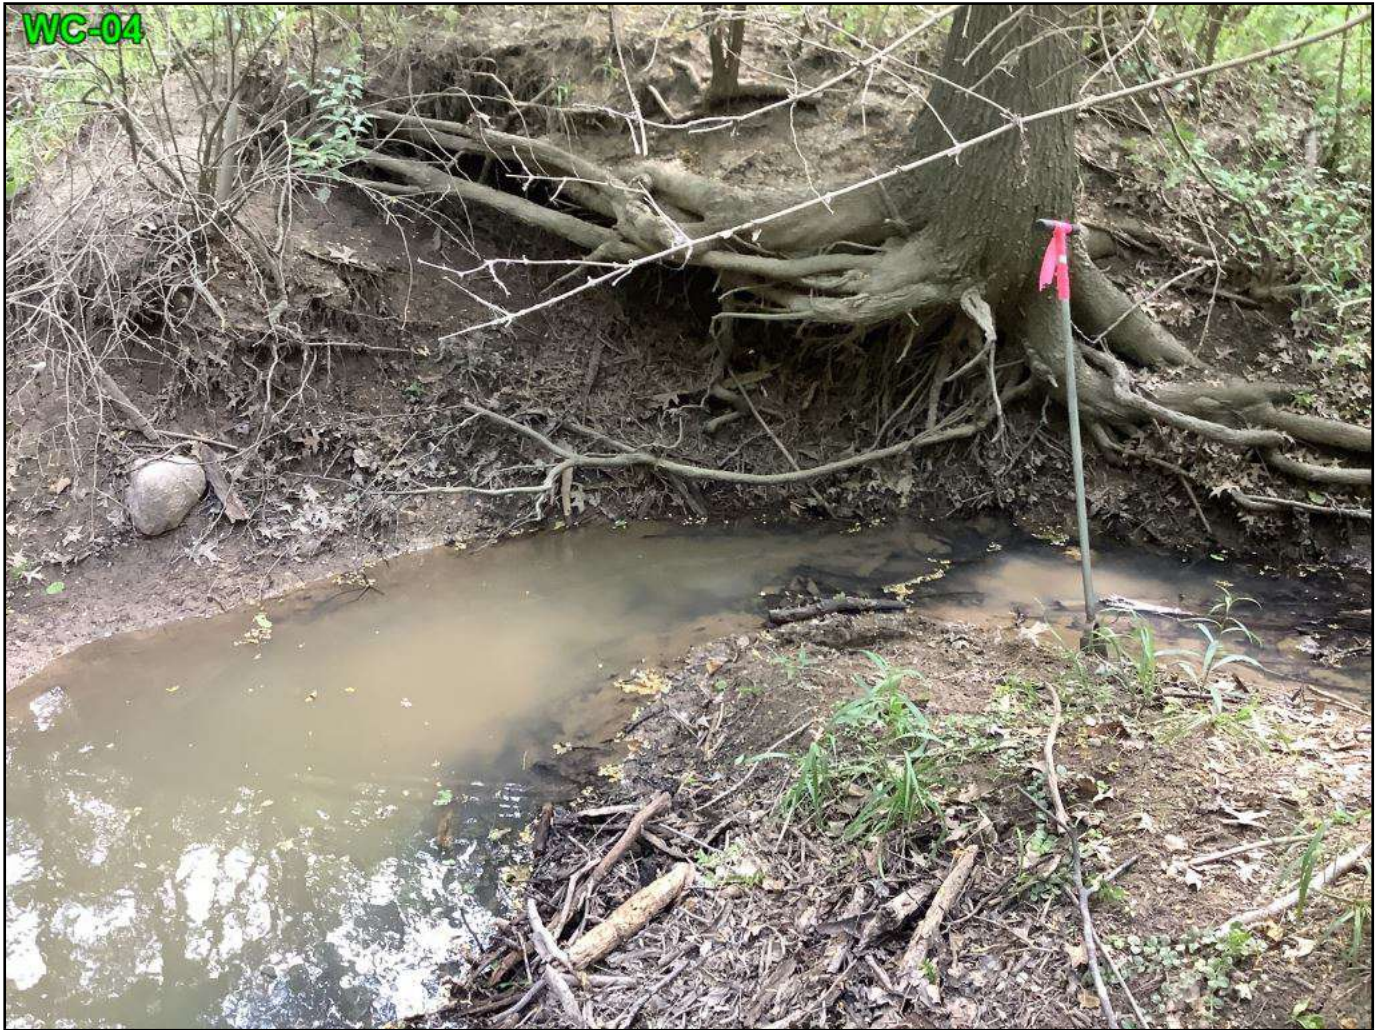
WC-04

Attributes	
Defined Bed and Bank	Yes
Waters of the US	Yes
Mapped on NHD	Yes
Mapped on NWI	No
Investigator	MCV
Flow Characteristics	Intermittent
Direction of Flow (Direction Downstream)	N
Water Width at Crossing (ft)	2
Water Depth at Crossing (ft)	0.5
Top of Bank Width (ft)	8
Left Bank Height (ft) (Looking Downstream)	4
Right Bank Height (ft) (Looking Downstream)	6
OHWM Width (ft)	7
OHWM Height (ft from substrate)	5
Evidence of Scour or Erosion	No
OHWM Criteria	Clear, Natural Line Impressed on Bank
Pools, Riffles, Runs Present?	Pools, Riffles, Runs
Substrate	Silt

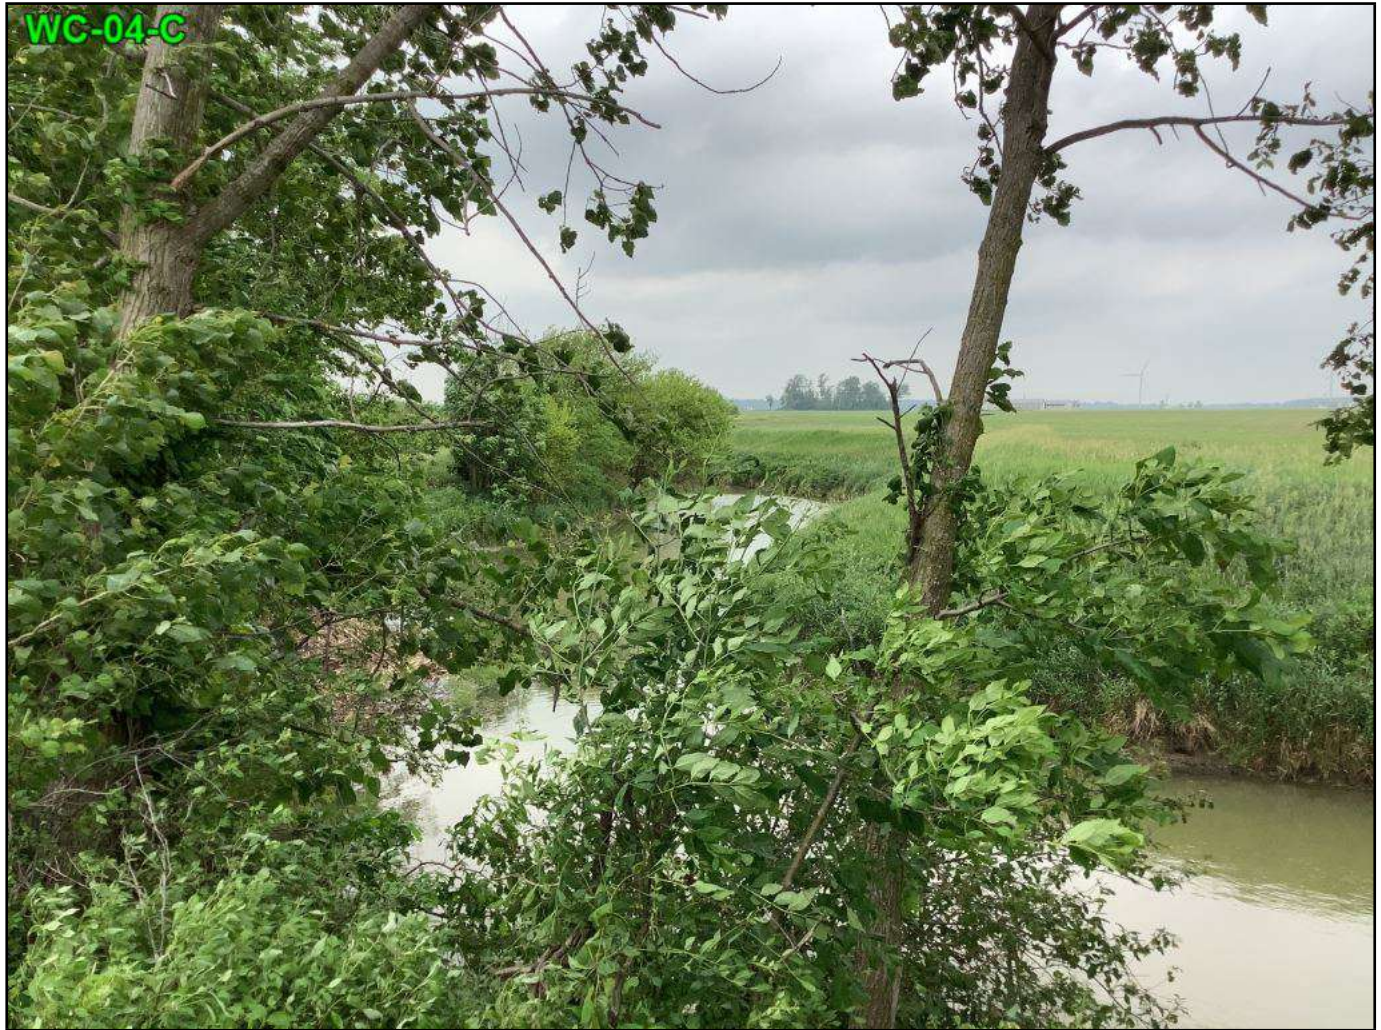
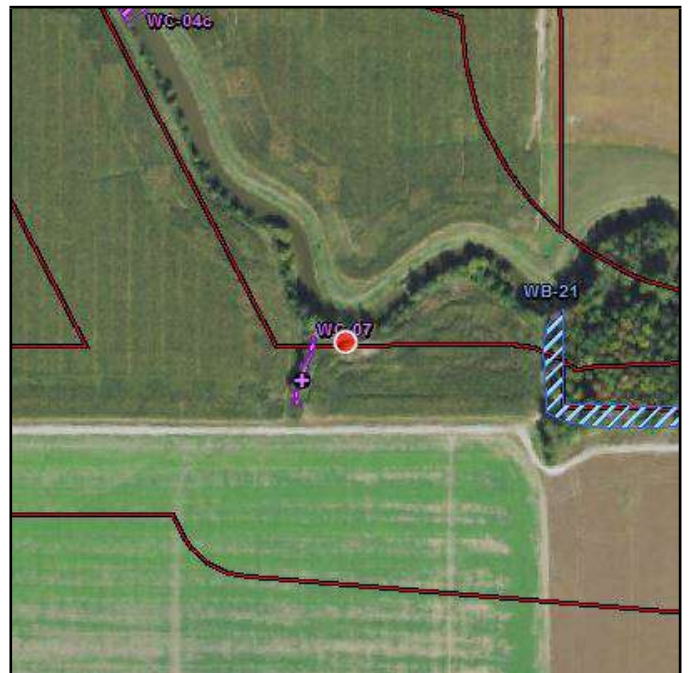
Attributes	
Defined Bed and Bank	Yes
Waters of the US	Yes
Mapped on NHD	Yes
Mapped on NWI	No
Investigator	MCV
Flow Characteristics	Perennial
Direction of Flow (Direction Downstream)	E
Water Width at Crossing (ft)	20
Water Depth at Crossing (ft)	2
Top of Bank Width (ft)	35
Left Bank Height (ft) (Looking Downstream)	9
Right Bank Height (ft) (Looking Downstream)	8
OHWM Width (ft)	25
OHWM Height (ft from substrate)	5
Evidence of Scour or Erosion	No
OHWM Criteria	Clear, Natural Line Impressed on Bank
Pools, Riffles, Runs Present?	Runs
Substrate	Sand

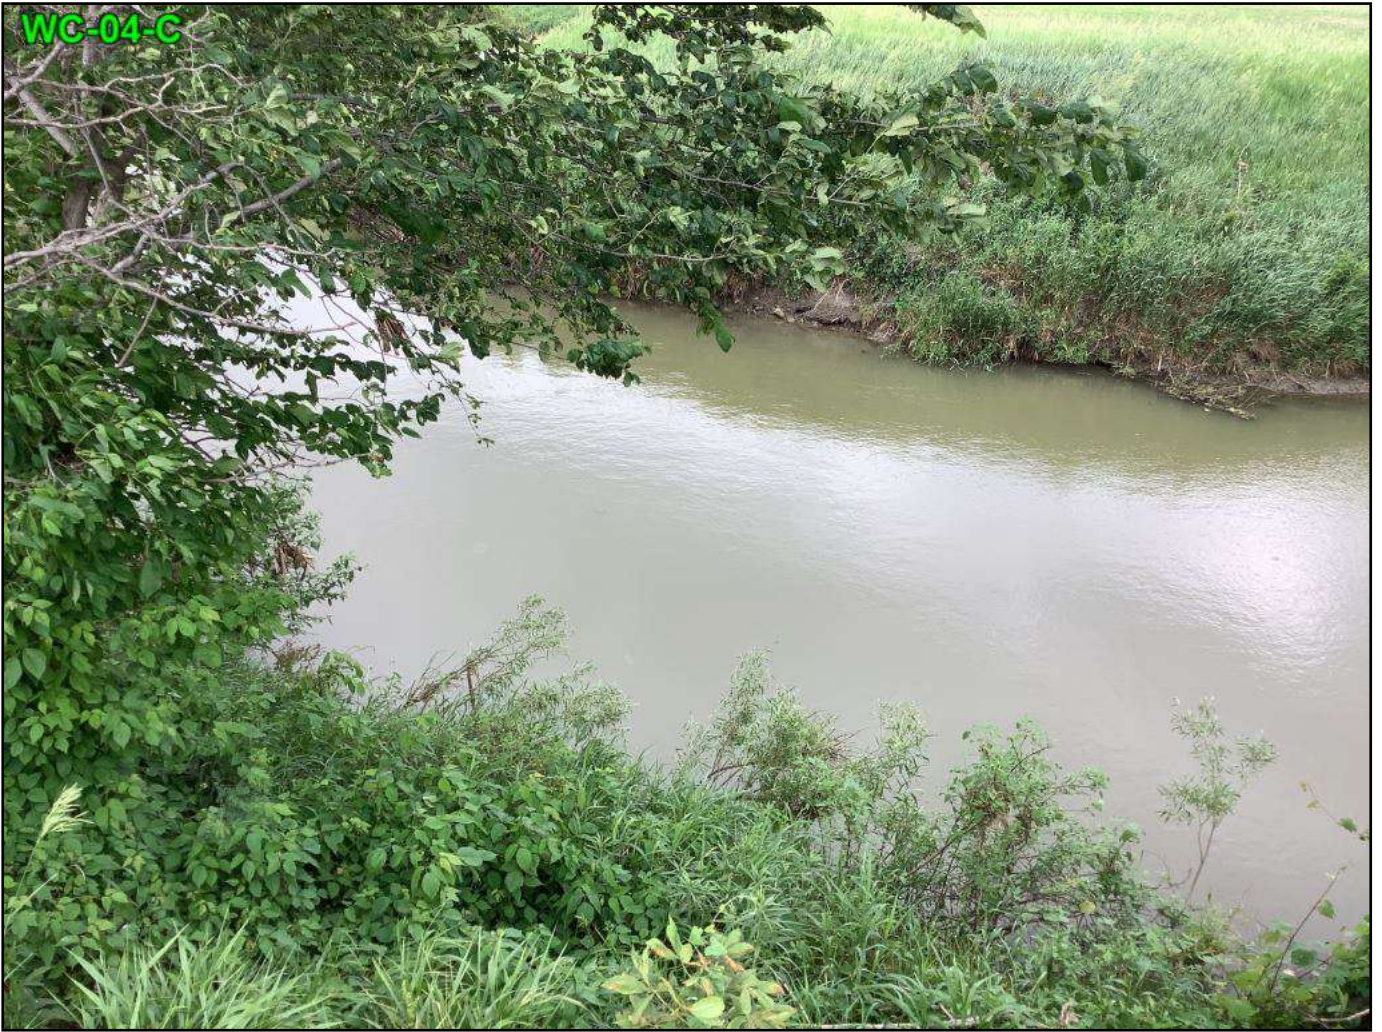
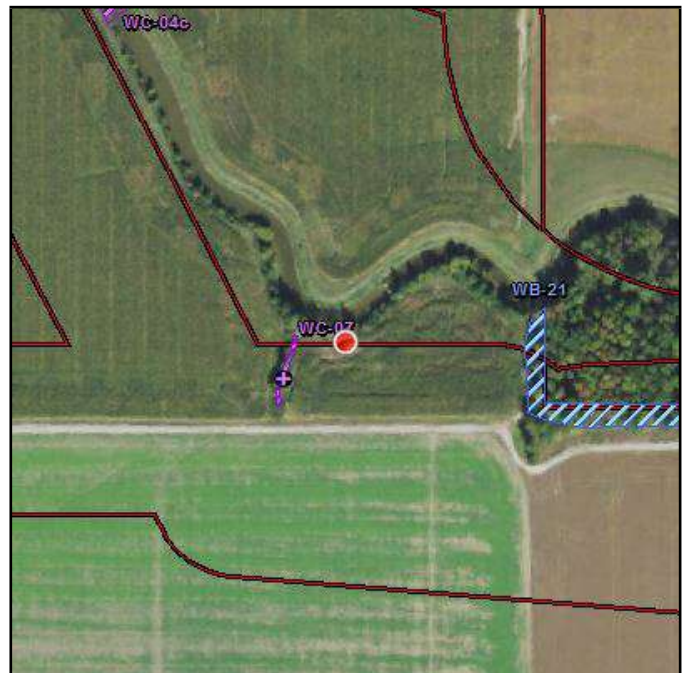
Attributes	
Defined Bed and Bank	Yes
Waters of the US	Yes
Mapped on NHD	Yes
Mapped on NWI	No
Investigator	MCV
Flow Characteristics	Perennial
Direction of Flow (Direction Downstream)	E
Water Width at Crossing (ft)	20
Water Depth at Crossing (ft)	3
Top of Bank Width (ft)	35
Left Bank Height (ft) (Looking Downstream)	9
Right Bank Height (ft) (Looking Downstream)	10
OHWM Width (ft)	25
OHWM Height (ft from substrate)	7
Evidence of Scour or Erosion	No
OHWM Criteria	Clear, Natural Line Impressed on Bank
Pools, Riffles, Runs Present?	Runs
Substrate	Silt

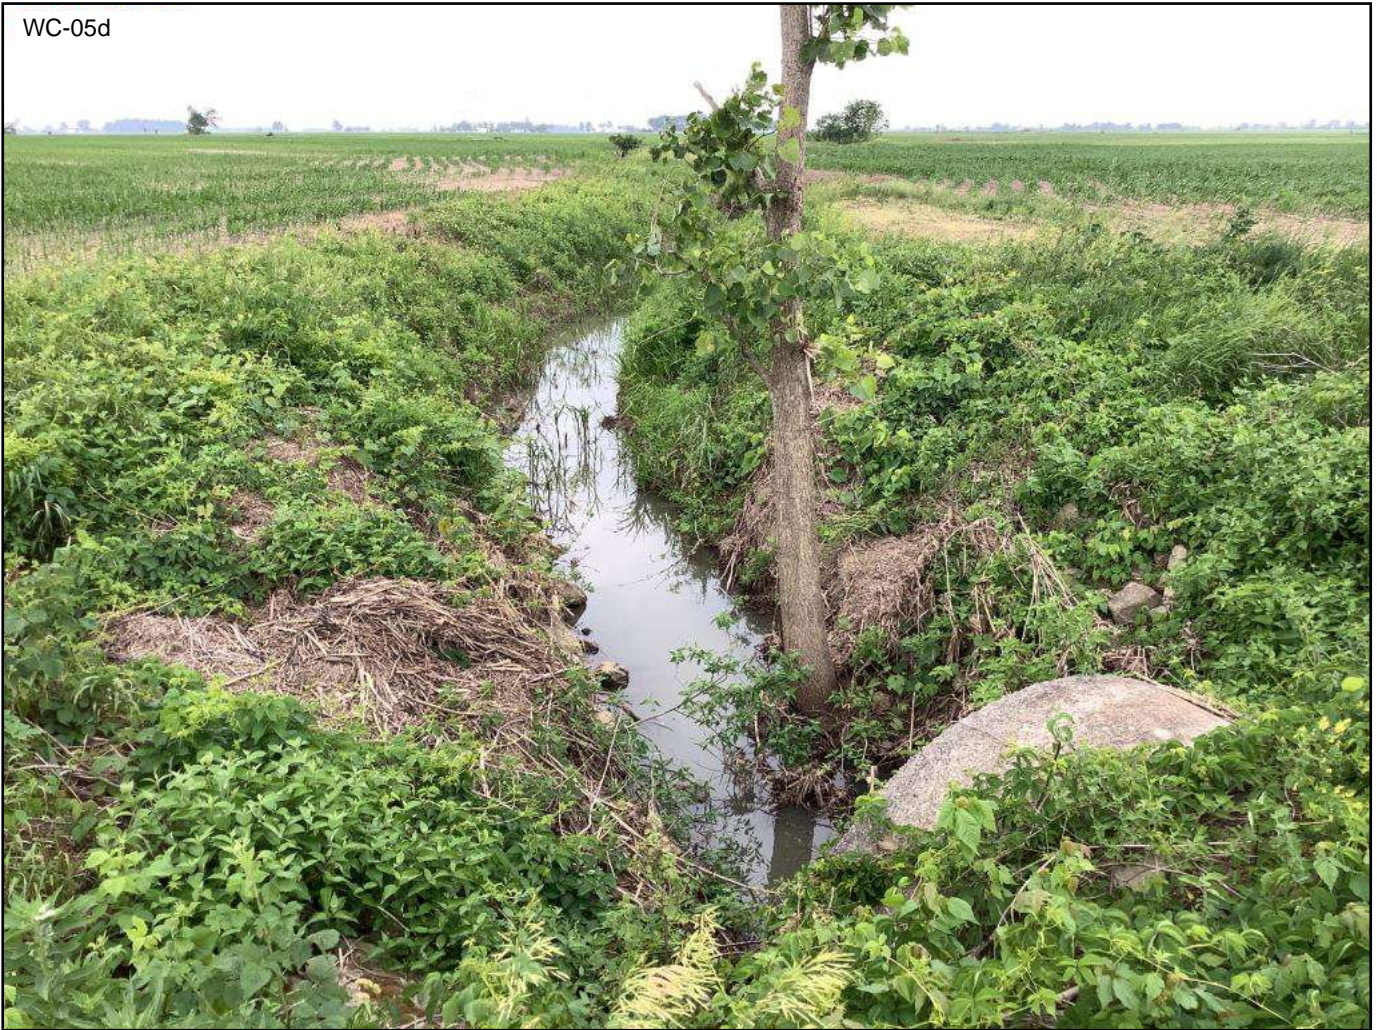
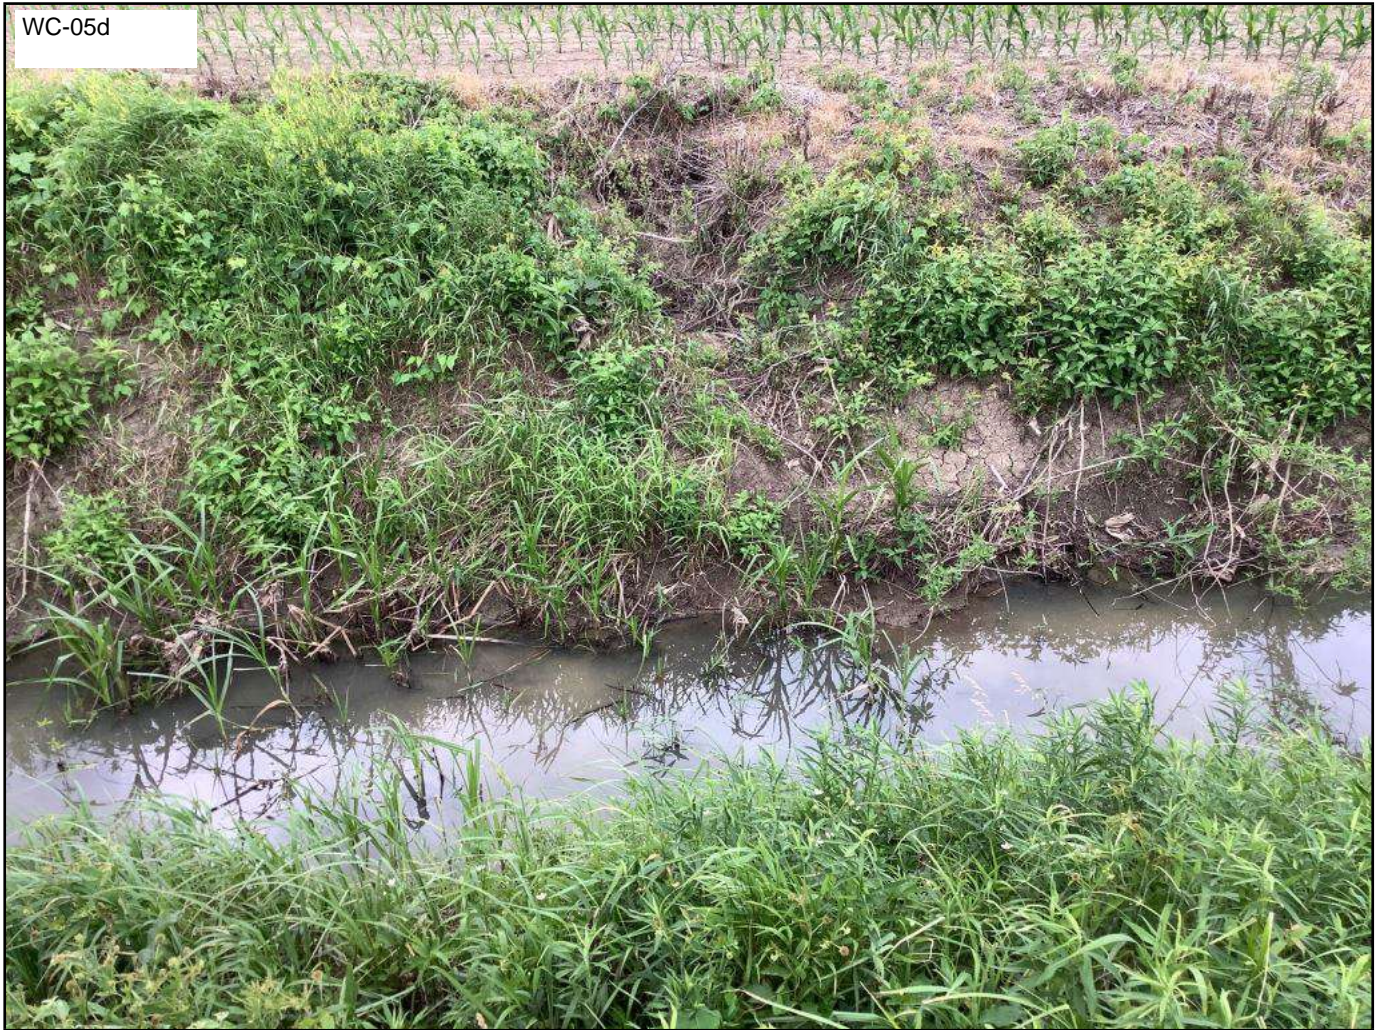
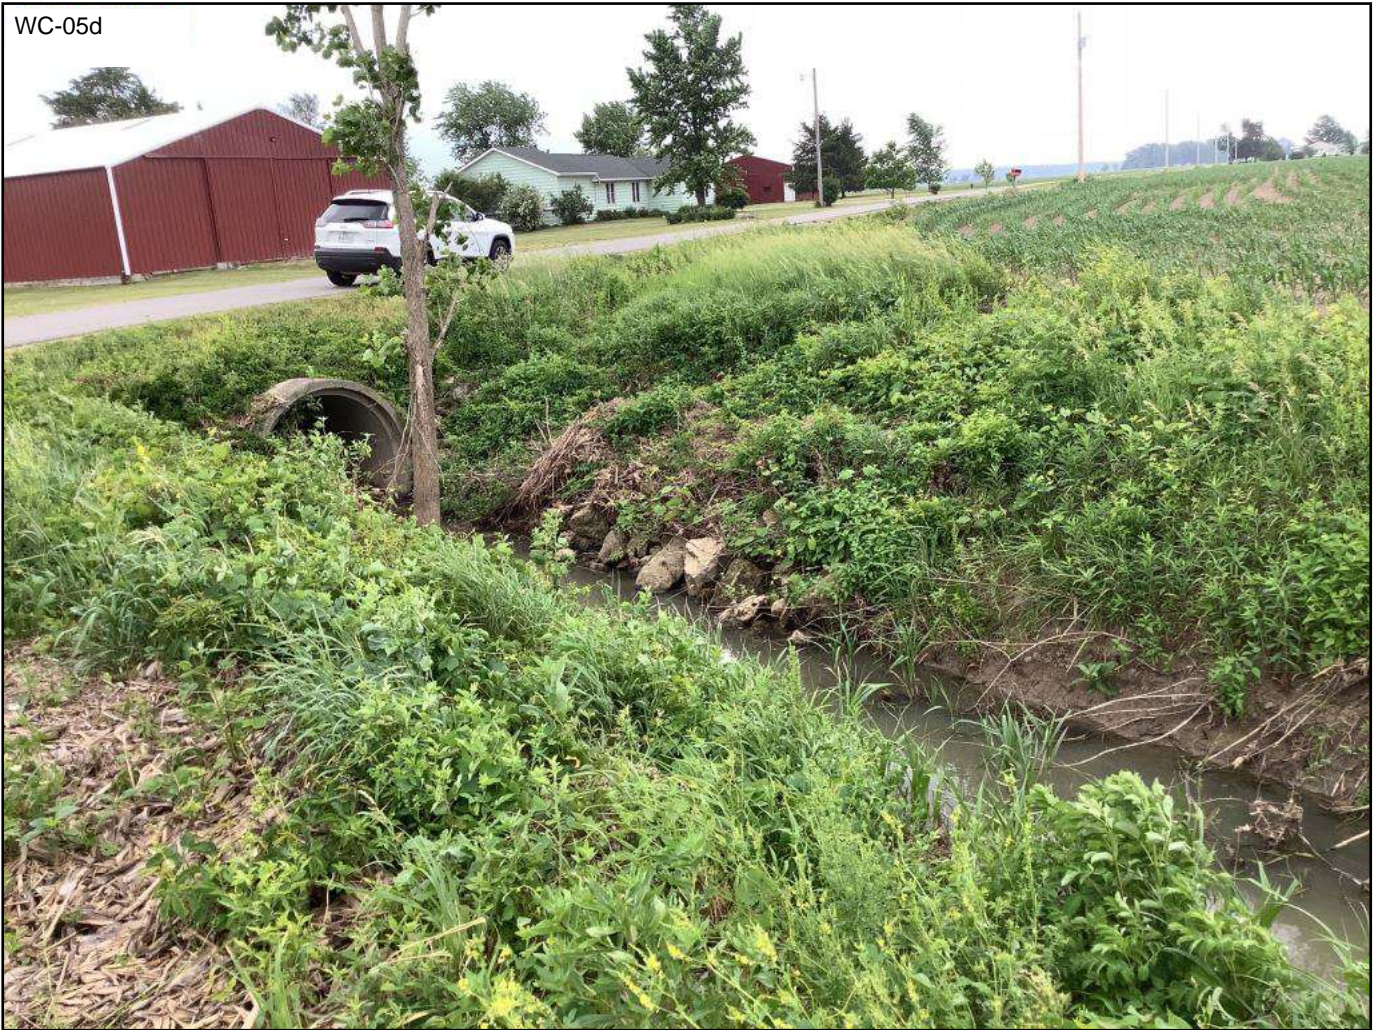
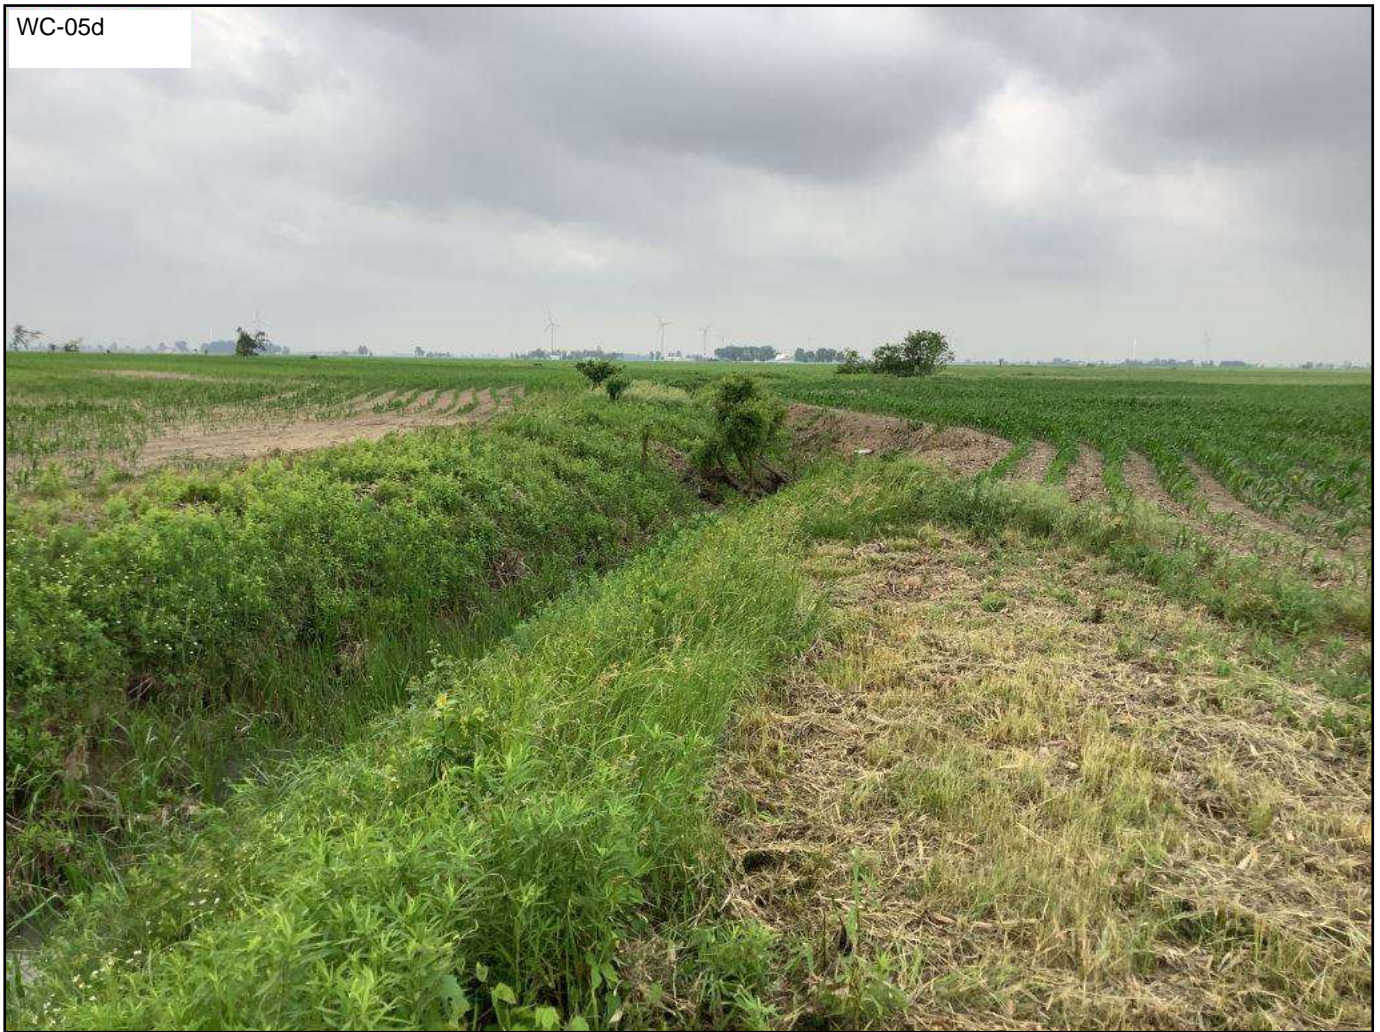
WC-05d

Attributes	
Defined Bed and Bank	Yes
Waters of the US	Yes
Mapped on NHD	Yes
Mapped on NWI	No
Investigator	MCV
Flow Characteristics	Intermittent
Direction of Flow (Direction Downstream)	E
Water Width at Crossing (ft)	2
Water Depth at Crossing (ft)	0.5
Top of Bank Width (ft)	13
Left Bank Height (ft) (Looking Downstream)	7
Right Bank Height (ft) (Looking Downstream)	7
OHWM Width (ft)	6
OHWM Height (ft from substrate)	5
Evidence of Scour or Erosion	No
OHWM Criteria	Clear, Natural Line Impressed on Bank
Pools, Riffles, Runs Present?	Runs
Substrate	Silt

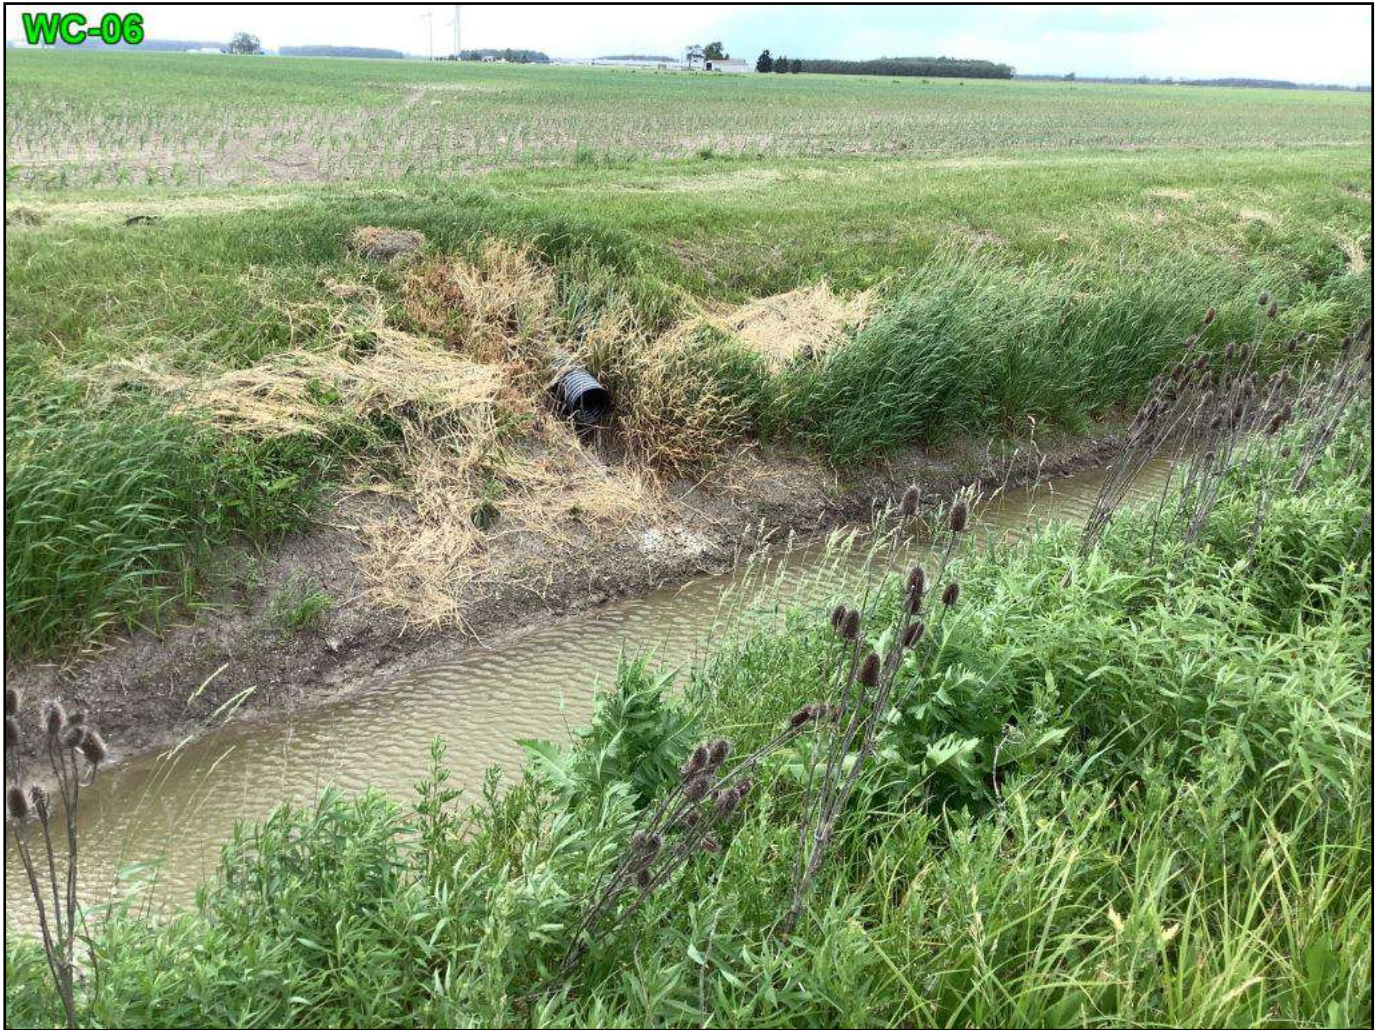
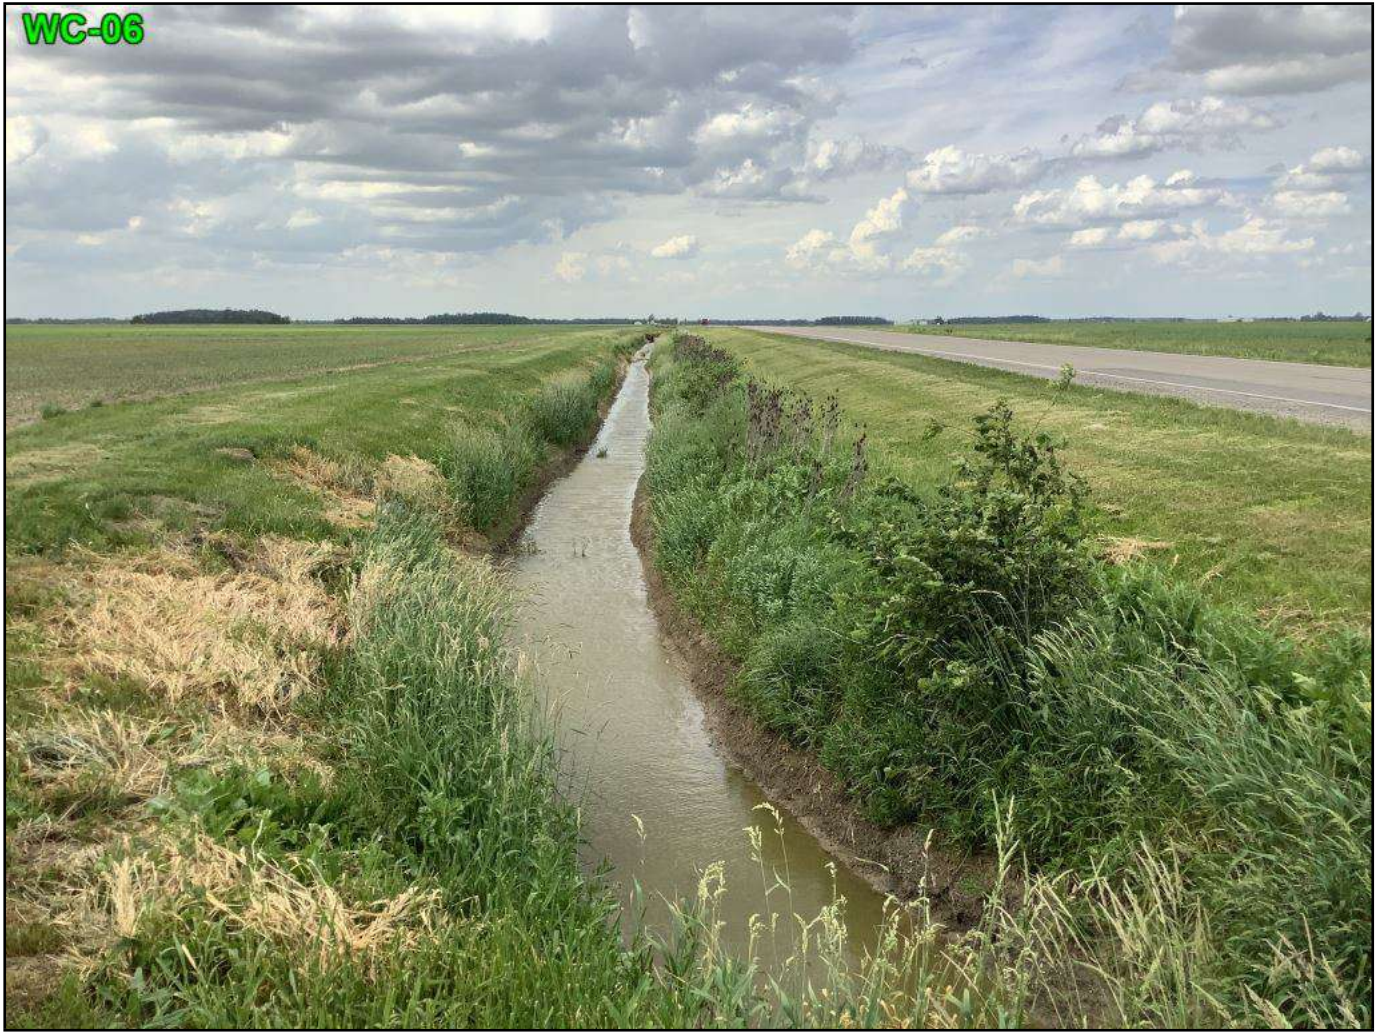
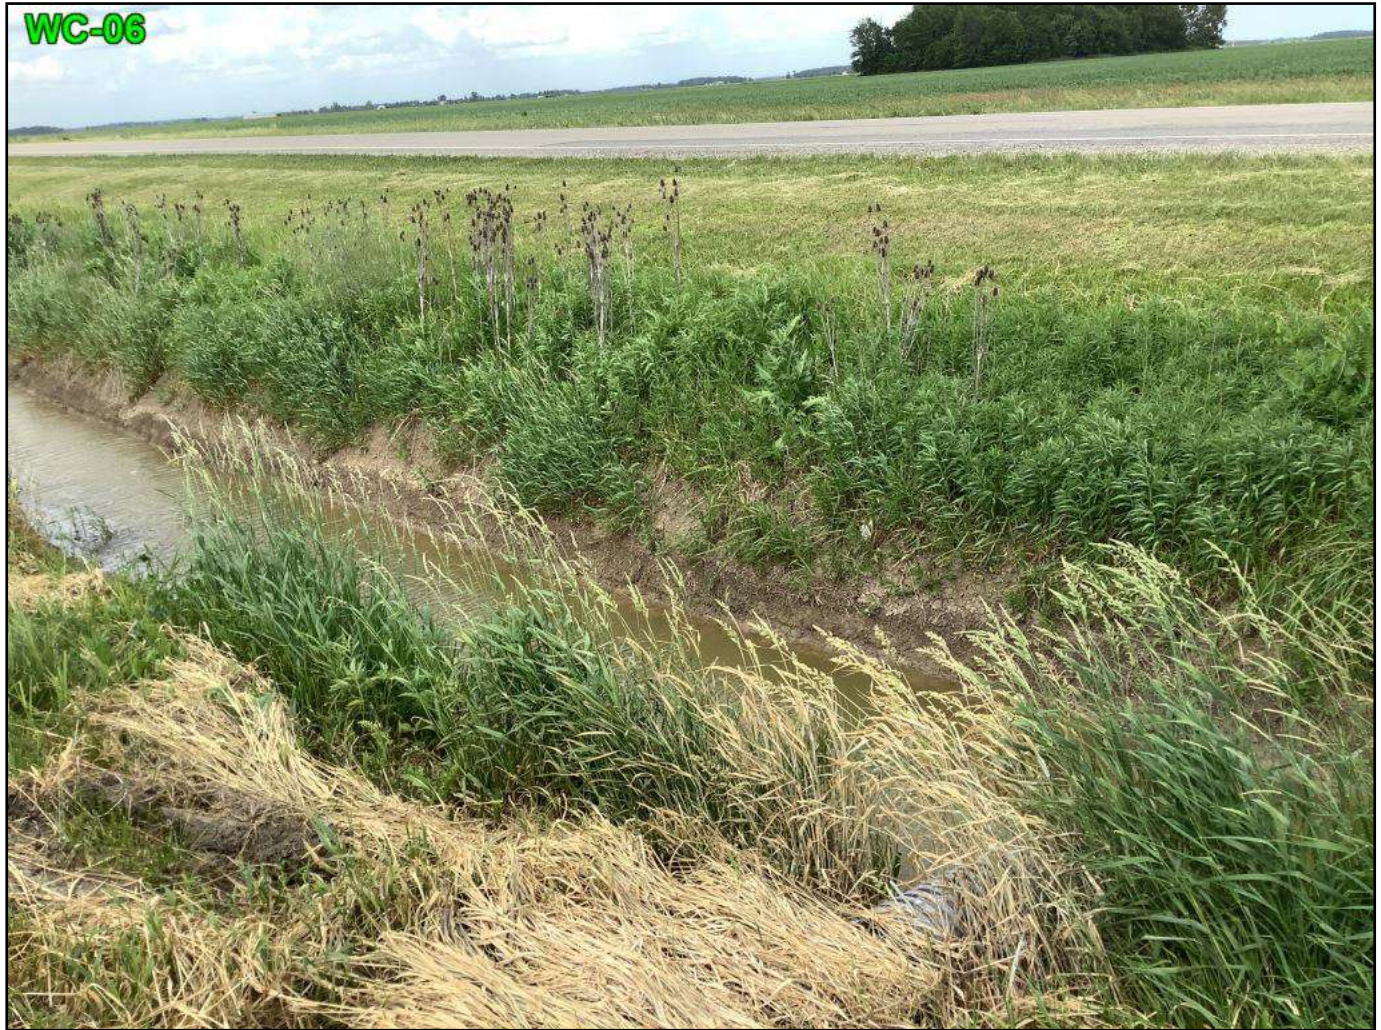
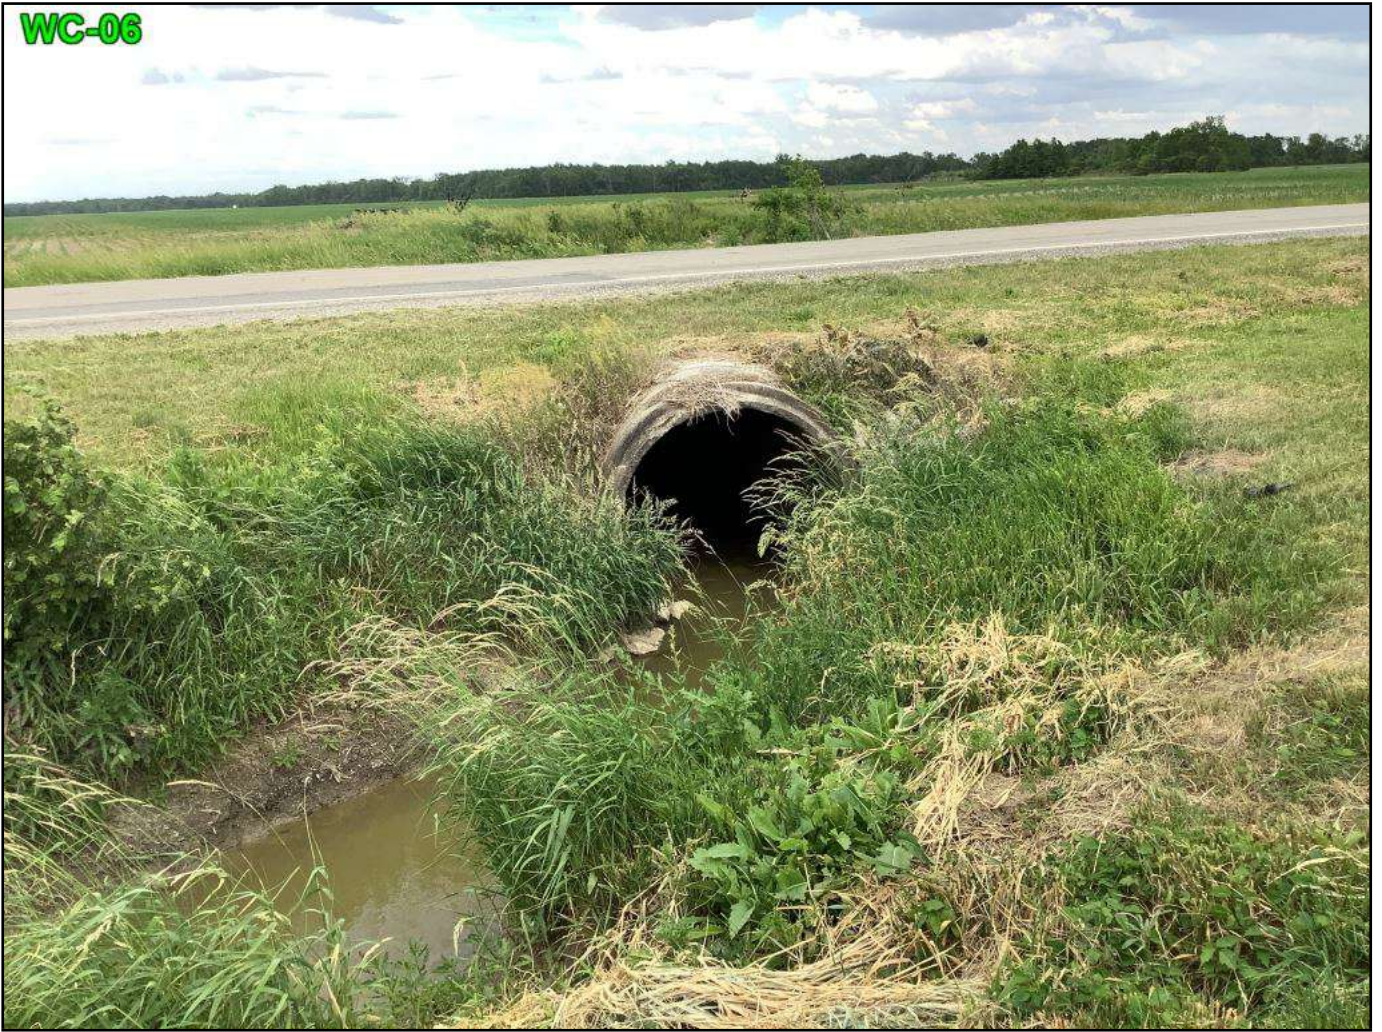
WC-06

Attributes	
Defined Bed and Bank	Yes
Waters of the US	Yes
Mapped on NHD	Yes
Mapped on NWI	No
Investigator	MCV
Flow Characteristics	Intermittent
Direction of Flow (Direction Downstream)	N
Water Width at Crossing (ft)	3
Water Depth at Crossing (ft)	1
Top of Bank Width (ft)	11
Left Bank Height (ft) (Looking Downstream)	6
Right Bank Height (ft) (Looking Downstream)	5
OHWM Width (ft)	6
OHWM Height (ft from substrate)	4
Evidence of Scour or Erosion	No
OHWM Criteria	Clear, Natural Line Impressed on Bank
Pools, Riffles, Runs Present?	Runs
Substrate	Silt

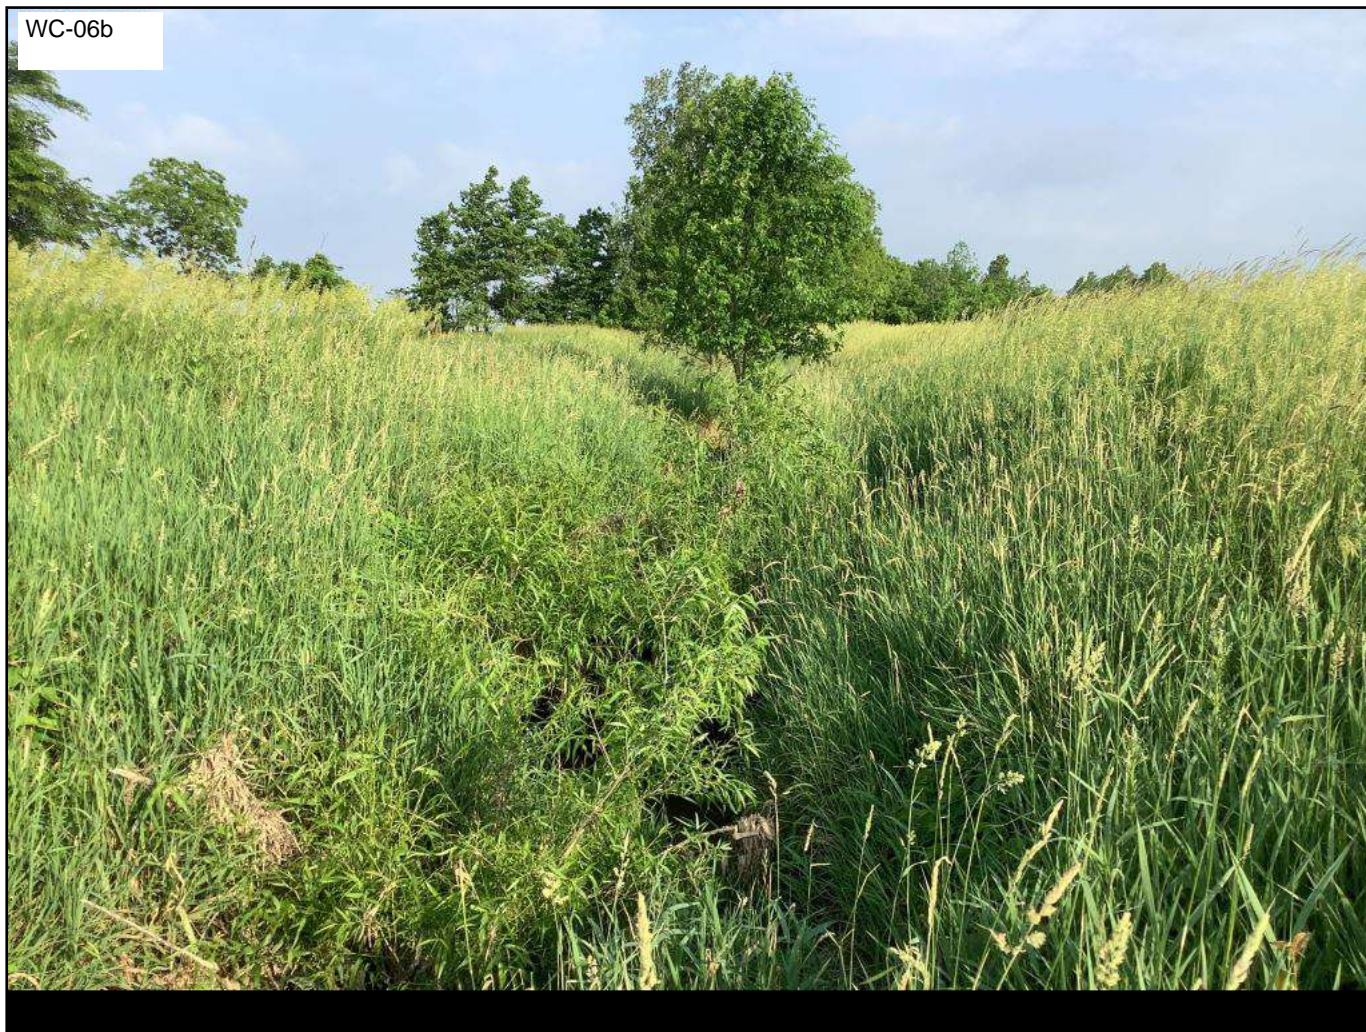
WC-06b

Attributes	
Defined Bed and Bank	Yes
Waters of the US	Yes
Mapped on NHD	Yes
Mapped on NWI	No
Investigator	MCV
Flow Characteristics	Perennial
Direction of Flow (Direction Downstream)	E
Water Width at Crossing (ft)	4
Water Depth at Crossing (ft)	1
Top of Bank Width (ft)	10
Left Bank Height (ft) (Looking Downstream)	5
Right Bank Height (ft) (Looking Downstream)	5
OHWM Width (ft)	8
OHWM Height (ft from substrate)	4
Evidence of Scour or Erosion	No
OHWM Criteria	Clear, Natural Line Impressed on Bank
Pools, Riffles, Runs Present?	Runs
Substrate	Silt
