**Case No(s). 20-0417-EL-BGN**

Summary: Application - 17 of 40 (Exhibit L – Part 3 of 3 - Water Resources Delineation Report) electronically filed by Christine M.T. Pirik on behalf of Grover Hill Wind, LLC

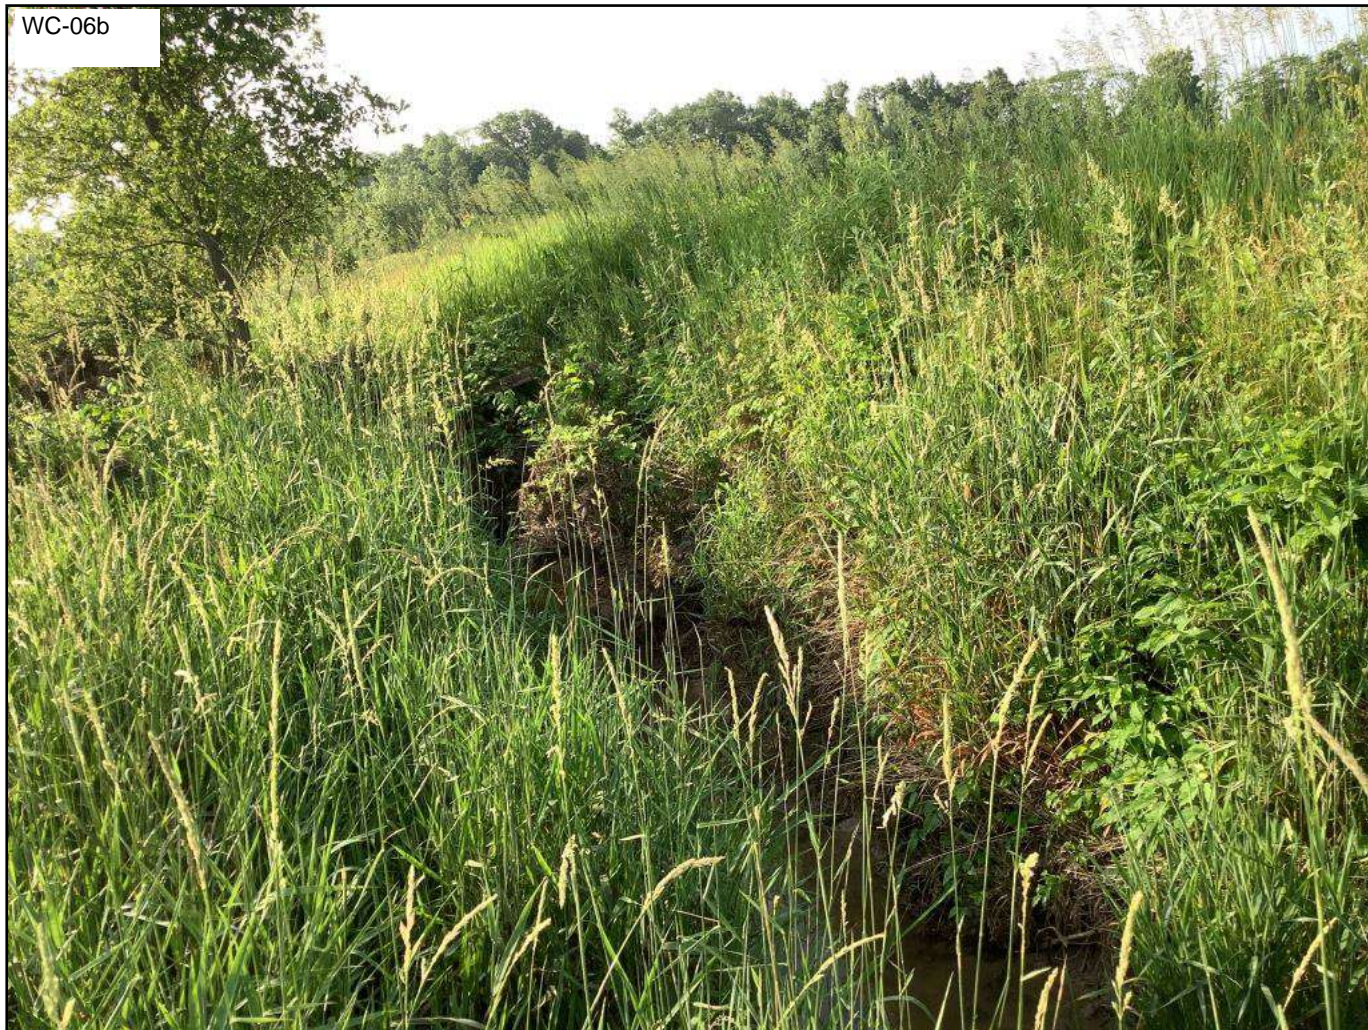
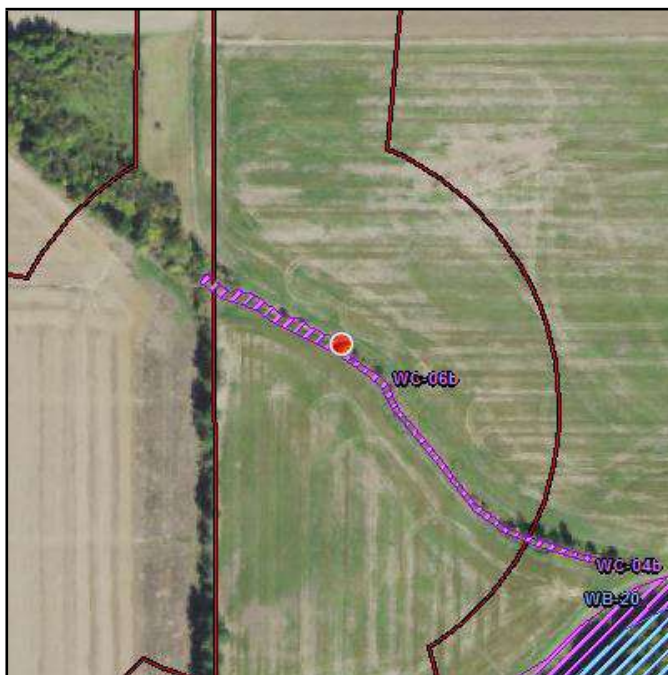
WC-06b

A photograph of a dense, overgrown field. The vegetation is primarily tall green grass and weeds, with some areas showing signs of decay and discoloration, appearing brown or tan. The field is captured from a slightly elevated perspective, showing the texture and density of the plants. A small white label with the text 'WC-06b' is visible in the top left corner.

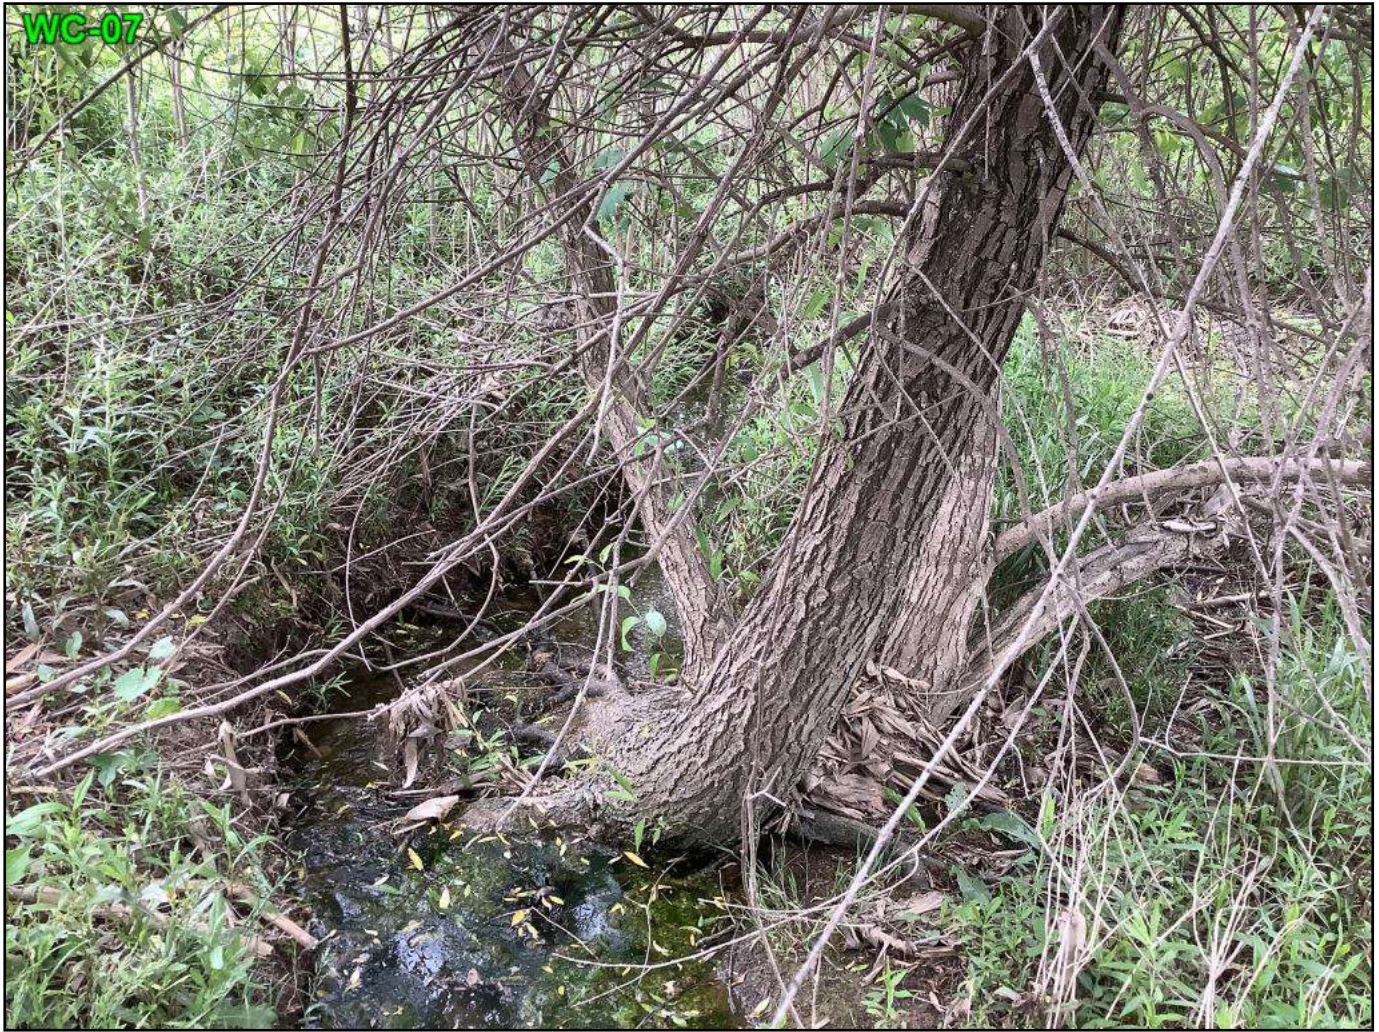
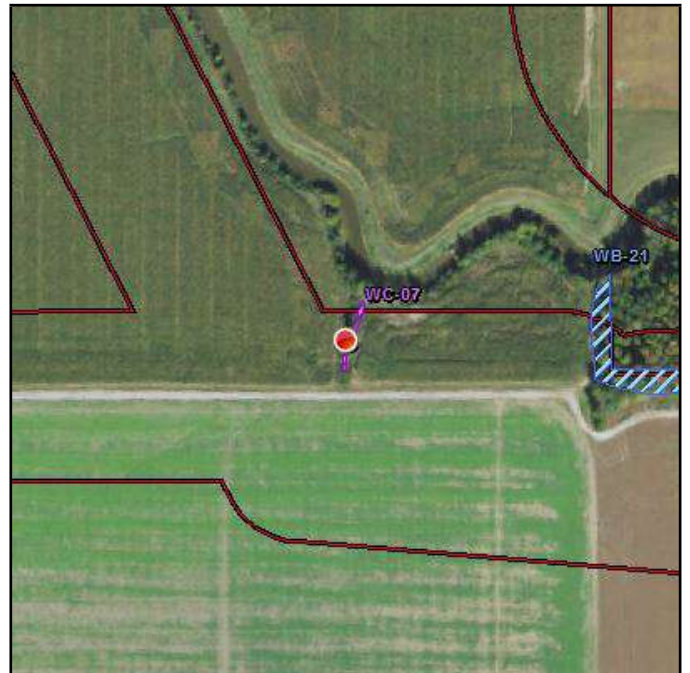
WC-07

Attributes	
Defined Bed and Bank	Yes
Waters of the US	Yes
Mapped on NHD	No
Mapped on NWI	No
Investigator	MCV
Flow Characteristics	Intermittent
Direction of Flow (Direction Downstream)	N
Water Width at Crossing (ft)	1
Water Depth at Crossing (ft)	0.5
Top of Bank Width (ft)	5
Left Bank Height (ft) (Looking Downstream)	3
Right Bank Height (ft) (Looking Downstream)	3
OHWM Width (ft)	5
OHWM Height (ft from substrate)	3
Evidence of Scour or Erosion	No
OHWM Criteria	Clear, Natural Line Impressed on Bank
Pools, Riffles, Runs Present?	Runs
Substrate	Silt

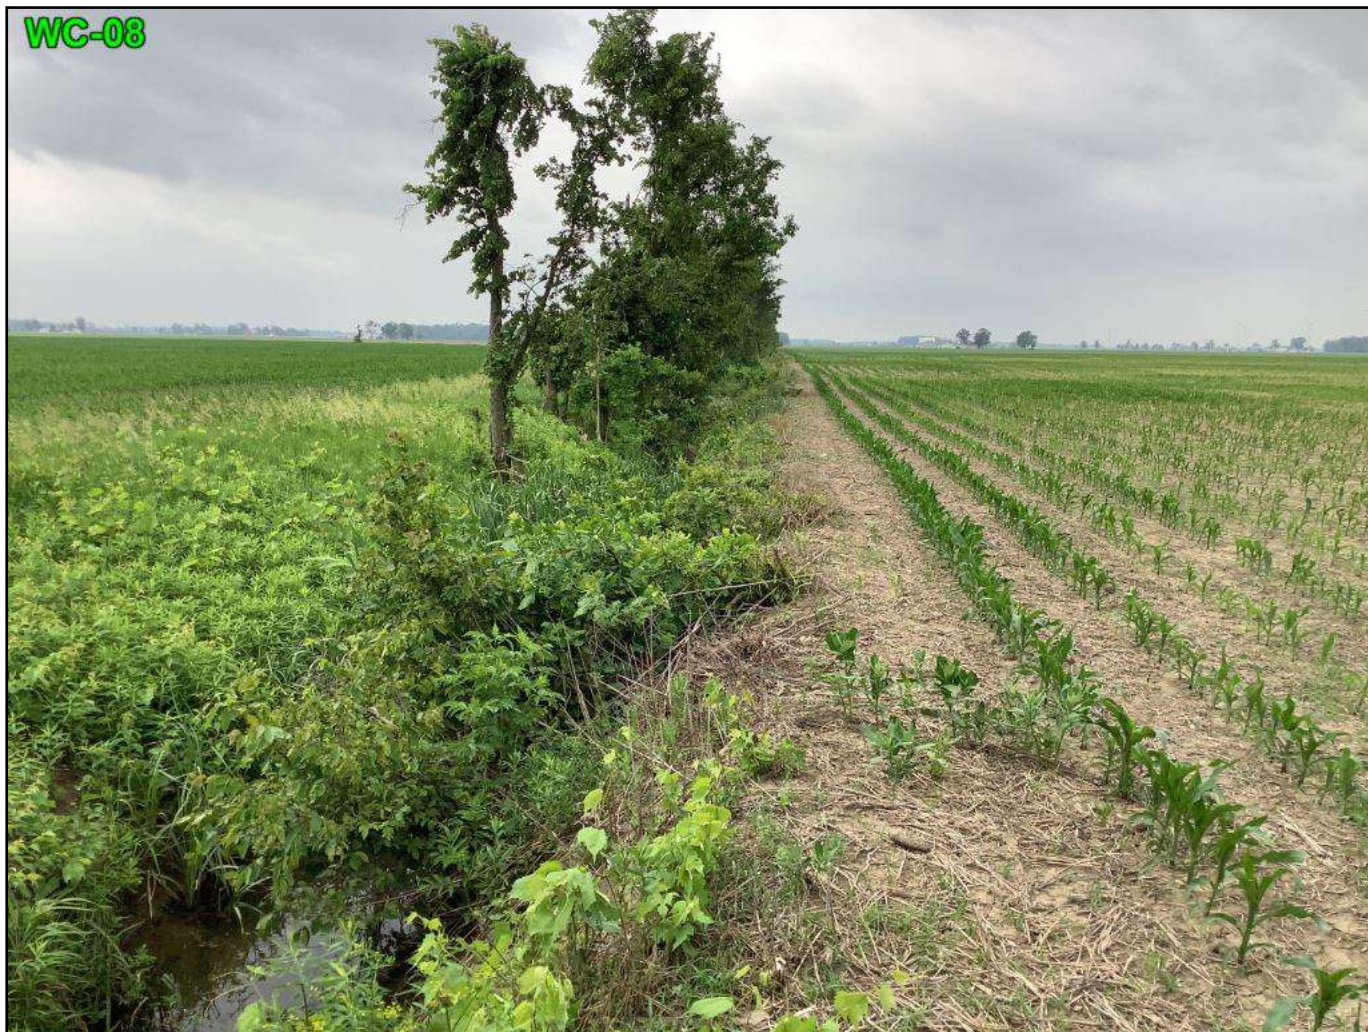
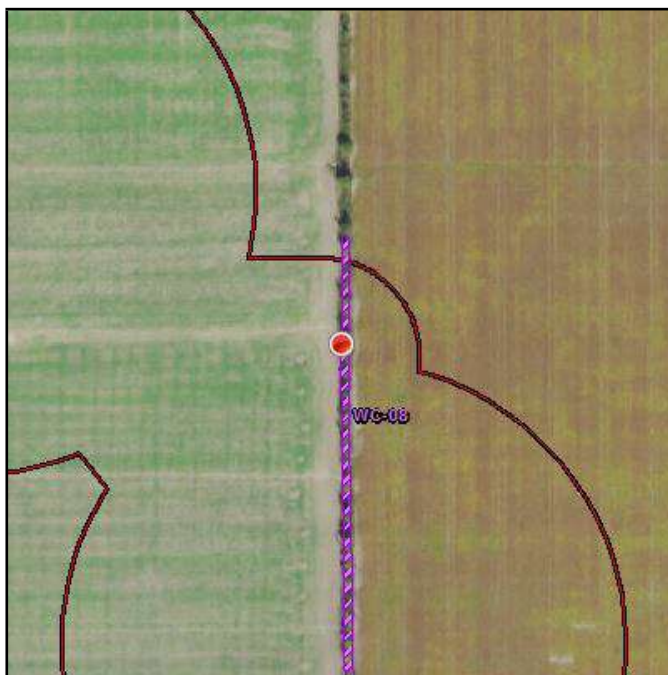
WC-08

Attributes	
Defined Bed and Bank	Yes
Waters of the US	Yes
Mapped on NHD	No
Mapped on NWI	No
Investigator	MCV
Flow Characteristics	Ephemeral
Direction of Flow (Direction Downstream)	N
Water Width at Crossing (ft)	2
Water Depth at Crossing (ft)	0.5
Top of Bank Width (ft)	8
Left Bank Height (ft) (Looking Downstream)	6
Right Bank Height (ft) (Looking Downstream)	5
OHWM Width (ft)	5
OHWM Height (ft from substrate)	4
Evidence of Scour or Erosion	No
OHWM Criteria	Clear, Natural Line Impressed on Bank
Pools, Riffles, Runs Present?	Runs
Substrate	Sand

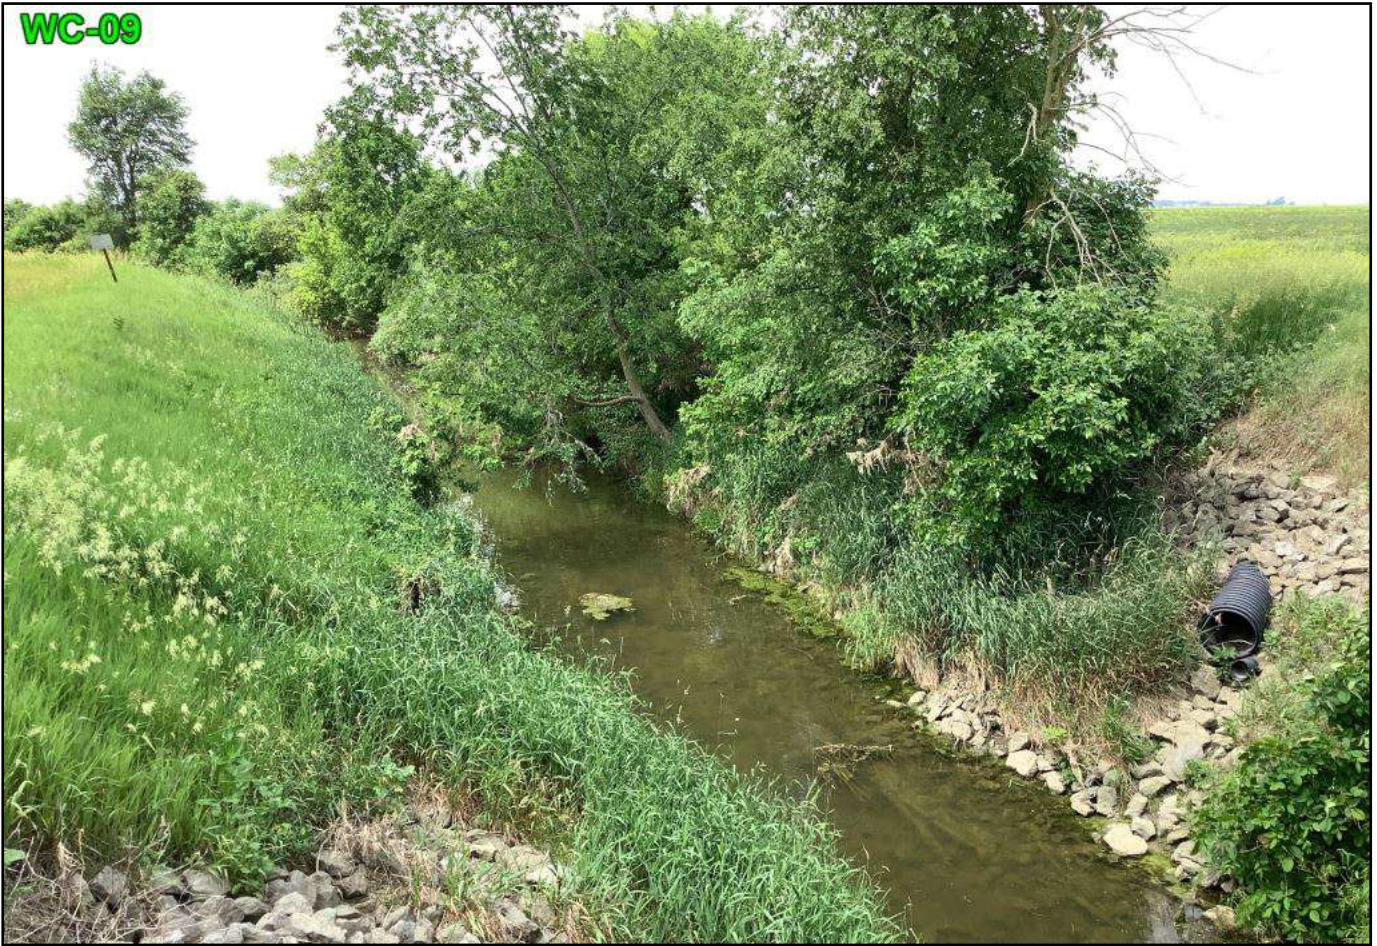
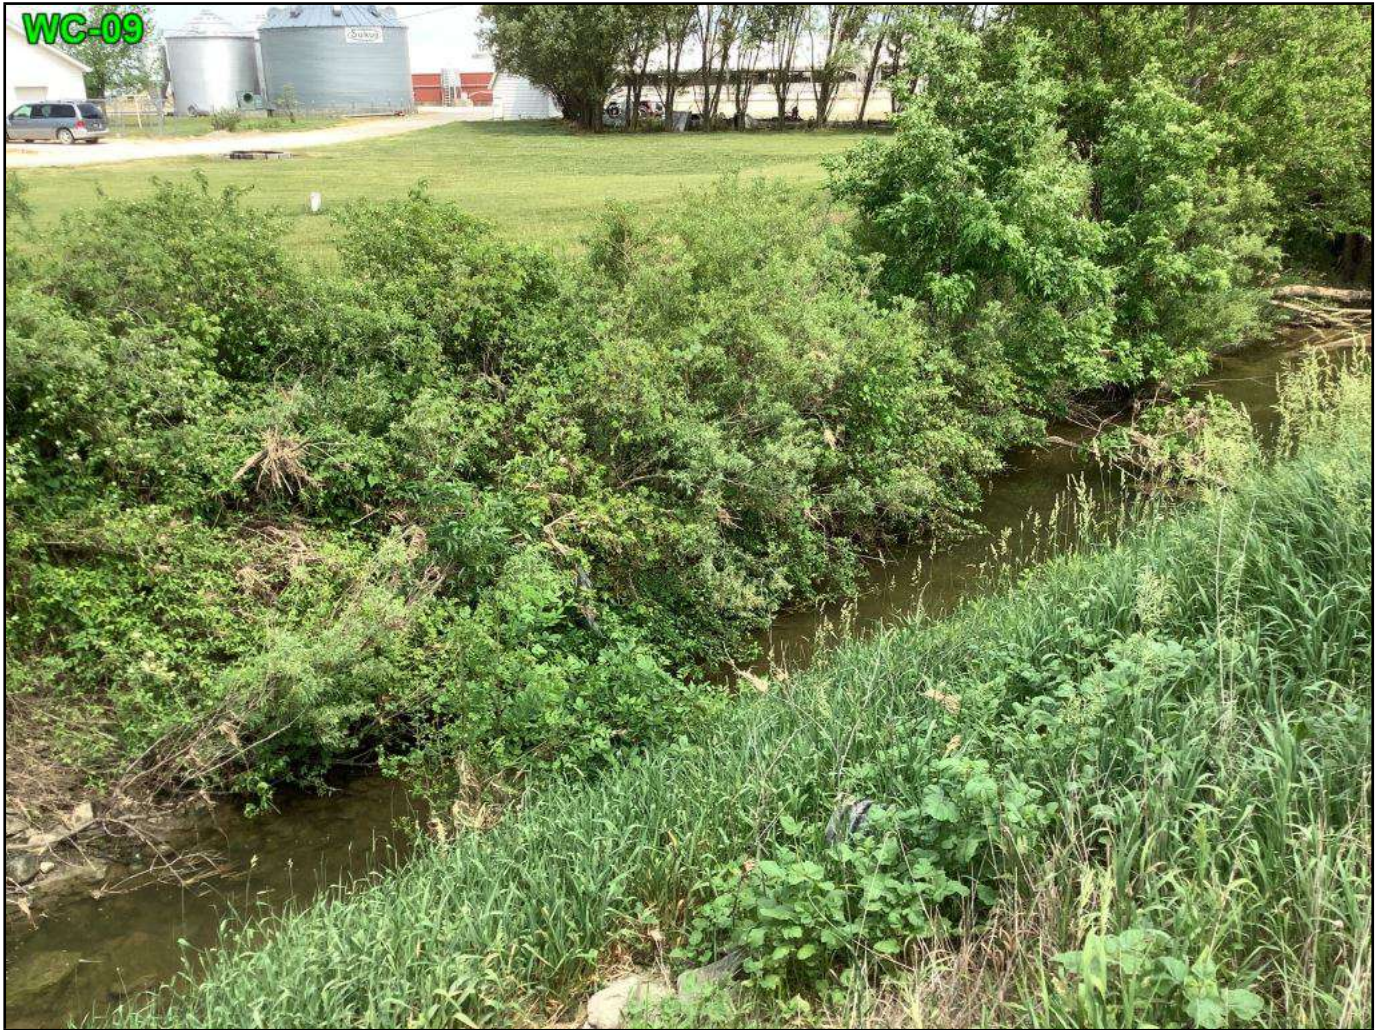
WC-09

Attributes	
Defined Bed and Bank	Yes
Waters of the US	Yes
Mapped on NHD	Yes
Mapped on NWI	No
Investigator	MCV
Flow Characteristics	Perennial
Direction of Flow (Direction Downstream)	NE
Water Width at Crossing (ft)	7
Water Depth at Crossing (ft)	2
Top of Bank Width (ft)	25
Left Bank Height (ft) (Looking Downstream)	10
Right Bank Height (ft) (Looking Downstream)	9
OHWM Width (ft)	13
OHWM Height (ft from substrate)	5
Evidence of Scour or Erosion	No
OHWM Criteria	Clear, Natural Line Impressed on Bank
Pools, Riffles, Runs Present?	Pools and Runs
Substrate	Sand

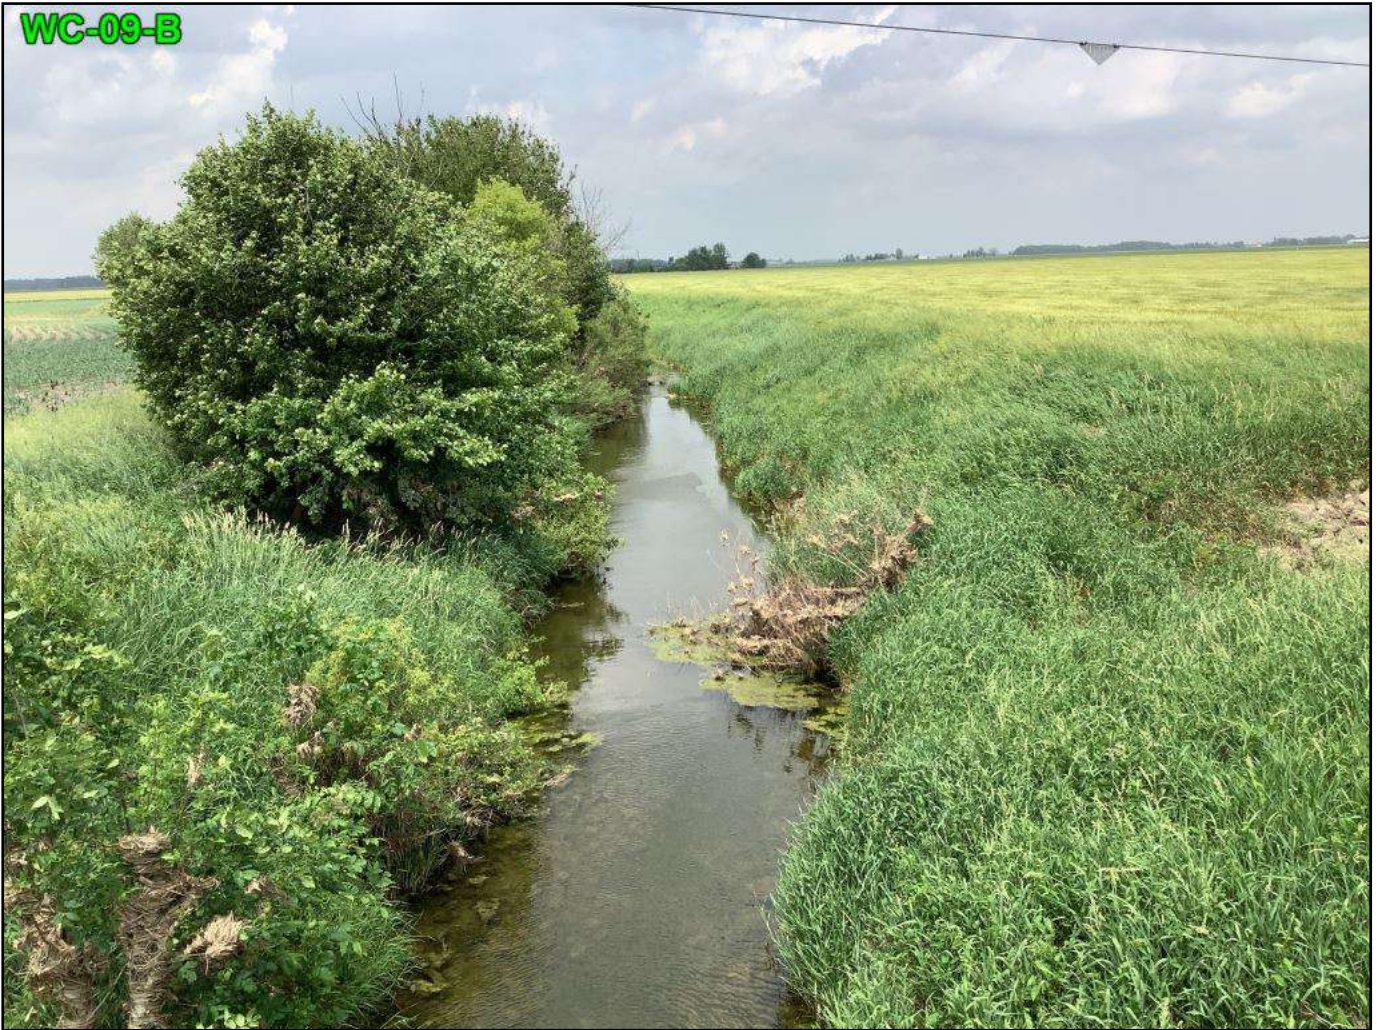
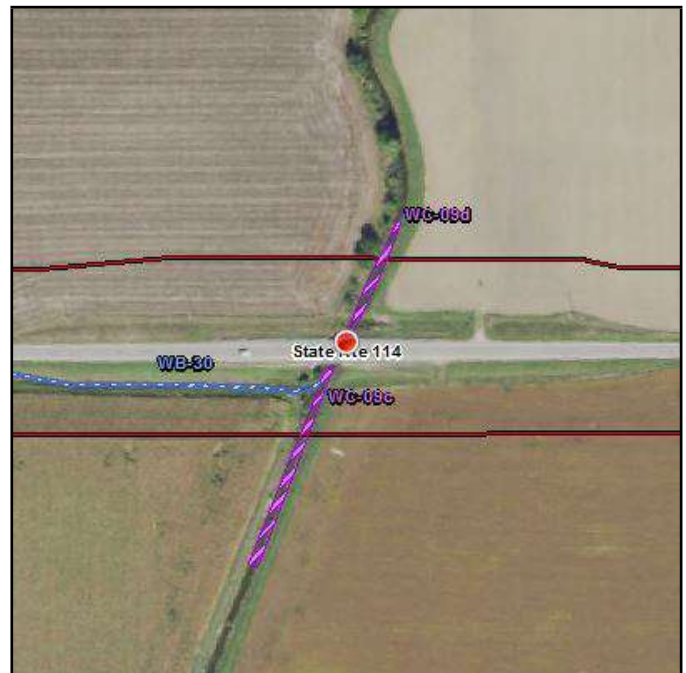
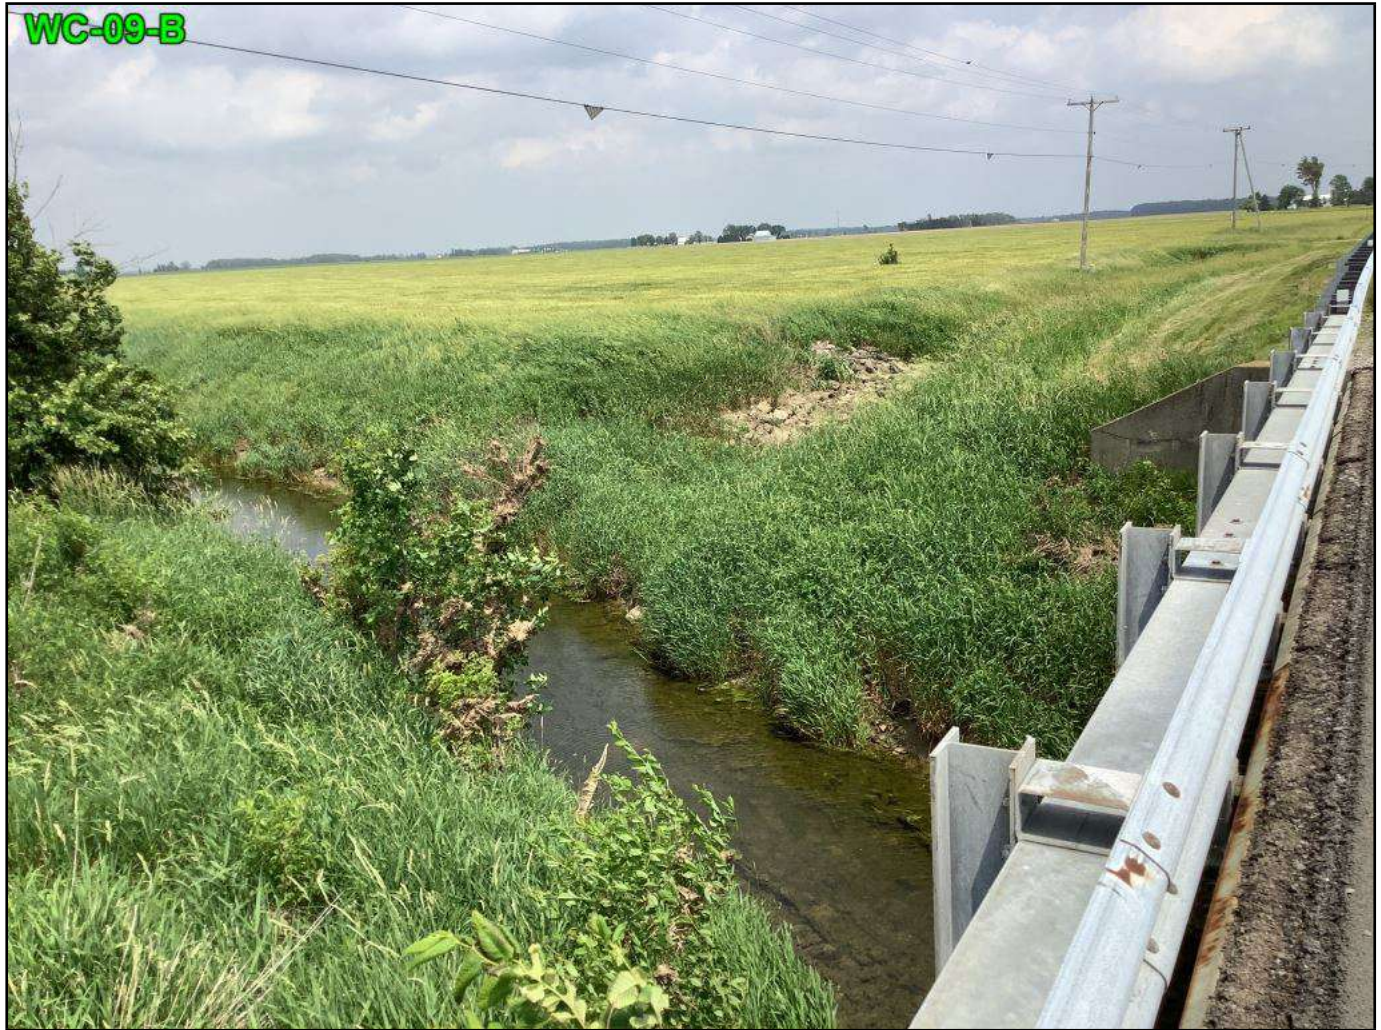
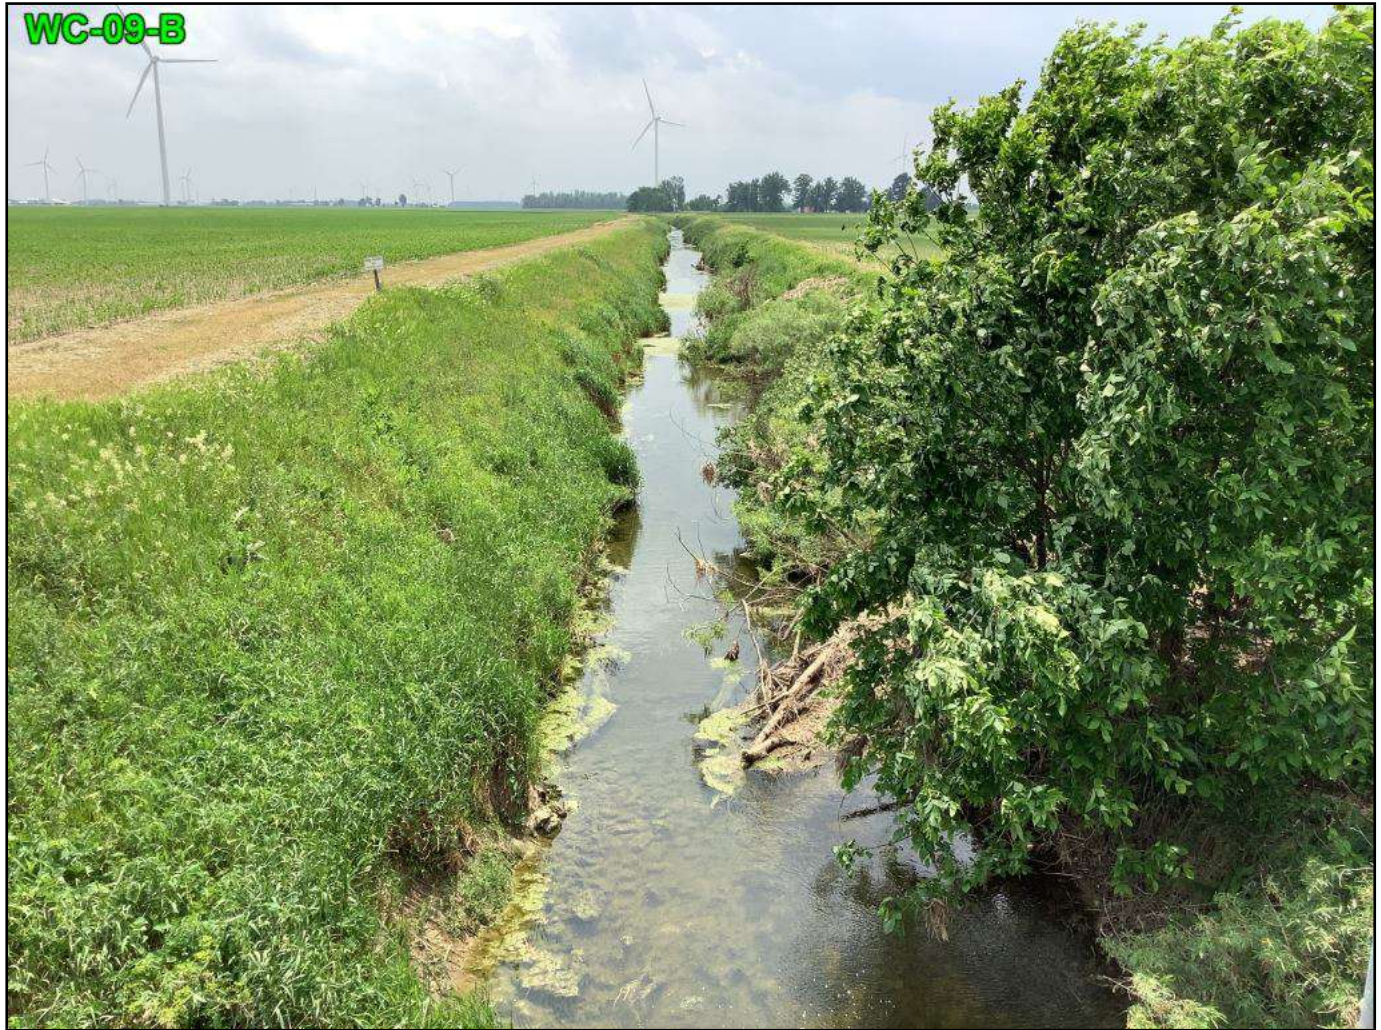
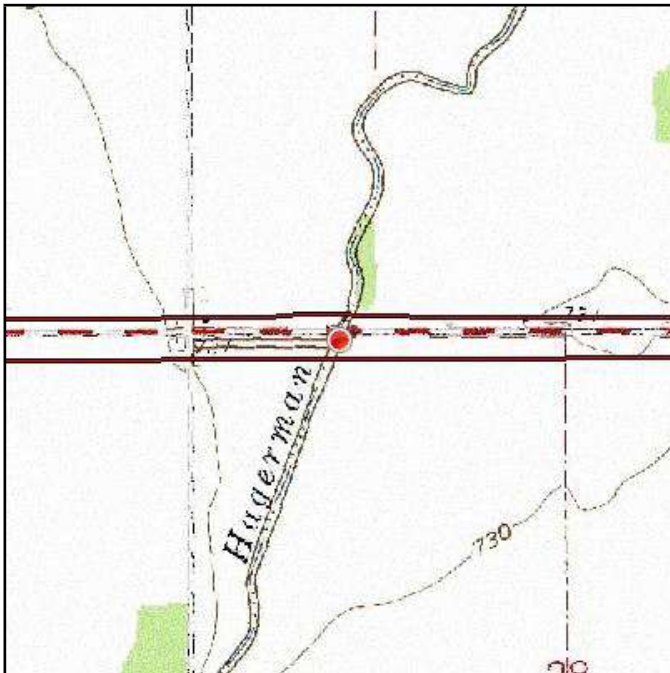
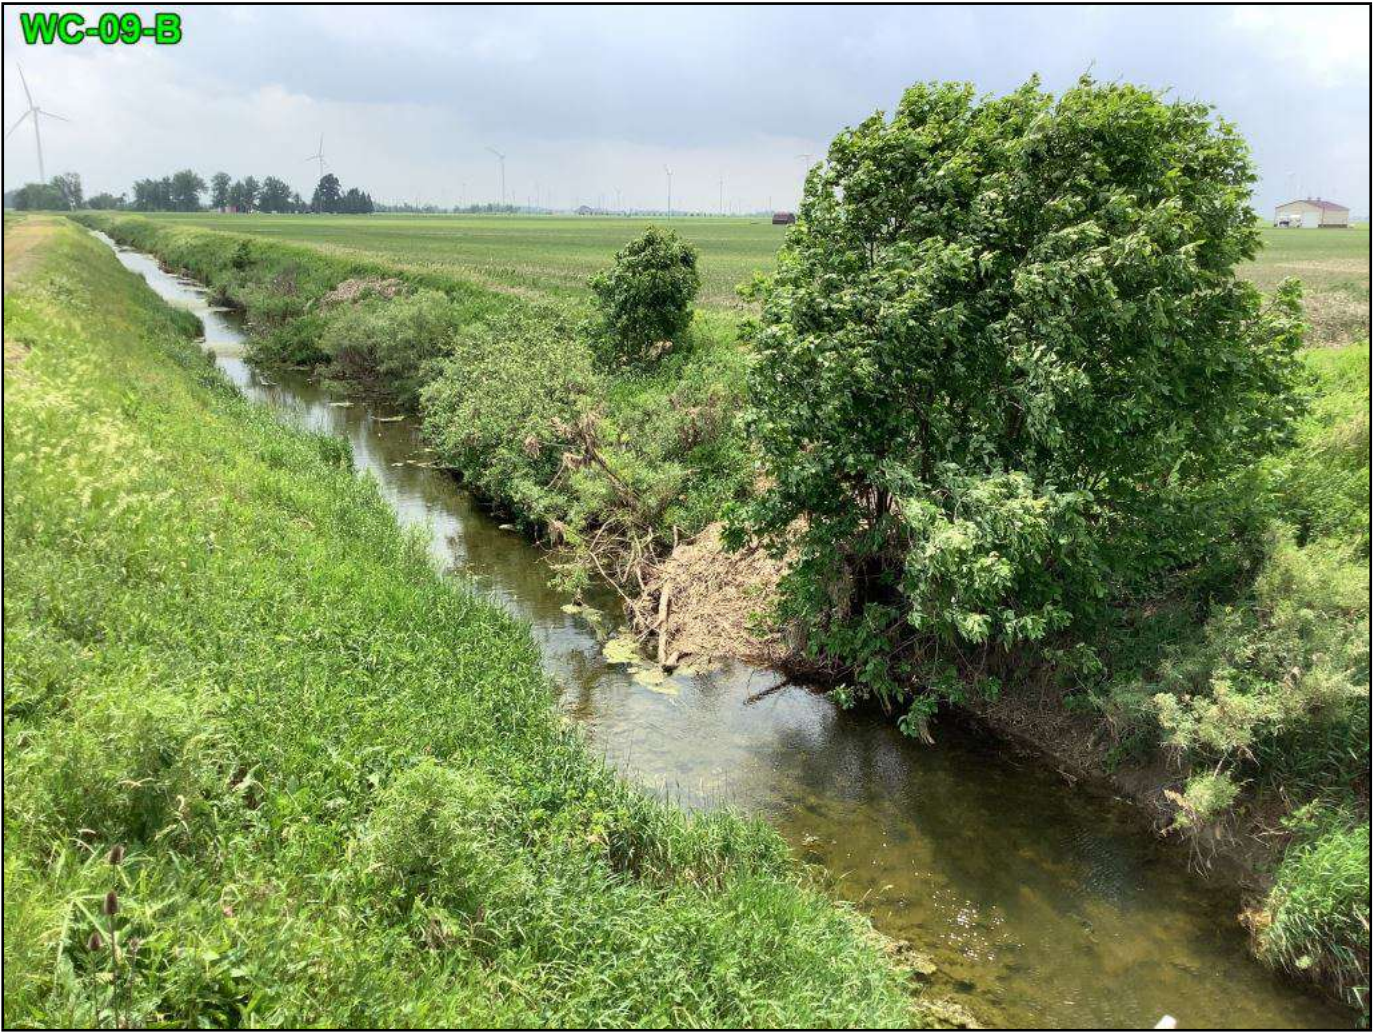
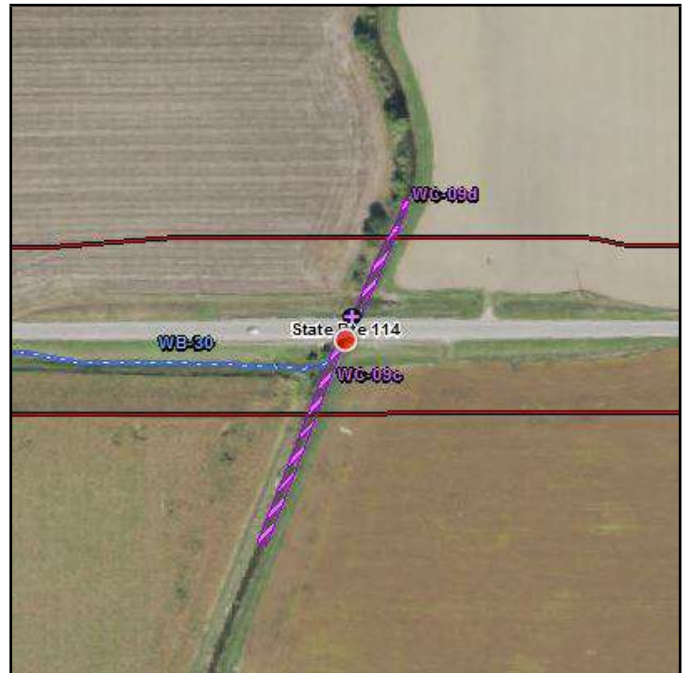
WC-09-B

Attributes	
Defined Bed and Bank	Yes
Waters of the US	Yes
Mapped on NHD	Yes
Mapped on NWI	No
Investigator	MCV
Flow Characteristics	Perennial
Direction of Flow (Direction Downstream)	NE
Water Width at Crossing (ft)	3
Water Depth at Crossing (ft)	0.5
Top of Bank Width (ft)	13
Left Bank Height (ft) (Looking Downstream)	8
Right Bank Height (ft) (Looking Downstream)	7
OHWM Width (ft)	9
OHWM Height (ft from substrate)	5
Evidence of Scour or Erosion	No
OHWM Criteria	Clear, Natural Line Impressed on Bank
Pools, Riffles, Runs Present?	Pools and Runs
Substrate	Sand

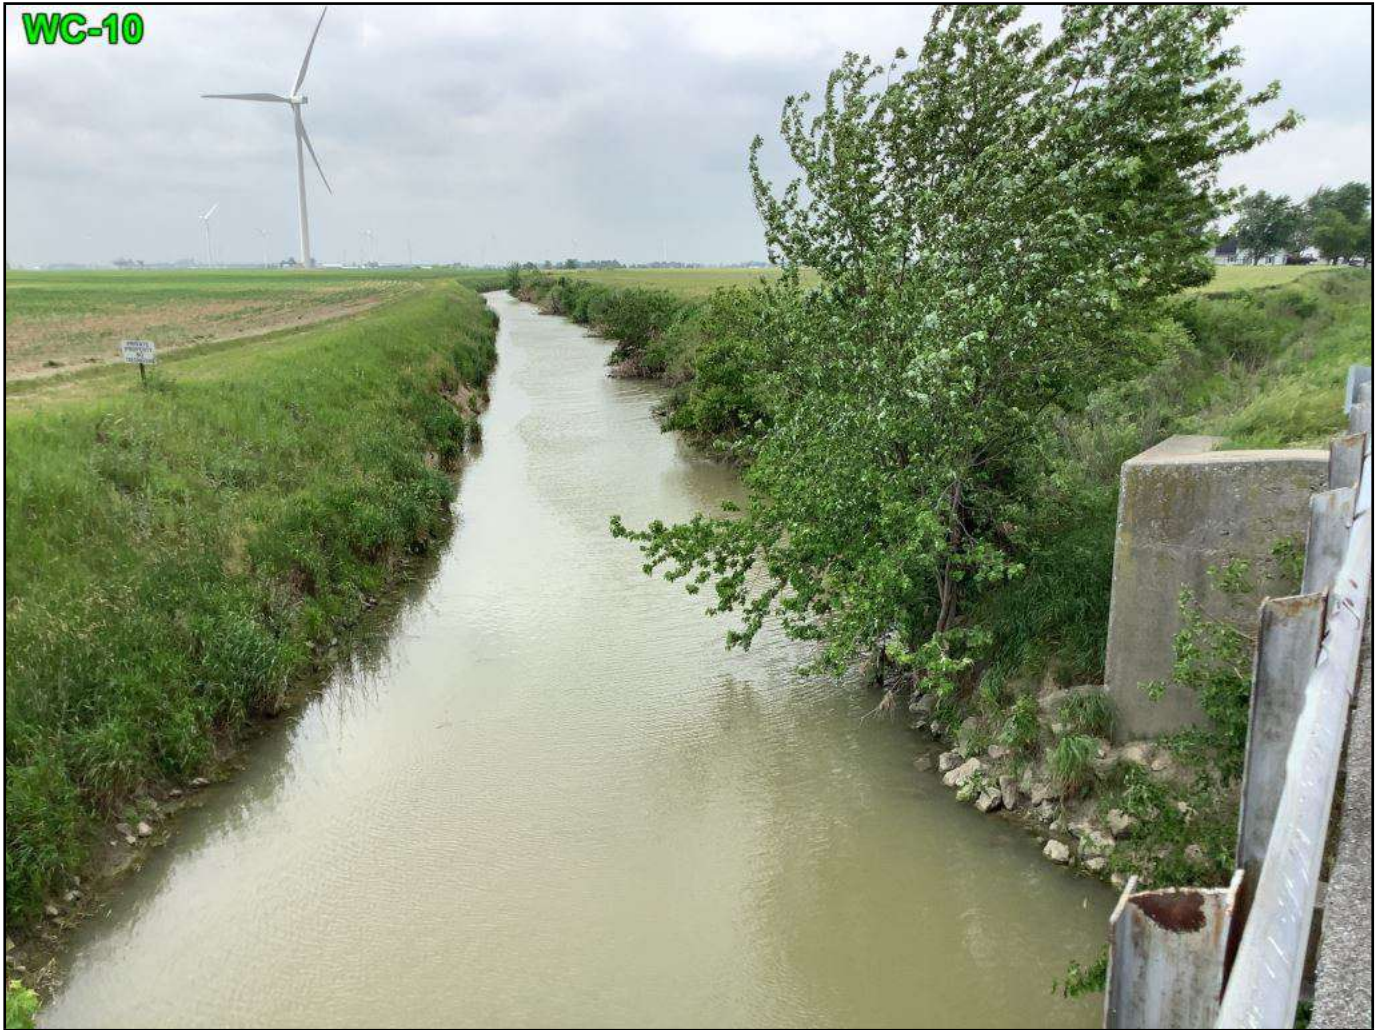
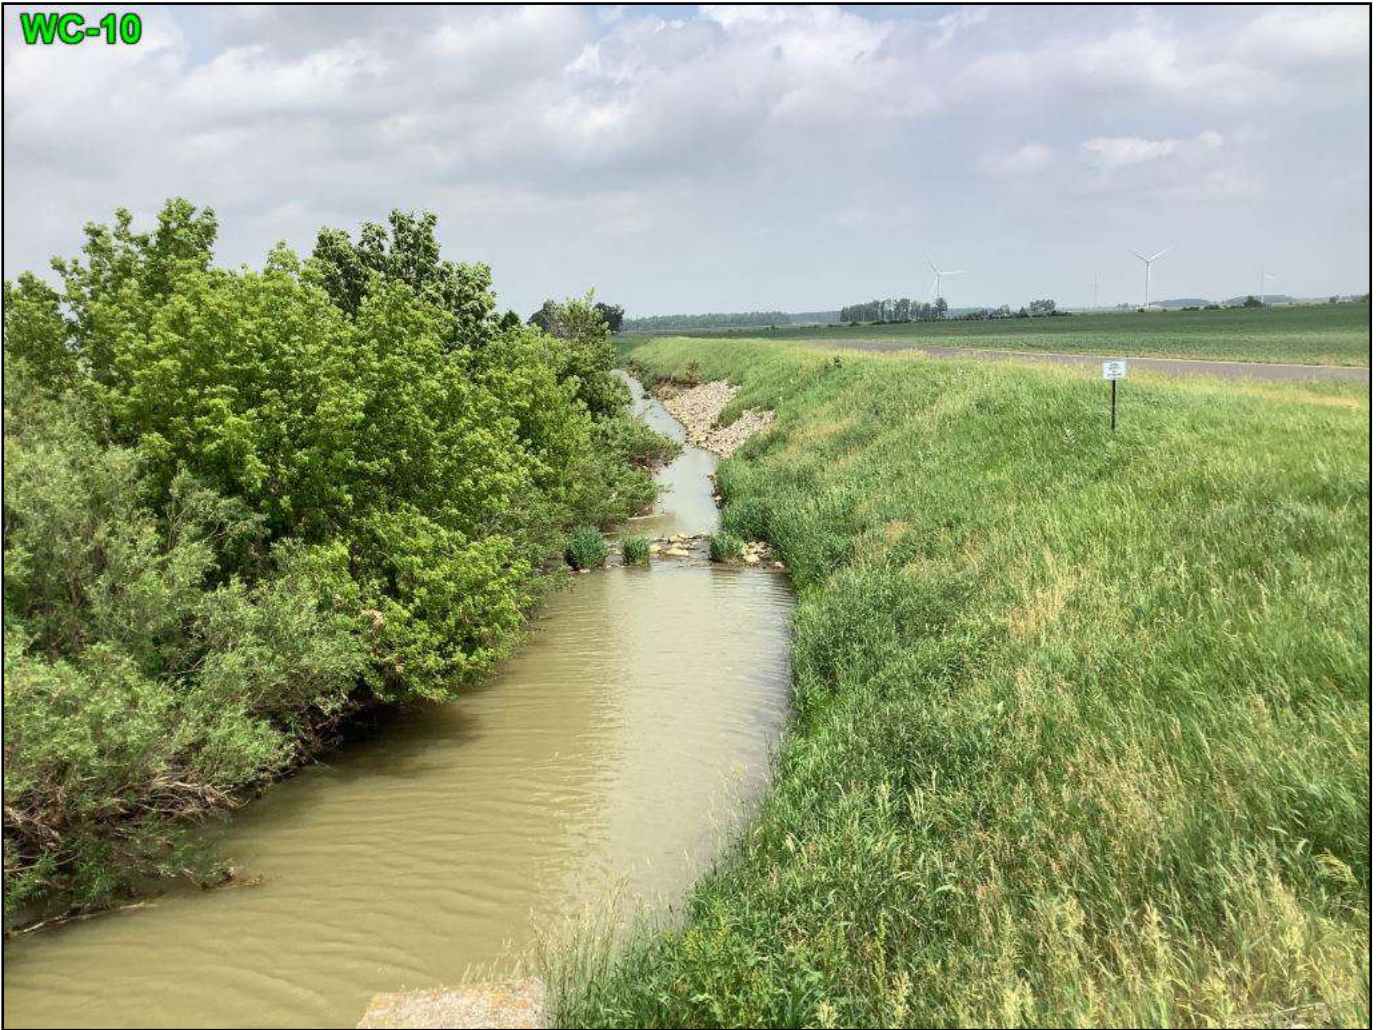
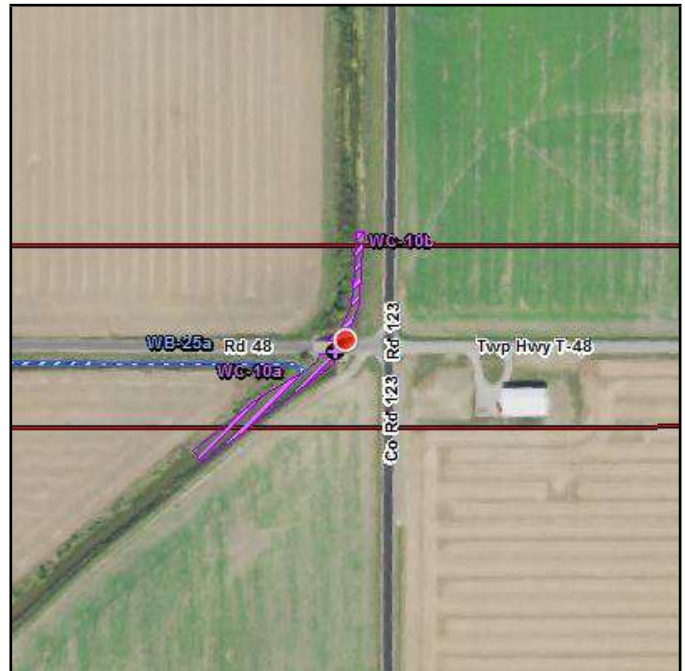
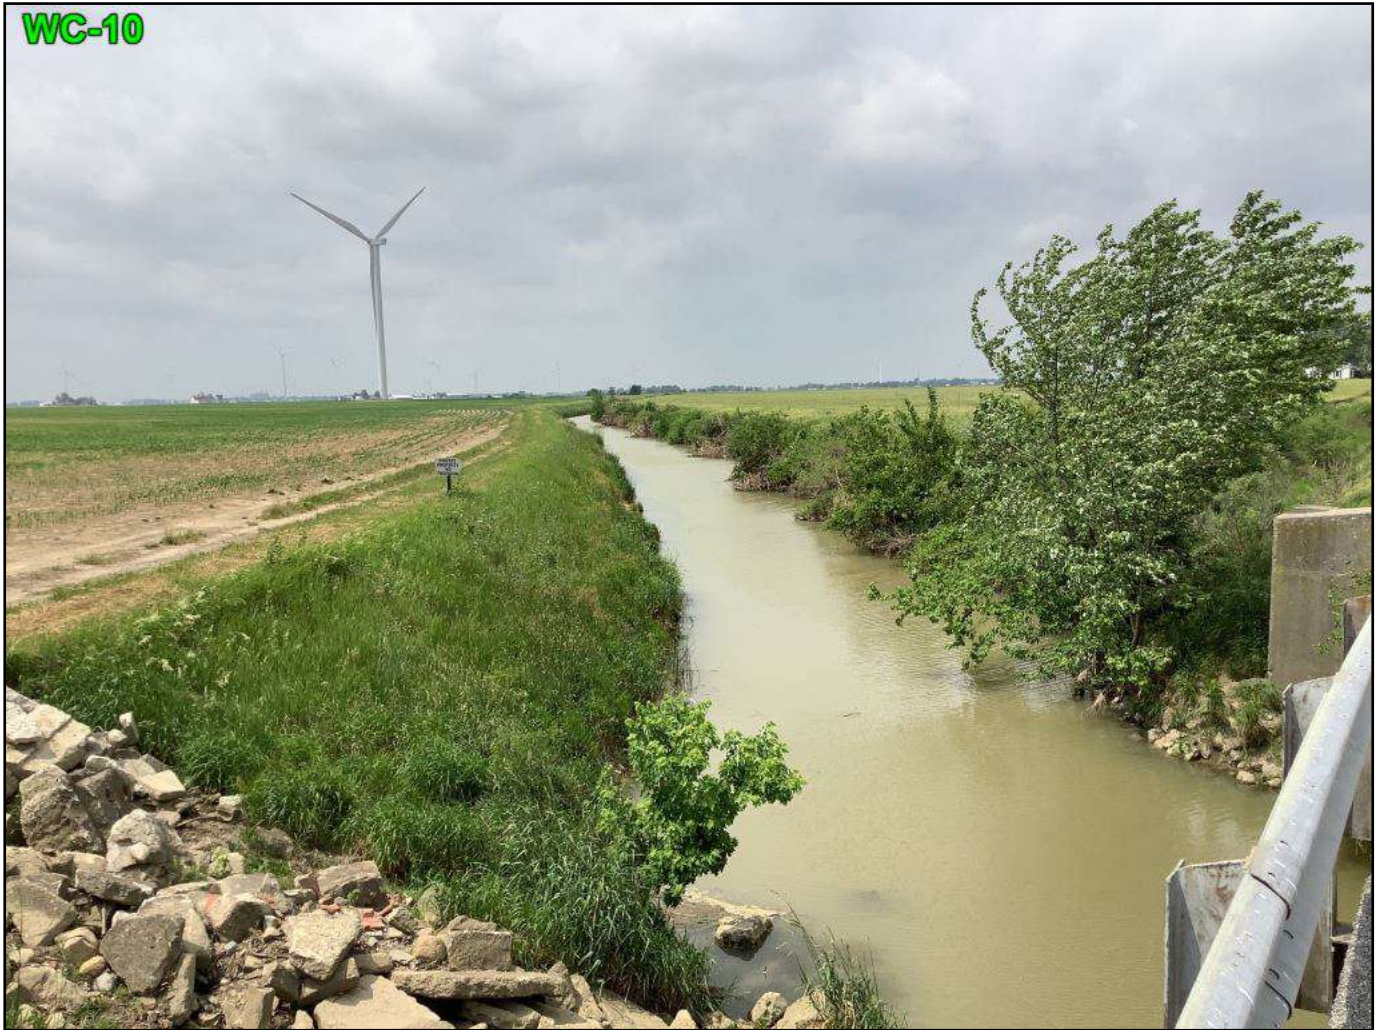
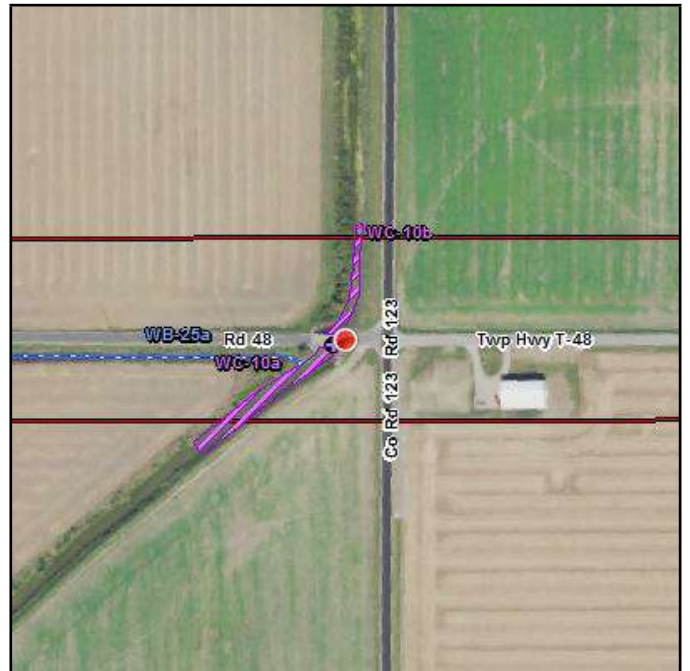
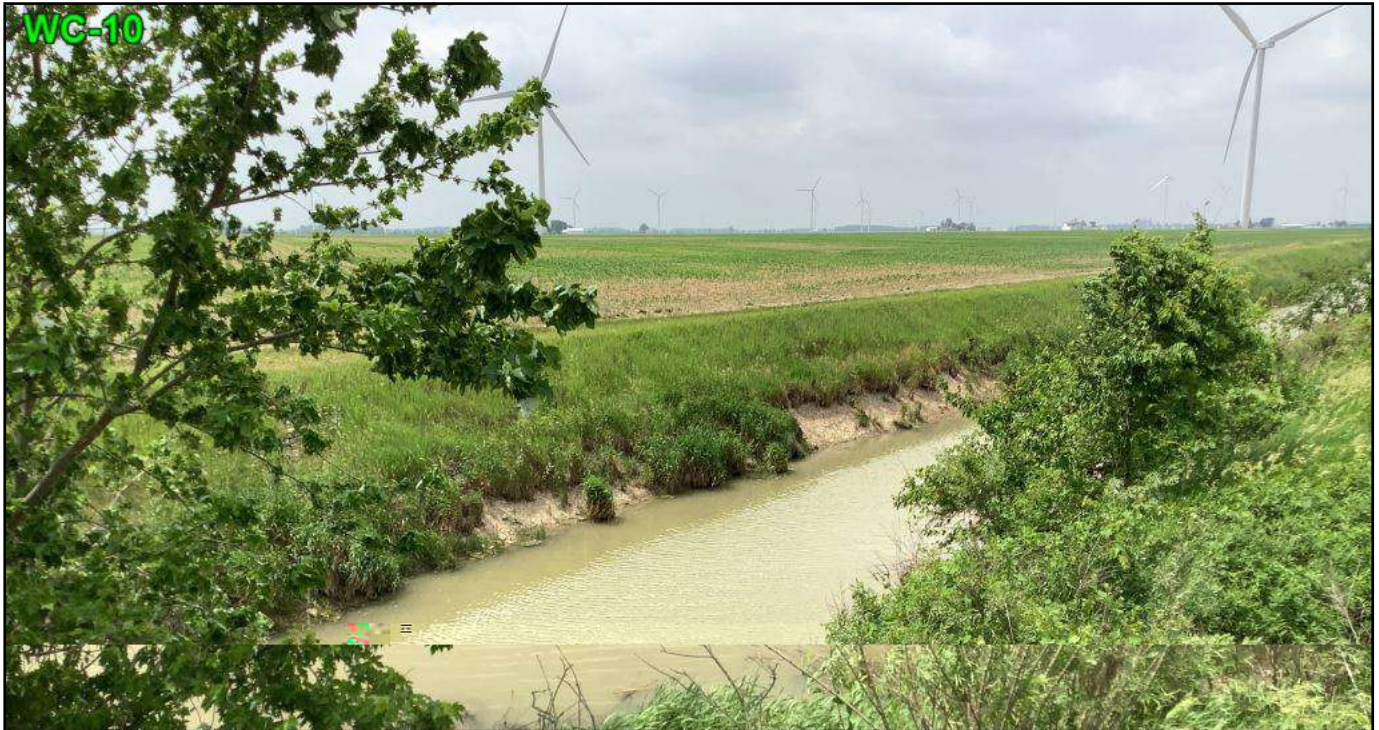
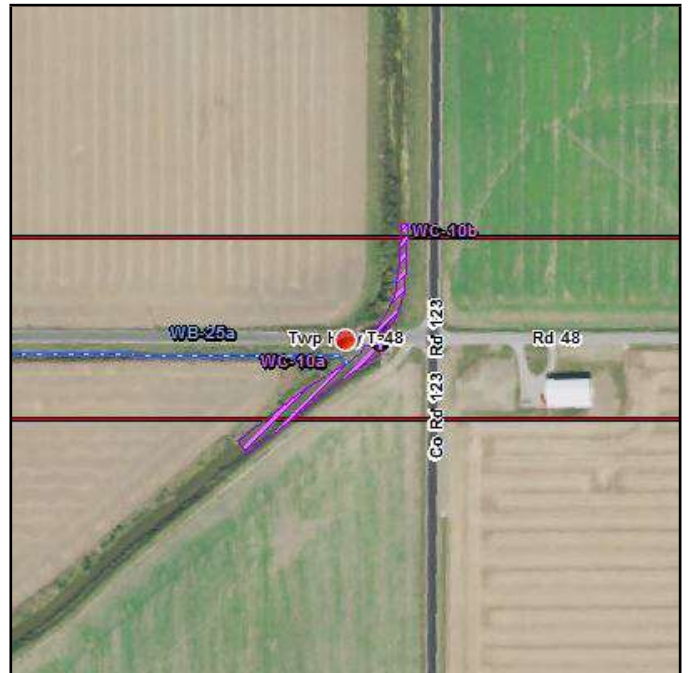
WC-10

Attributes	
Defined Bed and Bank	Yes
Waters of the US	Yes
Mapped on NHD	Yes
Mapped on NWI	No
Investigator	MCV
Flow Characteristics	Perennial
Direction of Flow (Direction Downstream)	NE
Water Width at Crossing (ft)	12
Water Depth at Crossing (ft)	3
Top of Bank Width (ft)	30
Left Bank Height (ft) (Looking Downstream)	8
Right Bank Height (ft) (Looking Downstream)	9
OHWM Width (ft)	20
OHWM Height (ft from substrate)	5
Evidence of Scour or Erosion	No
OHWM Criteria	Clear, Natural Line Impressed on Bank
Pools, Riffles, Runs Present?	Runs
Substrate	Silt
