**Case No(s). 20-0417-EL-BGN**

Summary: Application - 17 of 40 (Exhibit L – Part 3 of 3 - Water Resources Delineation Report) electronically filed by Christine M.T. Pirik on behalf of Grover Hill Wind, LLC

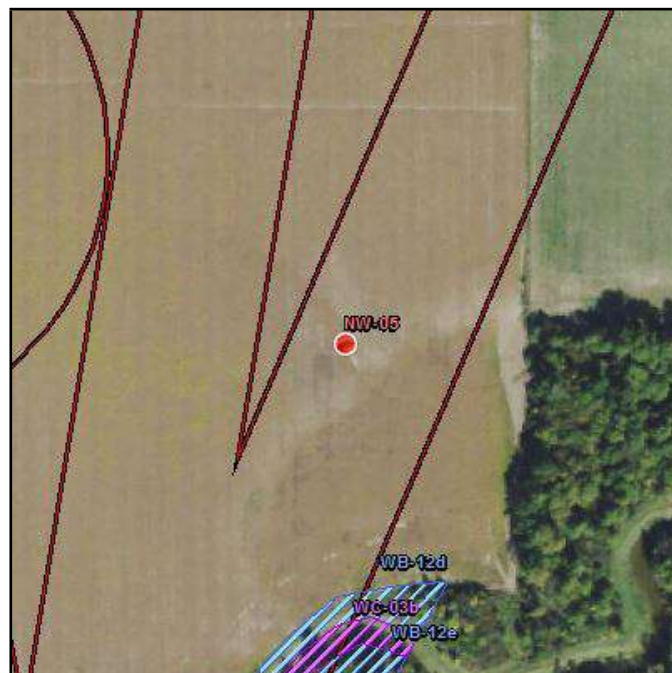
NW-05

Attributes	
Defined Bed and Bank	No
Waters of the US	No
Mapped on NHD	Yes
Mapped on NWI	No
Investigator	MCV
Flow Characteristics	No Evidence of Flow
Direction of Flow (Direction Downstream)	No Discernable Direction
Water Width at Crossing (ft)	No Water Noted
Water Depth at Crossing (ft)	No Water Noted
Top of Bank Width (ft)	N/A, No Defined Bank
Left Bank Height (ft) (Looking Downstream)	N/A, No Defined Bank
Right Bank Height (ft) (Looking Downstream)	N/A, No Defined Bank
OHWM Width (ft)	N/A, No OHWM Noted
OHWM Height (ft from substrate)	N/A, No OHWM Noted
Evidence of Scour or Erosion	No
OHWM Criteria	None Noted
Pools, Riffles, Runs Present?	None Noted
Substrate	Vegetated

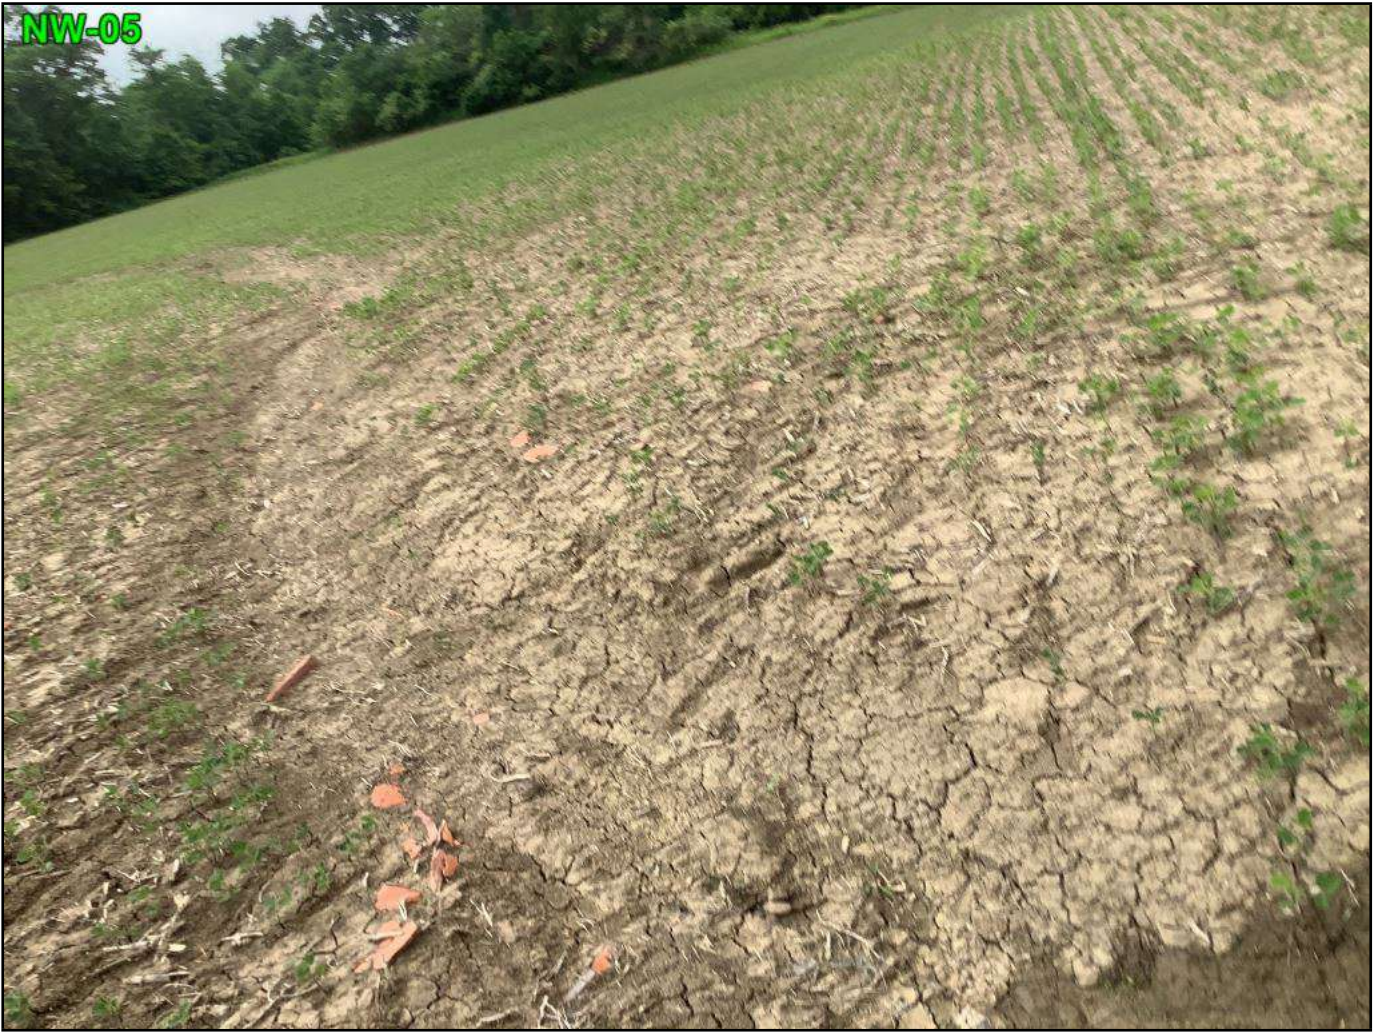
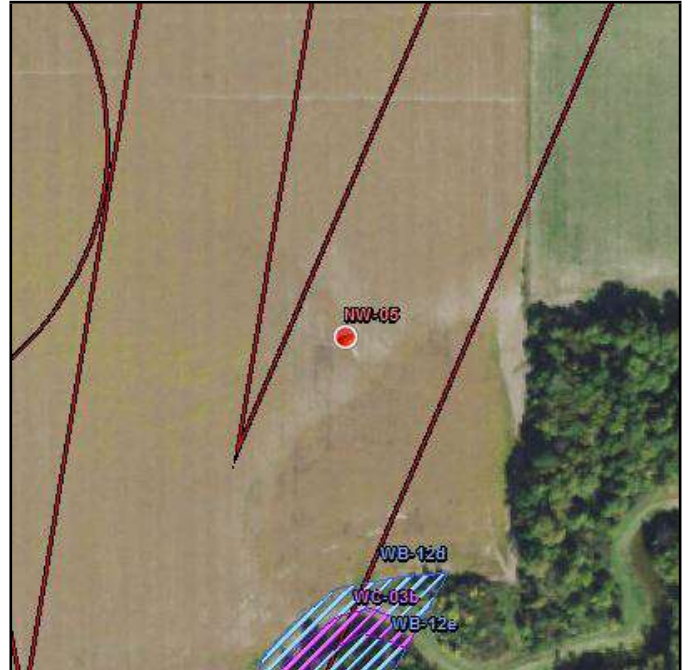
NW-05

Attributes	
Defined Bed and Bank	No
Waters of the US	No
Mapped on NHD	Yes
Mapped on NWI	No
Investigator	MCV
Flow Characteristics	No Evidence of Flow
Direction of Flow (Direction Downstream)	No Discernable Direction
Water Width at Crossing (ft)	No Water Noted
Water Depth at Crossing (ft)	No Water Noted
Top of Bank Width (ft)	N/A, No Defined Bank
Left Bank Height (ft) (Looking Downstream)	N/A, No Defined Bank
Right Bank Height (ft) (Looking Downstream)	N/A, No Defined Bank
OHWM Width (ft)	N/A, No OHWM Noted
OHWM Height (ft from substrate)	N/A, No OHWM Noted
Evidence of Scour or Erosion	No
OHWM Criteria	None Noted
Pools, Riffles, Runs Present?	None Noted
Substrate	Vegetated

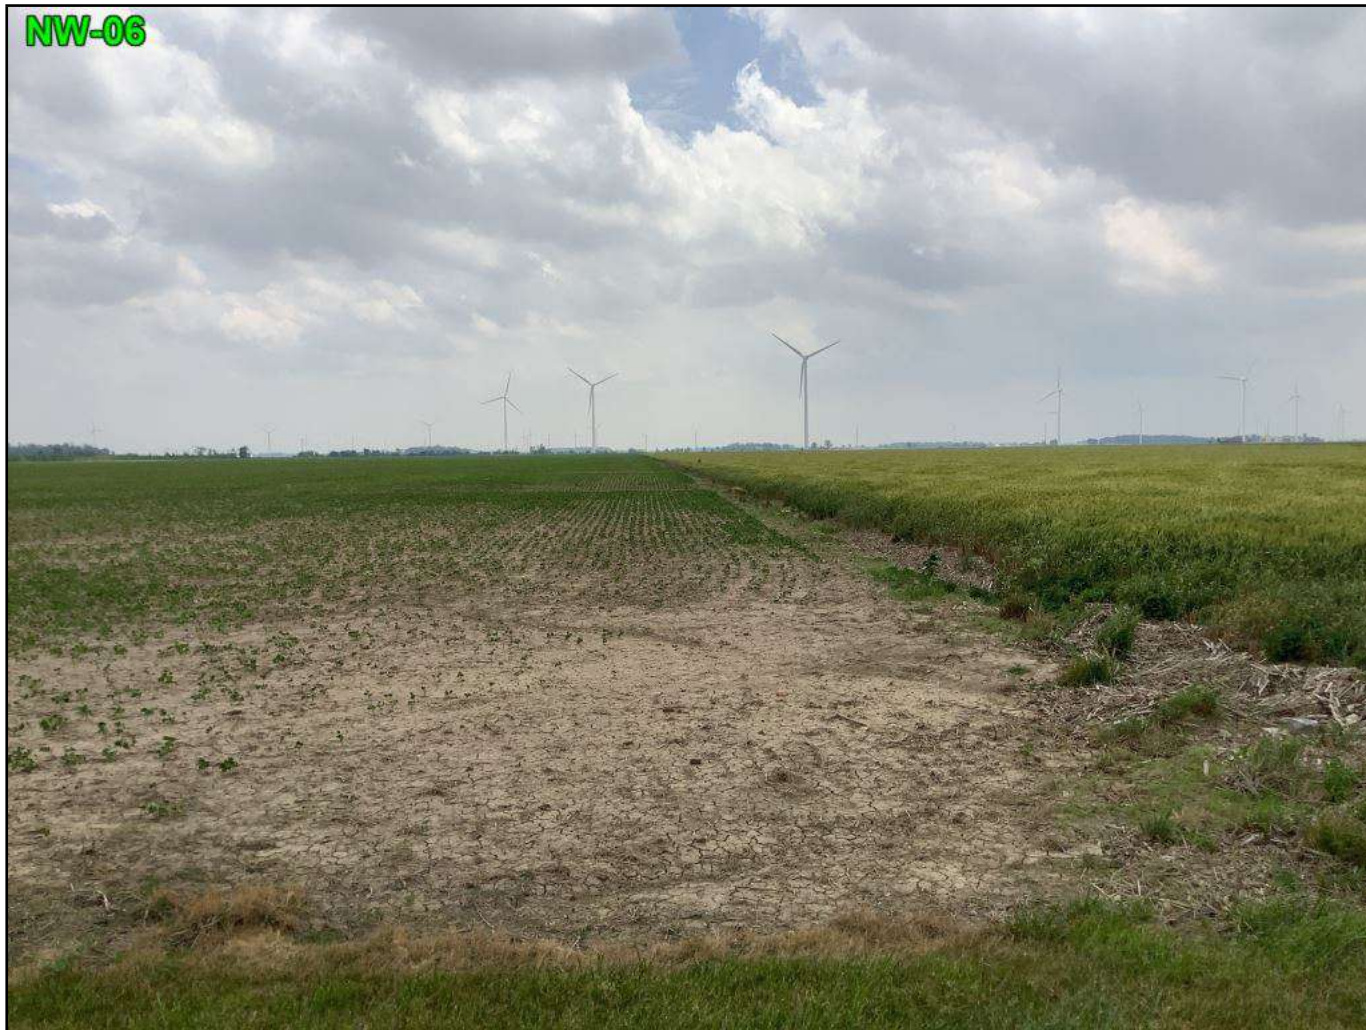
NW-06

Attributes	
Defined Bed and Bank	No
Waters of the US	No
Mapped on NHD	Yes
Mapped on NWI	No
Investigator	MCV
Flow Characteristics	No Evidence of Flow
Direction of Flow (Direction Downstream)	No Discernable Direction
Water Width at Crossing (ft)	No Water Noted
Water Depth at Crossing (ft)	No Water Noted
Top of Bank Width (ft)	N/A, No Defined Bank
Left Bank Height (ft) (Looking Downstream)	N/A, No Defined Bank
Right Bank Height (ft) (Looking Downstream)	N/A, No Defined Bank
OHWM Width (ft)	N/A, No OHWM Noted
OHWM Height (ft from substrate)	N/A, No OHWM Noted
Evidence of Scour or Erosion	No
OHWM Criteria	None Noted
Pools, Riffles, Runs Present?	None Noted
Substrate	Vegetated

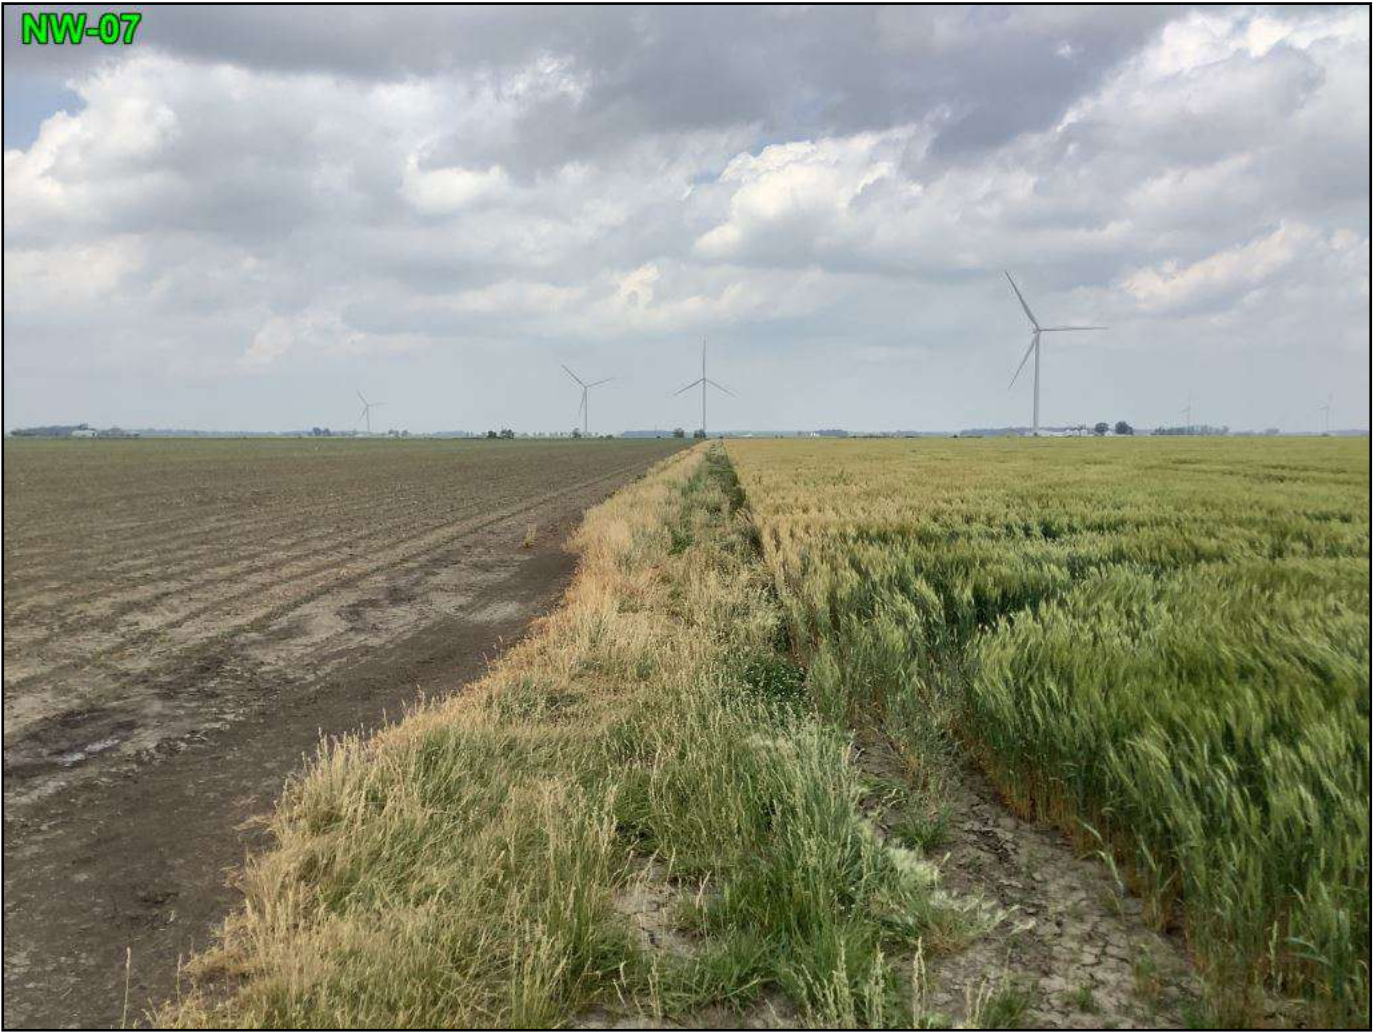
NW-07

Attributes	
Defined Bed and Bank	No
Waters of the US	No
Mapped on NHD	Yes
Mapped on NWI	No
Investigator	MCV
Flow Characteristics	No Evidence of Flow
Direction of Flow (Direction Downstream)	No Discernable Direction
Water Width at Crossing (ft)	No Water Noted
Water Depth at Crossing (ft)	No Water Noted
Top of Bank Width (ft)	N/A, No Defined Bank
Left Bank Height (ft) (Looking Downstream)	N/A, No Defined Bank
Right Bank Height (ft) (Looking Downstream)	N/A, No Defined Bank
OHWM Width (ft)	N/A, No OHWM Noted
OHWM Height (ft from substrate)	N/A, No OHWM Noted
Evidence of Scour or Erosion	No
OHWM Criteria	None Noted
Pools, Riffles, Runs Present?	None Noted
Substrate	Vegetated

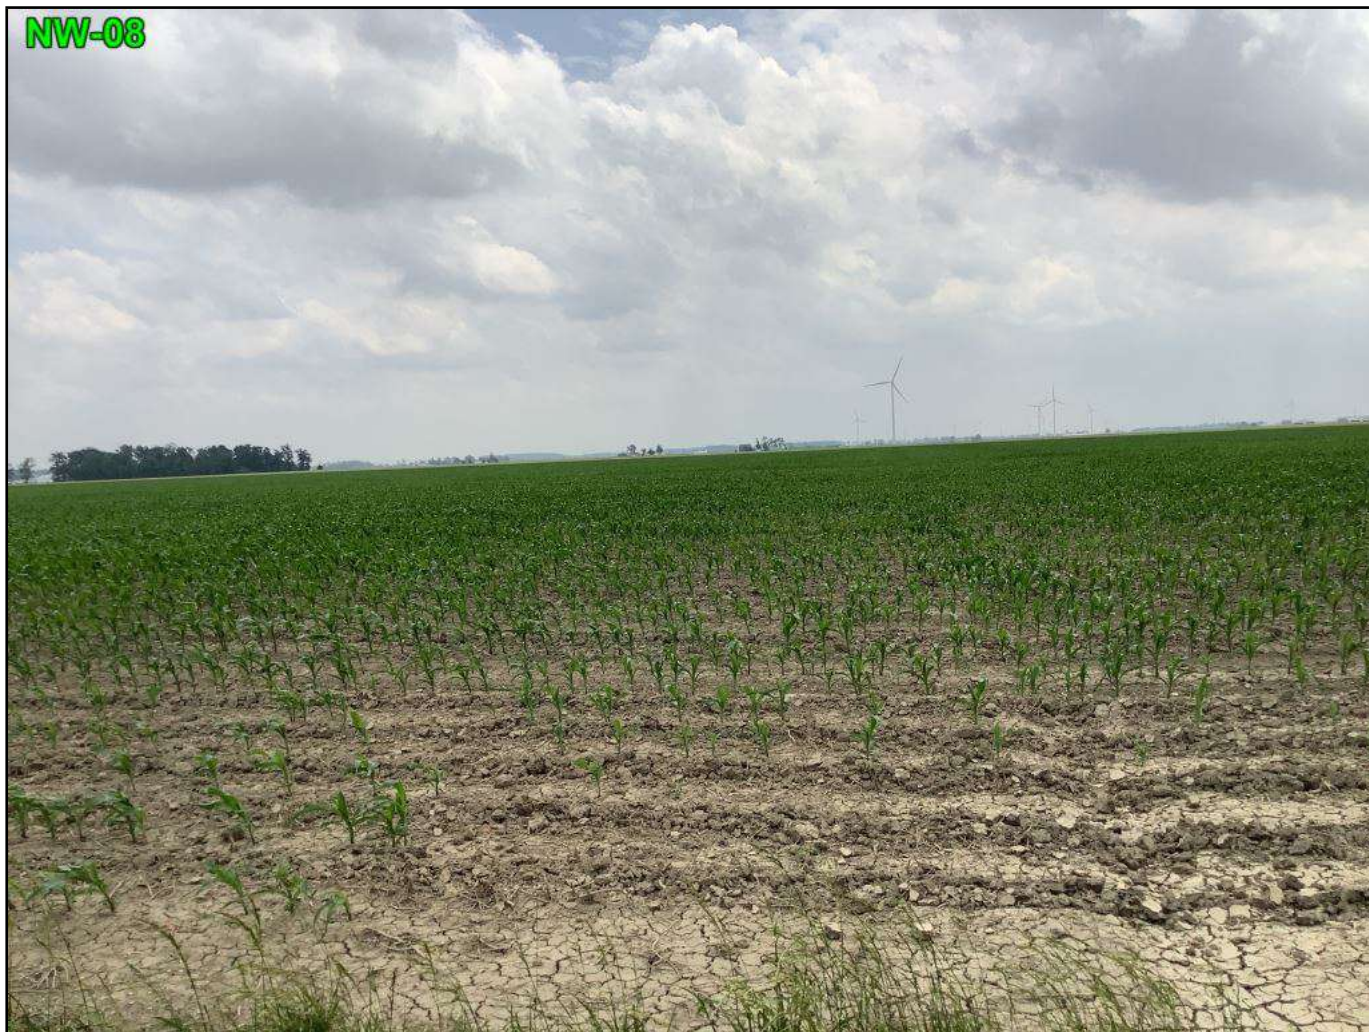
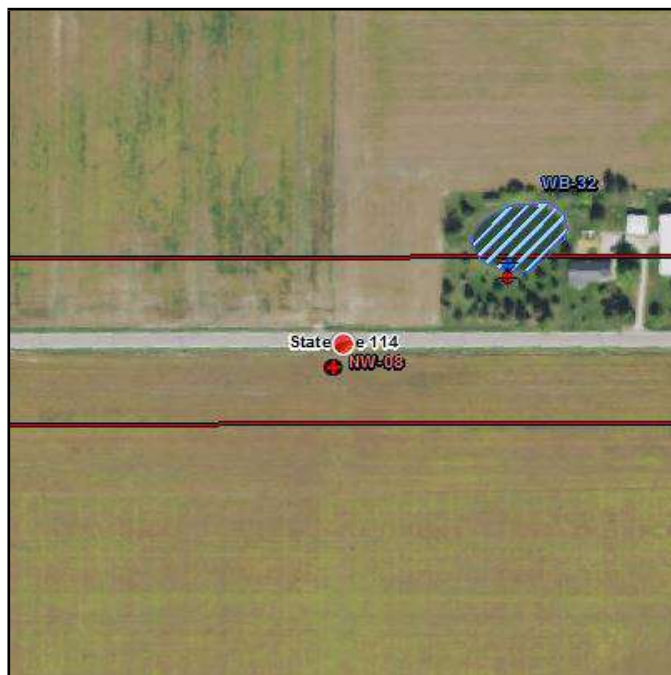
NW-08

Attributes	
Defined Bed and Bank	No
Waters of the US	No
Mapped on NHD	Yes
Mapped on NWI	No
Investigator	MCV
Flow Characteristics	No Evidence of Flow
Direction of Flow (Direction Downstream)	No Discernable Direction
Water Width at Crossing (ft)	No Water Noted
Water Depth at Crossing (ft)	No Water Noted
Top of Bank Width (ft)	N/A, No Defined Bank
Left Bank Height (ft) (Looking Downstream)	N/A, No Defined Bank
Right Bank Height (ft) (Looking Downstream)	N/A, No Defined Bank
OHWM Width (ft)	N/A, No OHWM Noted
OHWM Height (ft from substrate)	N/A, No OHWM Noted
Evidence of Scour or Erosion	No
OHWM Criteria	None Noted
Pools, Riffles, Runs Present?	None Noted
Substrate	Vegetated

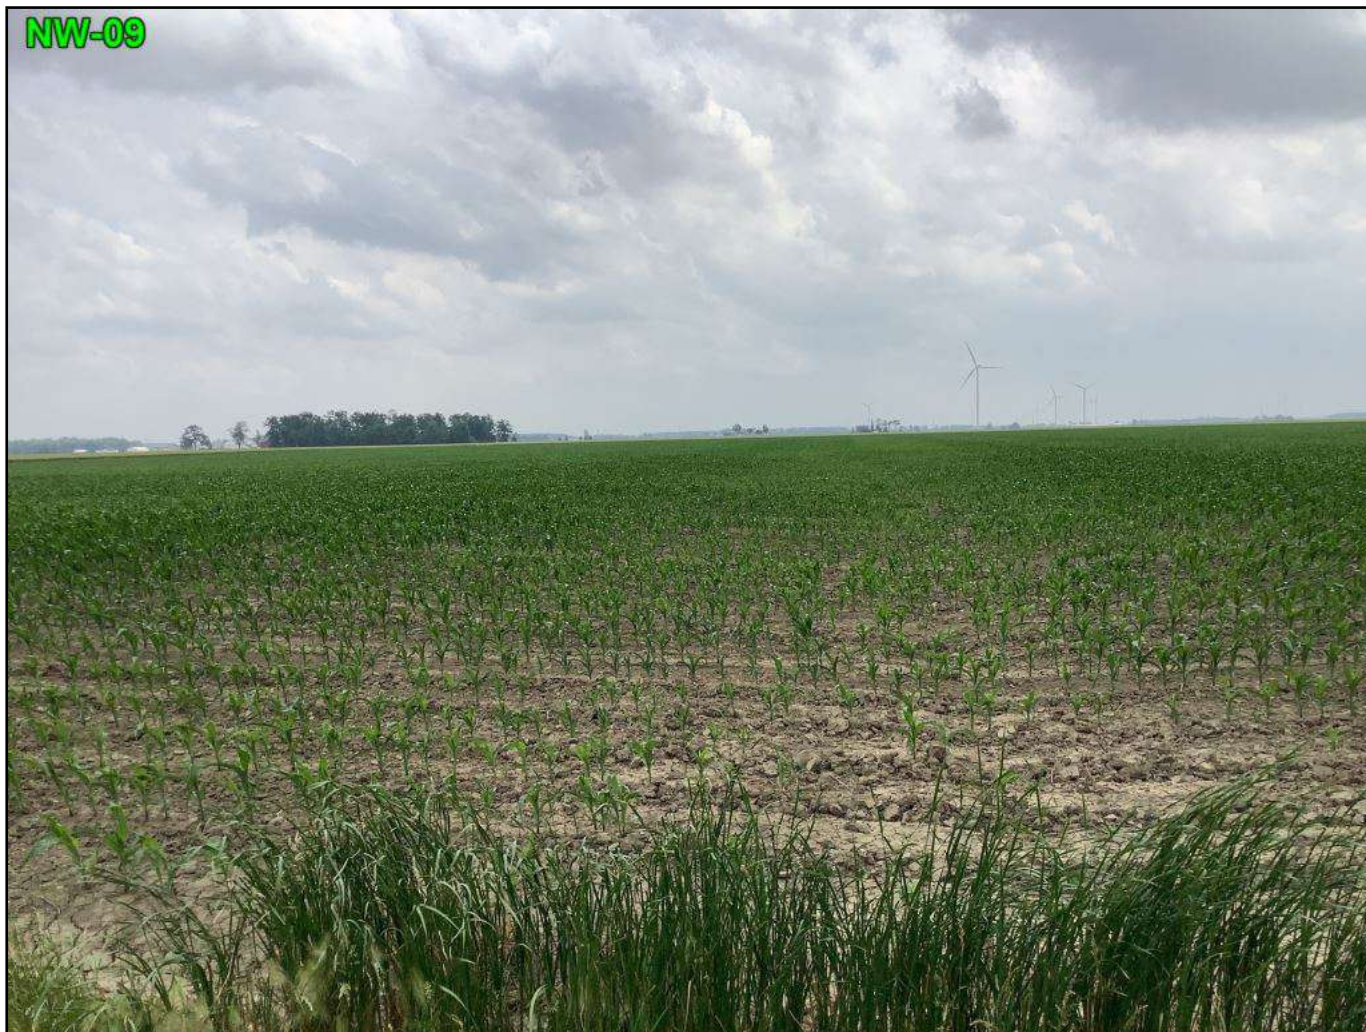
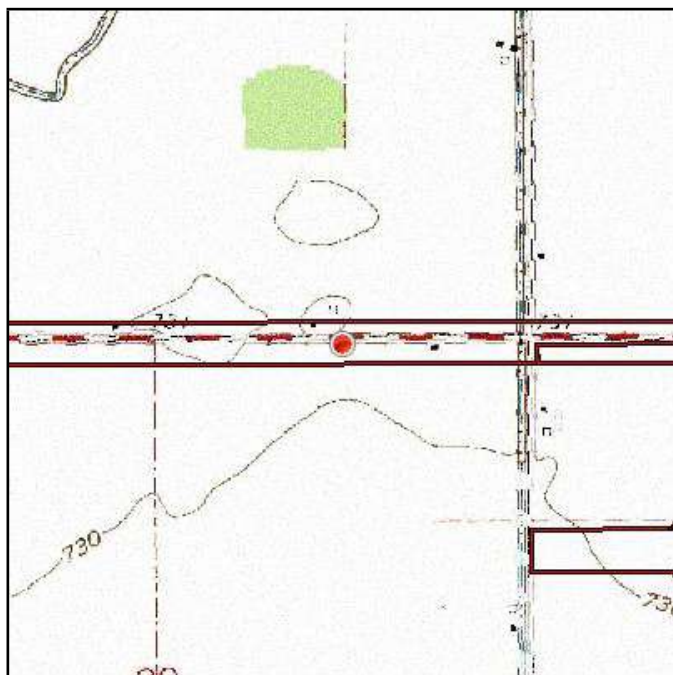
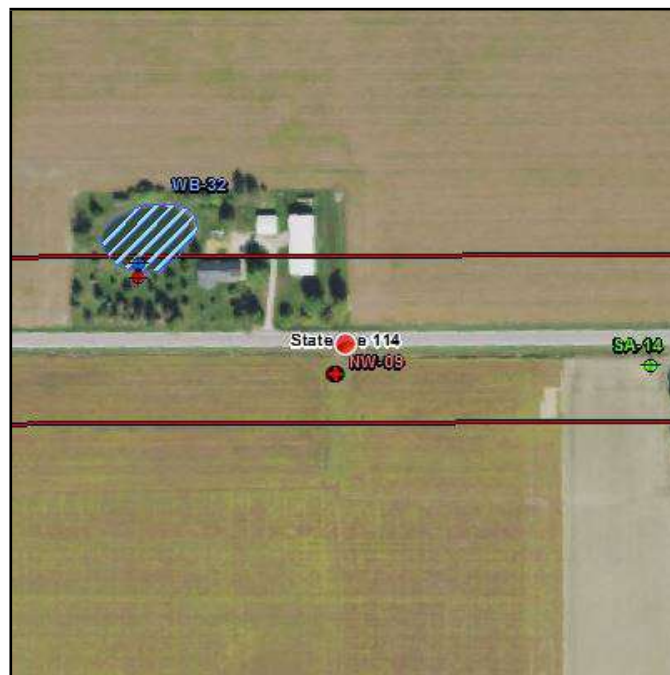
NW-09

Attributes	
Defined Bed and Bank	No
Waters of the US	No
Mapped on NHD	Yes
Mapped on NWI	No
Investigator	MCV
Flow Characteristics	No Evidence of Flow
Direction of Flow (Direction Downstream)	No Discernable Direction
Water Width at Crossing (ft)	No Water Noted
Water Depth at Crossing (ft)	No Water Noted
Top of Bank Width (ft)	N/A, No Defined Bank
Left Bank Height (ft) (Looking Downstream)	N/A, No Defined Bank
Right Bank Height (ft) (Looking Downstream)	N/A, No Defined Bank
OHWM Width (ft)	N/A, No OHWM Noted
OHWM Height (ft from substrate)	N/A, No OHWM Noted
Evidence of Scour or Erosion	No
OHWM Criteria	None Noted
Pools, Riffles, Runs Present?	None Noted
Substrate	Vegetated
